NATIONAL TRANSPORTATION SAFETY BOARD

ADDENDUM 2 – Electronic Devices - Passengers

Specialist's Factual Report By Sean Payne

Location: Lockhart, TX
Date: July 30, 2016
Aircraft: Balony Kubicek BB85Z
Registration: N2469L
Operator: Heart of Texas Hot Air Balloons, LLC.
NTSB Number: DCA16MA204

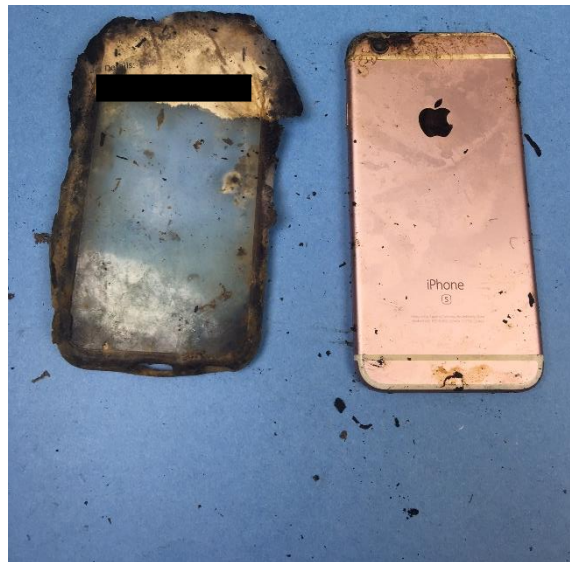
The Apple iPhone 6s arrived to the laboratory showing signs of thermal damage. The device's case was melted and the device's screen showed evidence of thermal damage. Figure 1 shows the device in its arrival condition at the laboratory.

Figure 1. The device in its arrival state. Some personal information has been redacted.

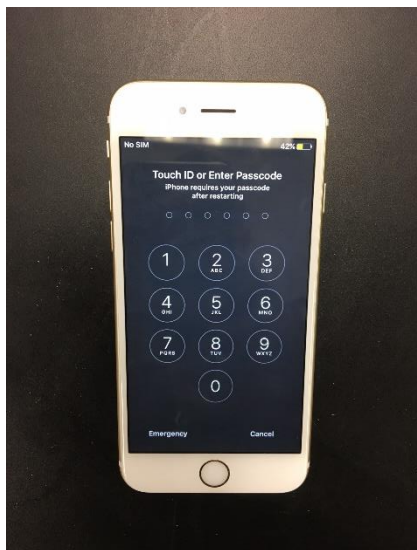
The device's main board was removed and placed into a surrogate device (figure 2). The device was able to power, but was passcode locked.

Figure 2. The device working in a surrogate.

Although after the accident a third party company had developed a method to determine the device's passcode, evidence had already been recovered from other devices including photos taken just moments before the accident. In agreement with the Investigator in Charge, unlocking the device was not pursued.

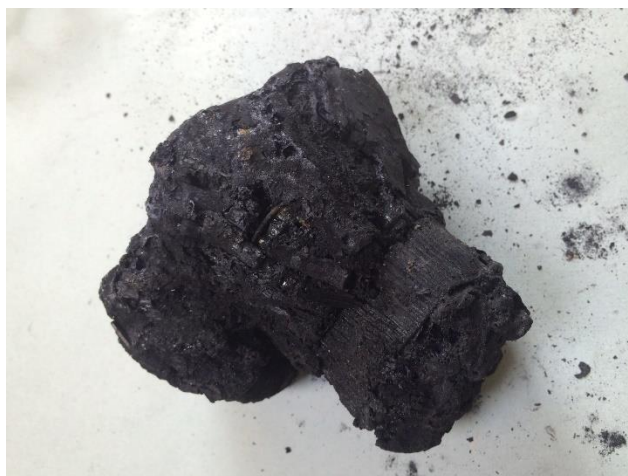
The Canon EOS Rebel T5 arrived to the laboratory showing signs of thermal damage. The device's screen was destroyed. All electronic control mechanisms and buttons were either melted or physically damaged. The device's externally removable lens was melted to the camera. Figure 3 shows the device's arrival condition. Figure 4 shows the bottom of the device. The battery and memory card door was intact, but physically displaced and melted. The serial number was read from the underside of the device.

Figure 3. The device's arrival condition.

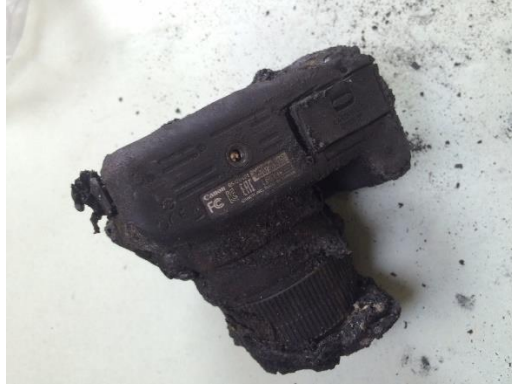
Figure 4. The underside of the device, including the battery and memory card door.

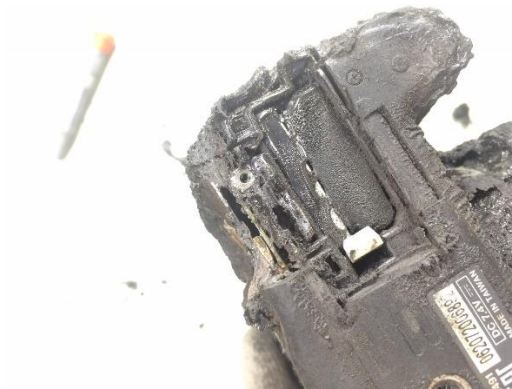
The memory card and battery door were removed. The battery was intact and melted. Melted remnants of an SD card were present. Figure 5 shows the battery door area with the battery and SD card in place.

Figure 5. The device's battery and memory card door removed.

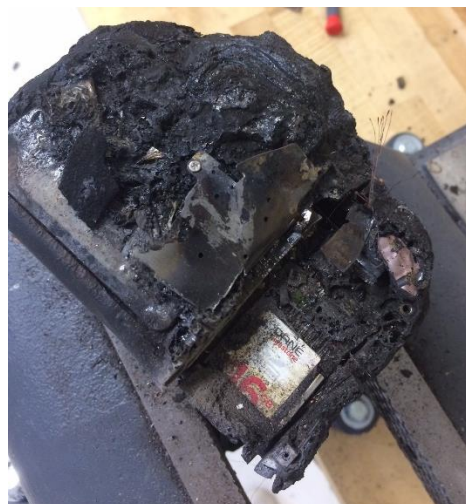
The area around the SD card and battery was cut away. The battery was removed, exposing the SD card (figure 6). The SD card was removed (figure 7).

Figure 6. The area around the SD card was removed.

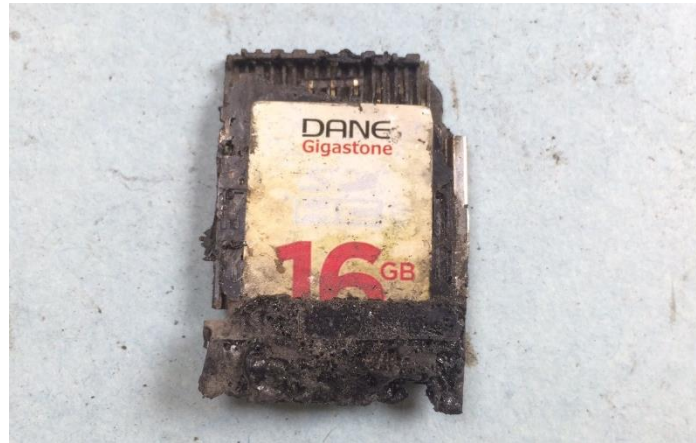
Figure 7. The SD card was removed.

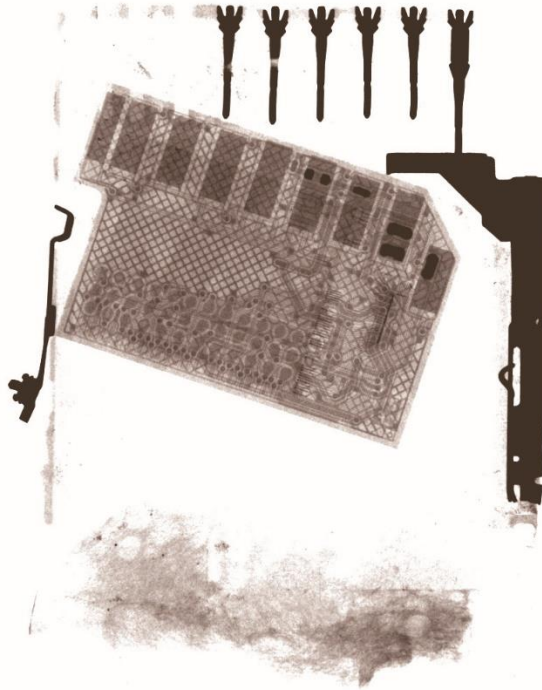
The SD card showed signs of heavy thermal and physical damage. The SD card was X-rayed. The X-ray did not reveal any obvious damage to the SD card's silicon chip (figure 8).

Figure 8. An x-ray image of the SD card.

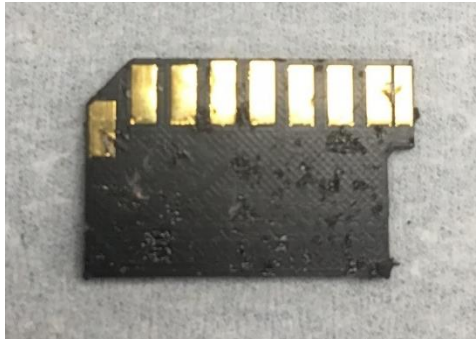
The silicon memory chip was removed from the SD card plastic package using a file and razor blade (figure 9).

Figure 9. The SD card's associated silicon chip removed.

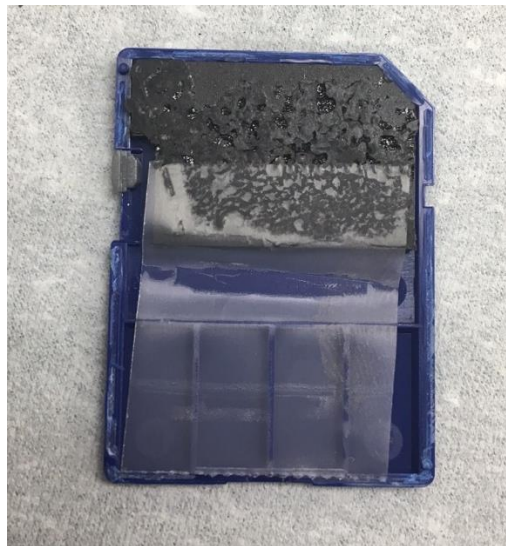
The silicon chip was inserted into a surrogate SD card package. The silicon chip/SD surrogate package combination was then interfaced with a PC (figure 10). Using a variety of different SD card readers, the silicon chip/SD surrogate package was not recognized by the PC. No data was recovered from the silicon chip.

Figure 10. The silicon memory chip interfaced with a SD card package prior to a readout attempt.

Neither the Apple iPhone 6s or the Canon EOS Rebel T5 produced any digital evidence.
