NATIONAL TRANSPORTATION SAFETY BOARD
Vehicle Recorder Division
Washington, D.C. 20594

Agricultural Aerial Spraying Electronic Devices

Specialist's Factual Report
by Bill Tuccio, Ph.D.

NTSB Number: WPR16FA148AB

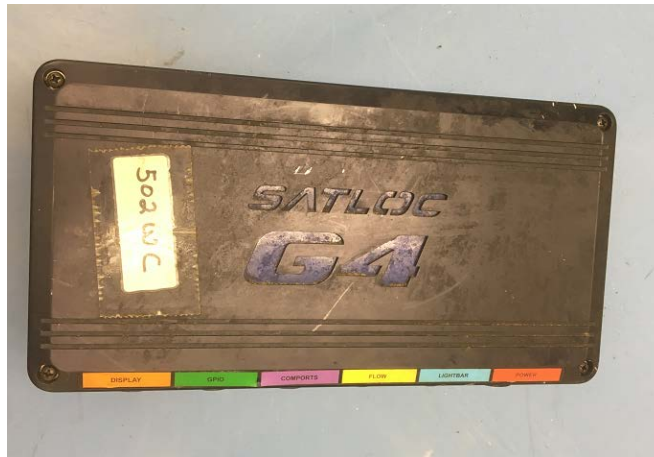
Figure 1. Satloc G-4, as received.

Upon arrival at the Vehicle Recorder Division, an exterior examination revealed the device had sustained minor damage, as shown in figure 1. The device was opened, and the eSata “1” solid-state drive (shown in figure 2) was intact, removed, and downloaded. The pertinent historical log file was decoded using the manufacturer’s Mapstar software.

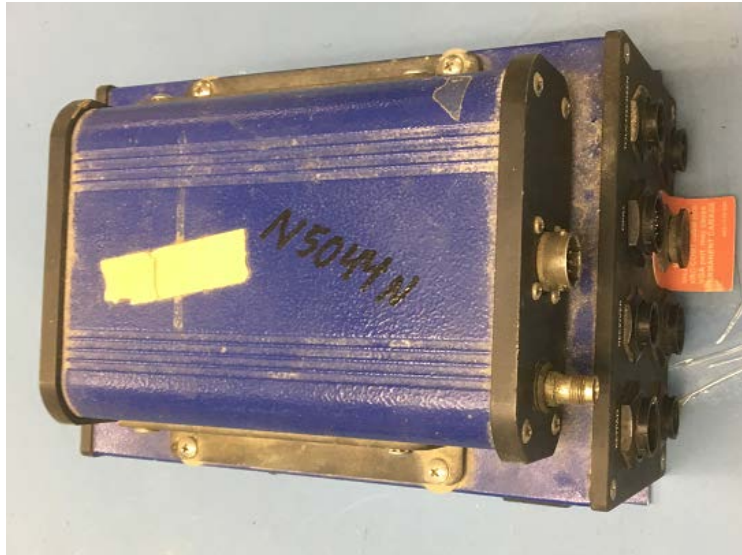
Figure 3. Satloc M3 CPU.

Upon arrival at the Vehicle Recorder Laboratory, an exterior examination revealed the unit had sustained minor damage, as shown in figure 3. The compact flash card, shown in figure 4, was removed and the contents downloaded. Additionally, the internal 1GB SATA flash drive, shown in figure 5, was removed; however, download attempts were unsuccessful.

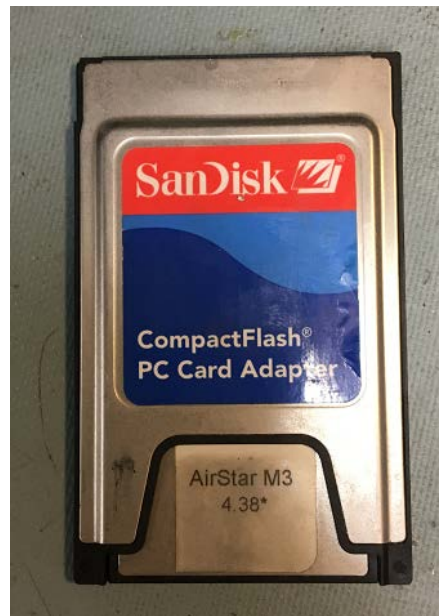
Figure 4. Compact flash card from Satloc M3 CPU.

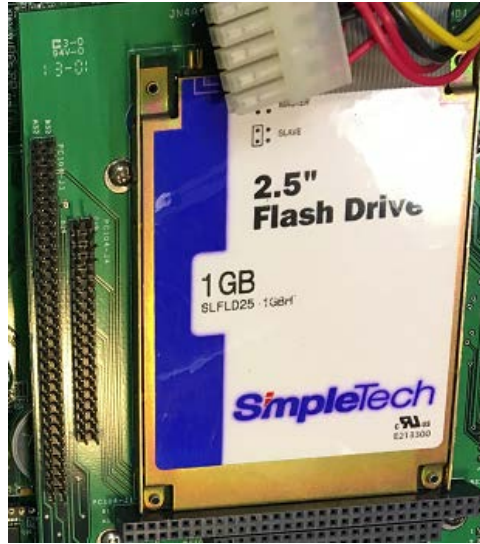
Figure 5. Satloc M3 CPU internal 1GB flash drive.

The compact flash card contained 95 log files from June, 2016, through the date of the accident on July 23, 2016. The accident day file only contained ground operations between 0531 and 0532 (time zone not verified). According to the manufacturer, the Satloc M3 was an older generation unit and only copied data from volatile memory to non-volatile memory when a new log was started, which typically was the result of a pilot action. Further, the manufacturer indicated the 1GB internal SATA drive contained no data and only contained operating system related files.

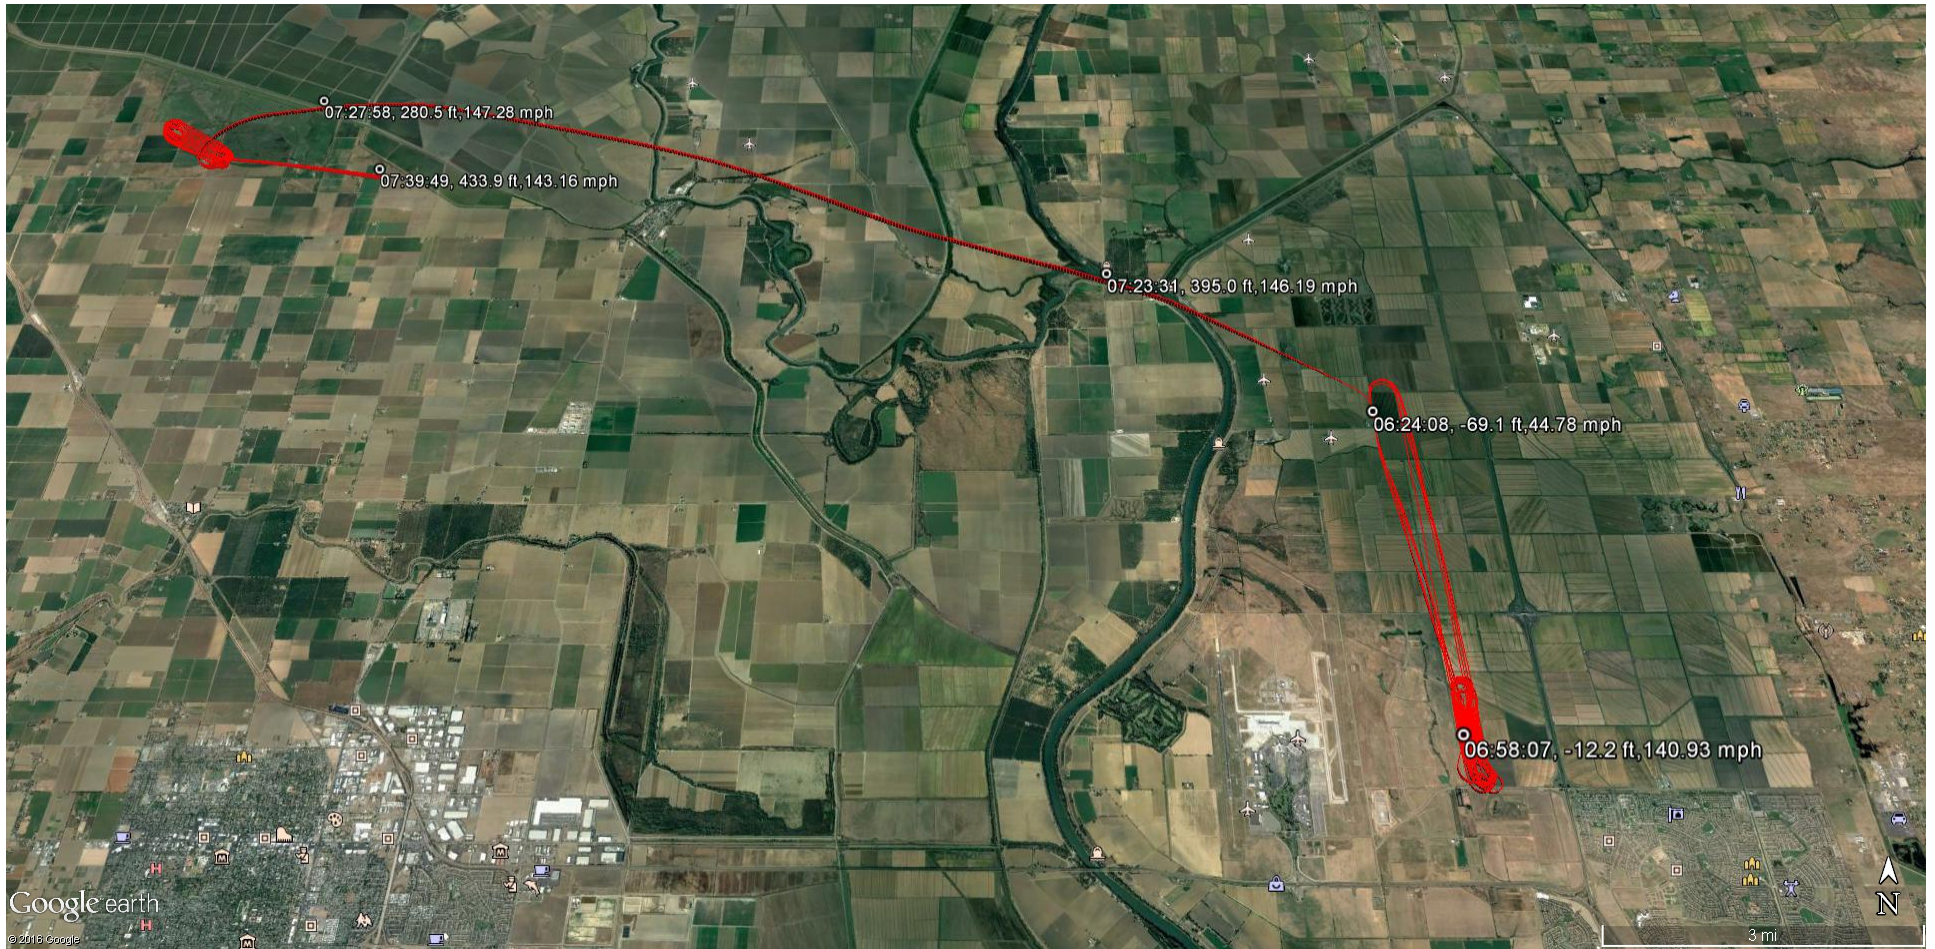
Figure 6. N502WC entire accident flight recording.

The weather and lighting conditions shown in figures 6 and 7 are not necessarily representative of those at the time of the accident. The overlays were created using Google Earth. Only data from N502WC (the aircraft with the Satloc G-4 installed) were recovered.

Figure 1 and 2 show the recovered data on a satellite overlay. The data ended as N502WC was travelling eastbound at about 143 miles per hour (mph).

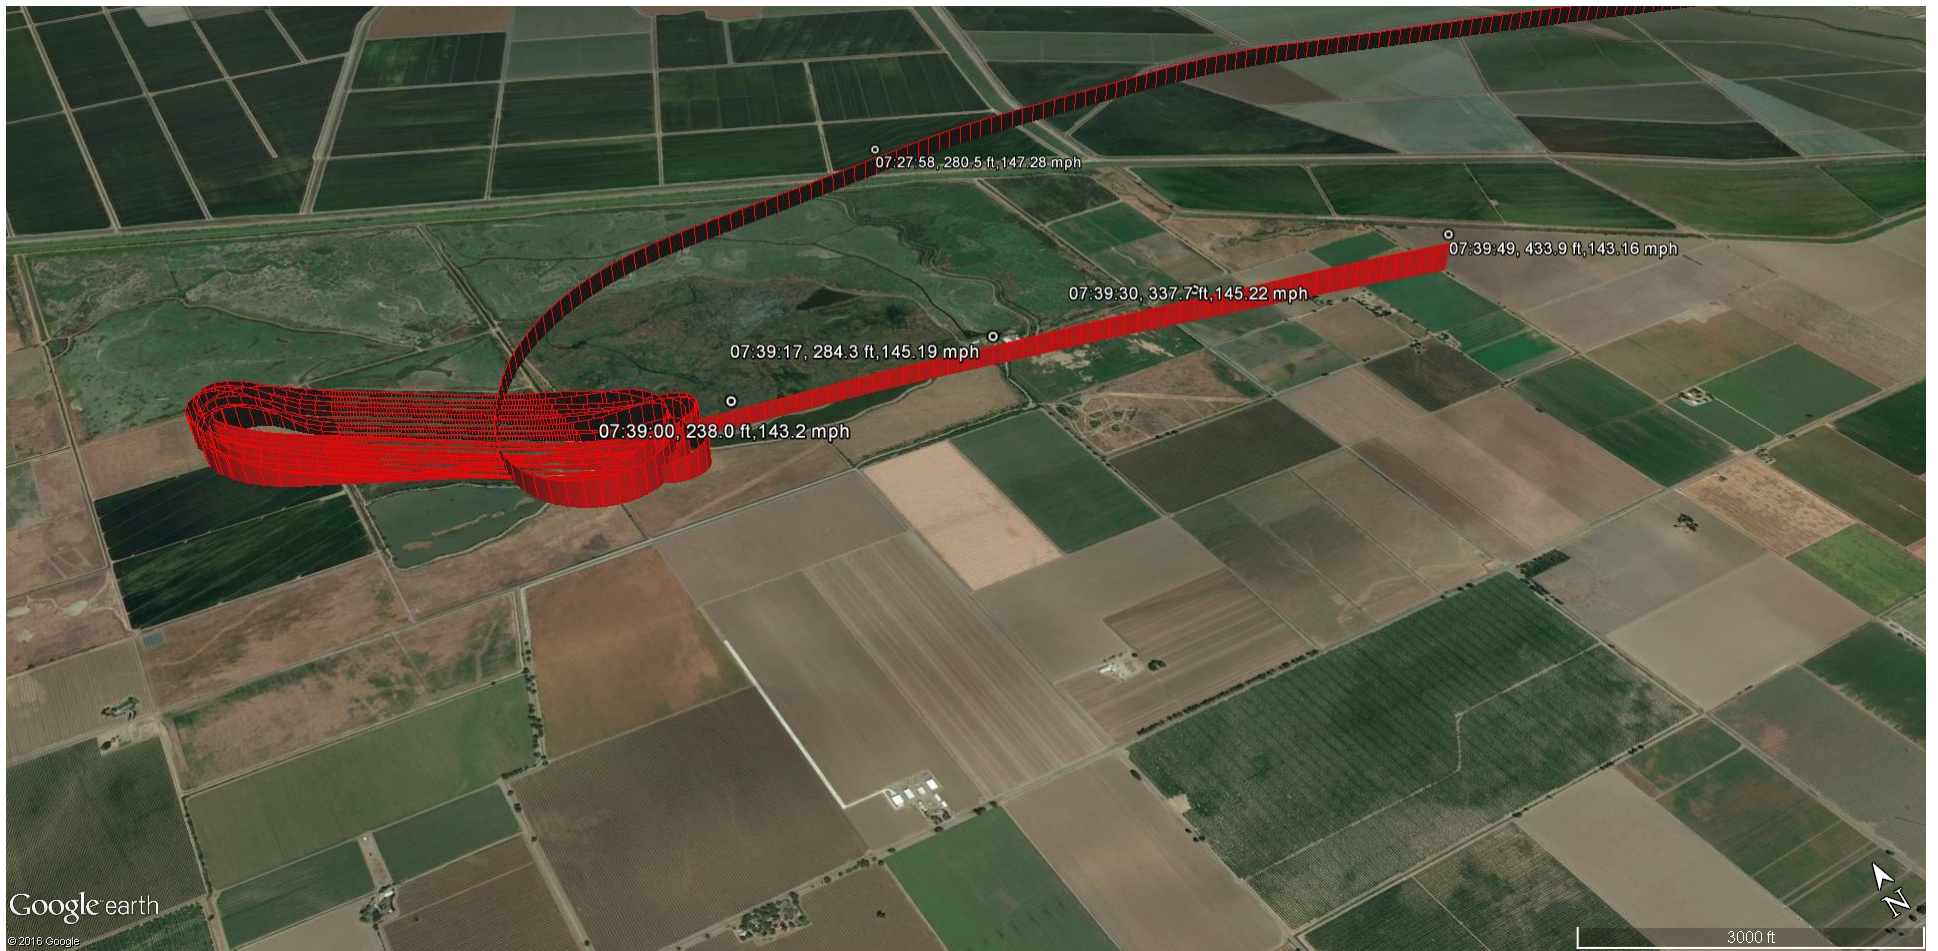
Figure 7. N502WC end of accident flight recording.
