Factual Report – Attachment 1
Figures and Illustrations

AIR TRAFFIC CONTROL

DCA17FA109

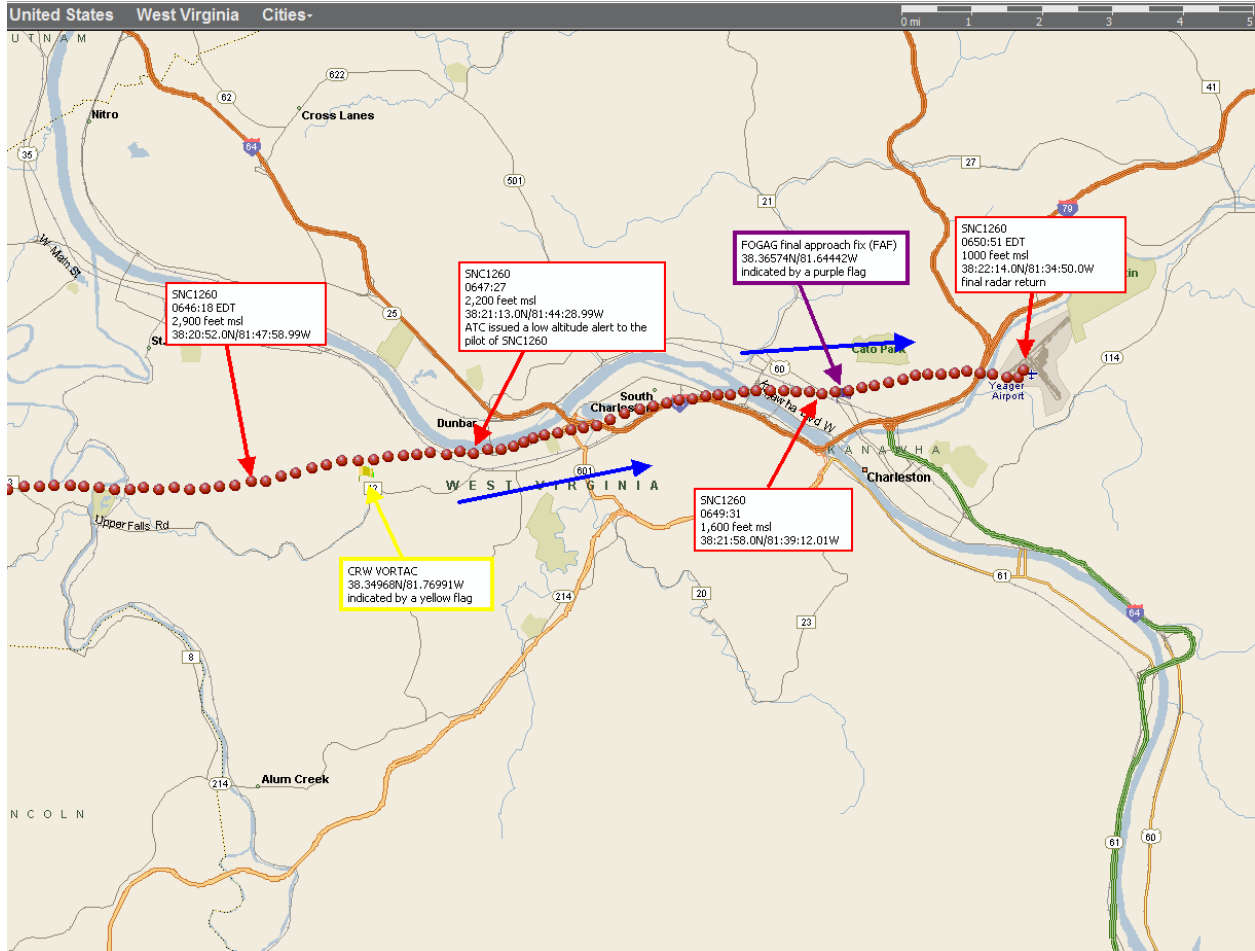
Figure 1 – Radar flight track of SNC1260 on May 5, 2017. Radar returns are indicated by red dots. The direction of flight is indicated by blue arrows. The CRW VORTAC location is indicated by yellow flag. The FOGAG final approach fix is indicated by a purple flag.

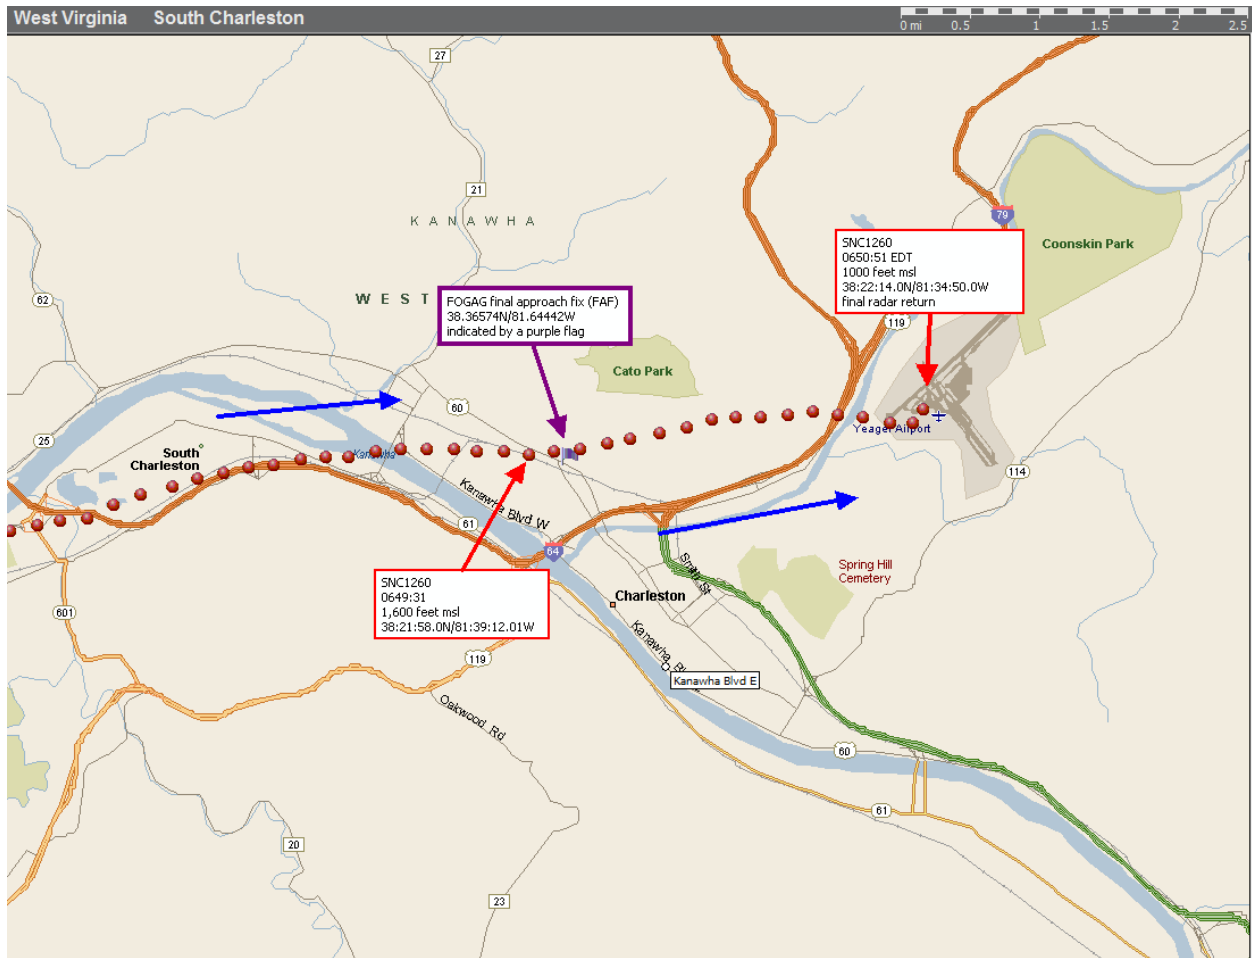
Figure 2 – Radar flight track of the final portion of flight of SNC1260 on May 5, 2017. Radar returns are indicated by red dots. Direction of flight is indicated by blue arrows. The FOGAG final approach fix is indicated by a purple flag.

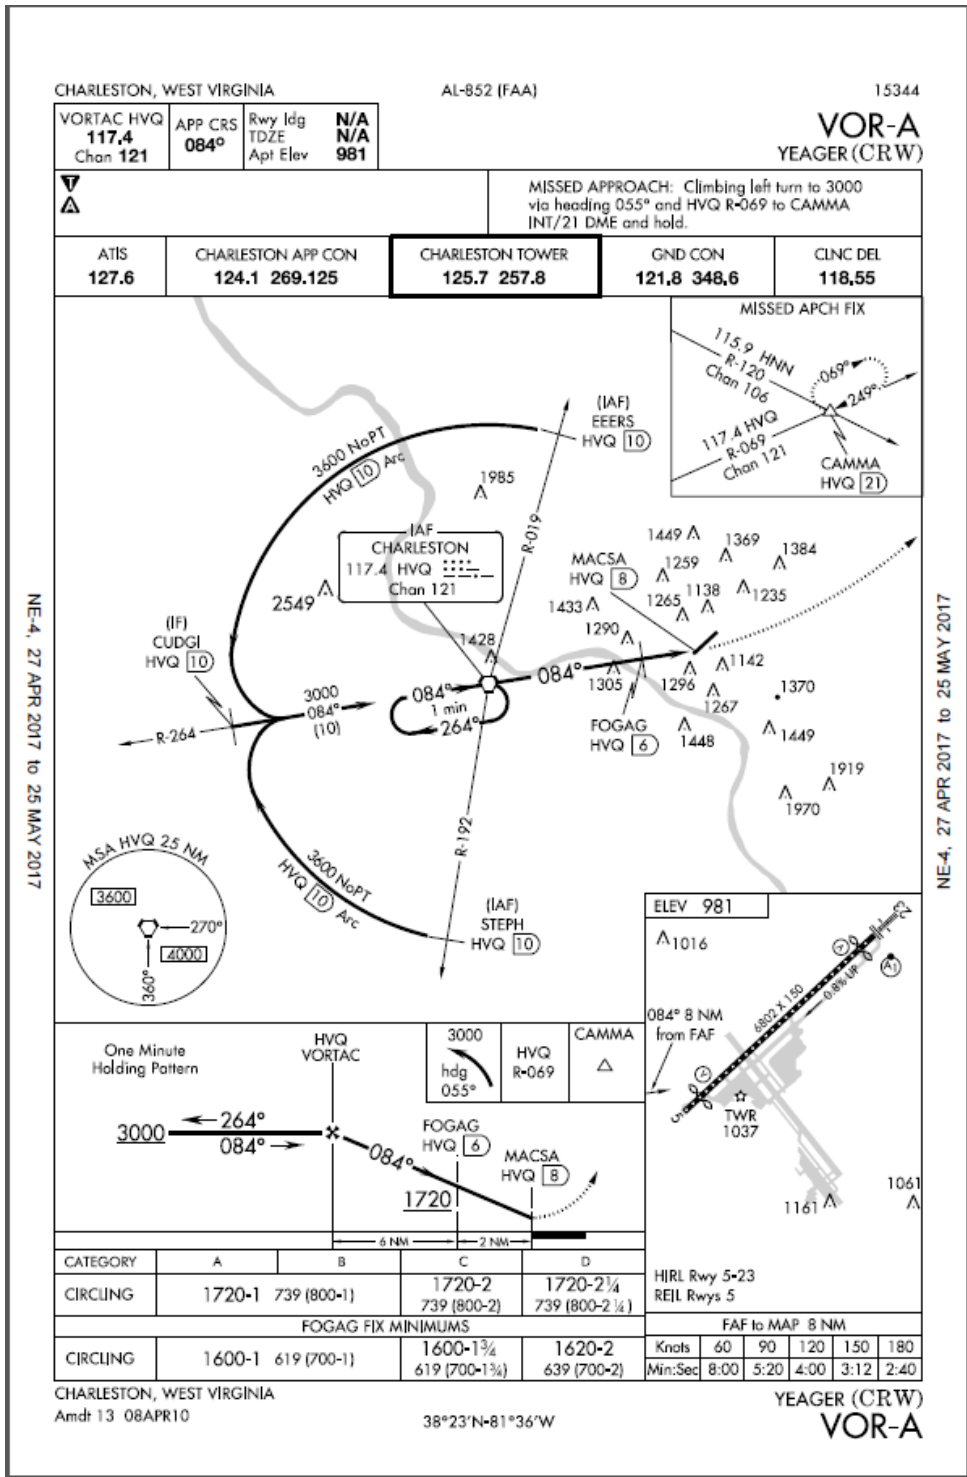
Figure 3 – The VOR-A approach procedure to CRW
