NATIONAL TRANSPORTATION SAFETY BOARD

Aircraft Performance Study

Location: Birmingham, AL
Date: August 14, 2013
Time: 04:47 Central Daylight Time (CDT)
09:47 Universal Coordinated Time (UTC)
Aircraft: Airbus A300 F4-622R, registration N155UP
NTSB#: DCA13MA133

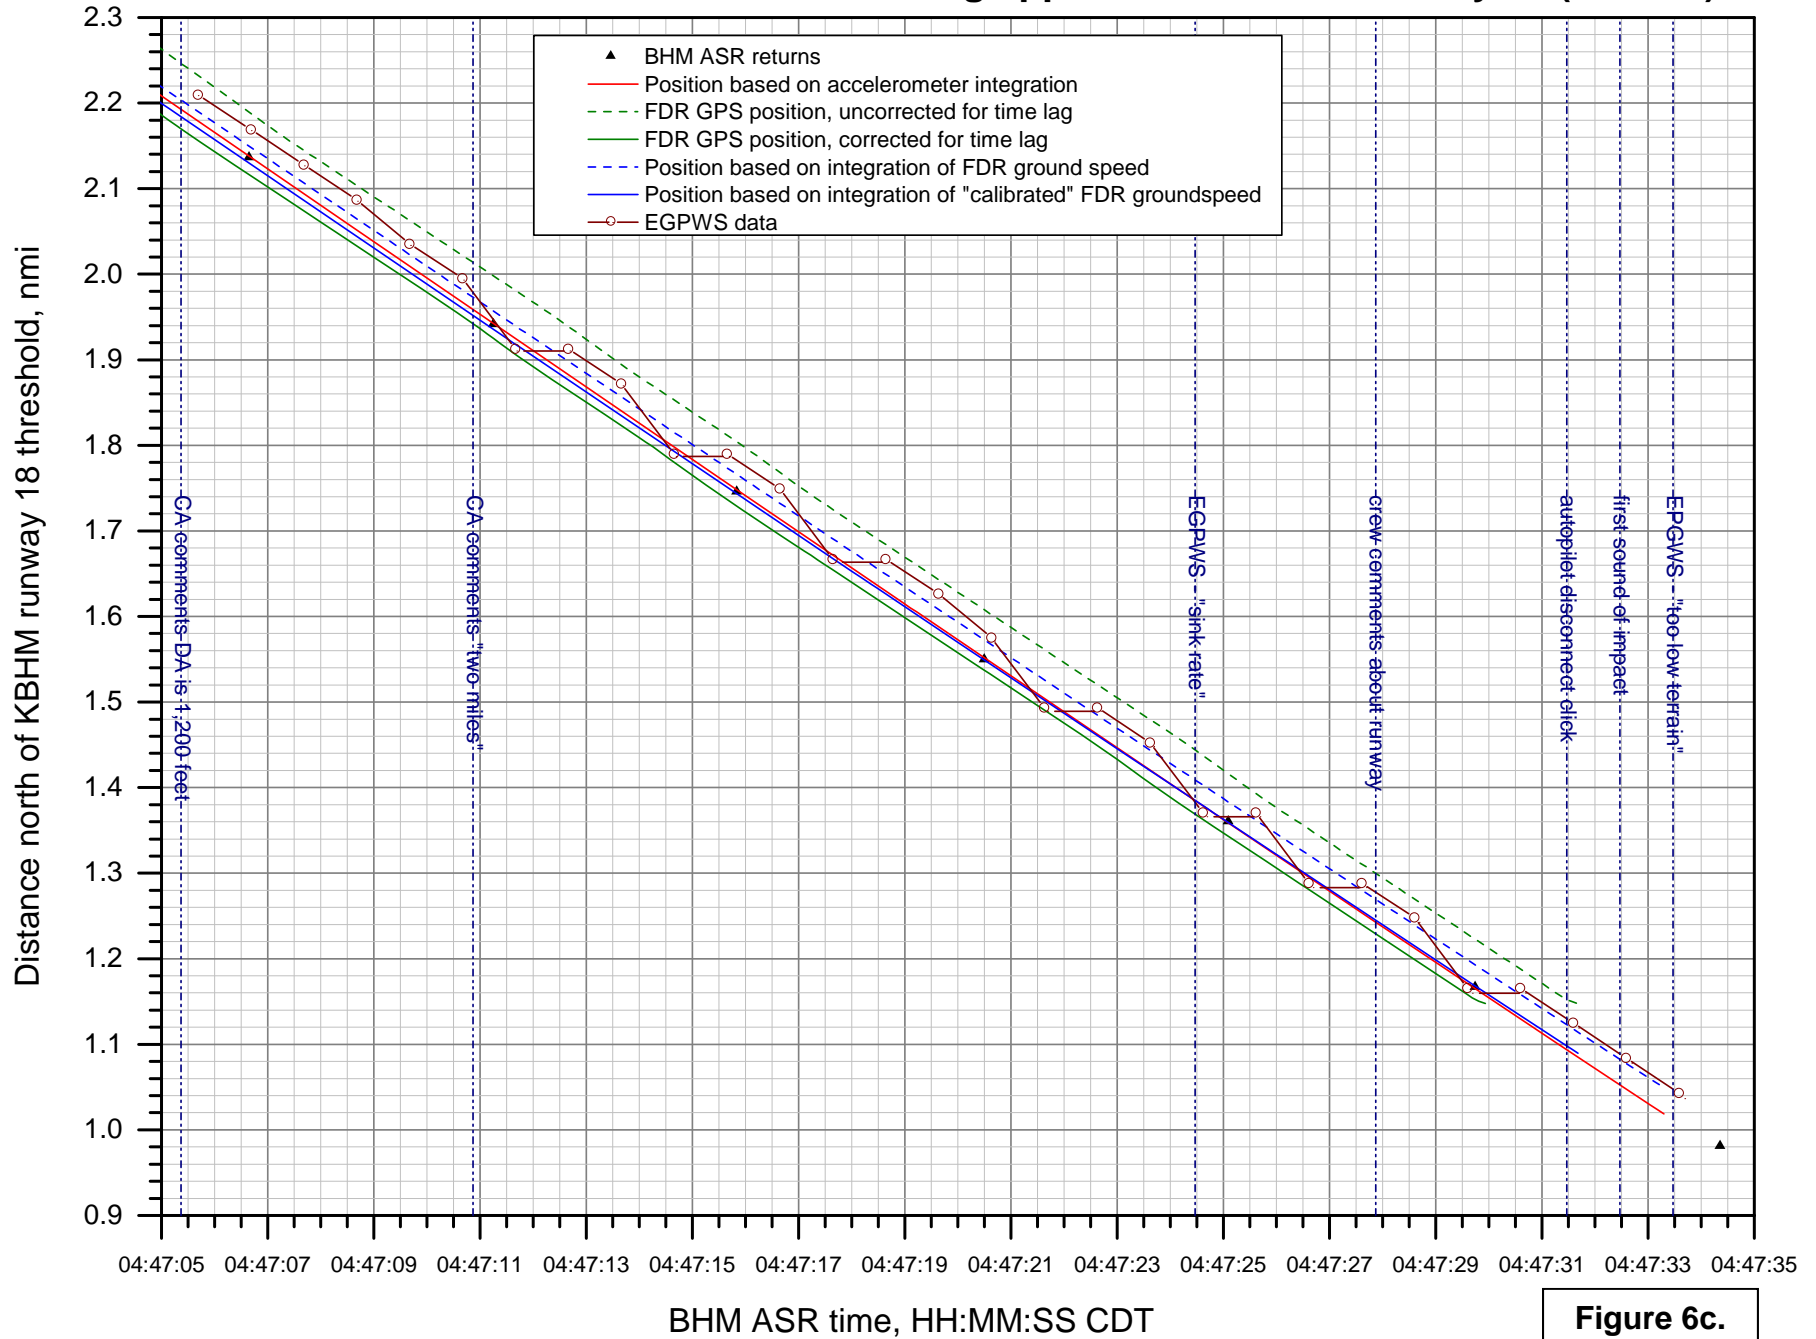
Figure 6c.

Distance north of threshold vs. time during approach to KBHM runway 18 (detail 2)

runway 18 localizer about 12 nmi north of the threshold. The COLIG, BASKN, and IMTOY approach fixes are also shown in the Figure, along with selected, paraphrased comments from the CVR transcript, shown at the points along the flight path at which they occurred. The ASR-9 radar returns are labeled with the time of the return (in HH:MM:SS CDT), and the FDR pressure altitude, corrected for the altimeter setting of 29.97 "Hg, and for time lags in the FDR altitude data (see Section D-V for more information about this correction). The actual CVR transcript text corresponding to the paraphrased comments shown in Figure 4 (and other Figures throughout this *Study*) are shown in Table 3. Figure 5 shows altitude vs. time during the approach, and Figure 7 shows a profile view (altitude vs. distance north of the threshold). More detailed plots of the final approach, from about 5 nmi north of the threshold, are shown in Figures 6-9.

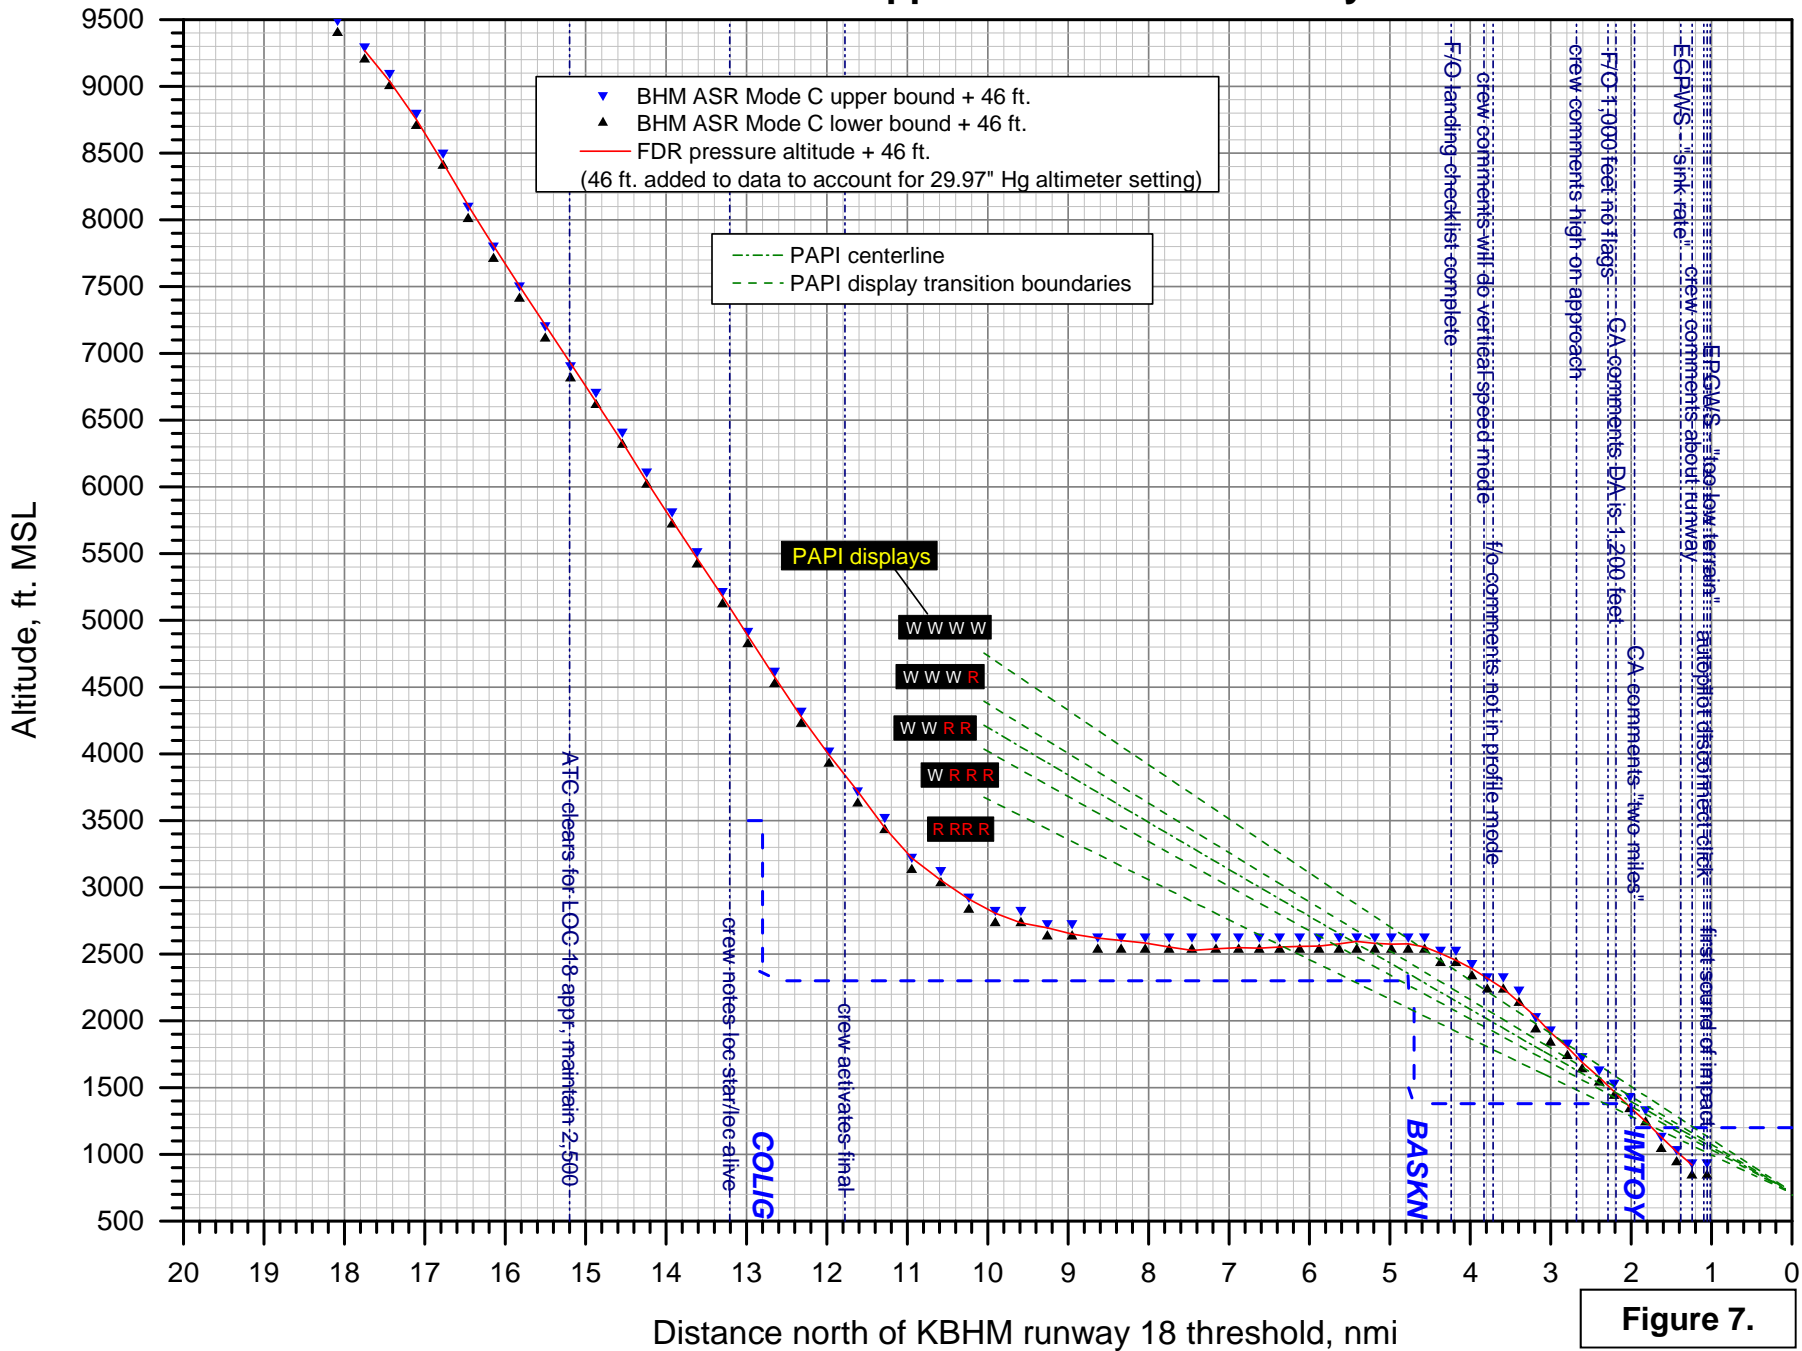
Figure 7.

Profile view of approach to KBHM runway 18

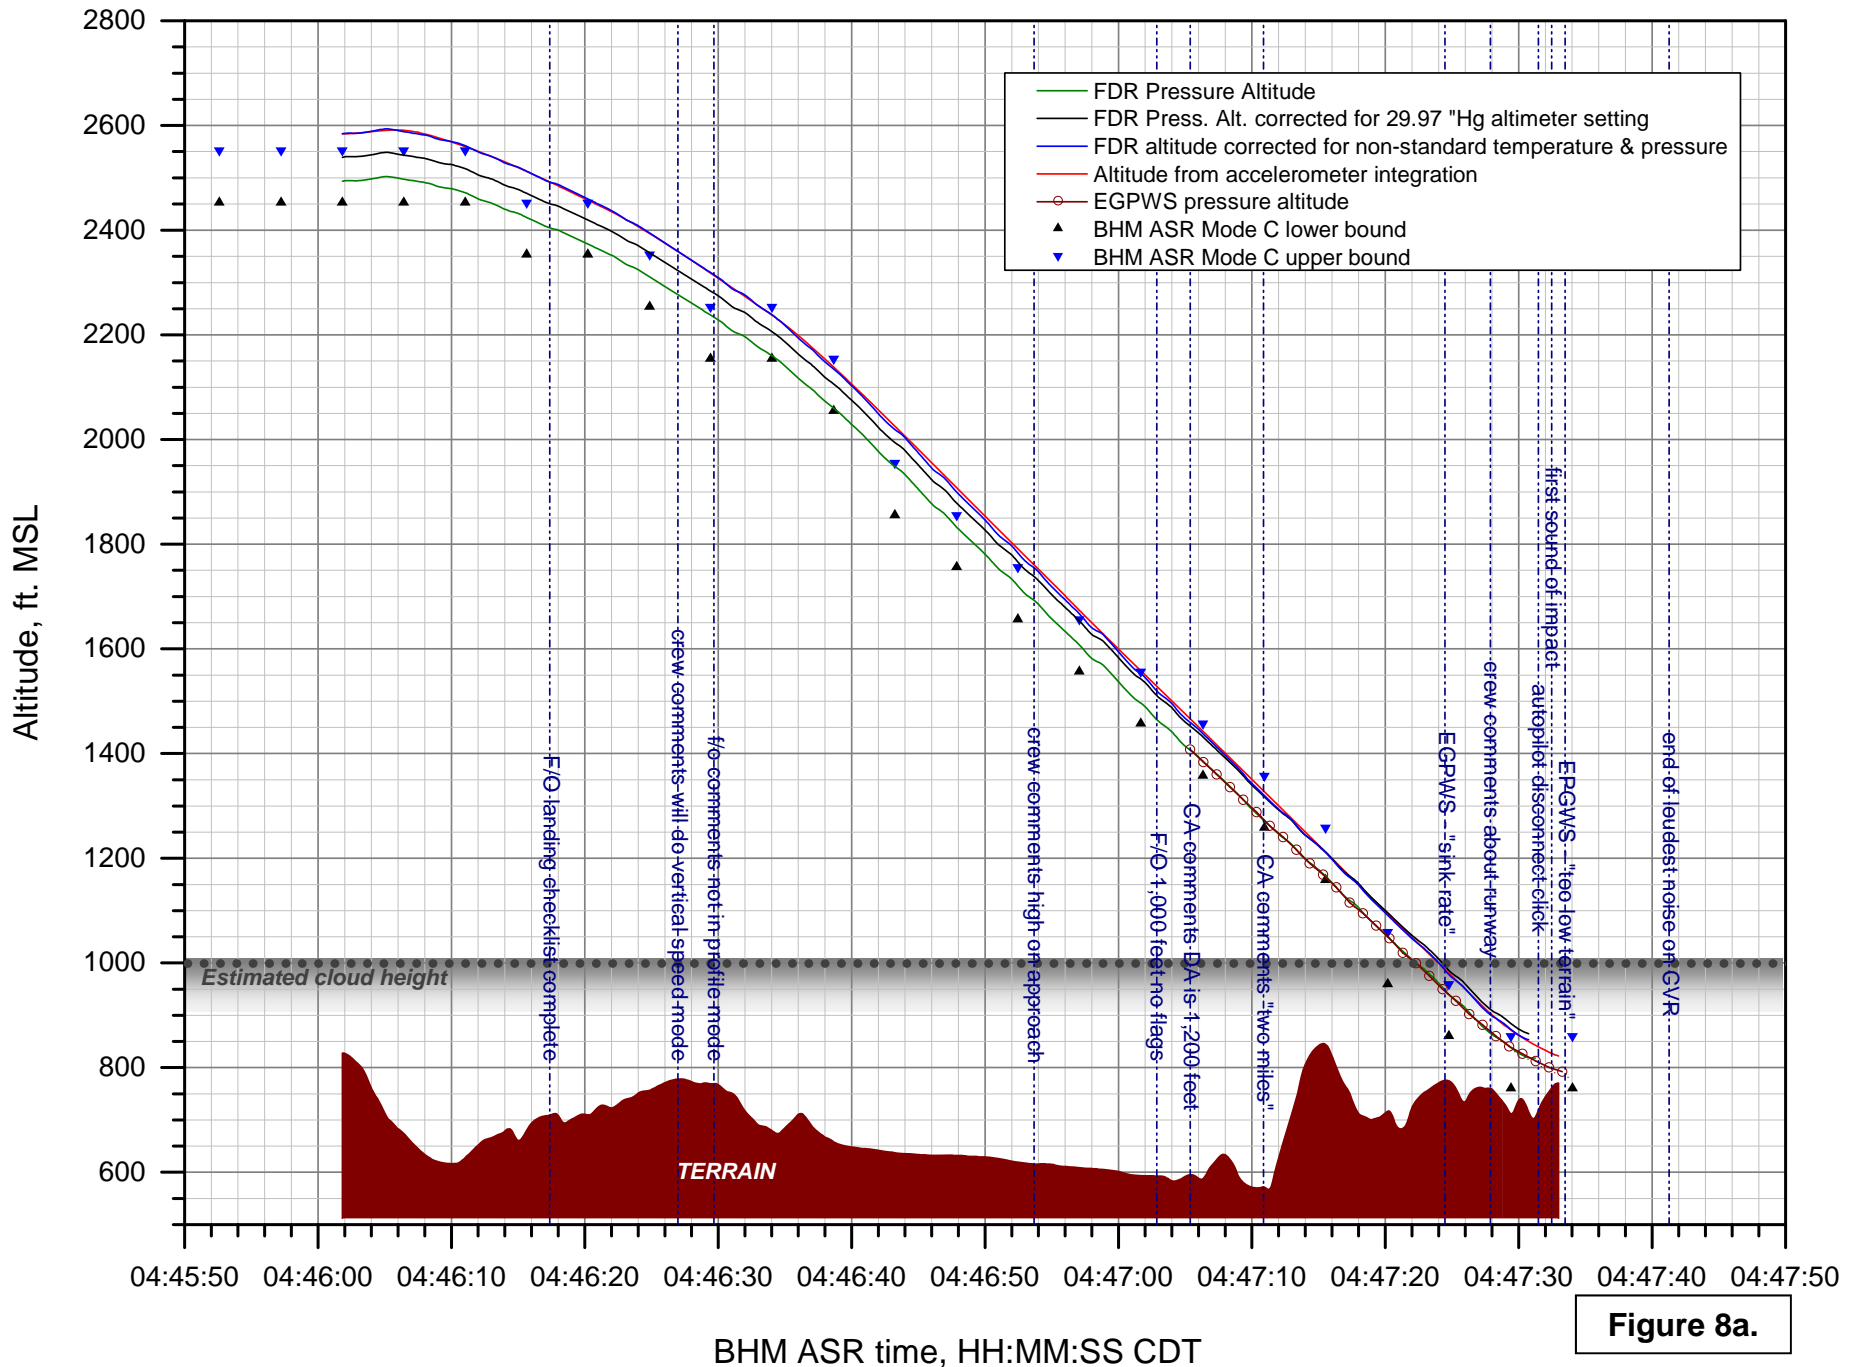
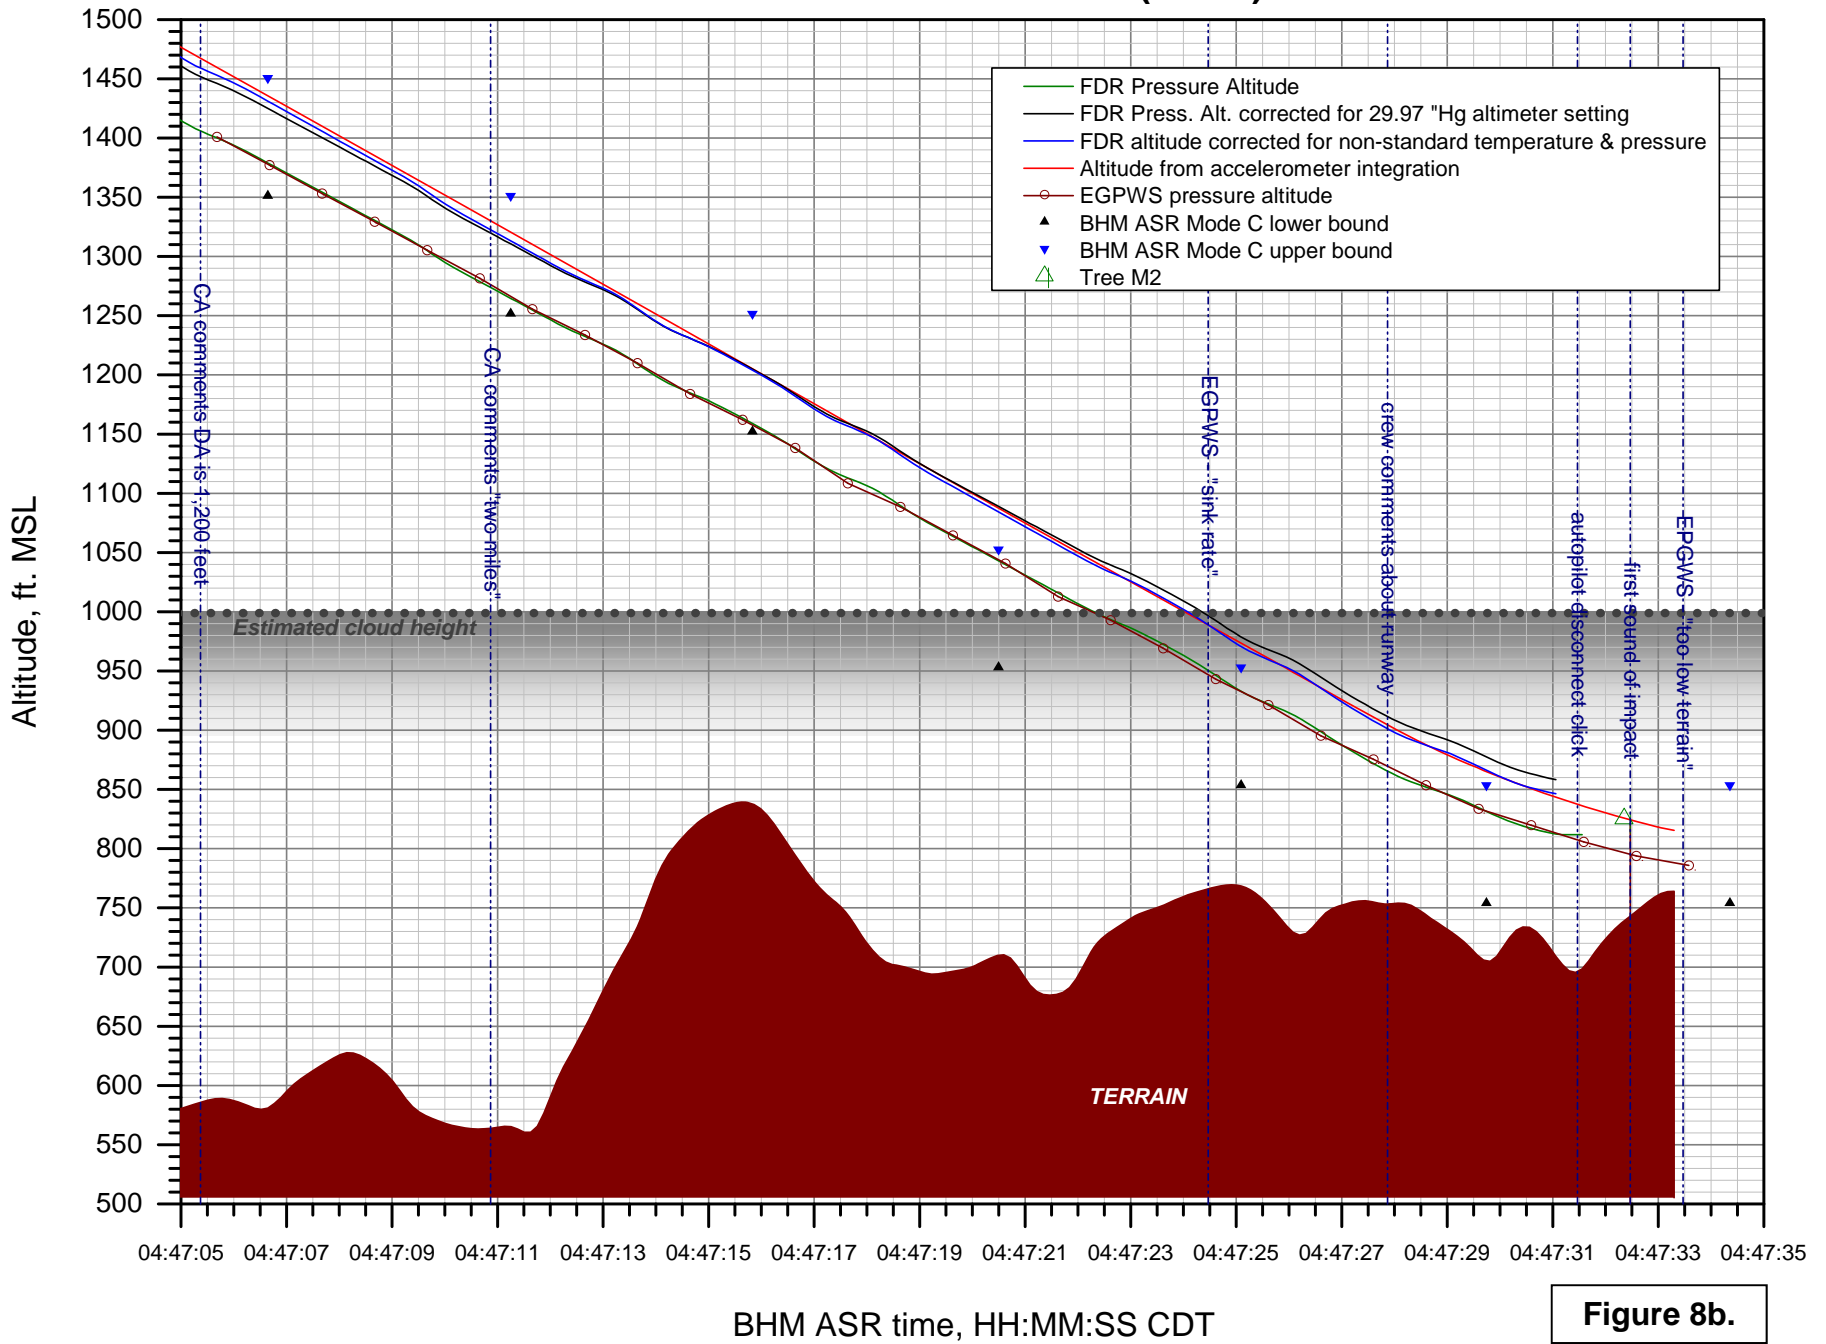
Figure 8b.

MSL altitude vs. time

MSL altitude vs. time (detail)

Figures 8, 9, and 24 depict a heavy dotted line labeled “Estimated cloud height.” This line represents an estimate of the MSL altitude at which the airplane landing lights first become visible on a security video (hereafter, called “the video”) from a camera located on a private hangar at the airport.¹⁹ It should be noted that:

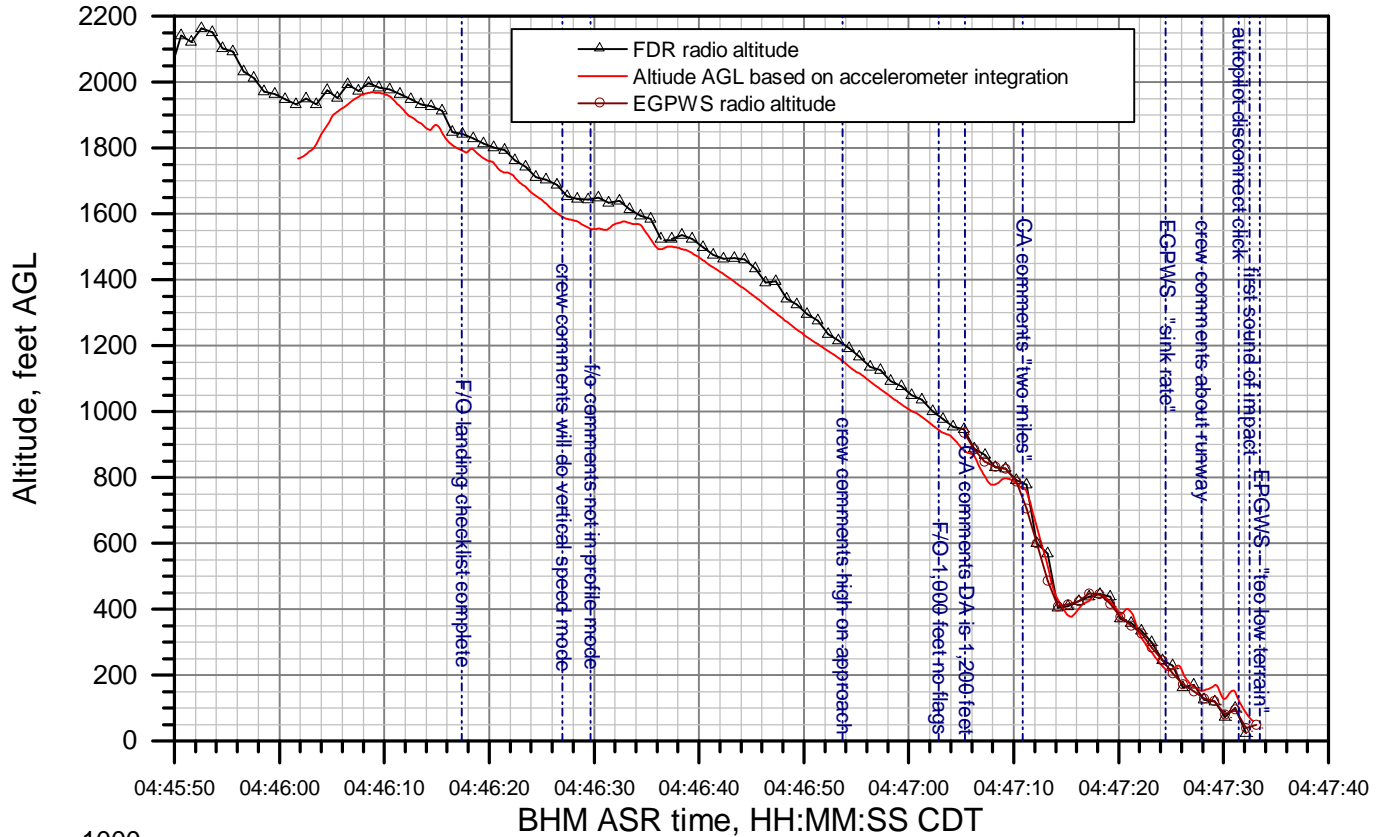
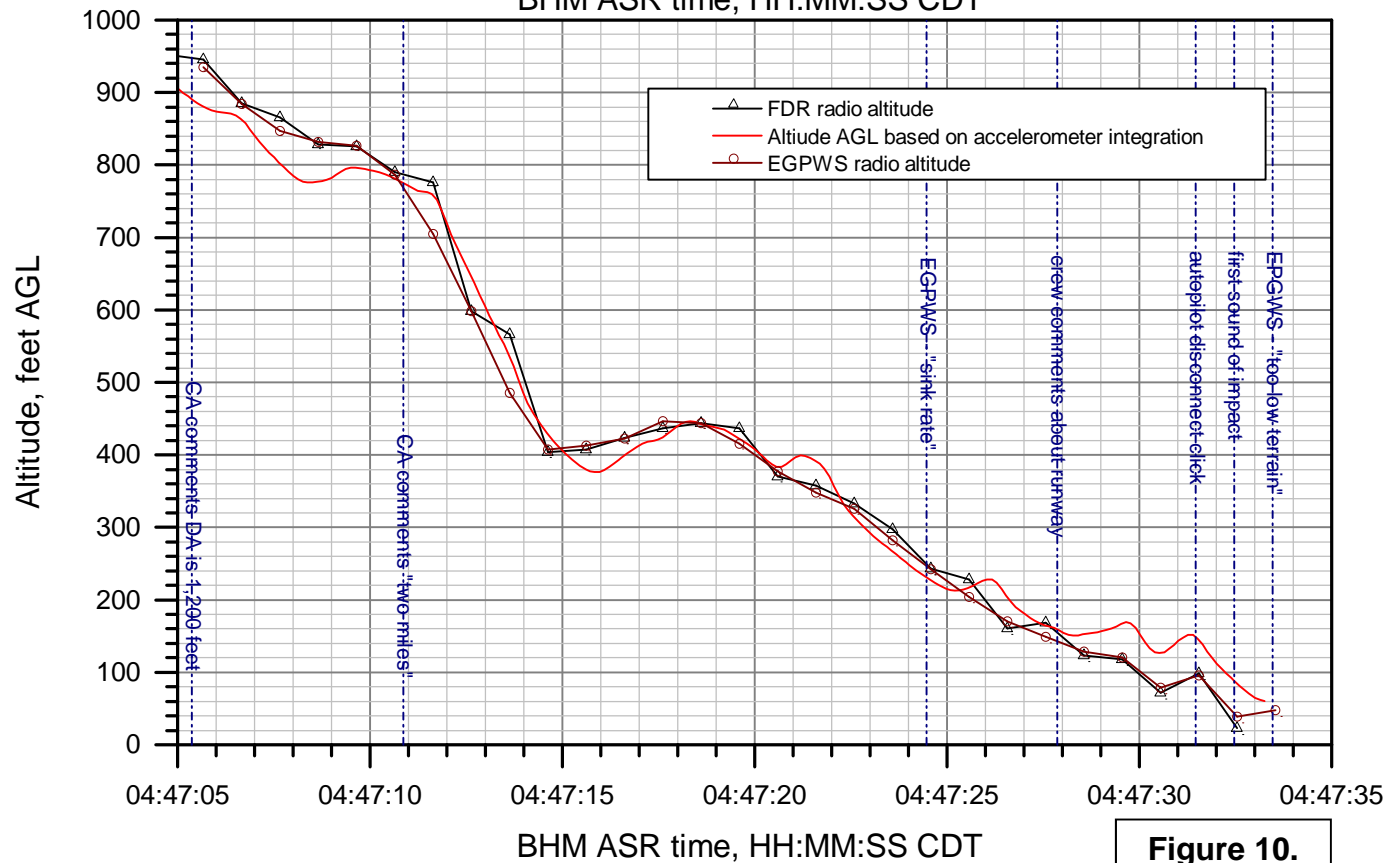
Figure 10.

AGL altitude vs. time

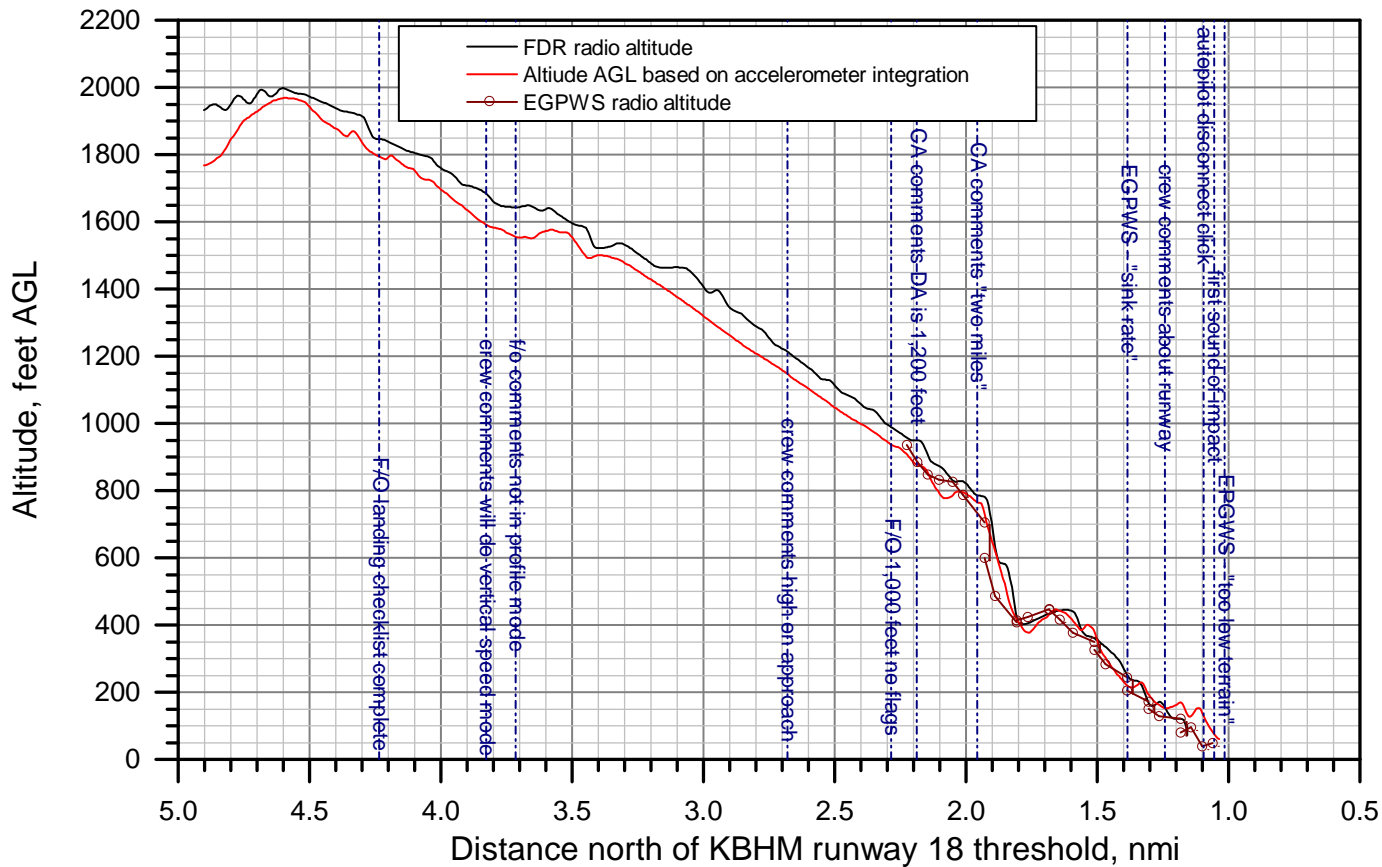
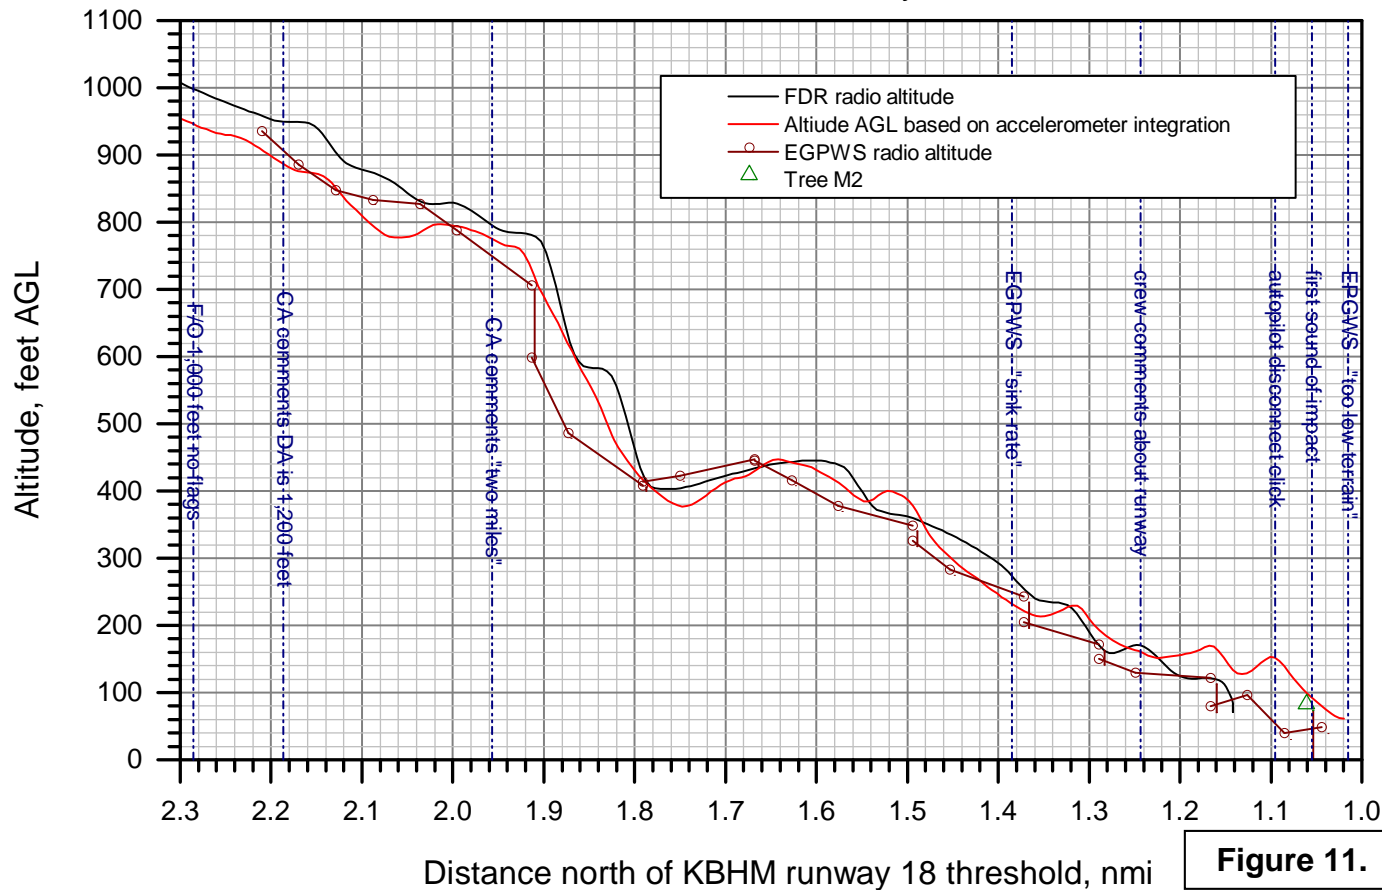
Figure 11.

AGL altitude vs. distance north of threshold

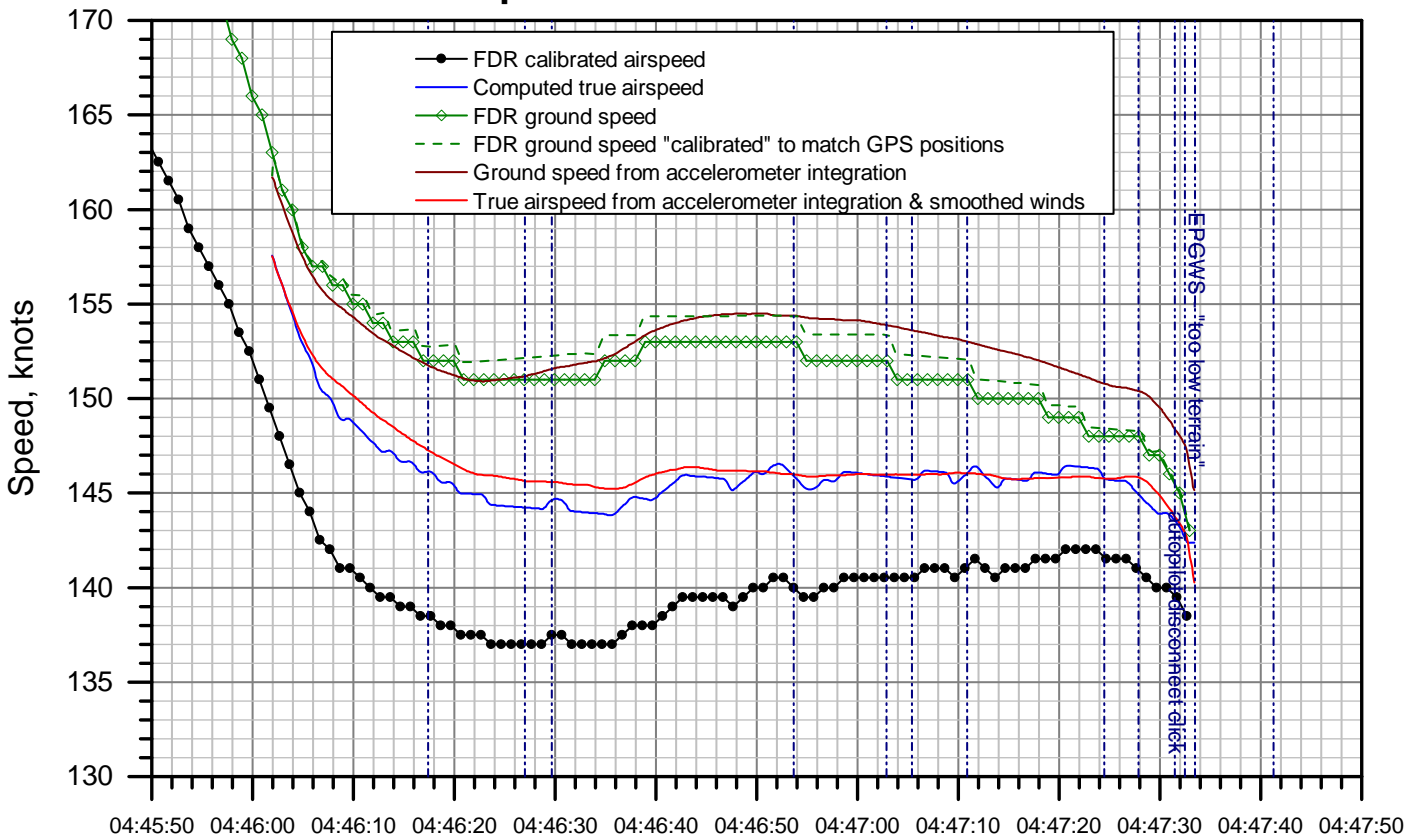
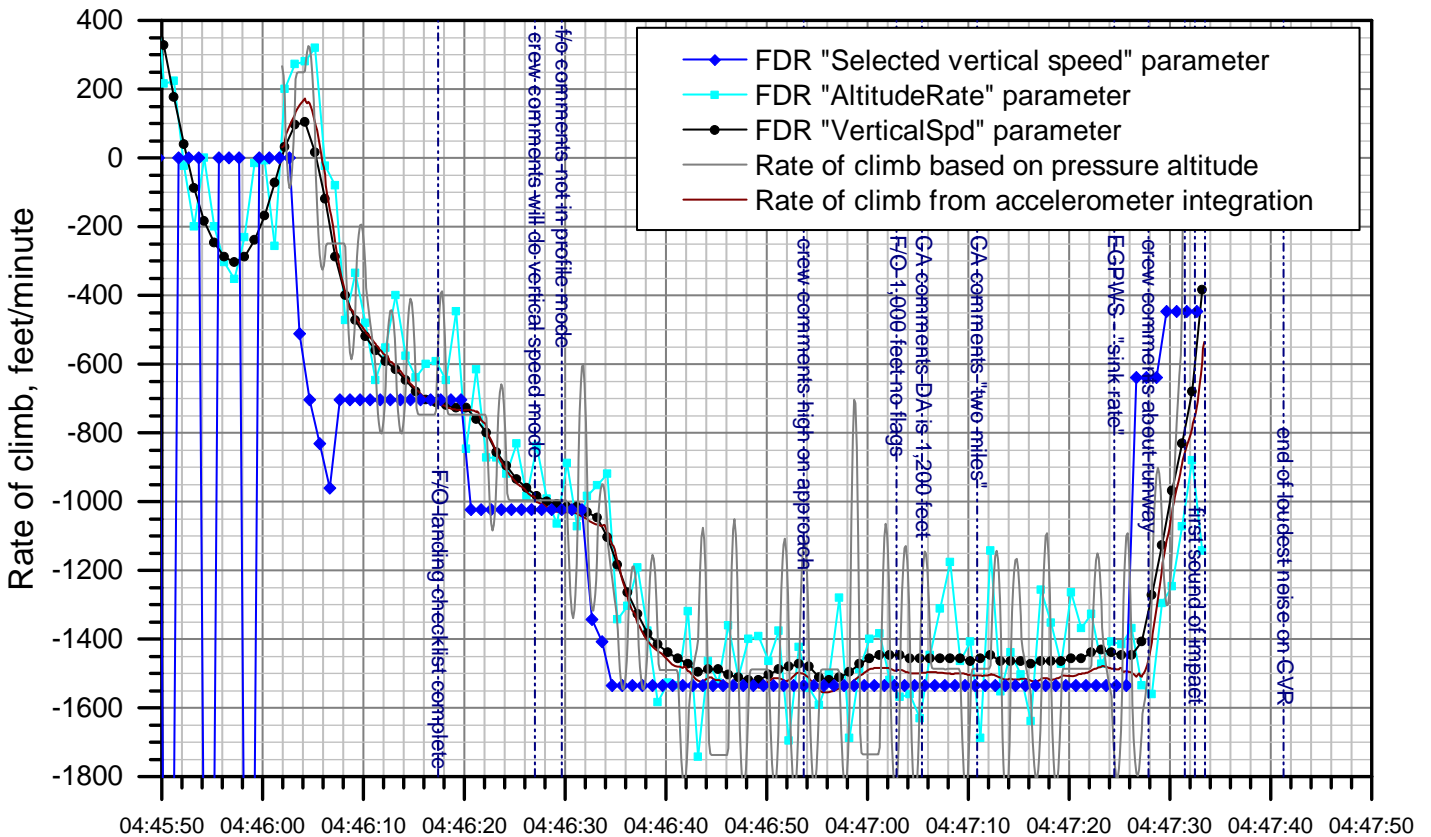
Figure 12a.

Speed and rate of climb vs. time

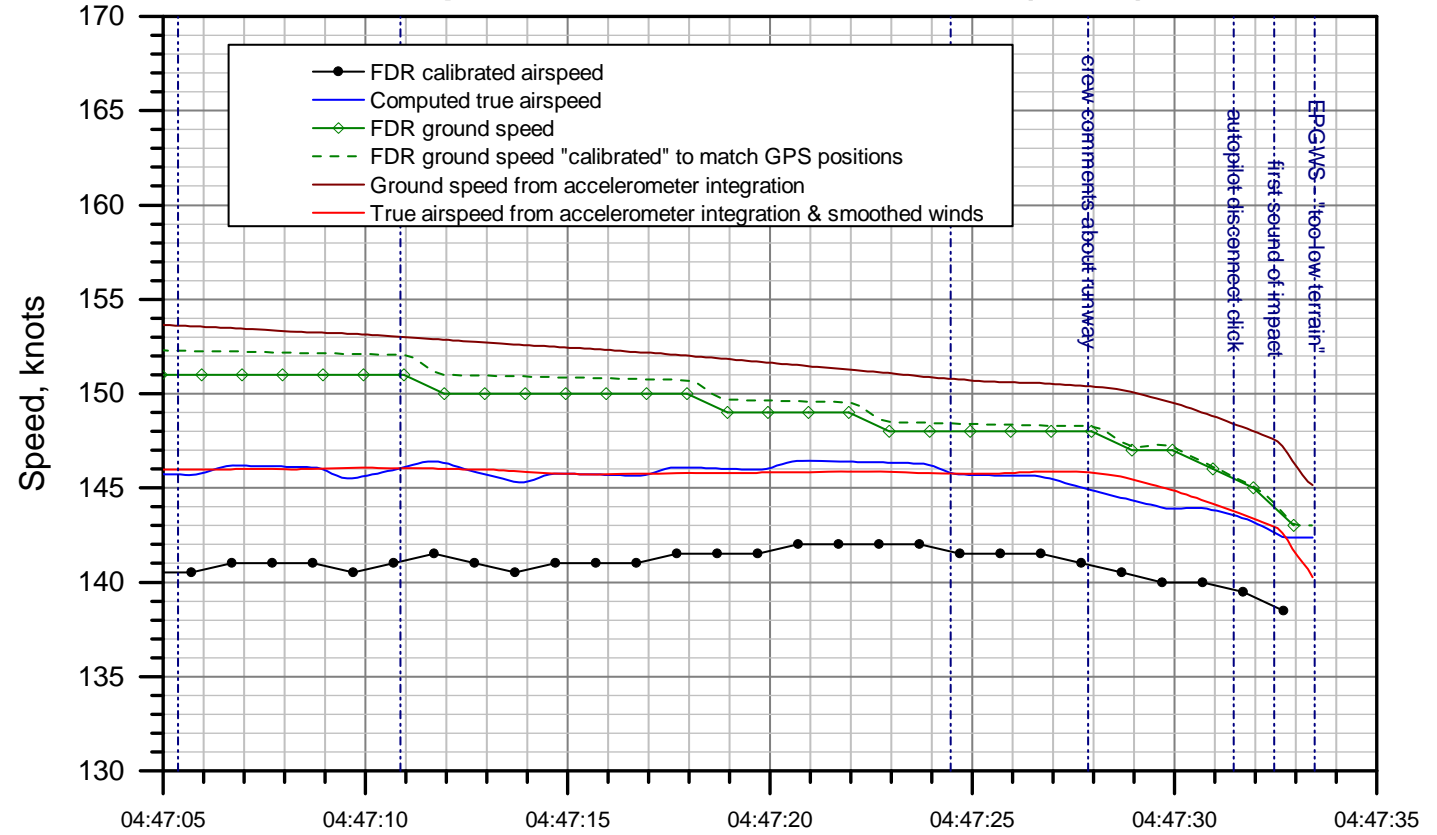
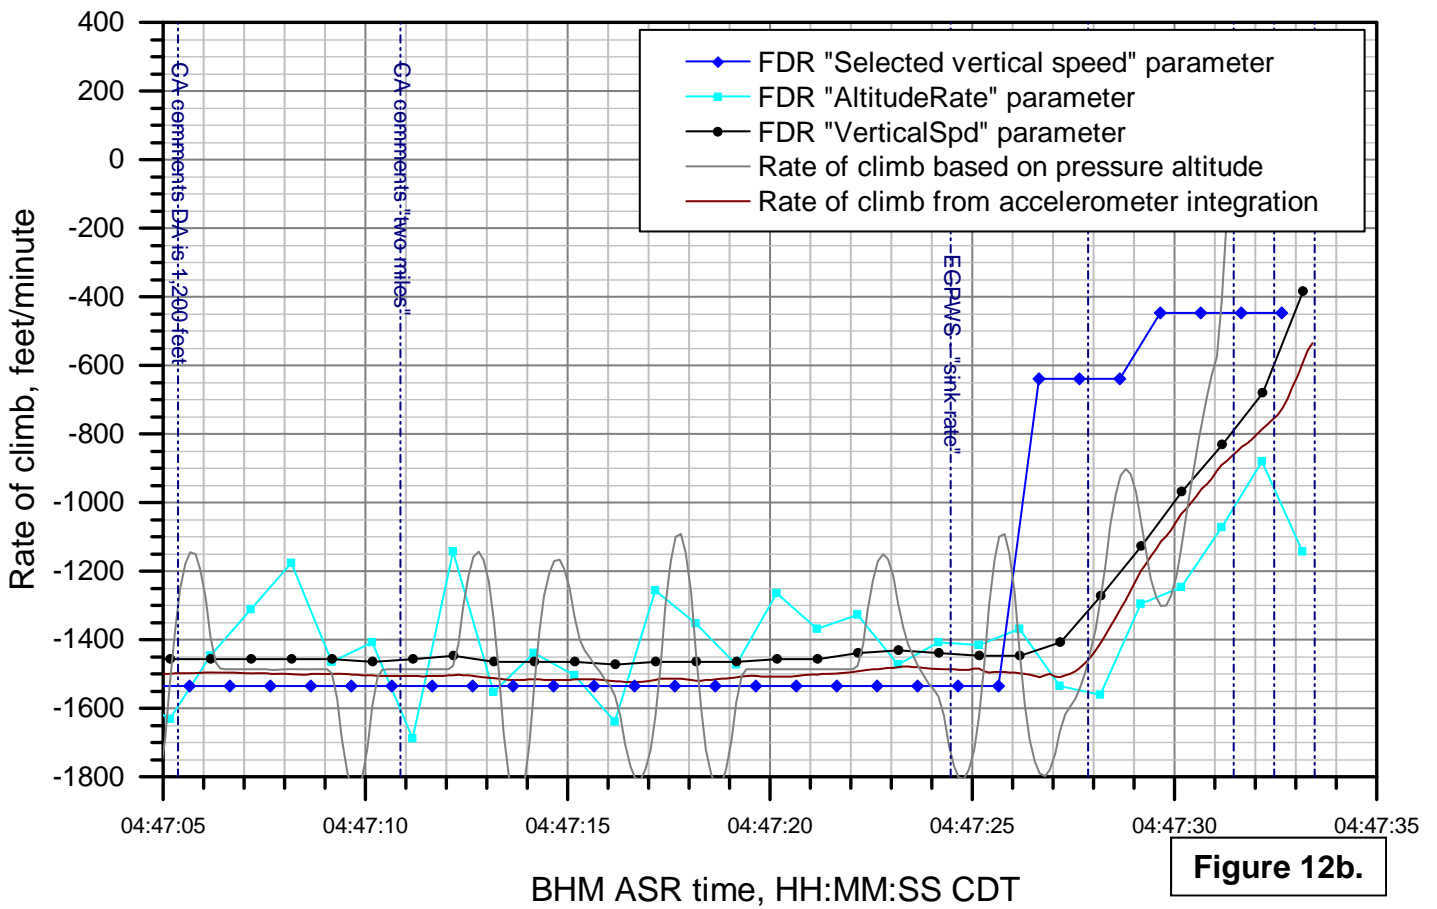
Figure 12b.

Speed and rate of climb vs. time (detail)

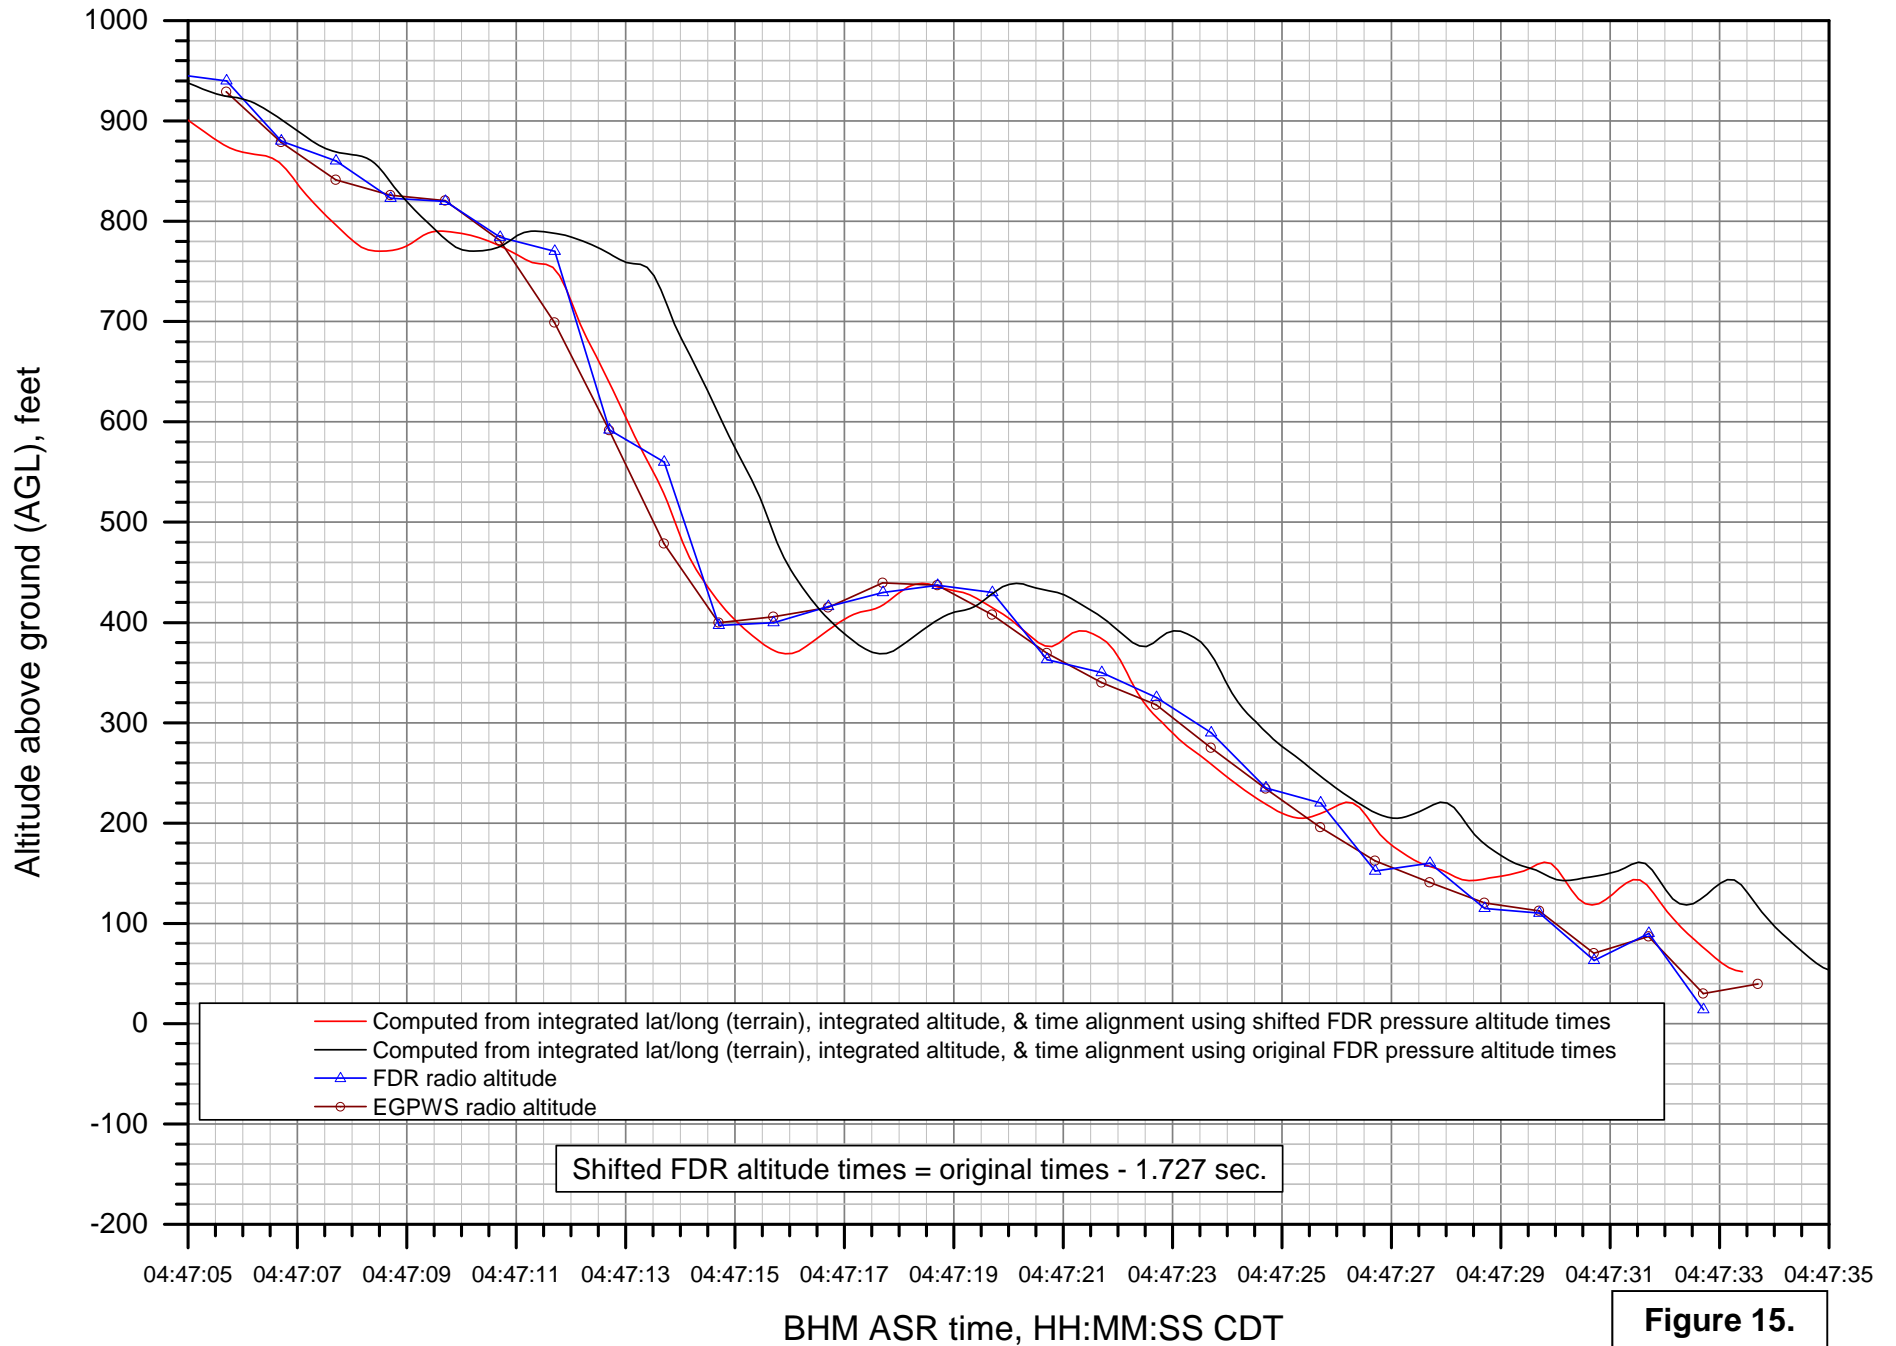
Figure 15.

Computed and recorded AGL altitudes with two time alignments
