NATIONAL TRANSPORTATION SAFETY BOARD

Aircraft Performance Study

Location: Birmingham, AL
Date: August 14, 2013
Time: 04:47 Central Daylight Time (CDT)
09:47 Universal Coordinated Time (UTC)
Aircraft: Airbus A300 F4-622R, registration N155UP
NTSB#: DCA13MA133

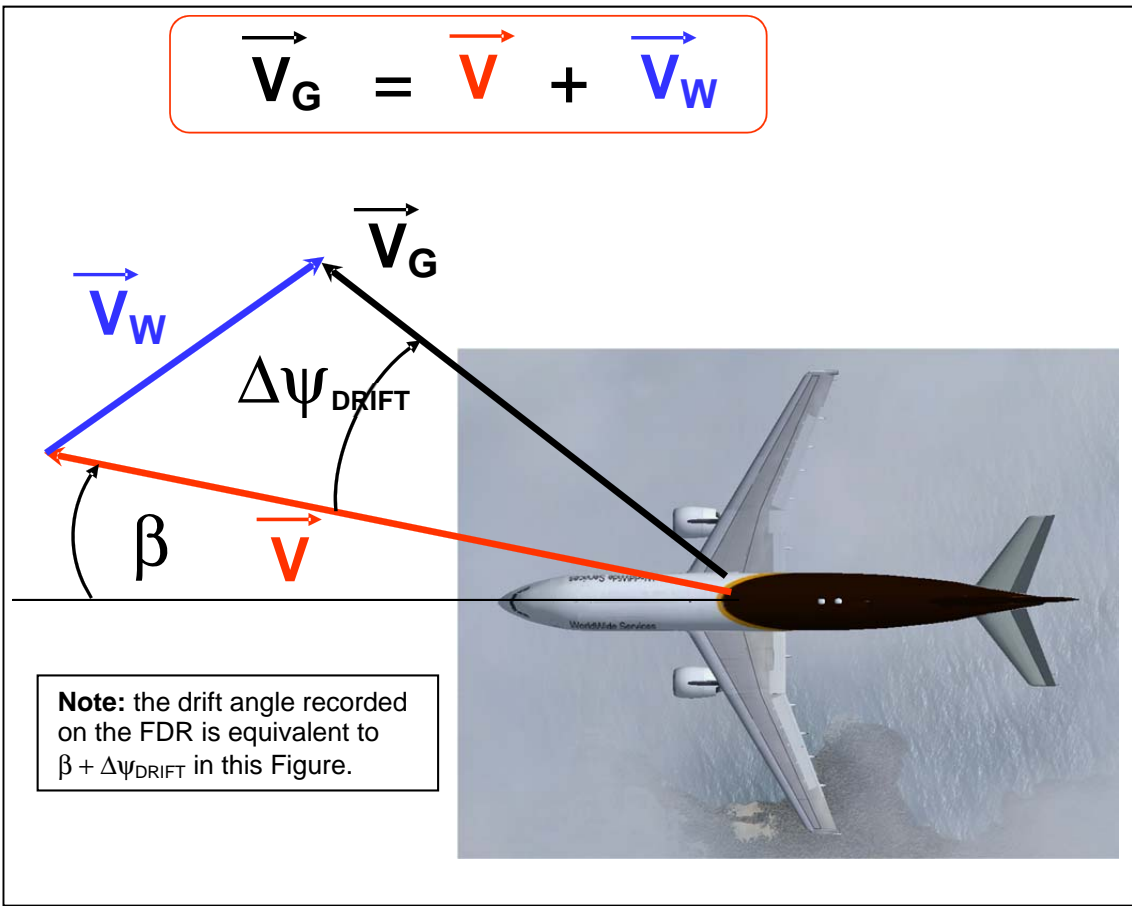
Figure 19. Wind triangle.

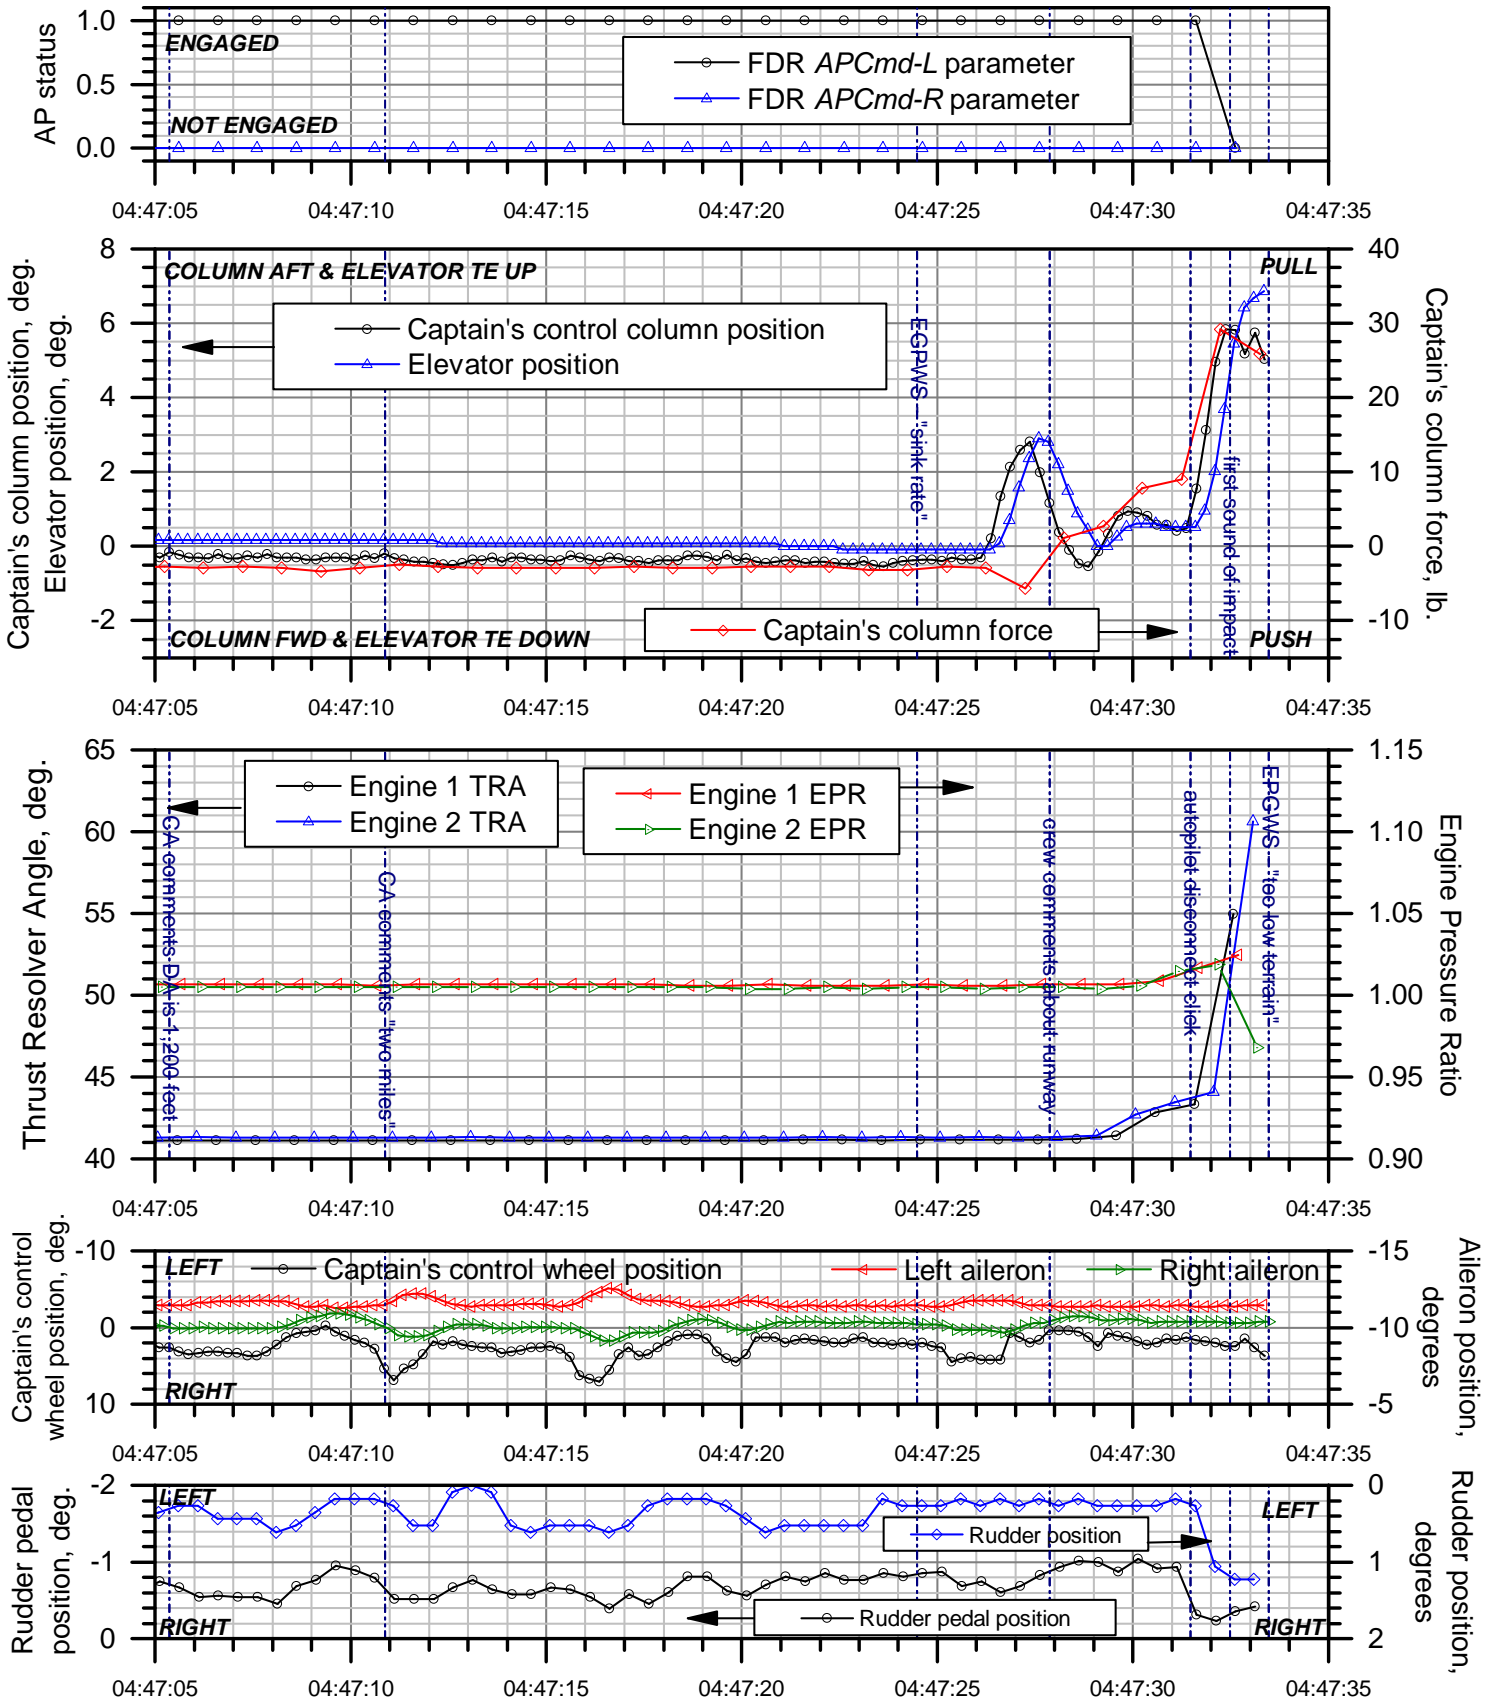
Figure 21b.

Control inputs vs. time (detail)

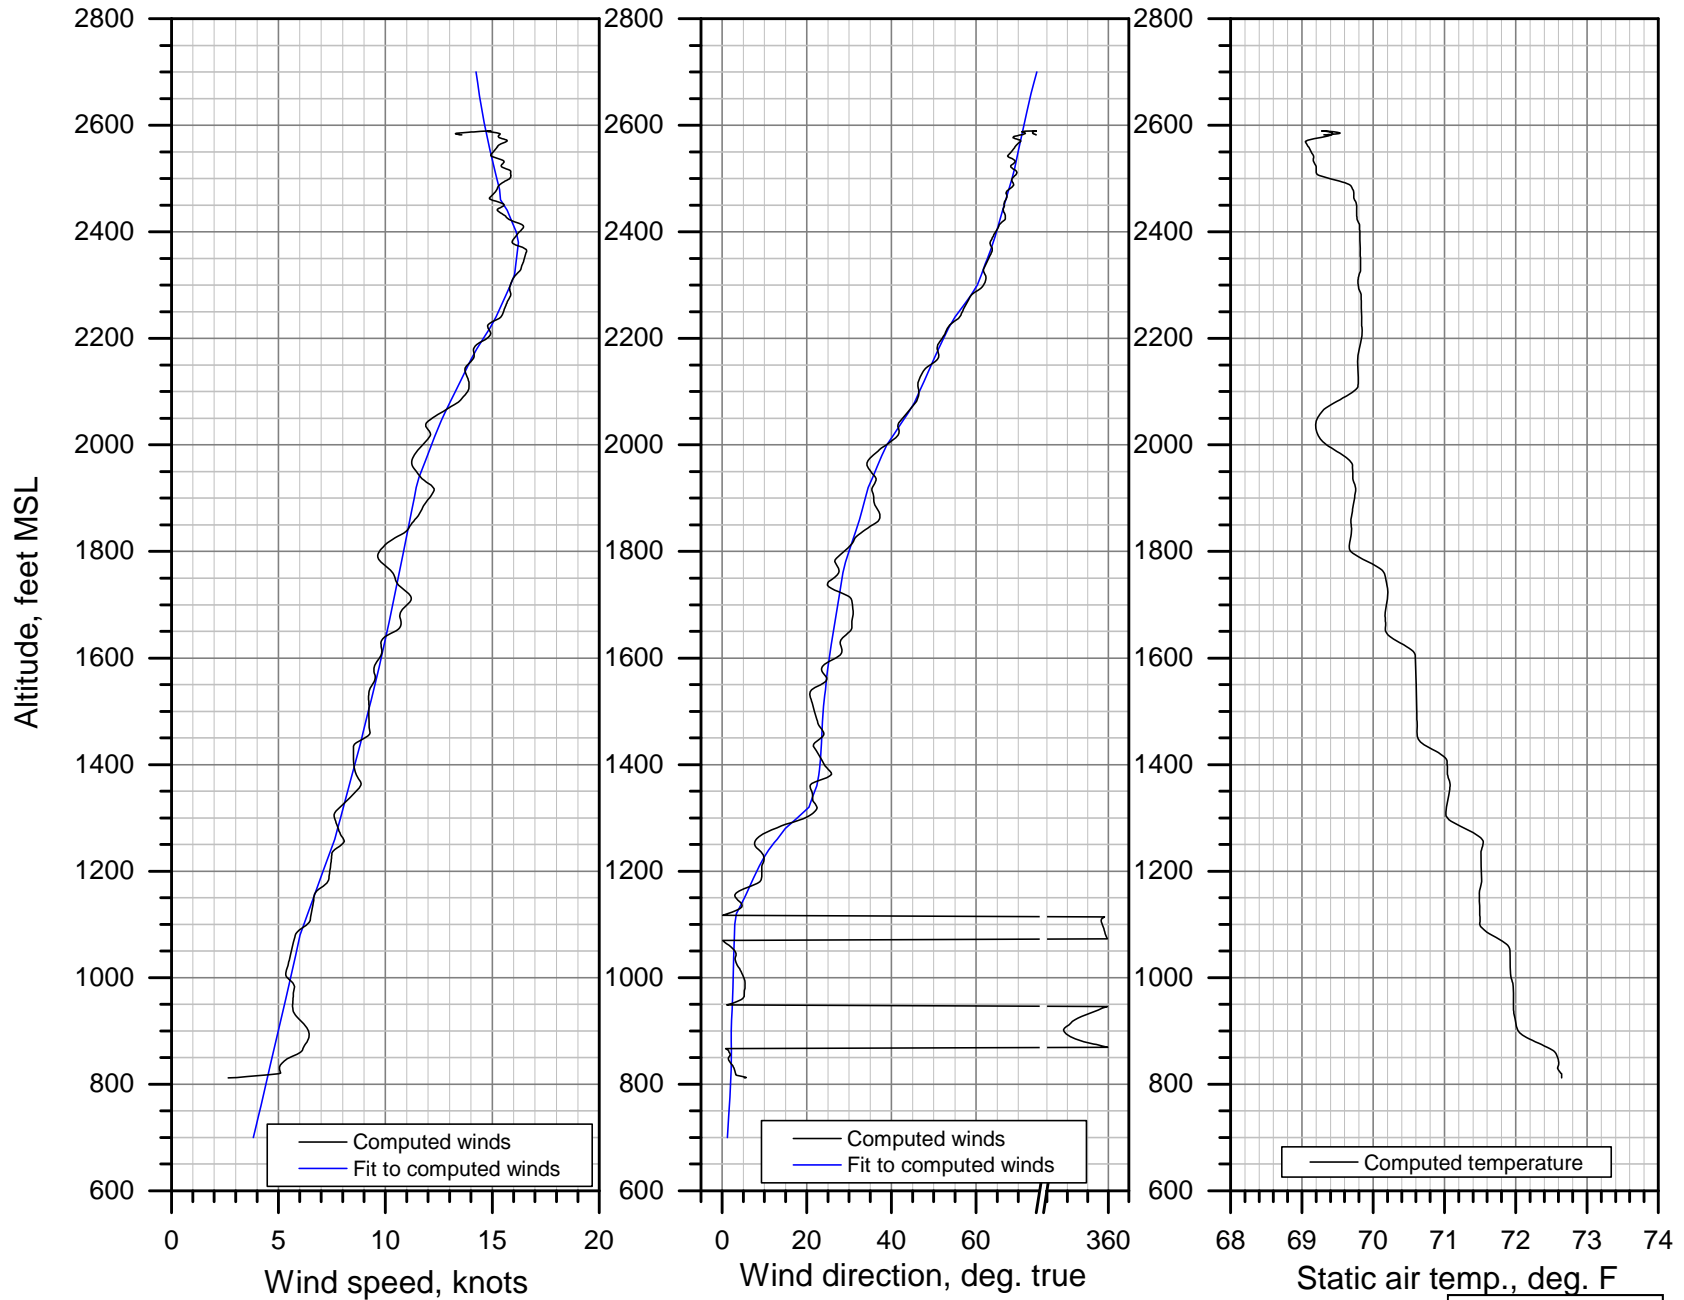
Figure 22.

Computed winds vs. altitude

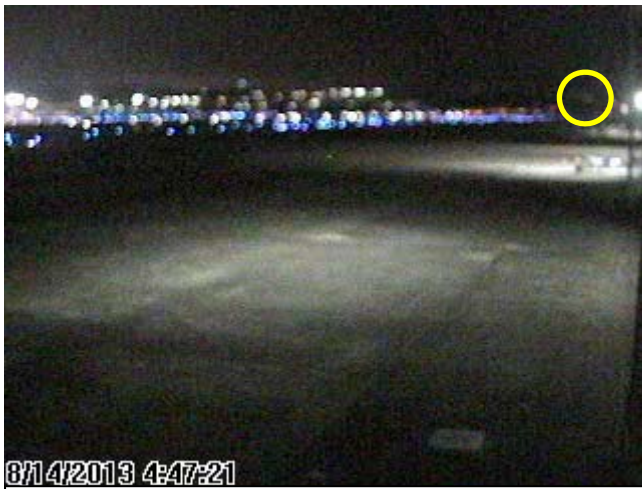
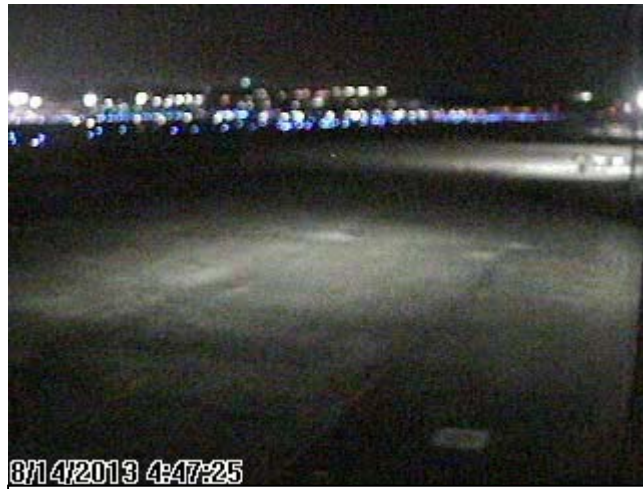
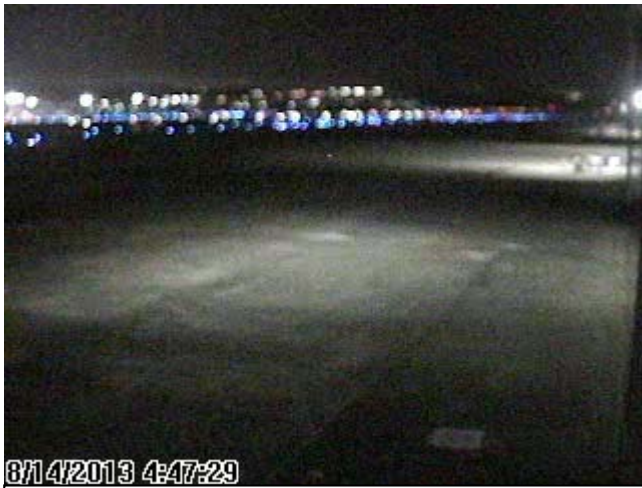
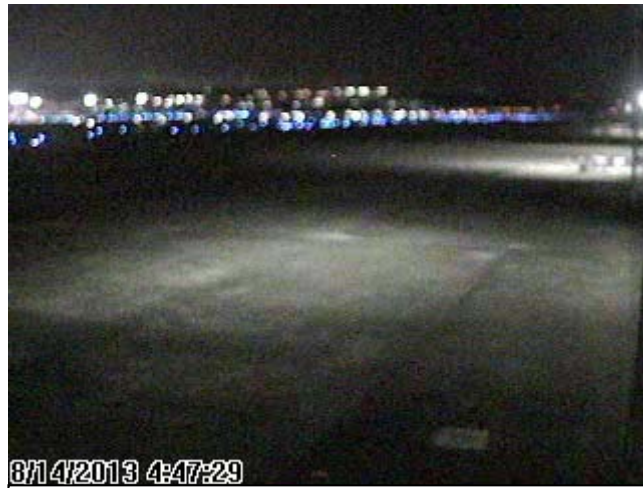
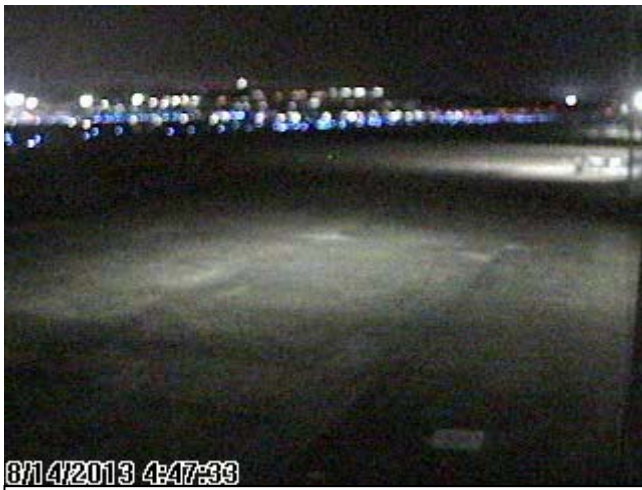
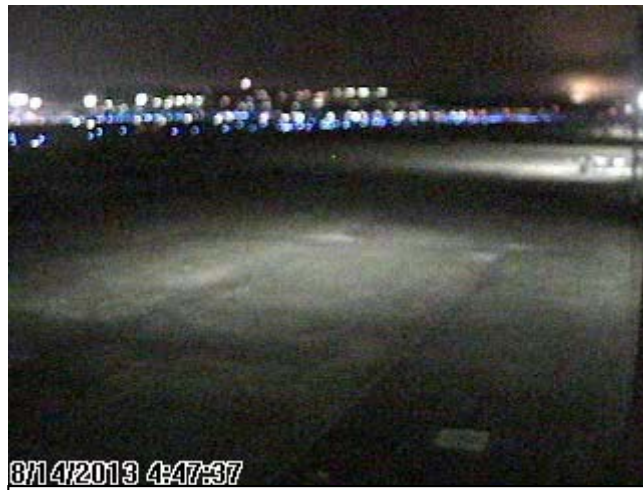
8/14/2013 4:47:21
a) Frame 183, 04:47:24.40: Lights first appear. Airplane lights indicated by yellow circle.

8/14/2013 4:47:25
b) Frame 307, 04:47:28.17: Peak of brightness.

8/14/2013 4:47:29
c) Frame 425, 04:47:32.10: Sudden dimming.

8/14/2013 4:47:29
d) Frame 433, 04:47:32.37: Lights totally out.

8/14/2013 4:47:33
e) Frame 545, 04:47:36.10: Transformer flash.

8/14/2013 4:47:37
f) Frame 683, 04:47:40.70: Impact explosion.

Figure 23. Selected frames from the security camera video. The timestamp on the video lags the BHM ASR CDT time by approximately 3 seconds.

Note in Figure 24 that, per the time correlation described in Table 6, the “Lights totally out” event (at 04:47:32.37) occurs about a second before the end of the FDR data (at 04:47:33.42). If the FDR stopped recording because power to the recorder was lost, the same power loss may have caused the airplane’s landing light to go out (see Ref. 3 for more information about the end of the FDR recording). However, in this case the average groundspeed between the end of the FDR data and the transformer flash would be $0.108 \text{ nmi} / (12.07 \text{ sec.} - 8.33 \text{ sec.}) = 0.0289 \text{ nmi} / \text{sec.} = 104 \text{ kts.}$, considerably below the 145 kts. corresponding to the end of the FDR data. The location of the impact explosion, corresponding to point 26 in Table 2, is 0.766 nmi north of the runway threshold; consequently, the average groundspeed between the transformer flash and the impact explosion is $(0.904 \text{ nmi} - 0.766 \text{ nmi}) / (16.67 \text{ sec.} - 12.07 \text{ sec.}) = 0.0300 \text{ nmi} / \text{sec.} = 108 \text{ kts.}$, roughly the same as (or a bit higher than) the average speed between the end of the FDR data and the transformer in this scenario. It seems unlikely that the airplane would cease decelerating after the impact with the transformer, after having decelerated so precipitously from the 145 kts. at the end of the FDR data; consequently, it is more likely that the “Lights totally out” event occurred *before* the end of the FDR data (as indicated in the correlation in Table 6), and was not the result of a loss of power to the lights.

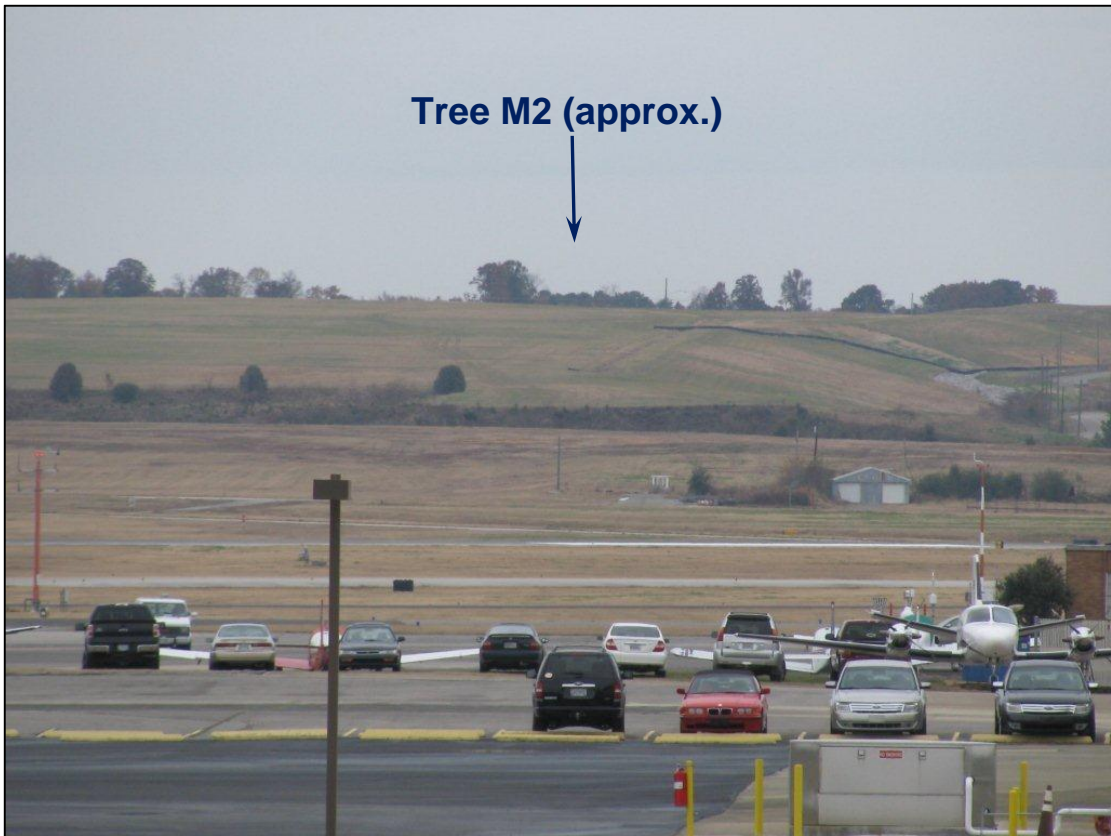
Figure 25.

a) Picture of security camera, and view north towards tree M2.

b) Zoomed-in photo of view to north.

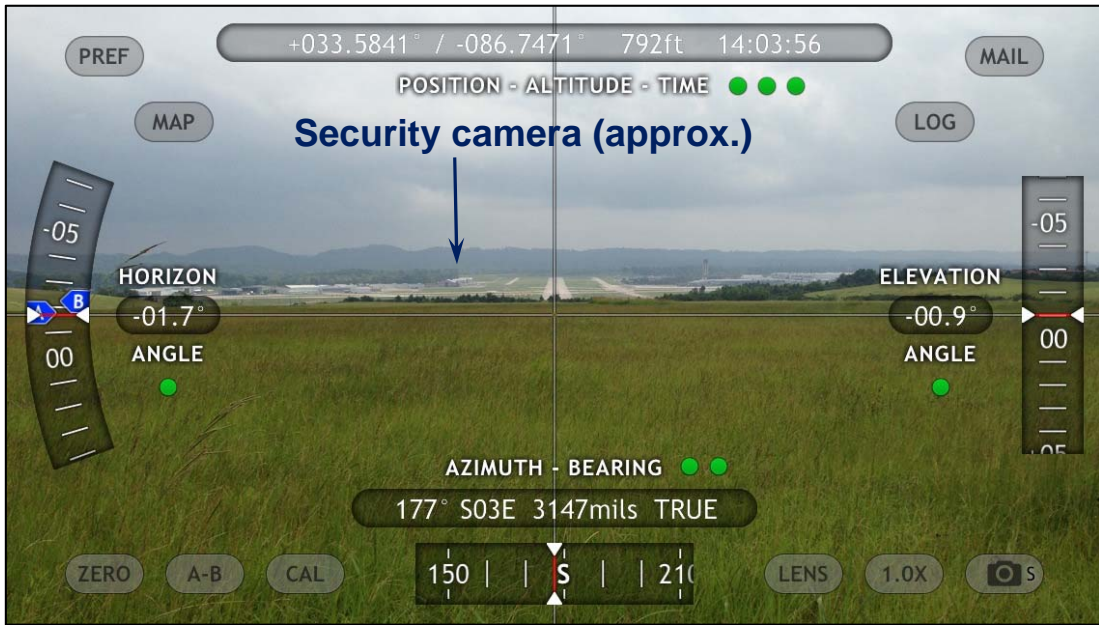
Figure 26. Photo from approximate brow of hill, looking south towards runway.

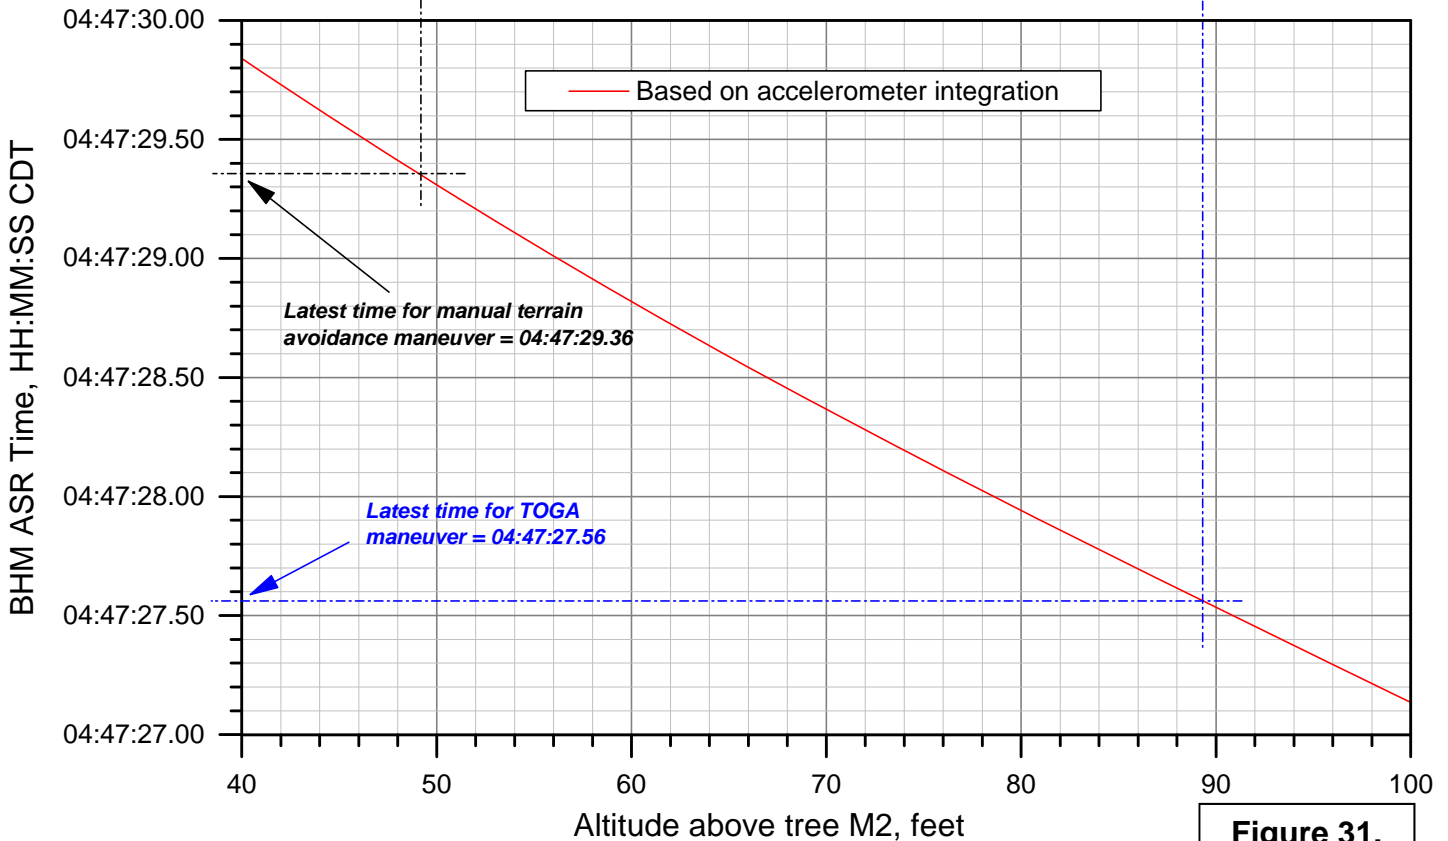
Figure 31.

Effect of vertical speed on minimum altitudes for succesful climb maneuvers

In order to ensure that the resulting runs were comparable, the initial conditions of each maneuver were matched by initiating the maneuver as the airplane passed through 1700 ft. MSL while the descending at 1500 ft./min. with the autopilot engaged in “vertical speed” mode.²² The simulator pilots attempted to initiate the maneuver at exactly 1700 ft., using a countdown (“three-two-one-go”) to time the maneuver as 1700 ft. was approached.
