**NATIONAL TRANSPORTATION SAFETY BOARD**

**Airplane Performance Study  
Korean Air Flight 801  
DCA97MA056**

**Guam  
August 6, 1997**

**Airplane Performance Study**

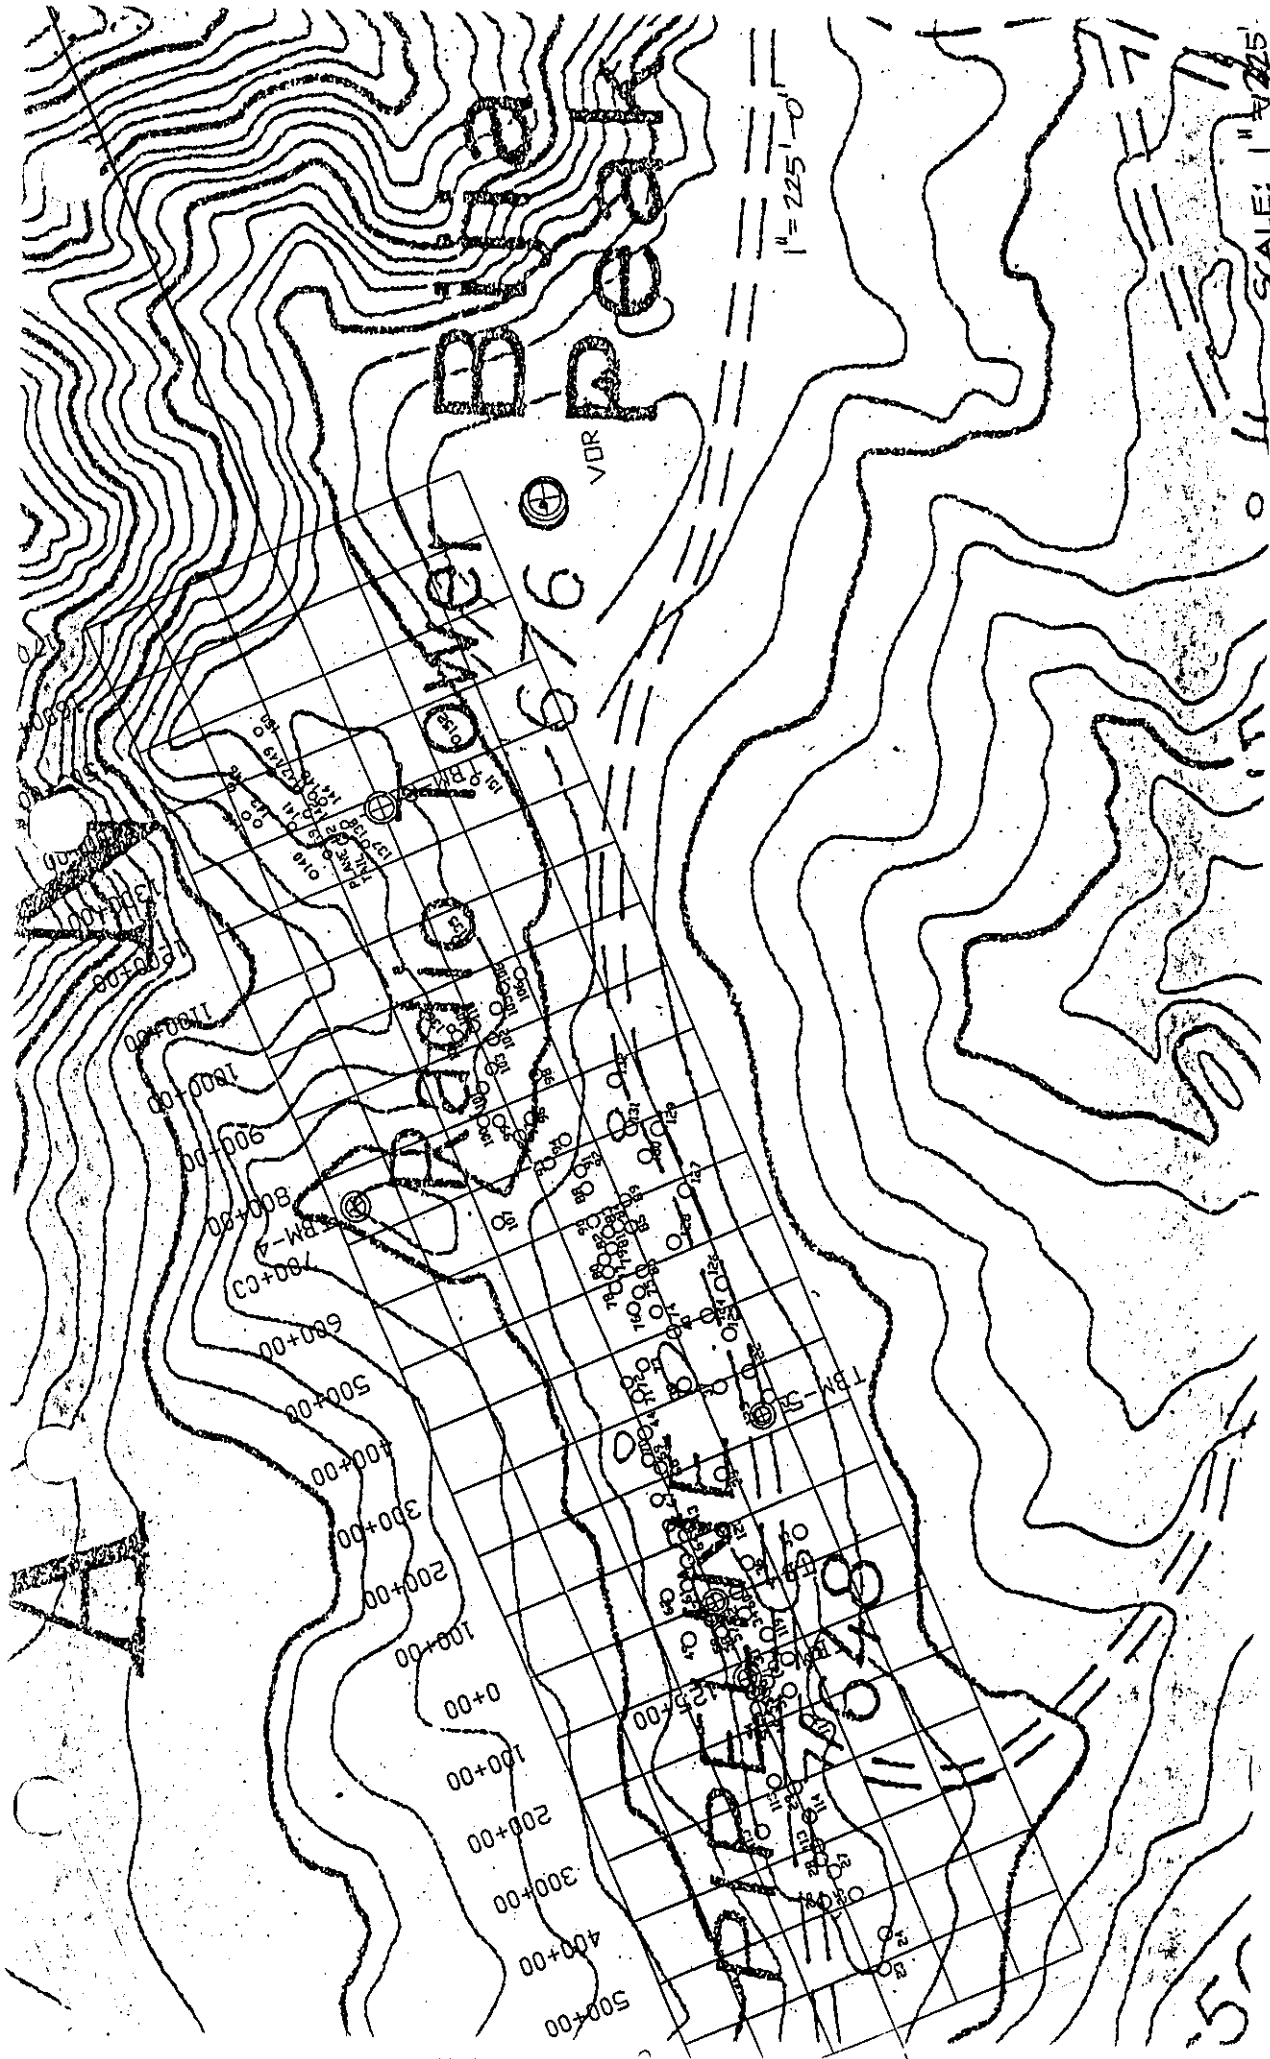
**Attachment I**  
**Ground Scar and Wreckage Location Data**

The United States Air Force conducted a survey of the accident site using a transit survey system. Their data were overlaid onto a 1:24,000 scale topographic map of the accident area for horizontal reference, and a vertical cross section of the terrain and accident site data was generated using the approximate center of the wreckage path as the cross section line (see Attachment I). The survey data indicate that KA801 first struck a small tree limb at a surveyed elevation of 673 feet msl. The #1 engine struck the ground hard approximately 415 feet later at a surveyed elevation of 662 feet msl. The landing gear tires struck the fuel pipeline approximately 440 feet after the first tree strike at a surveyed elevation of 650 feet msl. Subsequent deep landing gear ground scars were located approximately 485 feet after the pipeline contact at a surveyed elevation of 653 feet msl. The #1 engine resting place was approximately 965 feet beyond the initial tree strike and a surveyed elevation of 654 feet msl. The aft edge of the fuselage tailcone

in the main wreckage area was located approximately 1870 feet beyond the initial tree strike at a surveyed elevation of 582 feet msl.

Ground scar measurements and survey data indicate KA801's first significant impact with terrain occurred when the #1 engine, main landing gear, and right wing hit a rising hill and trees at a surveyed elevation of approximately 660 feet msl. The aircraft subsequently impacted larger trees and rising terrain before coming to rest on descending terrain just below the Nimitz VOR/DME. The ground scars show aircraft attitude and flight path consistent with the radar and FDR data.

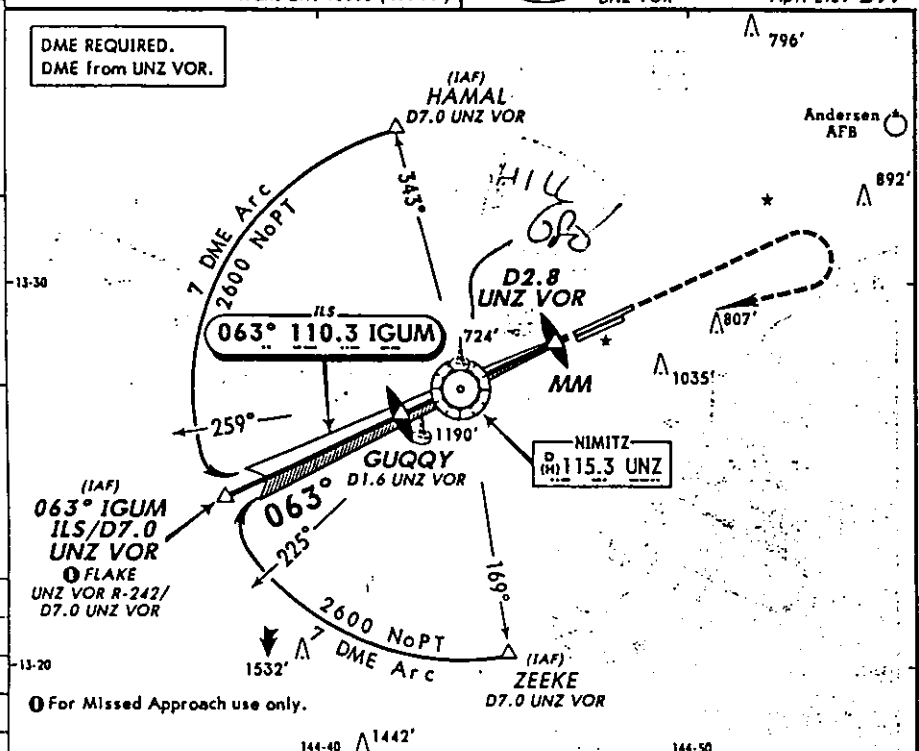
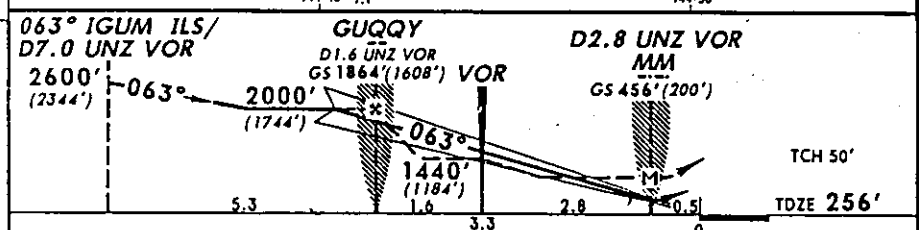
AGANA, GUAM  
 GUAM INTL  
 ILS Rwy 6L  
 LOC 110.3 IGUM  
 Apt. Elev 297'

MISSED APPROACH: Climb to 2600, then turn RIGHT via UNZ VOR R-242 to FLAKE D7.0 UNZ VOR and hold SOUTHWEST, RIGHT turn, 062° inbound.

STRAIGHT-IN LANDING RWY 6L							CIRCLE-TO-LAND	
ILS				LOC (GS out)			Not Authorized Southeast of Rwy 6R-24L	
2A(H) 456' (200')				MDA(H) 560' (304')				
LL	RAIL or ALS out		RAIL out	ALS out	Max Kts	MDA(H)		
2	3/4		1/2	3/4	90	720'	(423')-1	
					120	760'	(463')-1	
					140	760'	(463')-1 1/2	
			3/4	1	165	860'	(563')-2	
Kts		70	90	100	120	140	160	
GS 3.00°		377	484	538	646	753	861	
MAP at D7.8 UNZ VOR or

KA801 started to descend out of 2,640 feet msl at approximately 15:40:13 at a point approximately 9 nm from the runway 06L threshold (approximately 5.7 nm from the Nimitz VOR/DME ~ thus 5.7 DME). The runway 06 Left ILS approach procedures for the glideslope out condition show that altitude should remain above 2,600 feet msl until inside 7.0 DME.

15:40:37, a comment was made about the glideslope and 1,440 feet. At 15:40:42, CERAP advised KA801 to contact the Agana tower. KA801 subsequently advised Agana tower that they were intercepting the localizer 06 Left and the sounds of the configuration warning horn and altitude alert were heard. At 15:41:01, Agana tower cleared KA801 to land on runway 06 Left and advised that winds were 090 degrees at 7 knots. At about the same time, KA801 descended below 2,000 feet msl at a point approximately 6.8 nm from the runway 06 Left threshold (approximately 3.5 DME). The runway 06 Left ILS approach procedures for the glideslope out condition show that descent below 2,000 feet msl is not permitted until inside 1.6 DME.

The flaps began extending to 20 degrees at 15:41:13 as the airplane was descending through 1,800 feet msl, and KA801 advised Agana tower that they were cleared to land on runway 06 Left. Flaps began extending to 30 degrees at 15:41:23 and the configuration warning horn sounded. At 15:41:33, a comment was made about 560 feet followed by a call for a landing check. At 15:41:39, KA801 descended through 1,440 feet msl at a point approximately 5.3 nm from the runway 06 Left threshold (approximately 2.0 DME). The runway 06 Left ILS approach procedures for the glideslope out condition show that altitude should remain above 2,000 feet until inside 1.6 DME and should remain above 1,440 feet msl from 1.6 DME until inside 0.0 DME (inside the Nimitz VOR/DME).

The Jeppesen runway 06L ILS approach procedure plate was obtained from Korean Air (see Attachment III). The 2 Aug 96 version was determined to be the one in use based on the CVR conversation.

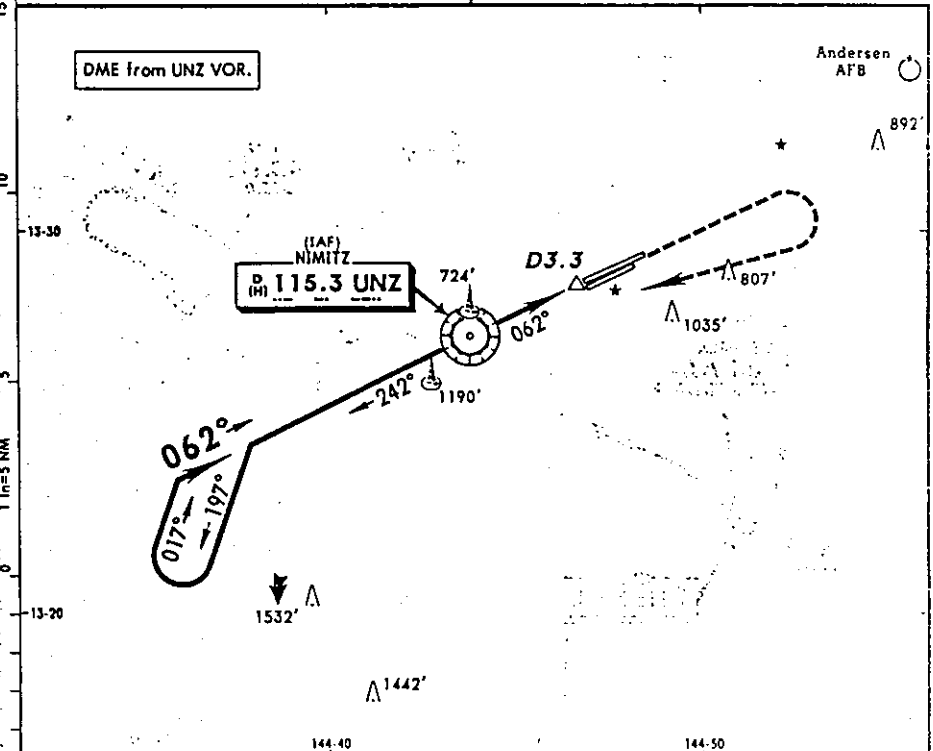
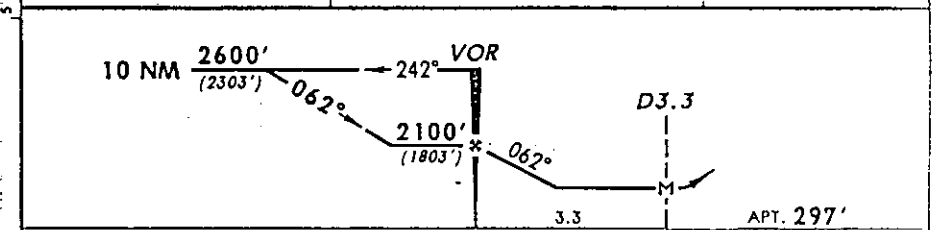
AGANA, GUAM  
 GUAM INTL  
 VOR-A  
 VOR 115.3 UNZ  
 Apt. Elev. 297'

2200'  
 090° → 270°  
 2600'  
 MSA  
 UNZ VOR

MISSED APPROACH: Climb to 2600° then turn RIGHT direct UNZ VOR.

CIRCLE-TO-LAND					
										Not Authorized Southeast of Rwy 6R-24L					
										Max Kts	MDA(H)				
										A 90	780' (483')-1				
										B 120					
										C 140	780' (483')-1 1/2				
										D 165	860' (563')-2				
Gnd speed-Kts										70	90	100	120	140	160
MAP at D3.3 or

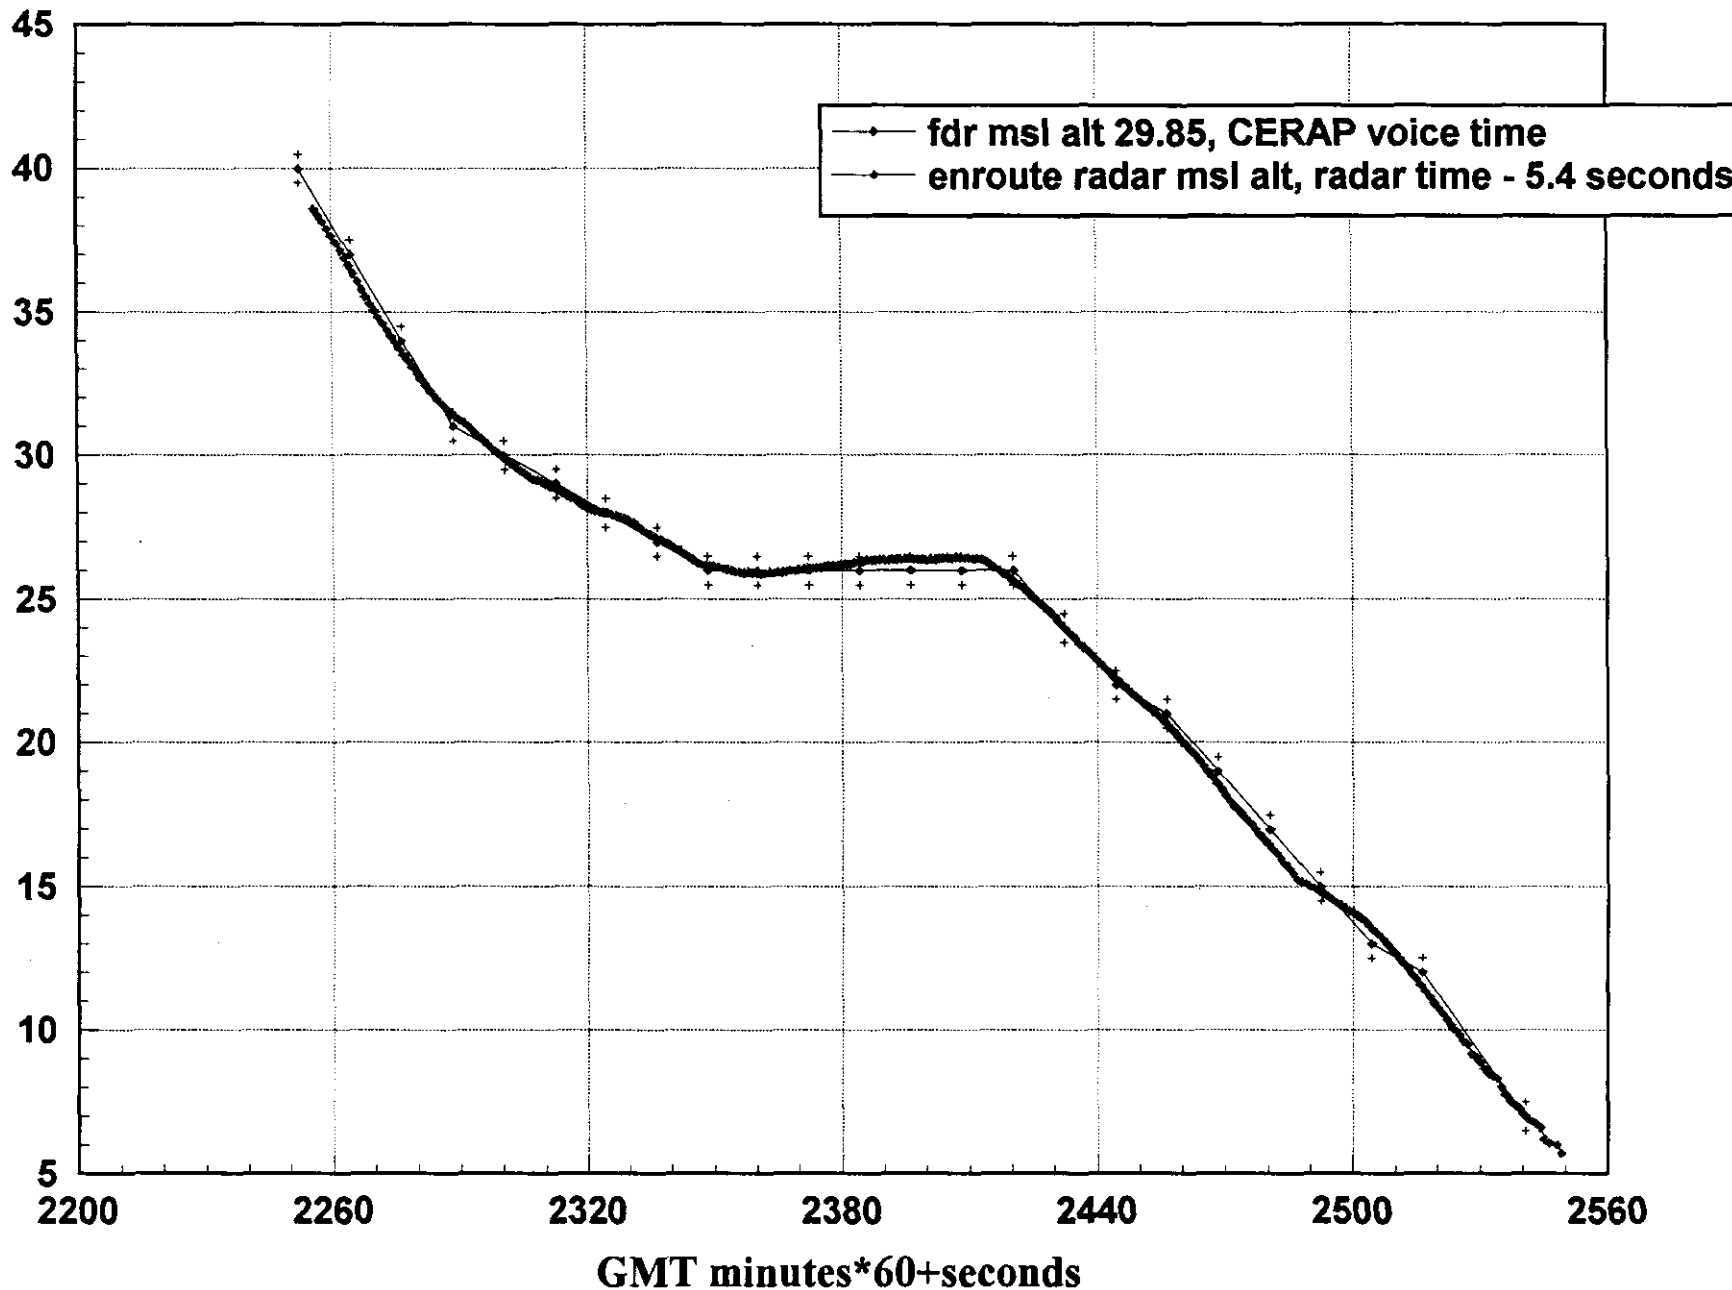
# KAL 801 FDR MSL ALTITUDE (29.85 in Hg) vs. TIME

MSL Altitude, feet/100

The FDR and CVR data are presented in the FDR and CVR group factual reports. FDR and CVR microphone keying data were aligned in order to establish a time correlation between the FDR and CVR (see Attachment IV). The alignment established that 10 hours 53 minutes and 28 seconds must be added to the FDR readout elapsed times in order to correlate with the CVR transcript time (CVR time is CERAP voice recording GMT). For example, FDR elapsed time 04:47:19 correlates to the CVR transcript time of 15:40:47 GMT. Overlays of CVR transcript excerpts onto graphs of the FDR data are shown in Attachment IV. The overlays show good correlation of key FDR and CVR events.

FDR altitude data and FAA radar altitude data were then aligned in order to establish a time correlation between the FDR/CVR times and the radar data times (see Attachment IV). The alignment established that 5.4 seconds must be subtracted from the FAA ARSR radar data times in order to correlate with the FDR/CVR times (CERAP voice recording GMT).

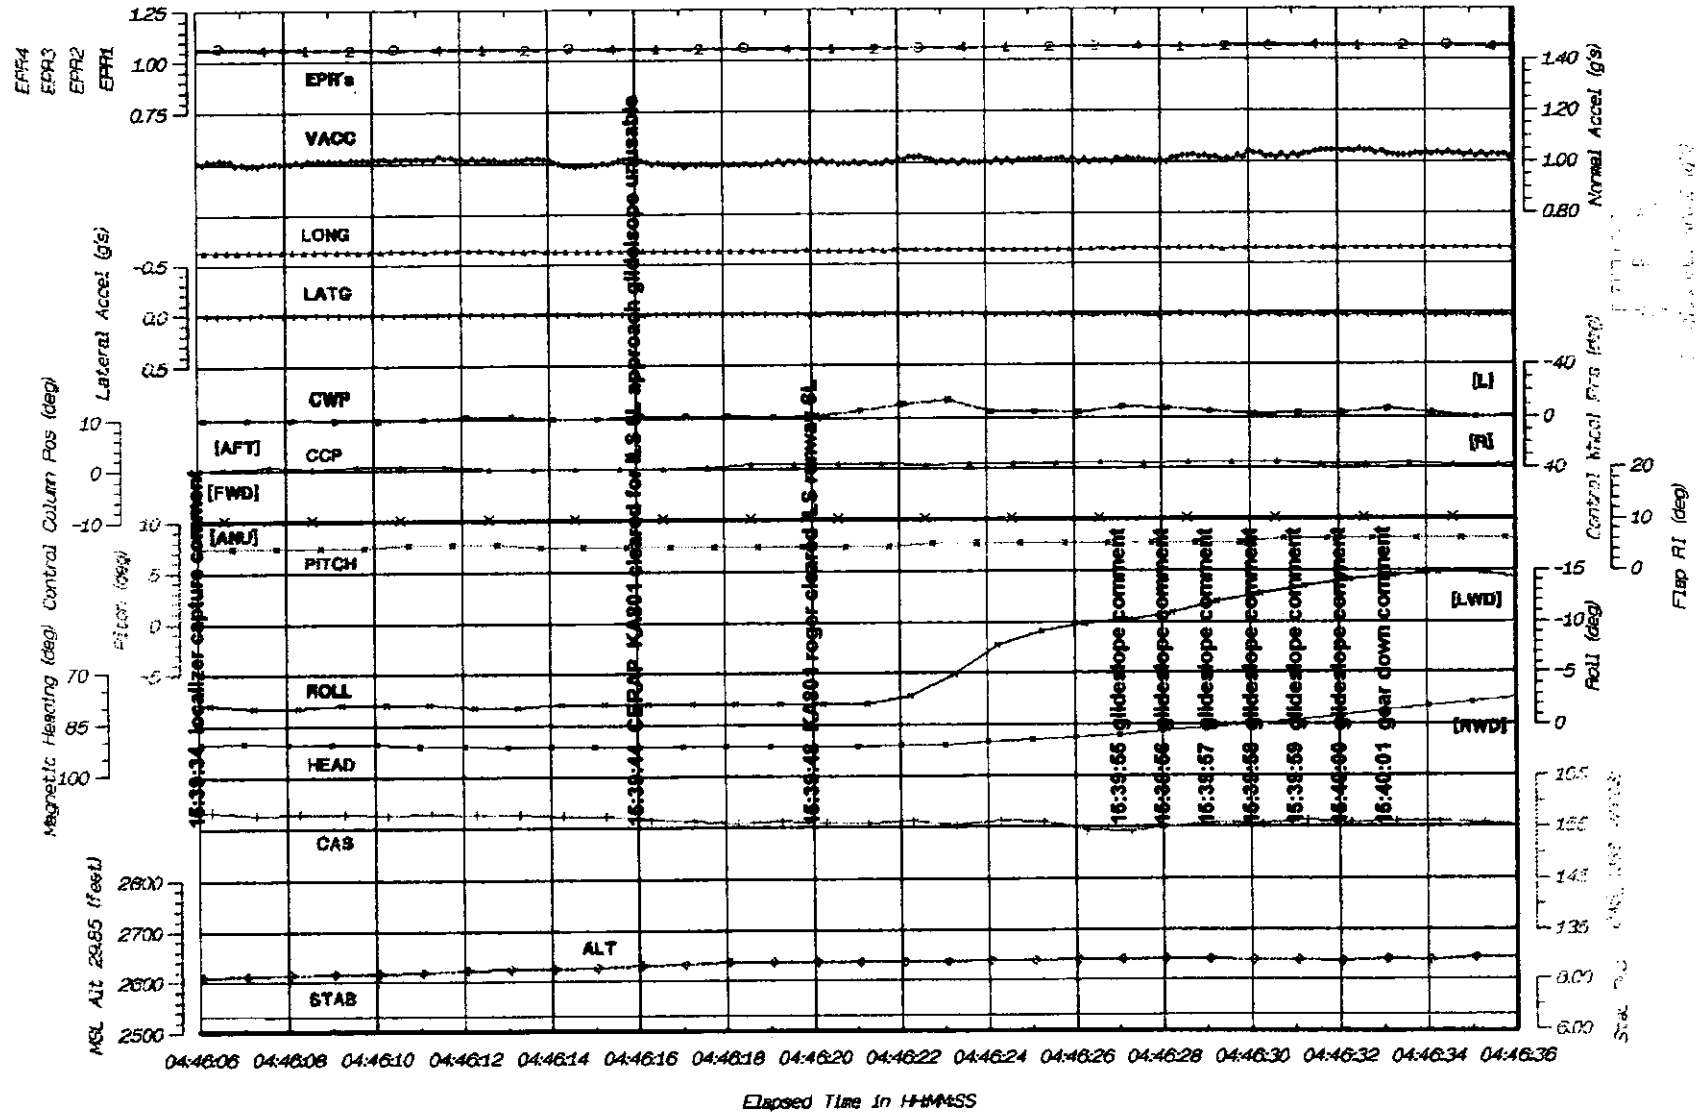
# KAL Flight 801

**The following plots do not show verbatim CVR excerpts. Copies with verbatim CVR excerpts will be provided after the CVR transcript is placed in the public docket.**

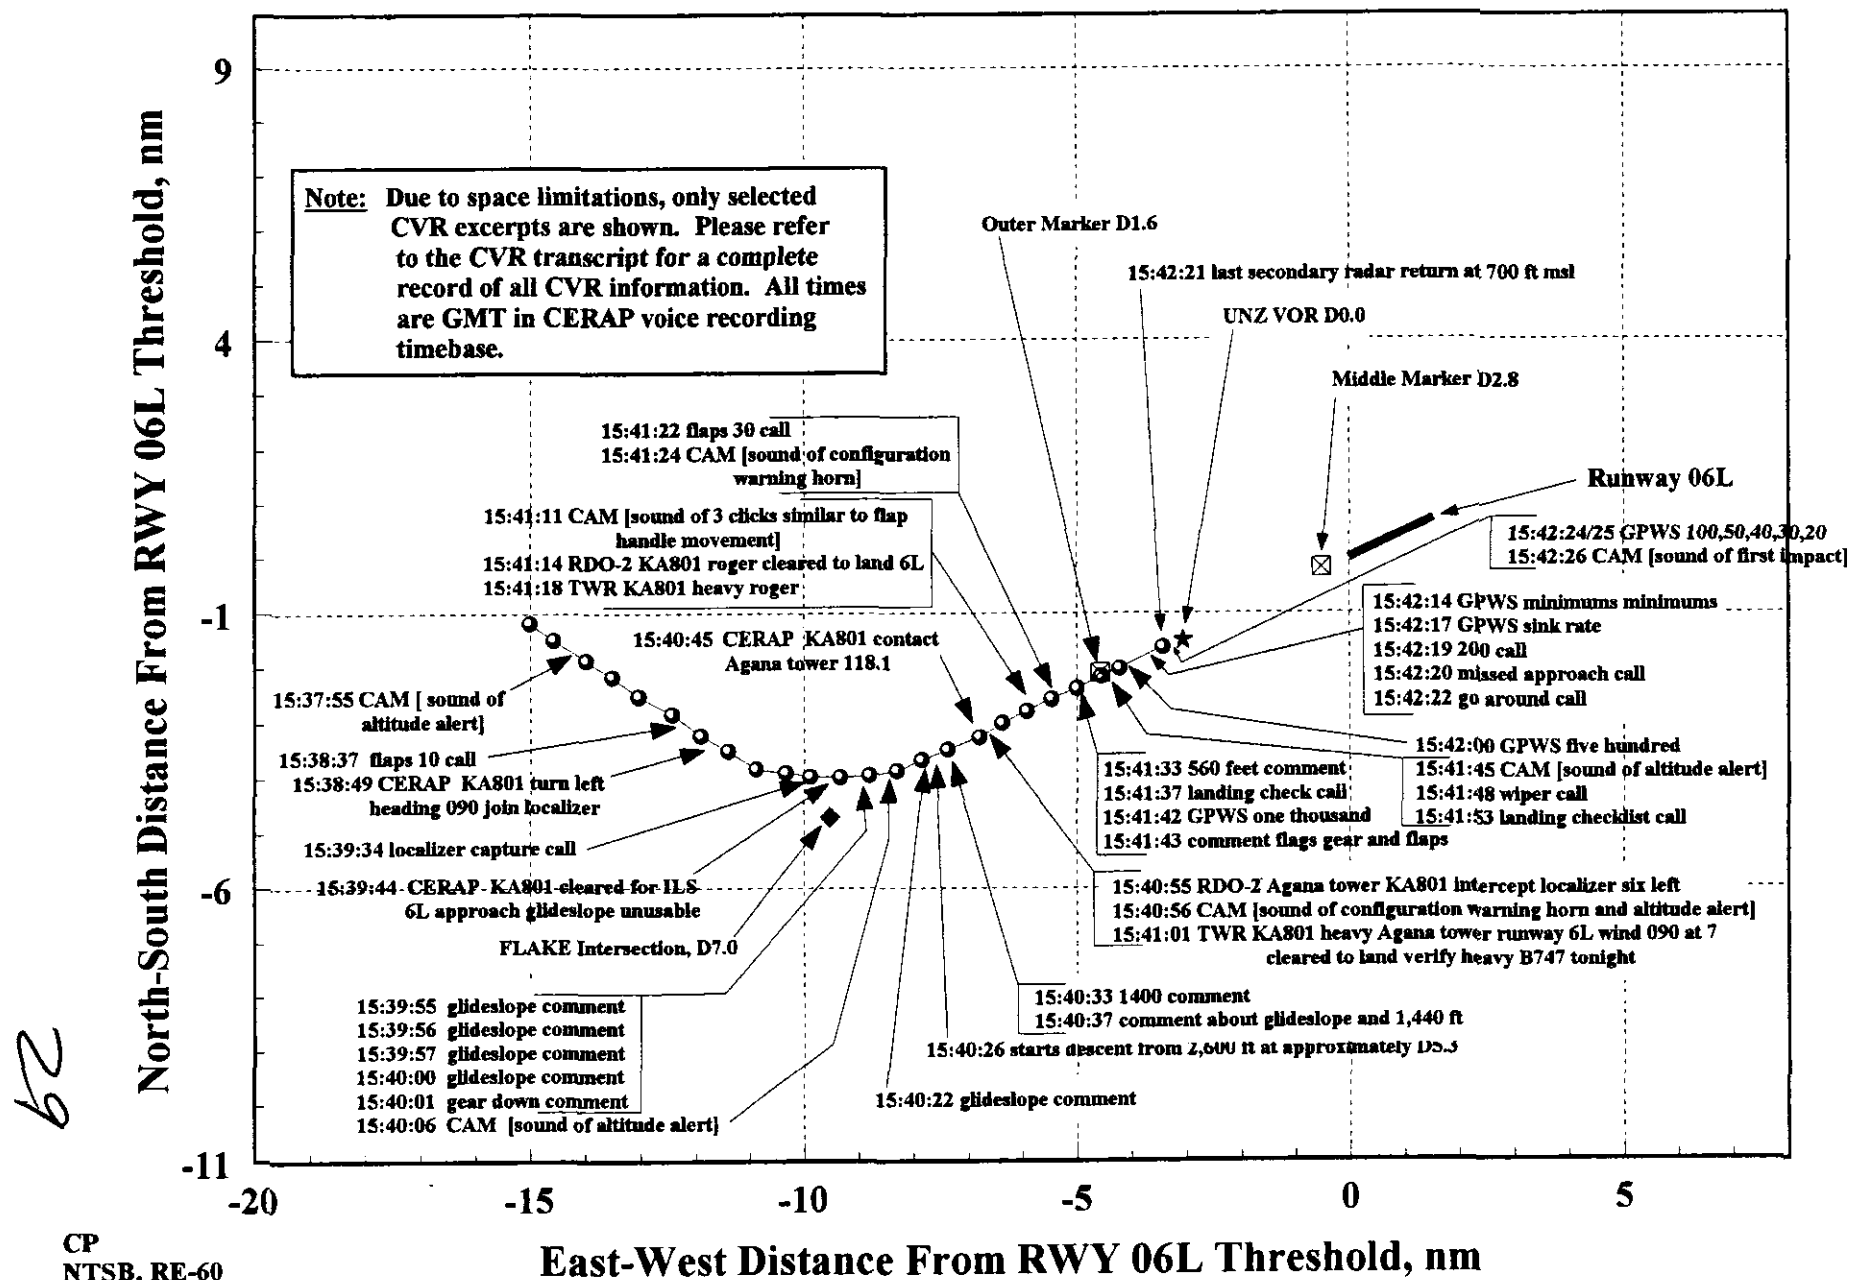
## Overhead View Of FAA Radar Data With Selected ATC And CVR Communication Excerpts

transcript were used to make annotated plots of the horizontal and vertical flight path of KA801 (see Attachment VI).

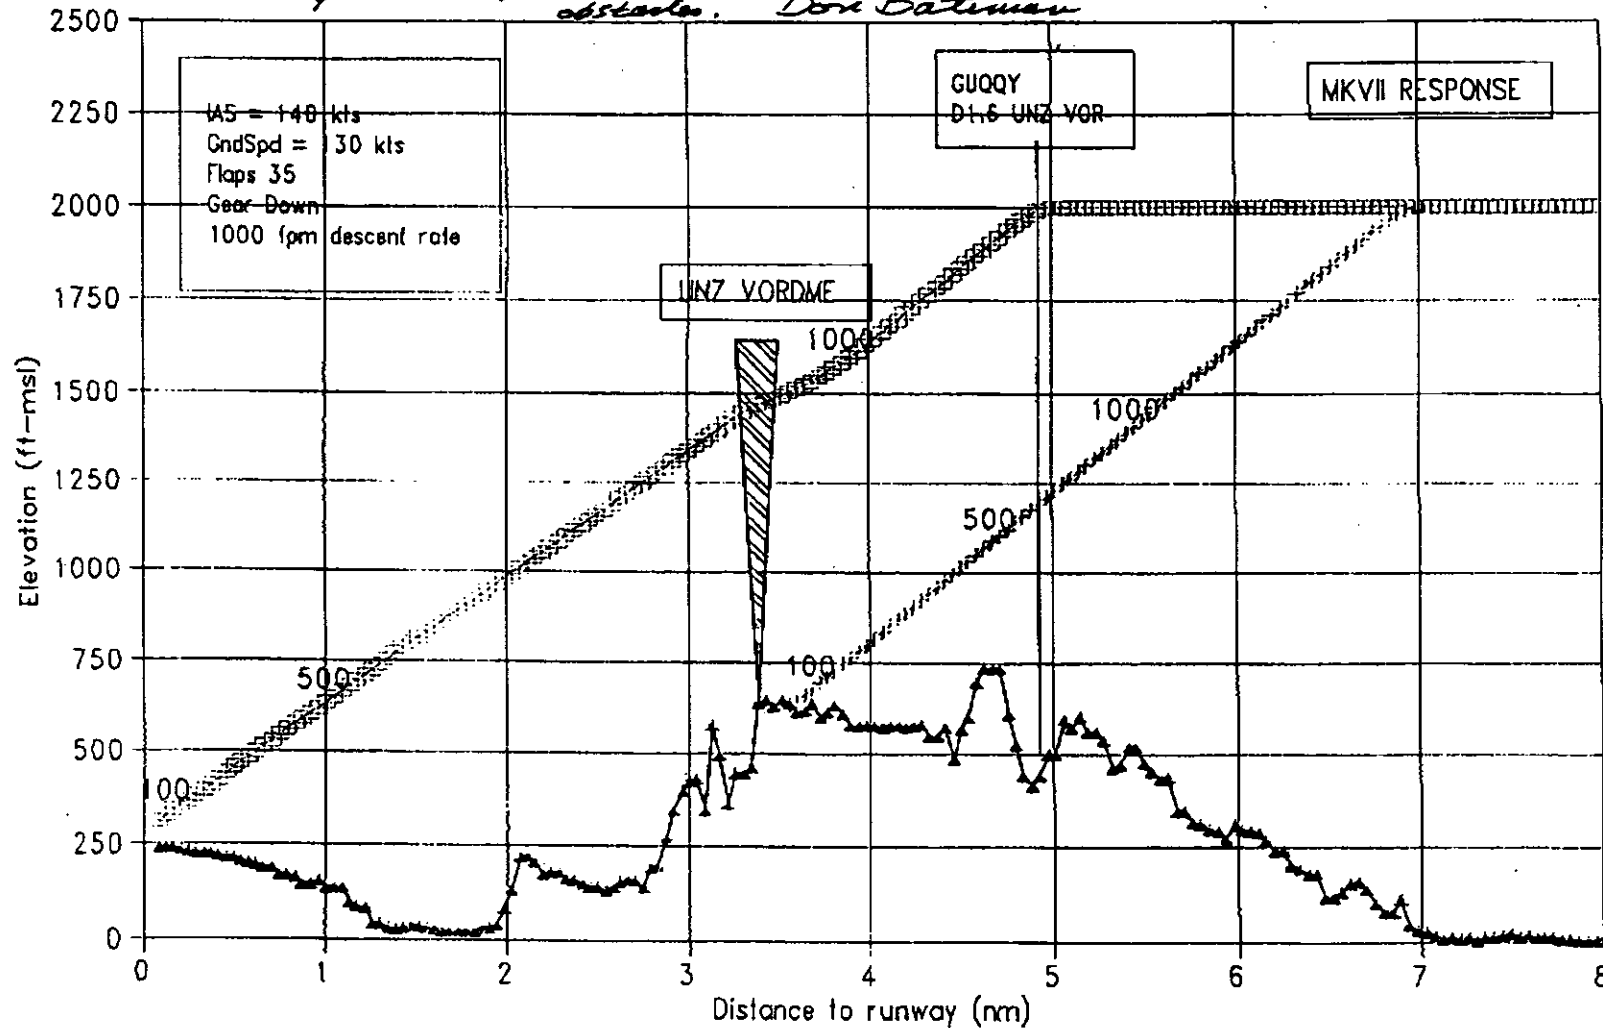
B747-300 Accident - Guam

① This is a revised plot of the terrain along the localizer of (The first earlier plot was along the VOR course) 3 arc second data base was used.

② Page 2 is the E-GPWS using both obstacle and terrain. Page 3 is the terrain data used in E-GPWS along with the towers or obstacles. Don Bateman

The simulation results (see Attachment VIII) indicate that KA801's GPWS functioned as designed and did not provide terrain or pull-up warnings due to the landing configuration. Radio altitude callouts, "minimums" callouts, and a sink rate callout were appropriate for the flight path. The EGPWS simulation showed that EGPWS would have provided aural and visual terrain warnings to KA801 as much as 60 seconds prior to initial impact.

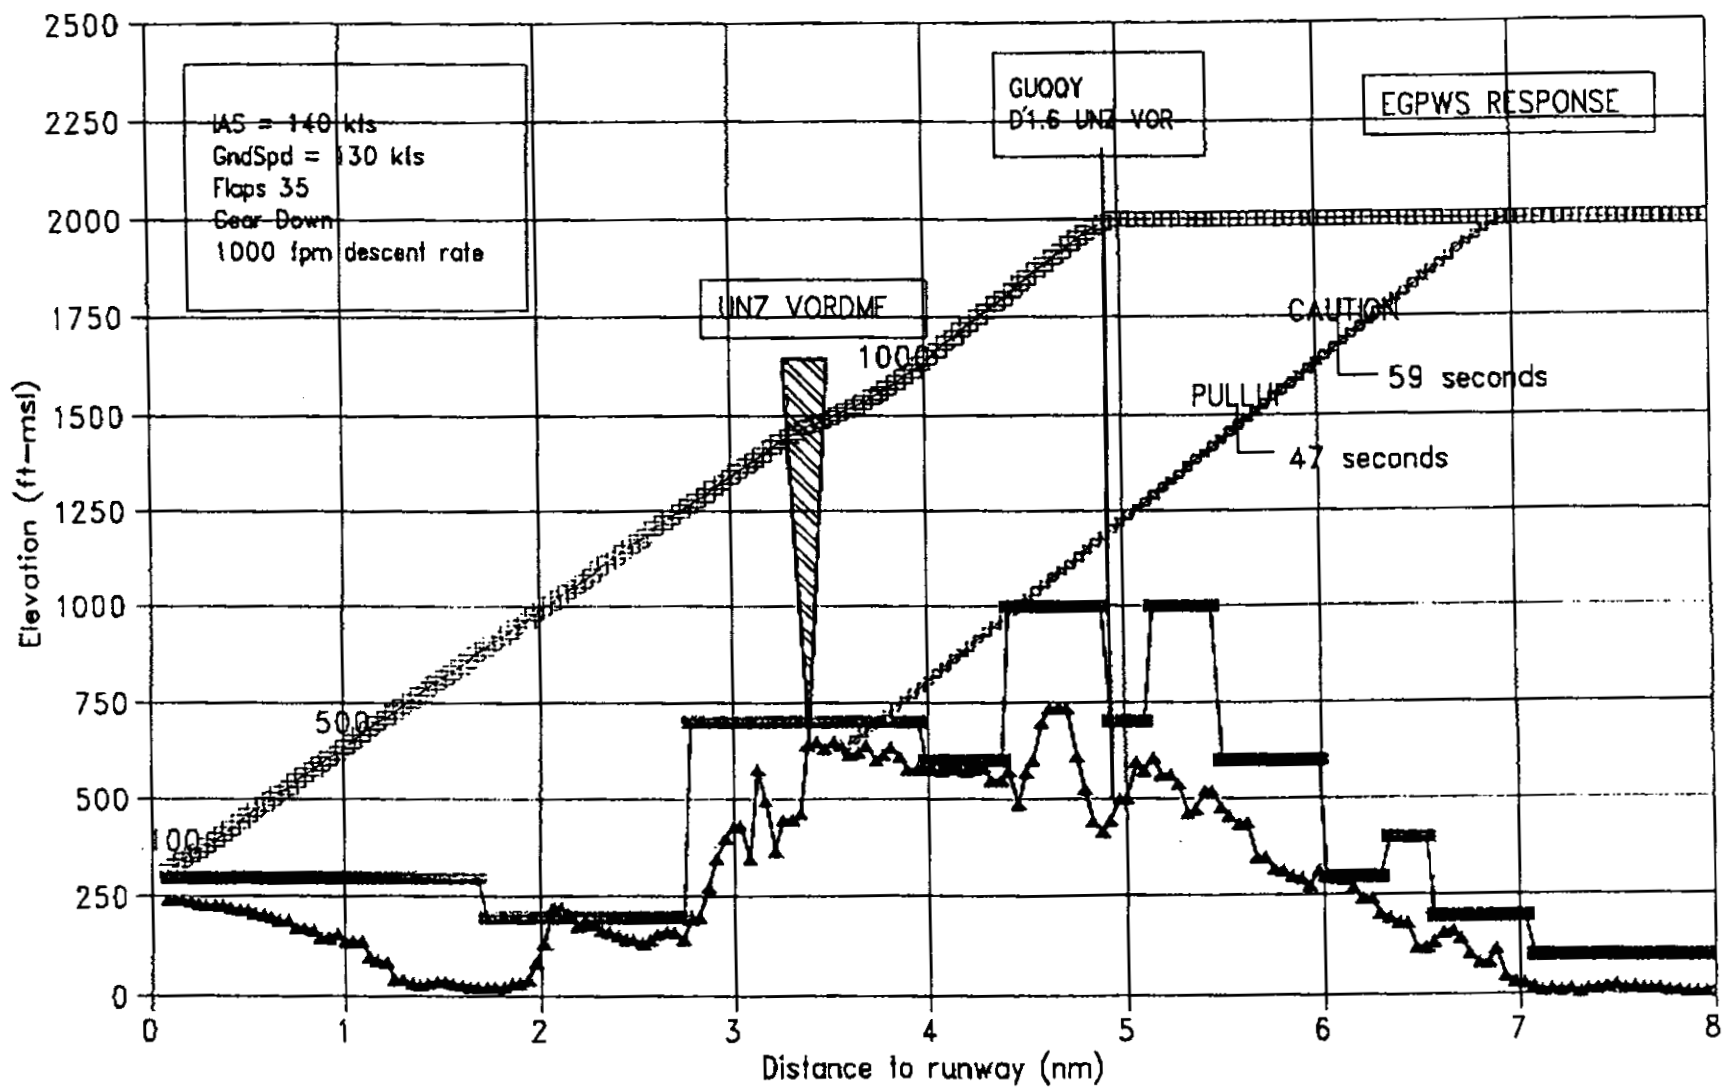
# B747-300 Accident - Guam August 8, 1997

★ PRELIMINARY SIMULATION - REVISED SIMULATION TO FOLLOW. ★

□ Normal Altitude    ■ EGPWS Database    ▲ 3 arc-second DB    + Accident Altitude
