**NATIONAL TRANSPORTATION SAFETY BOARD**  
Office of Research and Engineering  
Washington, D.C. 20594

### **Group Chairman's Aircraft Performance Study**

Location: Aspen, CO  
Date: March 29, 2001  
Time: 1902 MST  
Aircraft: Gulfstream III, N303GA  
NTSB Number: DCA01MA034

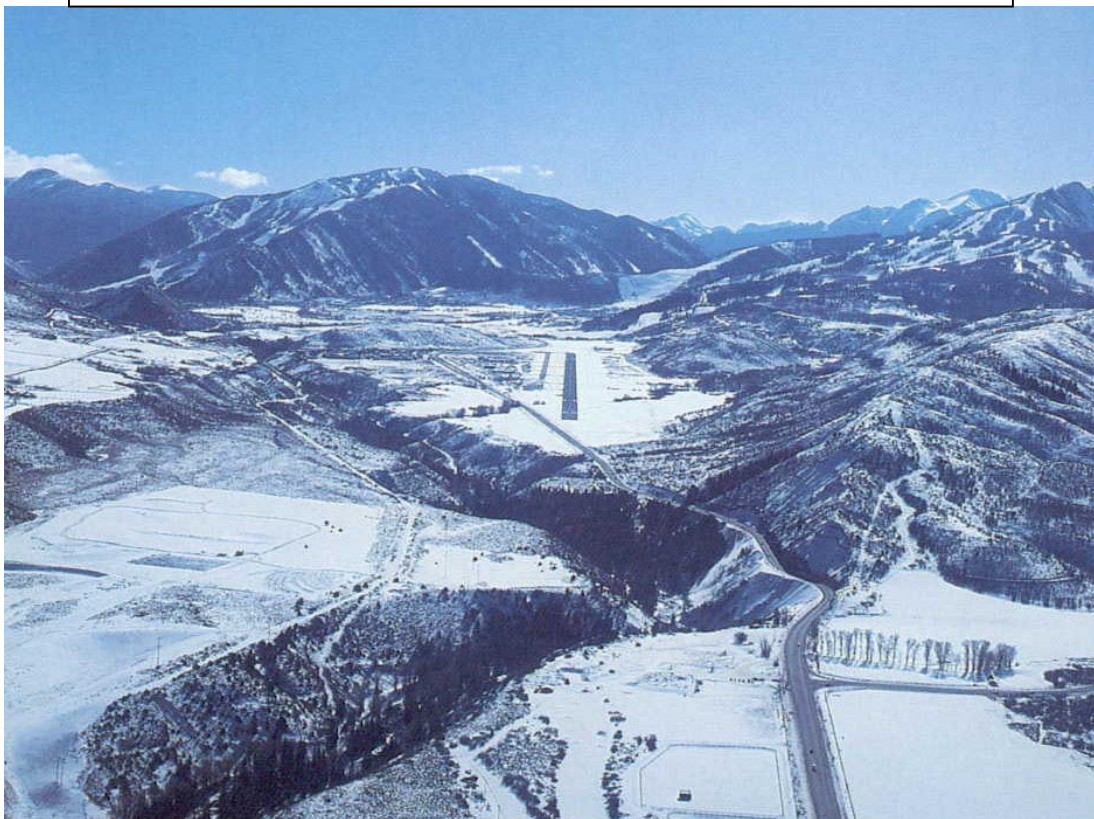
Figure 1 – Picture of approach to ASE runway 15

The aircraft followed the VOR-DME approach. Attachment I – 13 shows the altitude of N303GA as a function of North Range, relative to the ASR radar antenna. Selected ATC callouts regarding the visibility of the airport are shown on this attachment. Locations of the Red Table VOR, approach fixes and missed approach point (MAP) from the Jeppesen Chart are also shown in this figure. A picture of runway 15, as viewed during the approach to runway 15, is shown in figure 1.

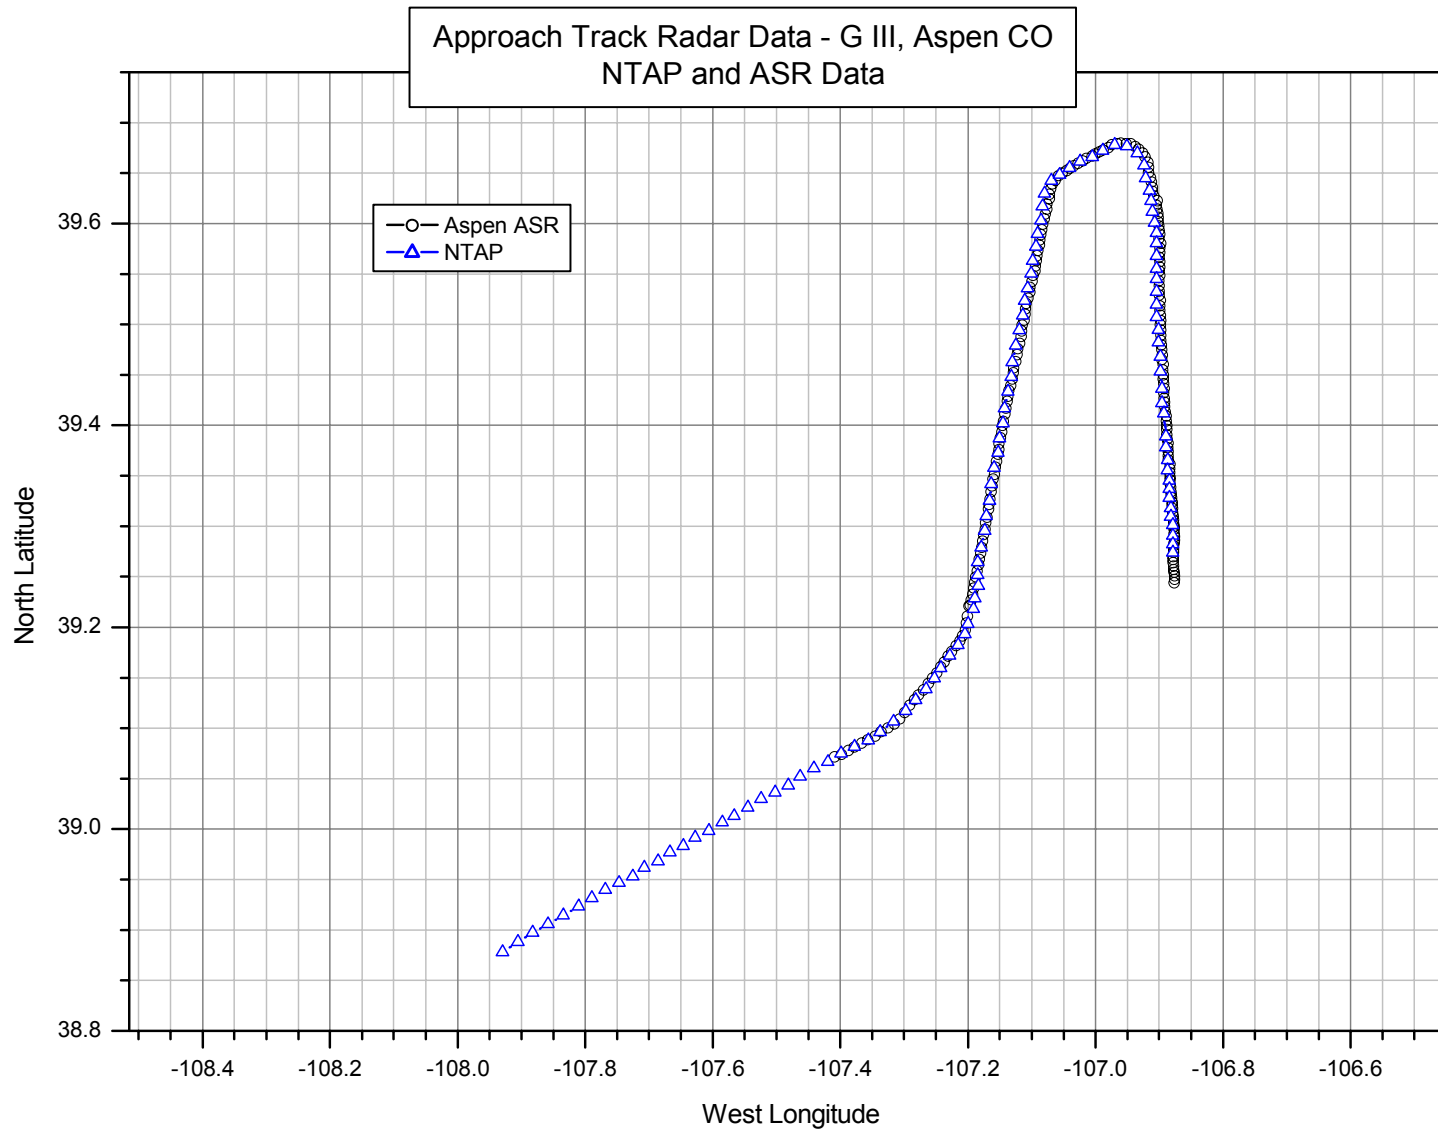
Attachment I -7 depicts the NTAP and ASR radar data for the entire approach of the accident aircraft plotted in latitude–longitude coordinates. Attachment I-8 depicts the altitudes recorded on the ASR radar data as a function of UTC time. Attachment I-9 shows the final four minutes of the approach into Aspen airport. UTC time and transponder altitudes are included on the plot, and the crash site and RWY 15 are noted. At 02:00:49 the flight descends below 10,000 feet and begins its final descent into the airport. The next minute show the airplane maneuvering to the right slightly, then maintaining a relatively straight track until 02:01:27 when the airplane had descended to 8600 feet. A slight deviation to the right towards the centerline of the runway is noted starting at 02:01:45 until the end of the recorded radar data. The final radar return was at 8000 feet altitude, and was approximately 0.35 n.m. north-northwest of the crash site.

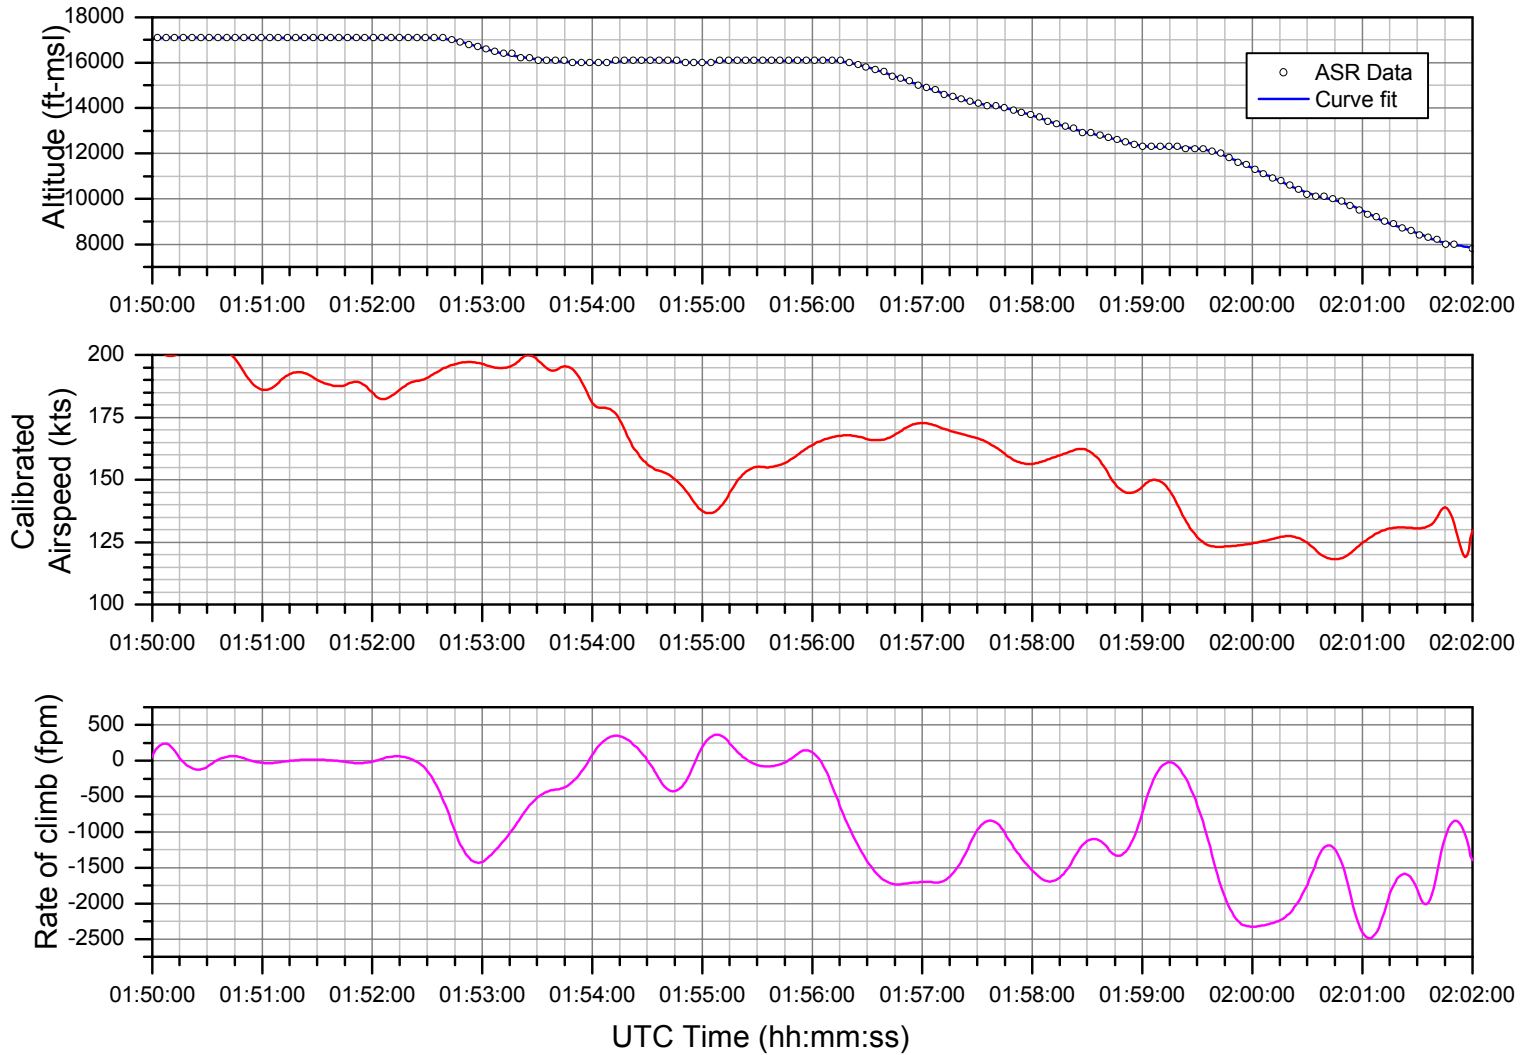
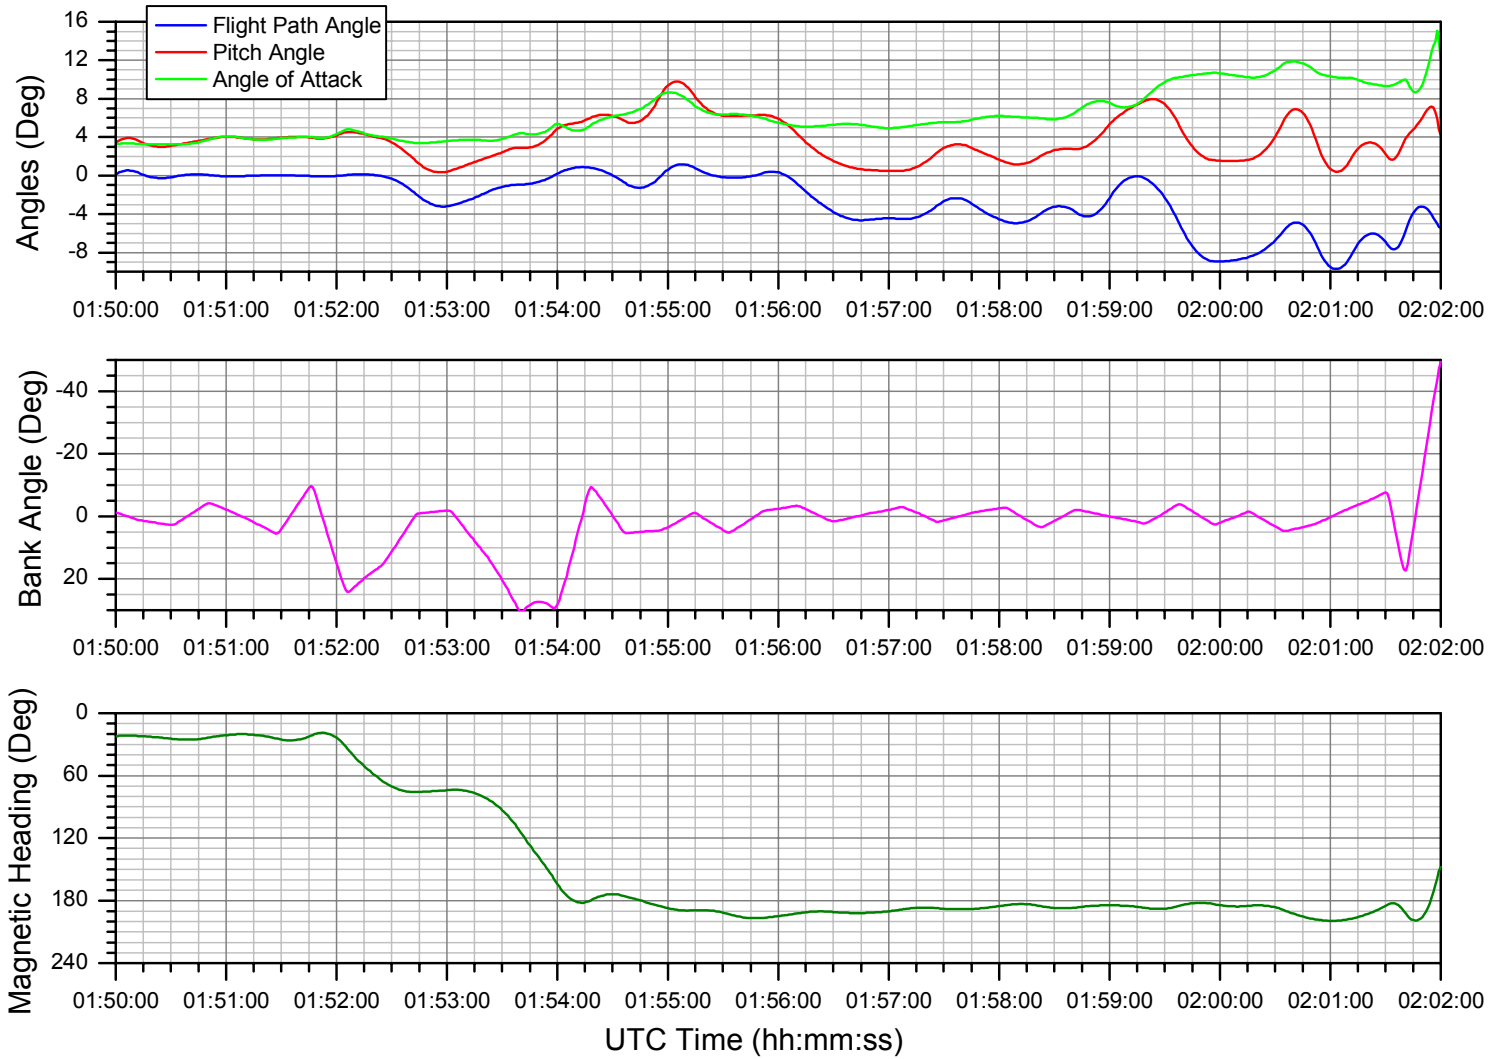
### N303GA Radar Data-based Calculations 0150:00 - 0202:00 UTC

Performance parameters computed for the entire flight are shown graphically in attachments I-21 through I-24. Attachments I - 21 and I - 22 show the calculated parameters for the first half of the flight for the last ten minutes of flight, and the last minute of the flight is shown in attachments I -23 and I -24. The calculated parameters include airspeed, flight path and pitch angle, vertical speed, and magnetic heading. Also shown on these plots are selected excerpts from the CVR transcript.

The flight was following the VOR/DME approach, and was following the altitude step-downs in the approach. The airplane crossed the Red Table VOR at 0157:49 while at 14000 feet, magnetic heading 168, and at an airspeed of approximately 160 knots. At 0157:49, N303GA was cleared to land on runway one five, following a Challenger aircraft. The next step down, D3.0, was crossed at 0158:40, while at an altitude of 12700 feet, and an airspeed of 150 knots. At 0159:00, N303GA started to level near 12200 feet, and reduced speed to approximately 125 knots by 0159:30. N303GA crossed the ALLIX approach fix at 0159:40 at an altitude of 12100 feet.

The aircraft continued its descent after passing ALLIX, maintaining approximately 2200 feet per minute descent rate, and remaining at approximately 125 knots airspeed.  $V_{ref}$  for the aircraft's weight was 123 KIAS. At 0200:28, N303GA asked "are the lights all the way up?", to which the local control (LC) tower replied "affirmative...". N303GA leveled at 10,200 feet for approximately 10 seconds, the started to descend again at 0200:49, as the magnetic heading increased approximately 20 degrees as the airplane turned to the right slightly. At that instant, the LC asked "...do you have the runway in sight?", and N303GA responded "...in sight...". N303GA continued its descent at the same speed and rate as prior to leveling at 10200. The

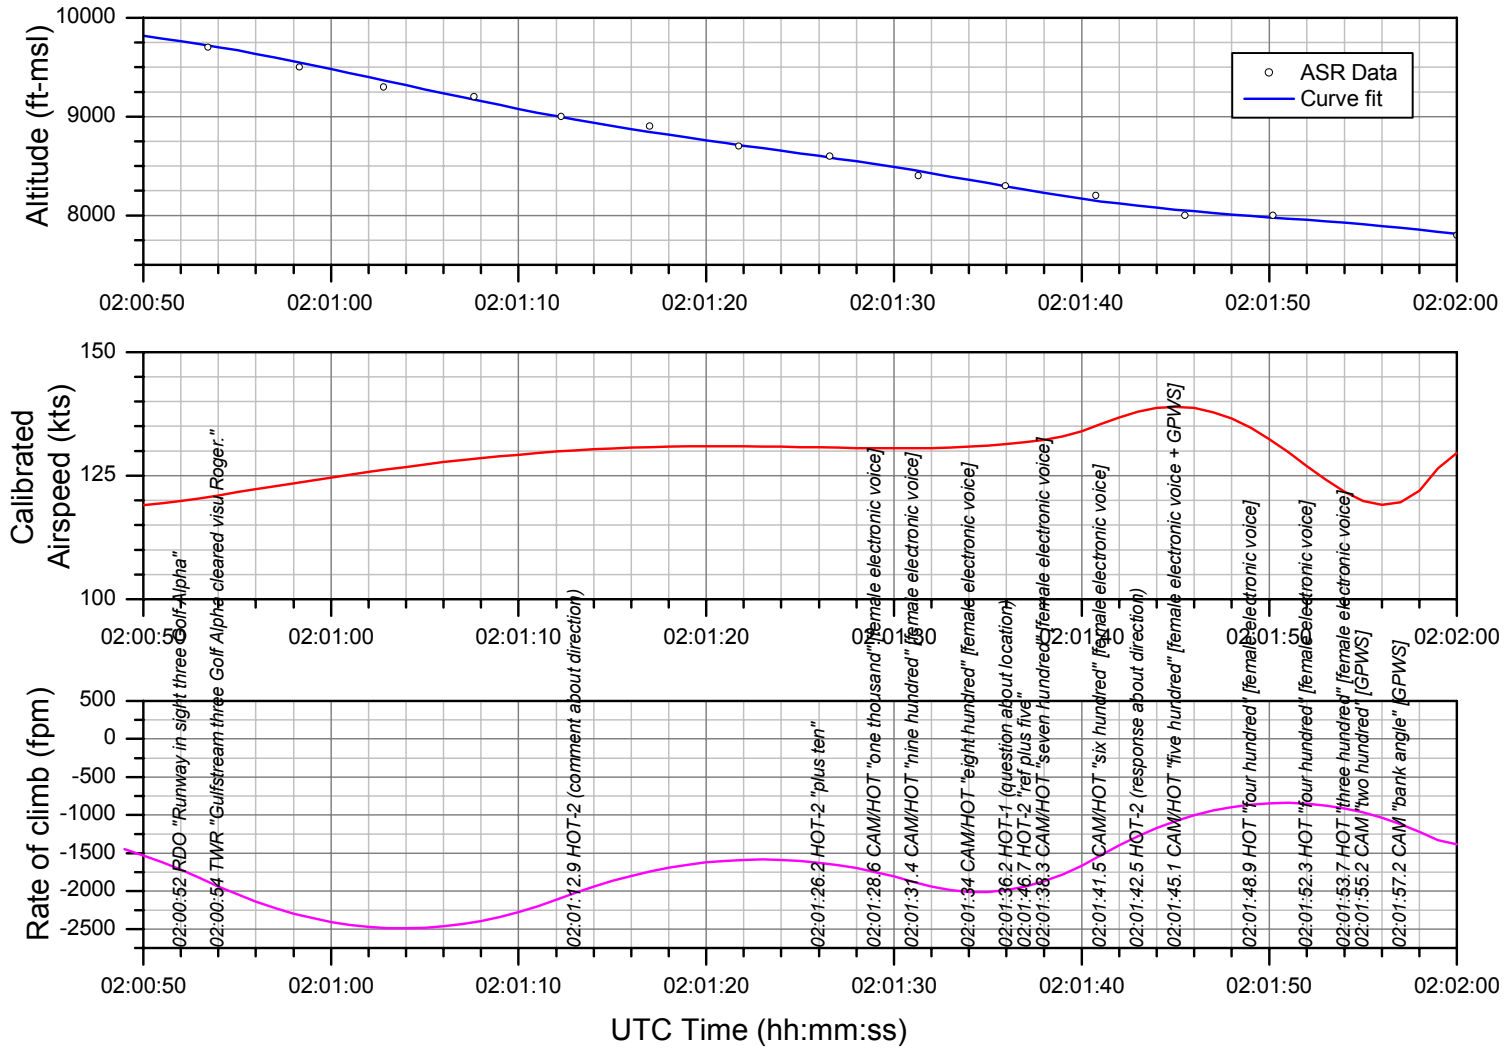
### N303GA Radar Data-based Calculations with Selected CVR Comments 0200:50 - 0202:00 UTC

At 0201:13, a comment regarding direction is recorded on the CVR while the airplane is at 9000 feet altitude as the heading starts to decrease slightly. Airspeed remained between 125 - 130 knots. The first callout of "one thousand " was recorded on the CVR at 02:01:28.6, when the aircraft was at 8600 feet altitude, followed by the "nine hundred" callout three seconds later. The calculated airplane bank angle started to increase in the RWD direction, and the airplane magnetic heading started increase from approximately 185 degrees at the time of the "eight hundred" callout.

At 02:01:36, a question about location from the captain was recorded on the CVR, as the airplane was banked to the right, with heading decreasing, as the airplane turned to the right. The first officer responded at 02:01:42.5, as the airplane began to bank towards the LWD direction. The "five hundred" callout was recorded 2.5 seconds later as the airplane was flying on a heading of 200 degrees. By the time the "four hundred callout is heard at 02:01:49, the airplane has now banked to 10 degrees LWD, and the heading starts to decrease as the airplane starts to turn back to the left. The last recorded radar return occurs at 02:01:50, while the airplane is at 8000 feet altitude. The "four hundred" callout is repeated at 02:01:53.

The calculated bank angle continued to increase in the LWD direction through the next several callouts. The final recorded altitude callout of "two hundred" occurred at 02:01:55.2 when the aircraft was at approximately 7900 feet altitude. The aircraft bank angle exceeded 40 degrees LWD as the "bank angle "callout is recorded on the CVR at 02:01:57.2. The recording stopped 1 second after the "bank angle" callout. The LWD bank angle in excess of 40 degrees is consistent with ground scar information discussed previously in this report, and shown in the tree strike photograph in figure 1.

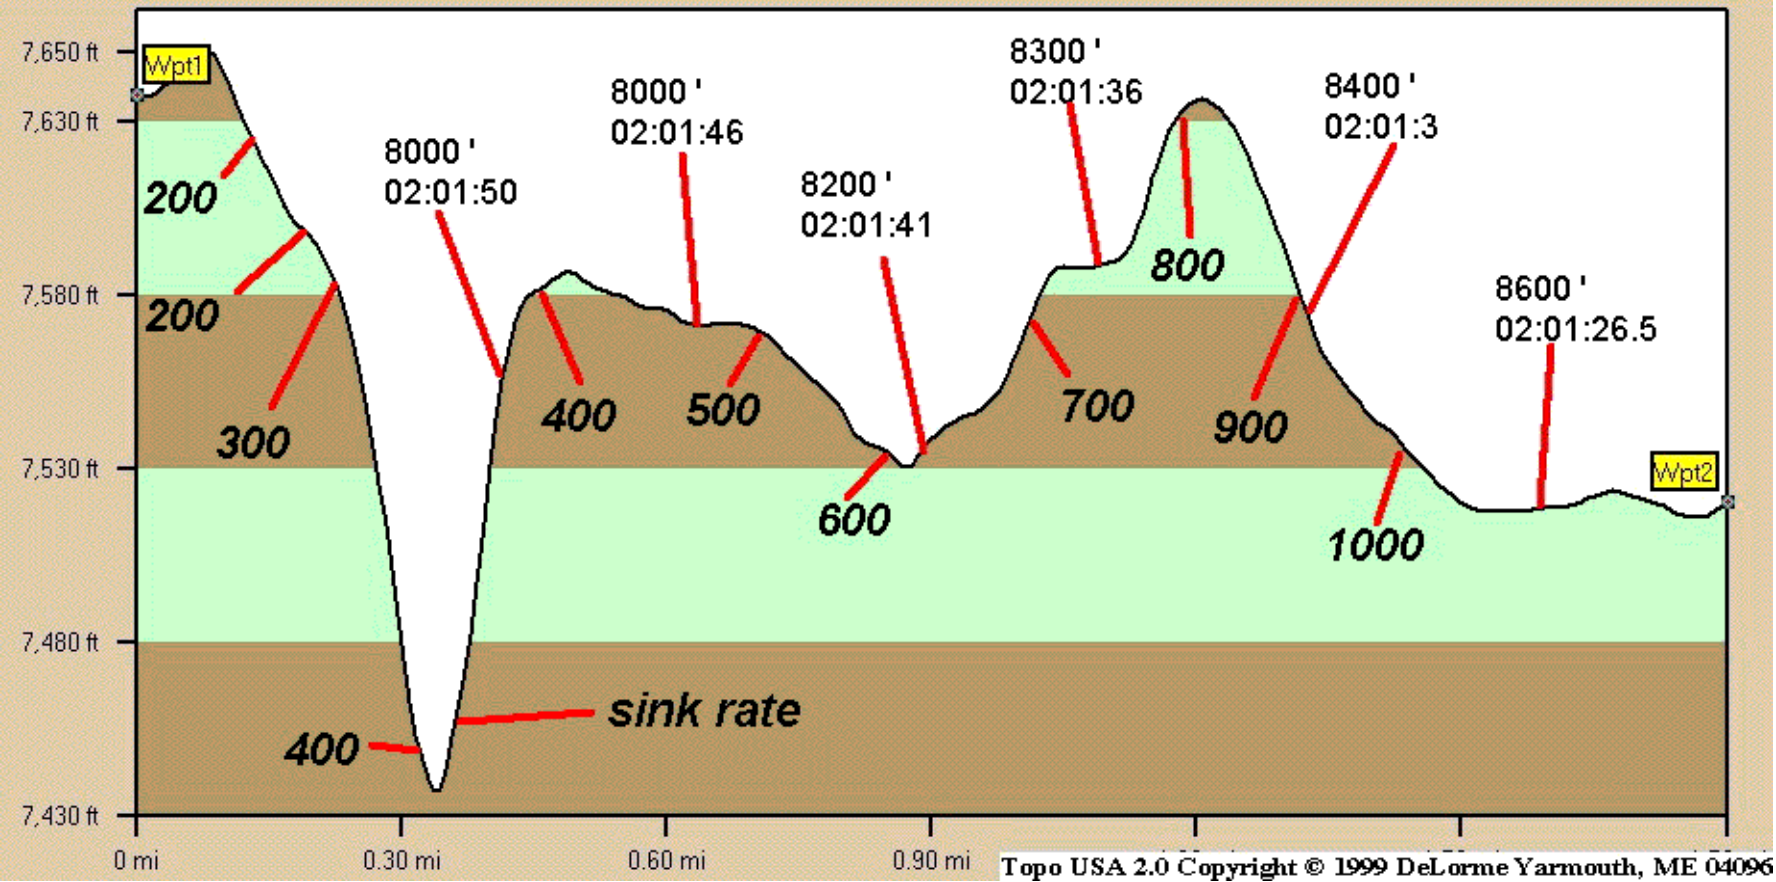
The smoothed and interpolated ground track was used to determine the ground track between recorded radar returns. Shown in attachment I -25 is a representation of the ground terrain under N303GA for the final 30 seconds of the flight. This figure

represents distance from the end of runway 15 on the horizontal axis, and ground elevation along the ground track on the vertical axis. In this figure, the ground track of the airplane travels from right to left as the airplane approaches runway 15. Overlaid onto this chart is ground track location when the height above ground level FPA callouts are recorded on the CVR. Also shown are the groundtrack locations of the final six radar returns, labeled with time and altitude.

Of note in this attachment is the change of terrain below the aircraft between the first “four hundred” callout, and the second callout 2.4 seconds later. During this phase of the approach, the descent rate was approximately constant. However, the second “four hundred” callout occurs as the airplane is traversing a riverbed, and the local terrain drops 140 feet in elevation from one bank to the lowest point in the riverbed. This riverbed is clearly visible on the north side of the road in the photograph in figure 1, and in the topographical information in attachment I – 12. The terrain rises again as the aircraft crosses the riverbed, as the “three hundred” and “two hundred” height callouts are recorded on the CVR. After the final “two hundred” callout, the terrain rose another 25 feet to the elevation of the impact site.
