Gates Learjet 35A N800GP
Vehicle Performance Study

CEN11FA144

A. ACCIDENT: CEN11FA144

Location:	Springfield, IL
Date:	January 6, 2011
Time:	Approximately 17:00 GMT
Airplane:	Learjet 35A

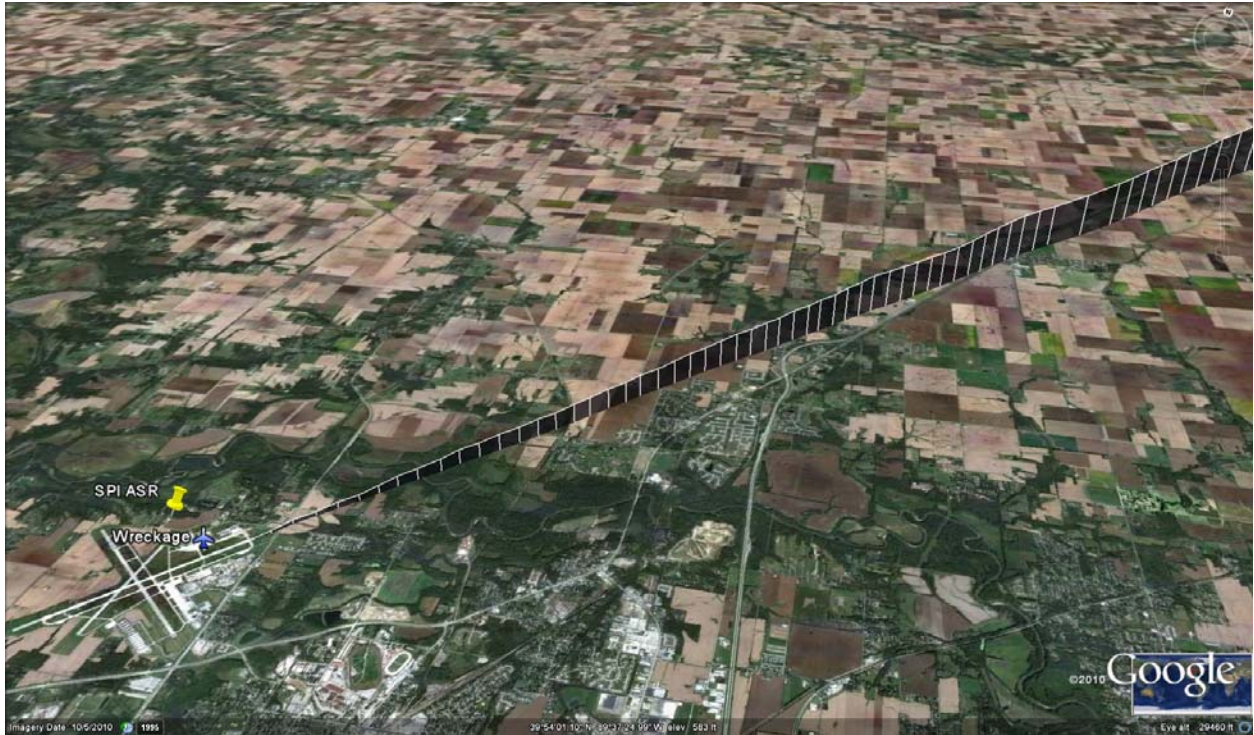
Figure 1. Radar ground track and elevation.

Figure 1 shows the altitude and ground track of the aircraft on a satellite image of SPI and the surrounding area. Figure 2 shows the northing and easting track in nautical miles from the ASR for the last 23 returns. The uncertainty in positions is also shown in Figure 2. The final resting point of the main aircraft wreckage is noted in both figures.

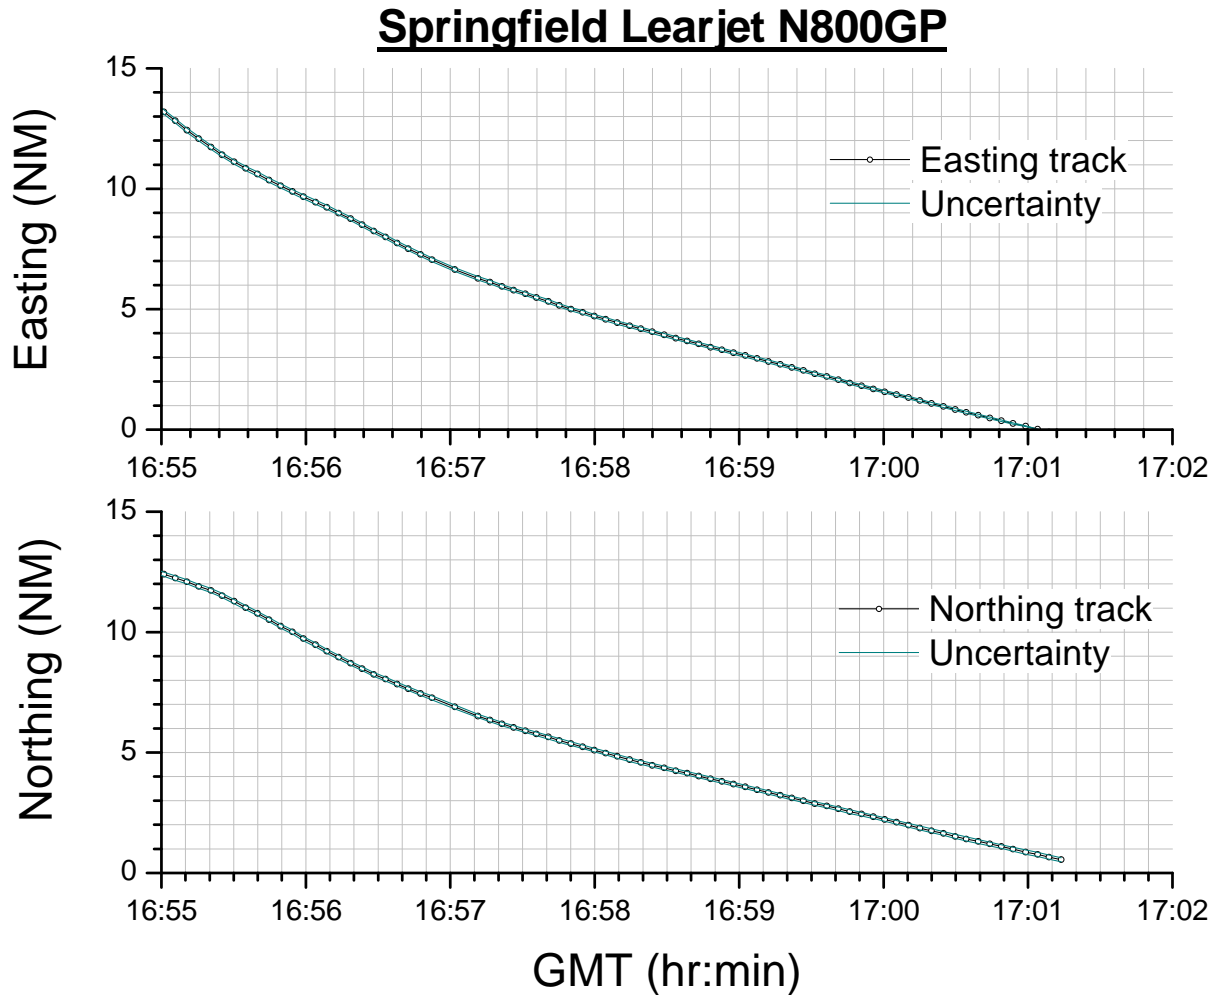
Figure 3. Easting and northing ground track with uncertainty.

Figure 3 shows the northing and easting tracks individually for the last six minutes of the flight that was recorded by radar.

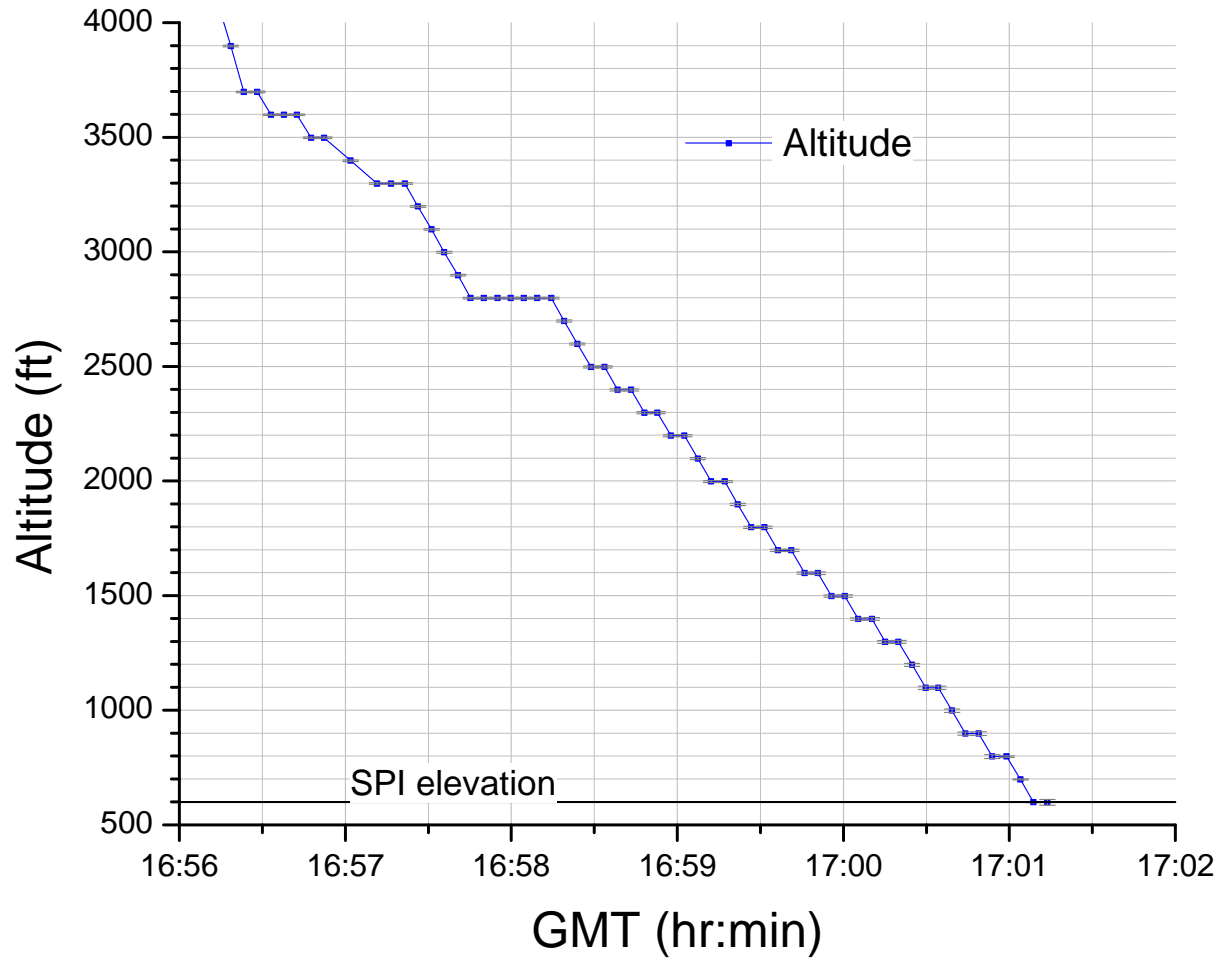
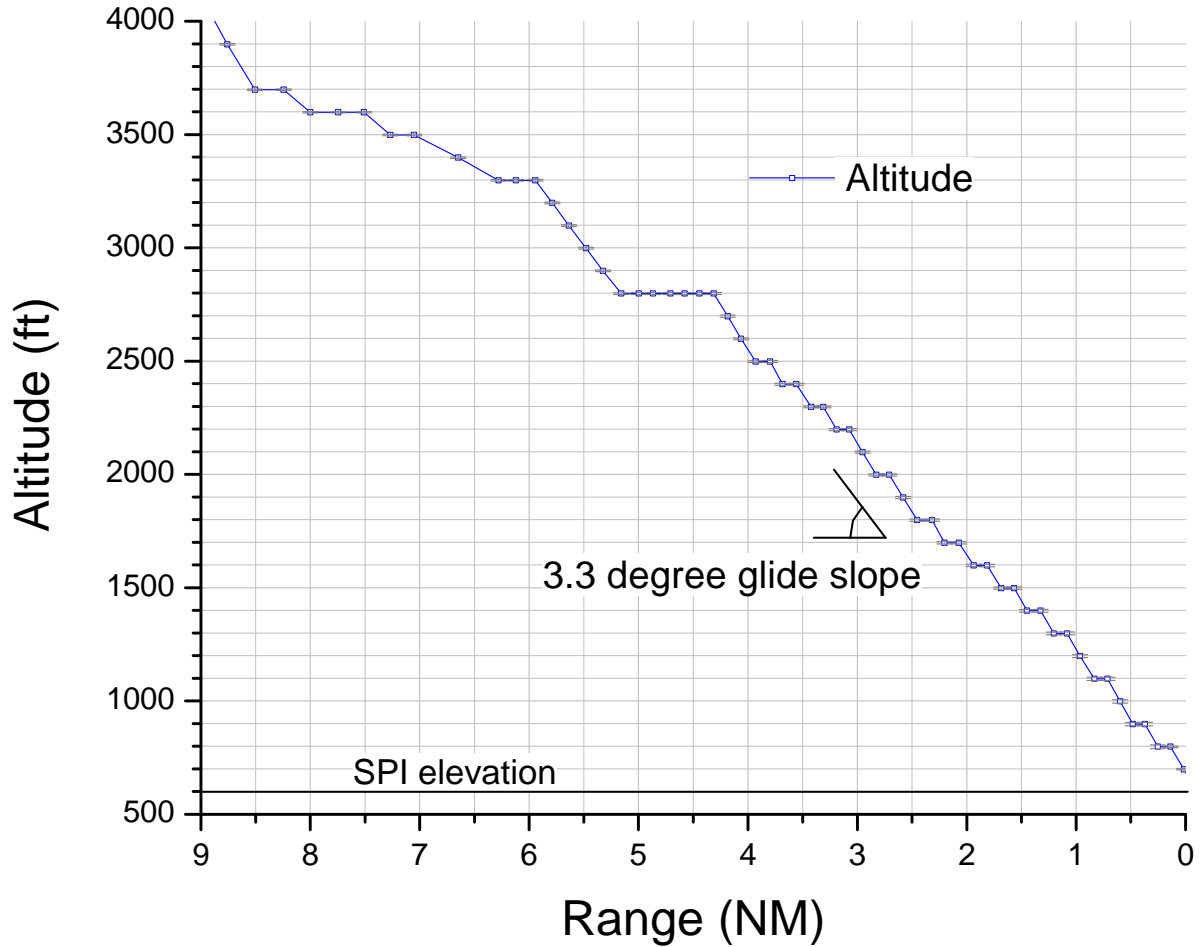
The aircraft altitude is shown in Figure 4 and Figure 5 with respect to time and distance to runway threshold. During the final 8 NM of the approach, the aircraft's glide slope was 3.3° and its descent rate was 730 ft/min. In the raw radar data, the final return (17:01:13 GMT) shows the aircraft altitude as 100 ft above the runway (the previous return is at the runway elevation). Ground strike data indicate that the aircraft was on the ground at this point and the altitude has been changed from 698 ft to 598 ft (the SPI elevation) to reflect this. The inaccurate altitude is possibly due to an erroneous pressure reading caused by an unusual attitude of the aircraft as it impacted the ground.

Figure 4. Altitude versus time.

Figure 5. Altitude and glide slope with respect to distance to runway.

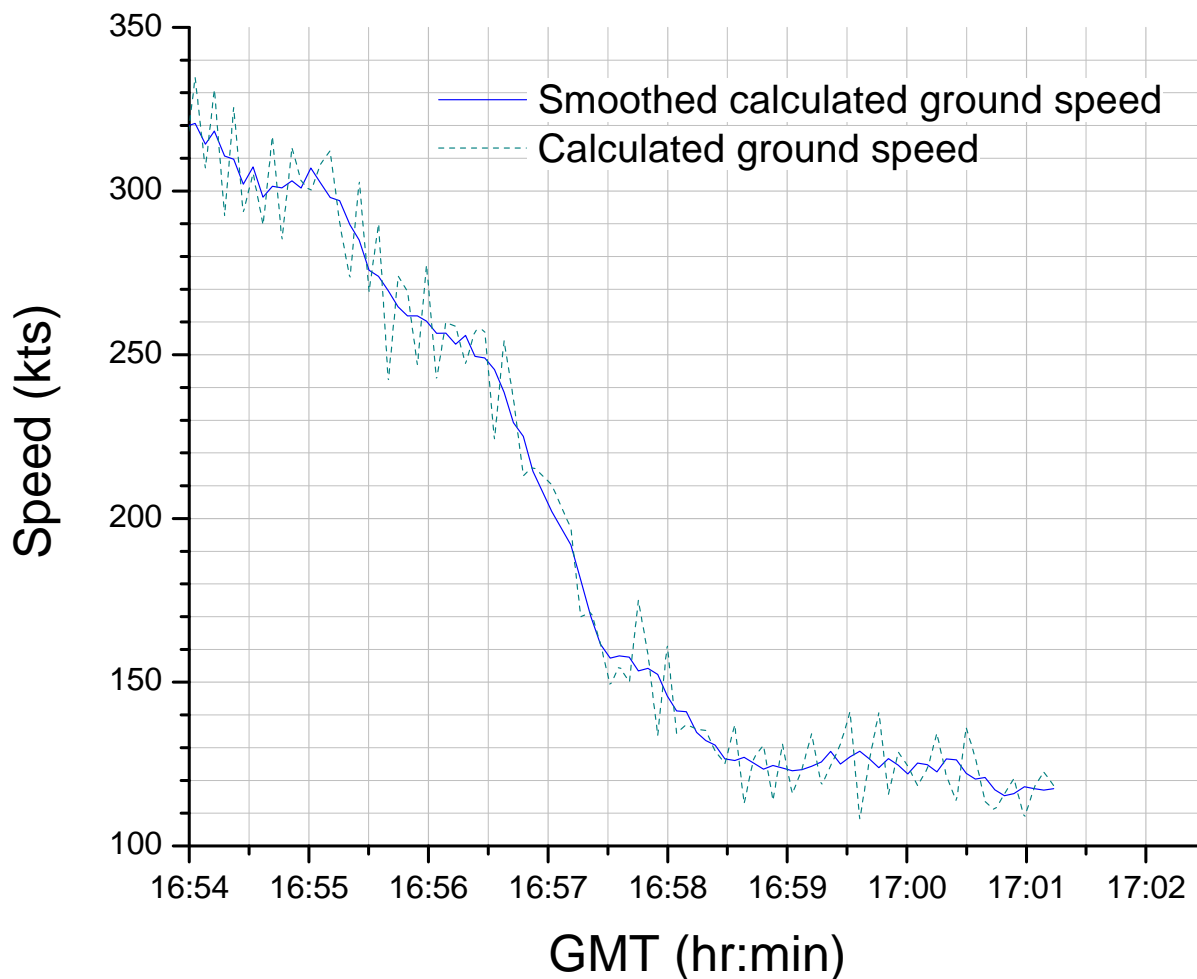
Figure 6. Calculated approach ground speed.

The aircraft's ground speed was calculated using the ground track and time radar data. Figure 6 shows the speed during the last 6 minutes of flight. The numerical differentiation of the raw radar returns leads to unrealistic noisiness in aircraft performance parameters so the ground speed data is smoothed using a moving average method.

The speed for the final 30 seconds of flight was relatively stable with an average speed of approximately 116 knots. The targeted landing speed for the aircraft for the calculated landing weight was 121 knots. The expected stall speed for the aircraft was 93 knots.

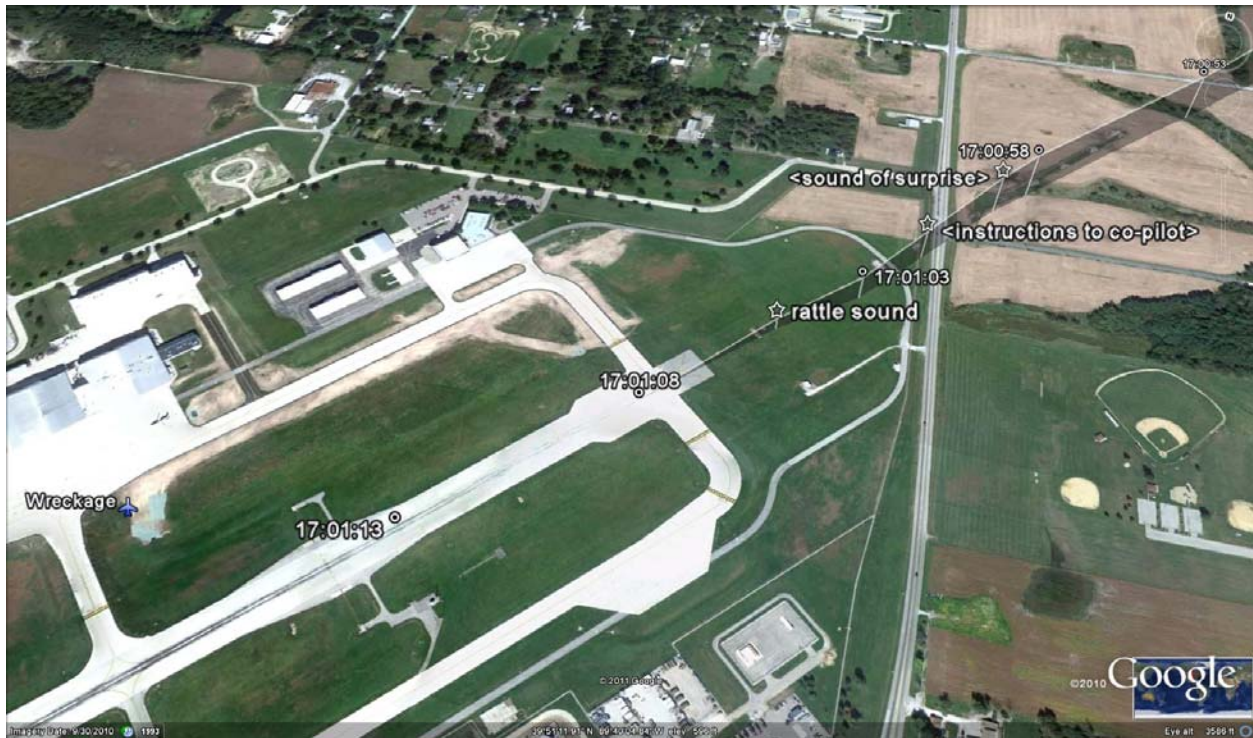
Figure 8. Approach with CVR recordings.

The CVR data was time correlated with the radar data. In interviews the crew reported that the de-icing system had been turned on during the flight, but was turned off in preparation for landing [Reference 1] and the CVR indicated that the de-icing system was turned off at 16:53:30 GMT [Reference 2]. At 16:56:48 GMT, about 4 minutes before impact, the pilot mentions a light rime ice. At 17:01:01 GMT there is an exclamation of surprise from the pilot and a series of rapid instructions is given to the co-pilot. At 17:01:05 GMT, there is a rattling noise in the cockpit indicative of the activation of the stick shaker. The final minute of the approach is shown in Figure 8 with the CVR comments. The gasp of surprise, instructions from the pilot, and stick shaker rattle all occur when the airplane was less than 200 ft (± 50 ft) above the ground.

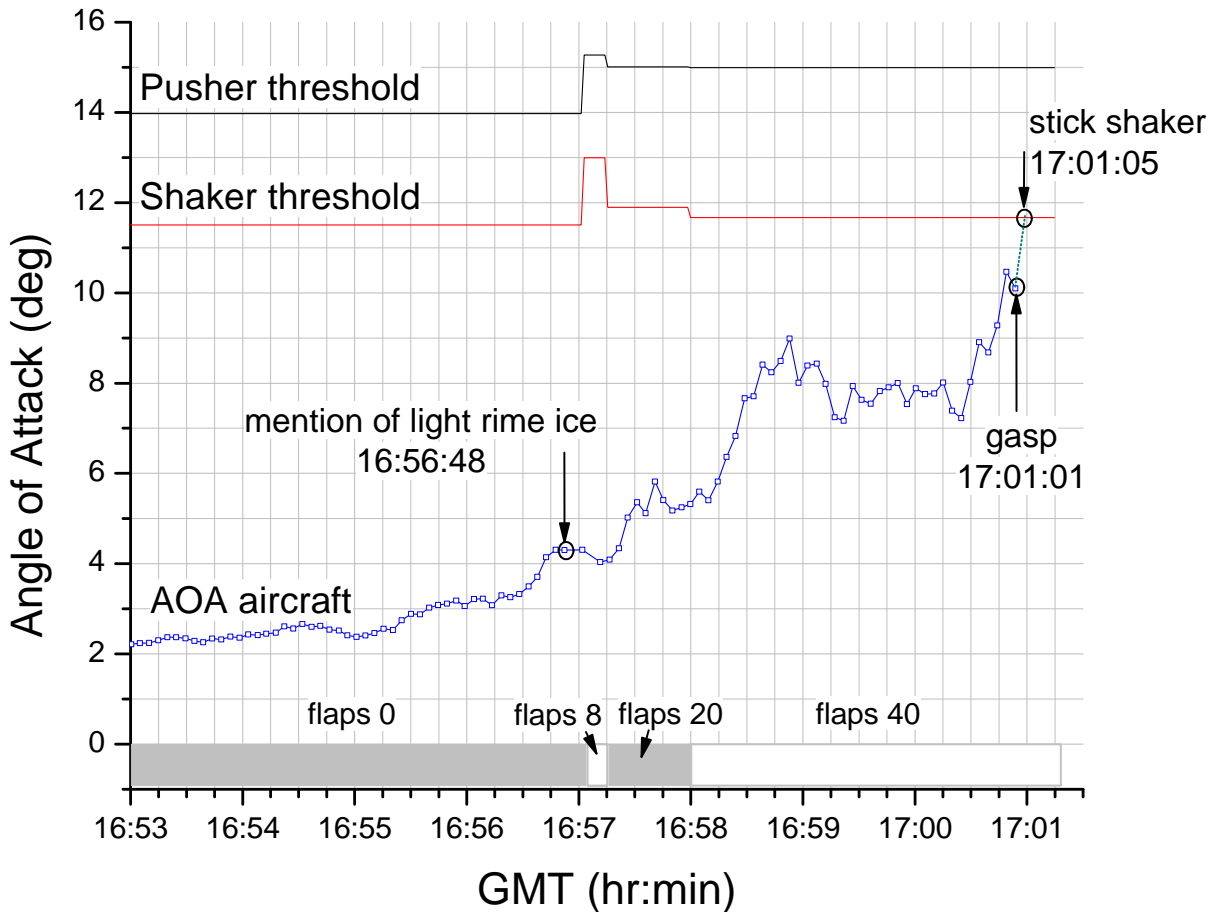
Figure 9. Aircraft angle of attack (AoA) and shaker and pusher thresholds.

The angle of attack (AoA) of the aircraft was calculated using lift curves provided by Bombardier Aerospace for the Learjet M35A with Century III wings in a clean (no ice) configuration and compared to the stick shaker and stick pusher thresholds. When the AoA of the aircraft exceeds the stick shaker threshold, the aircraft's control yoke is noisily shaken to alert the pilot to an imminent stall situation. If the aircraft AoA continues to increase past the stick pusher threshold, the aircraft's control yoke is mechanically pushed to decrease the aircraft AoA and avoid stall. The stick shaker and stick pusher are programmed to be below the actual aircraft stall AoA in free air.

Figure 9 shows the calculated AoA of the aircraft in relation to the angle of attack thresholds for the stick shaker and the stick pusher for each flap setting. The times of changes in flap settings were determined from pilot and co-pilot callouts on the CVR.

The AoA of the aircraft increases as it nears the runway, but stays below the shaker and pusher thresholds. At 17:01:01 GMT, the CVR recorded a gasp of surprise and subsequent instructions given to the co-pilot to put the nose down and add power, which are actions consistent with stall recovery procedures. These events occurred before the stick shaker activated at 17:01:05 GMT. The subsequent activation of the stick shaker indicates that the angle of attack continued to climb after the surprised reaction of the pilots began. There is no indication the stick pusher activated.

The aircraft descent and approach into SPI proceeded normally with expected course, descent rate, glide slope, and approach speed. Four minutes before landing, the development of light rime ice is noted in the CVR transcript. The CVR recorded a gasp of surprise and subsequent instructions given to the co-pilot to push the nose down and add power, which are actions consistent with stall recovery procedures. Angle of attack calculations from radar show that these actions were taken below the stick shaker threshold angle of attack and the stick shaker did activate after the described events. A buildup of ice on the wings will reduce the stall angle of attack so that the aircraft can experience an aerodynamic stall before the stick shaker activates.
