Docket No. SA-533

Exhibit No. 13B

ATR Presentation – ATR-42 Icing Systems and Design Changes Since  
Roselawn

# ATR42-320 Ice Protection Systems

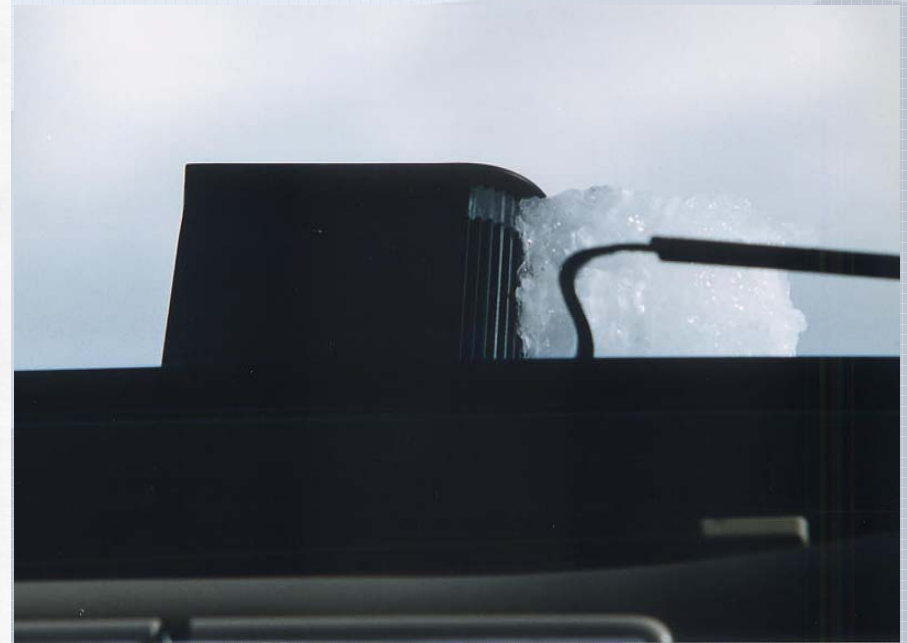
## Ice Evidence Probe: IEP

IEP visible by both pilots (propeller spinner if not installed)

- When clean  $\Rightarrow$  critical surfaces are free of ice
- IEP provides an indication on ice accretion rate

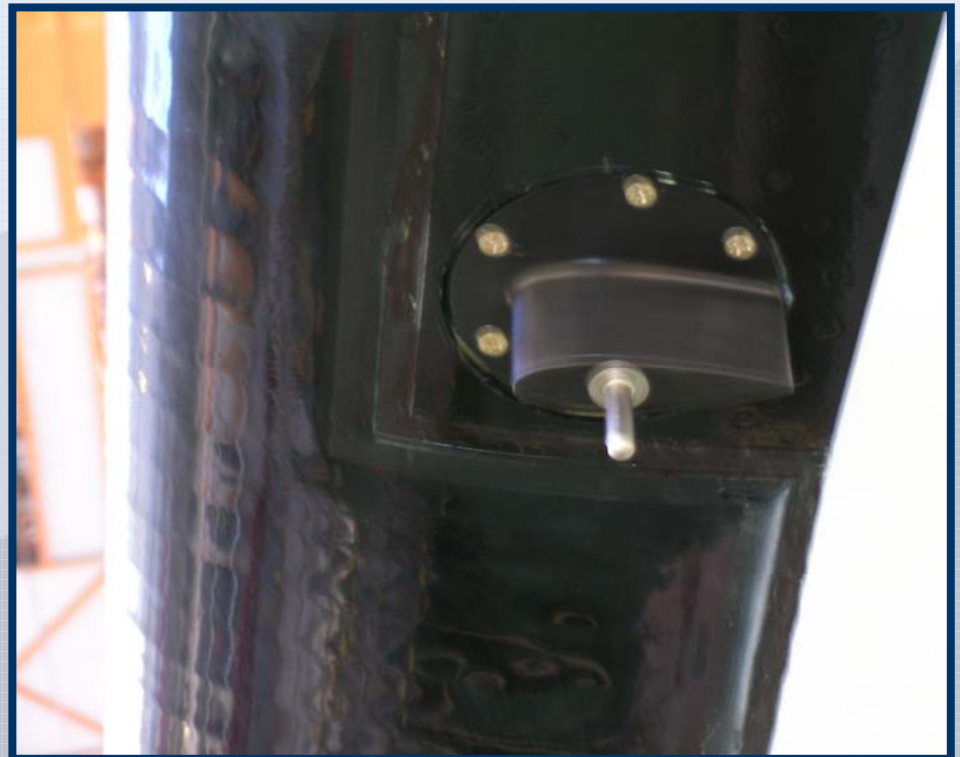
## Ice Detector part of the Advisory Anti-icing System

Ice detector (BFG)  $\Rightarrow$  Icing signal (amber light + Single Chime)

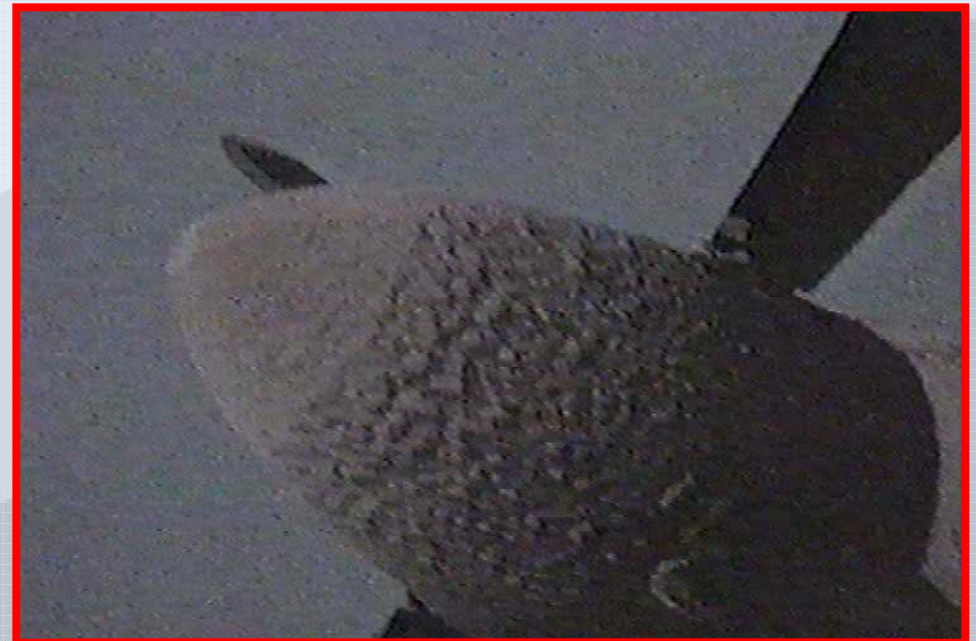
Ice accretion on the spinner under SLD's
