**National Transportation  
Safety Board**

## **Memorandum**

Subject: Plots of GAU2000 data and performance estimates for WPR16FA040

# WPR16FA040: Airbus Helicopters AS350B3, N74317, Superior, AZ, 12/15/2015

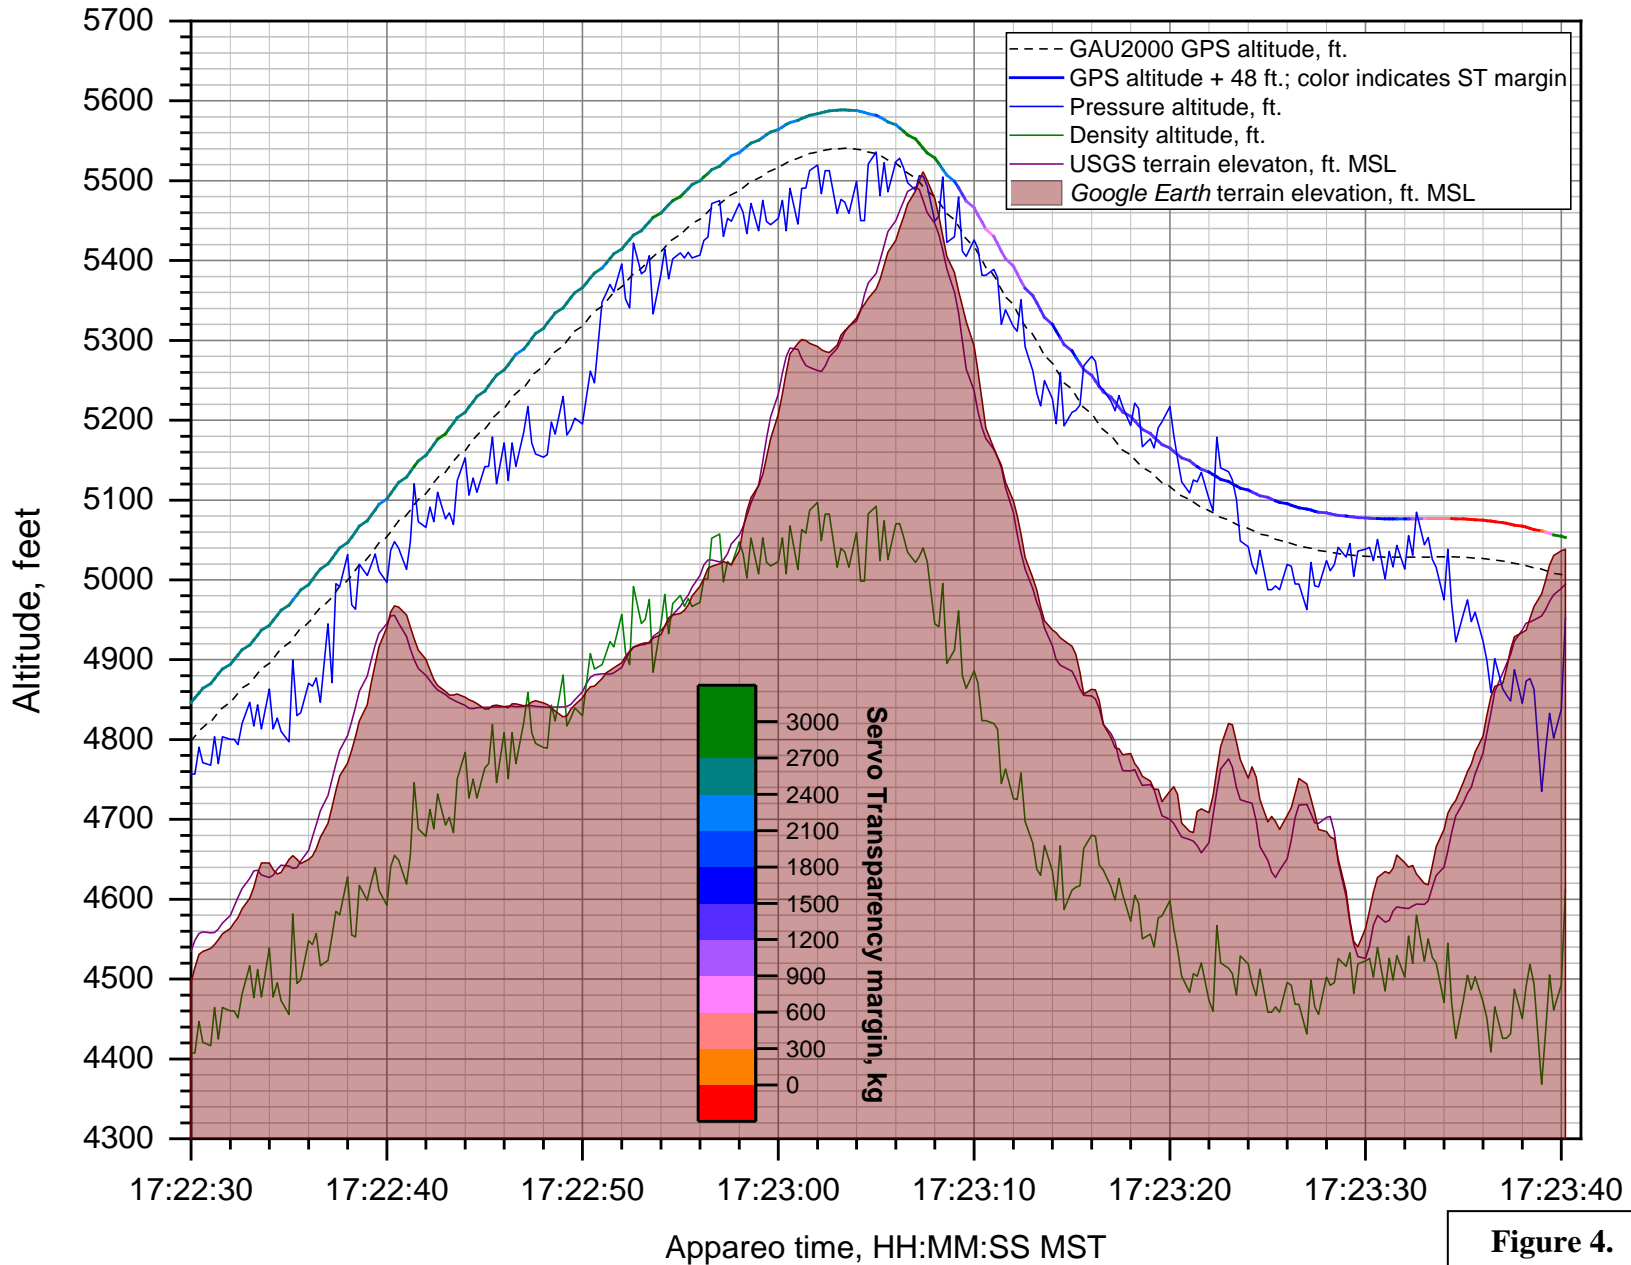
Figure 4 plots MSL altitude and terrain elevations vs. time for the last minute of the flight. The color of the MSL altitude (GPS altitude + 48 ft.) in this plot also indicates the "STP margin," a measure of the value of the STP from the threshold of flight conditions conducive to the servo transparency phenomenon (servo transparency is possible when the margin reaches 0). The plot

shows that the margin decreases to zero (the line turns red) at about 17:23:34, as the helicopter is approaching higher terrain.

Altitude & elevation vs. time

The brown-shaded terrain data in Figure 4 is taken from *Google Earth*. For comparison, 1-arc second elevation data (i.e., elevation data sampled every arc-second, or about every 100 ft.) from the USGS<sup>4</sup> is plotted as the purple line. The datasets show some differences, but are in general agreement. The AGL altitudes plotted in Figure 3 are computed using the *Google Earth* elevations.

Figure 4 also plots additional altitude parameters computed from the GAU2000 data, including pressure altitude and density altitude. The computation of these altitudes and of the STP is described in the next section.

To evaluate Equation [1] and determine the actual value of the  $STP$  at each point in the accident flight, the load factor  $n$ , mass  $M$ , and density ratio  $\sigma$  are required.  $n$  is recorded directly on the GAU2000;  $M$  is assumed to be 4446 lb. (2017 kg);<sup>5</sup> and  $\sigma$  can be computed from other parameters recorded on the GAU2000. Specifically, the recorded air temperature and true airspeed data can be used to compute the Mach number. The Mach number and recorded indicated (calibrated) airspeed can be used to find the static air pressure; and the static air pressure and air temperature can be used to compute pressure altitude, air density, density altitude, and the density ratio. The pressure and density altitudes are plotted in Figure 4.

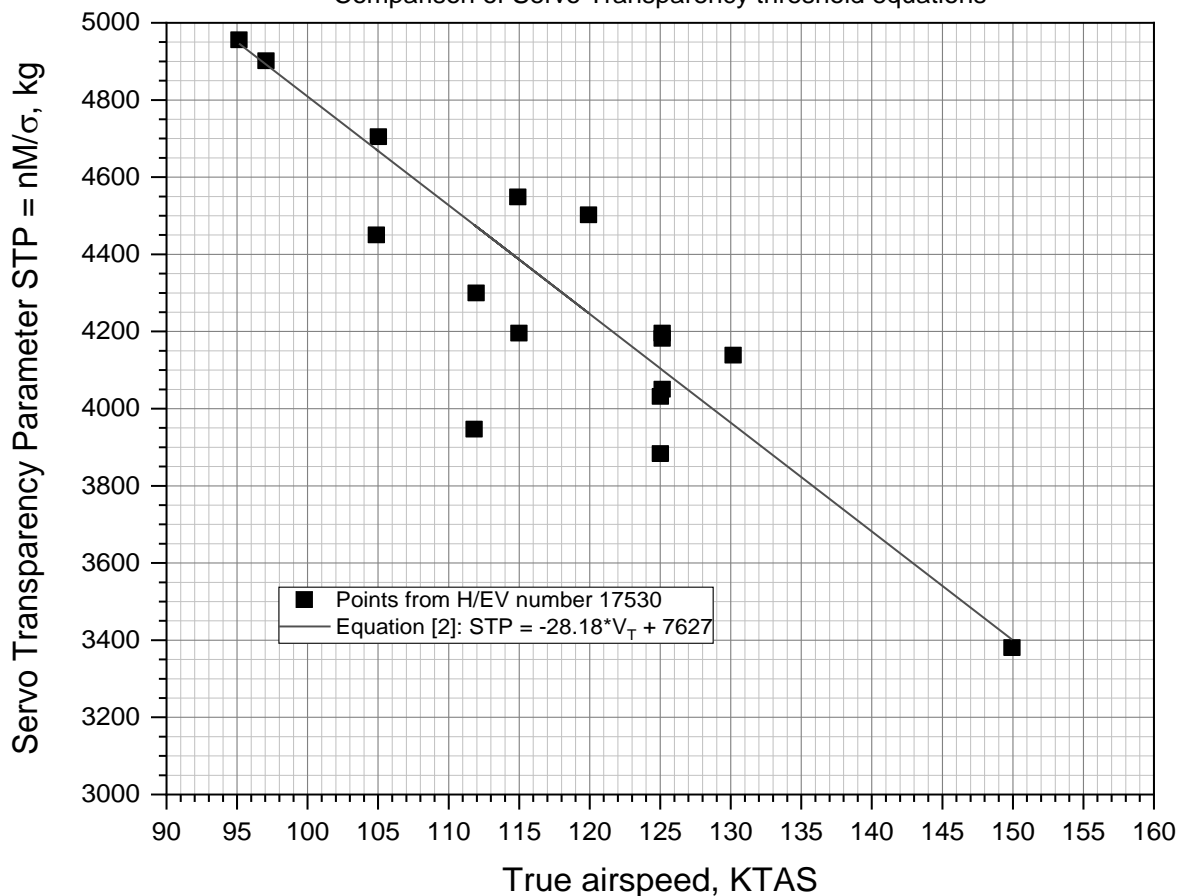
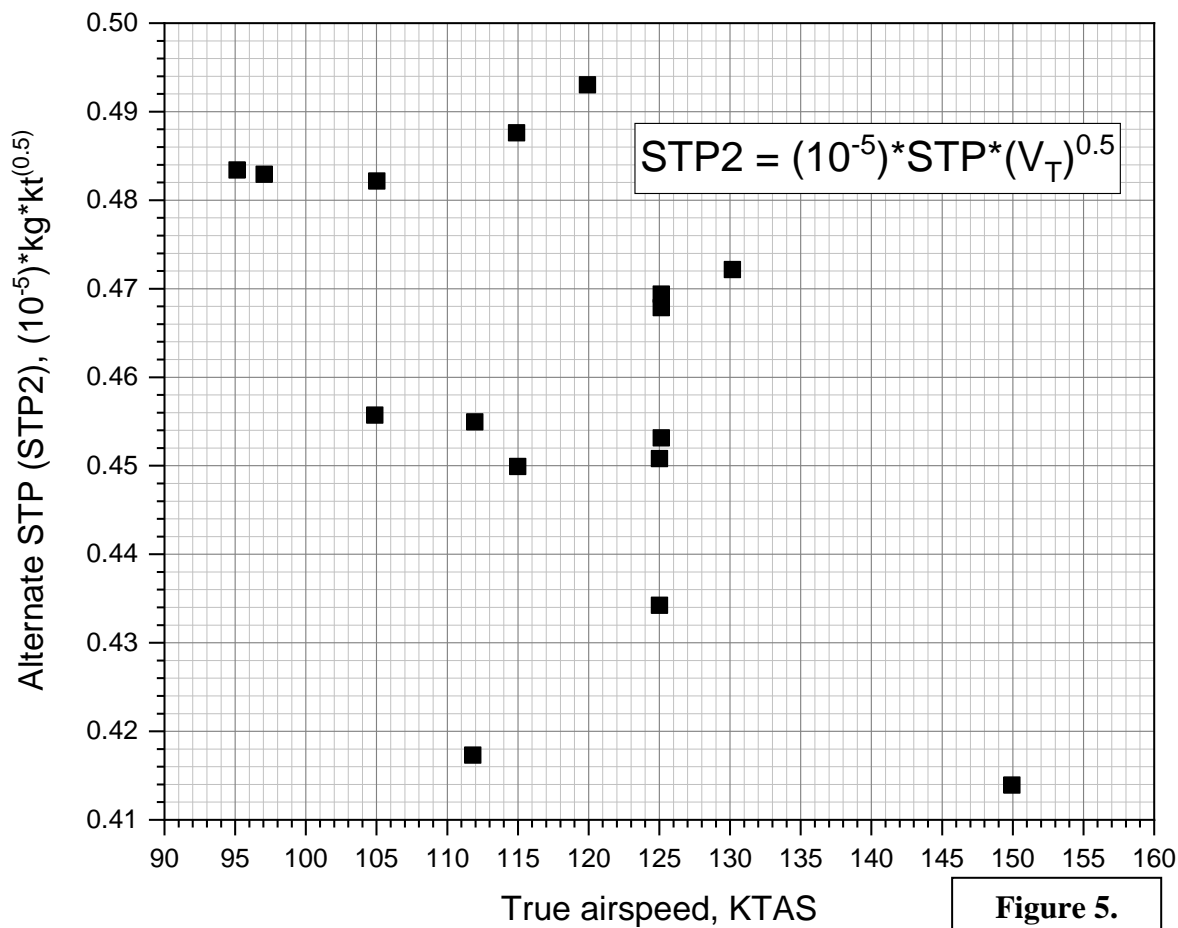
**Figure 5.**

Reference 1 provides the results of the flight tests and the Eurocopter servo transparency data in various Appendices. Of greatest relevance is a document that references Eurocopter certification document H/EV number 17530, dated 12 November 1985, and that presents a plot of the conditions under which the servo transparency condition was encountered. This plot is reproduced here as the top plot in Figure 5. The STP is plotted on the y-axis versus true airspeed on the x-axis, and is defined as

The document that presents the plot reproduced in Figure 5 also presents the following linear curve fit through the data:

Note that the  $STP$  decreases with true airspeed. It is of interest whether an “alternate  $STP$ ” parameter can be found that would provide a single threshold value across all airspeeds. The bottom plot of Figure 5 plots such an alternative  $STP$ , defined as

Note that the scatter of the  $STP2$  values across the airspeed range is relatively level. Based on this plot, it appears that the servo transparency condition can be encountered when the value of  $STP2$  reaches a value in the range of 0.414 to 0.494, regardless of airspeed.

Comparison of Servo Transparency threshold equations

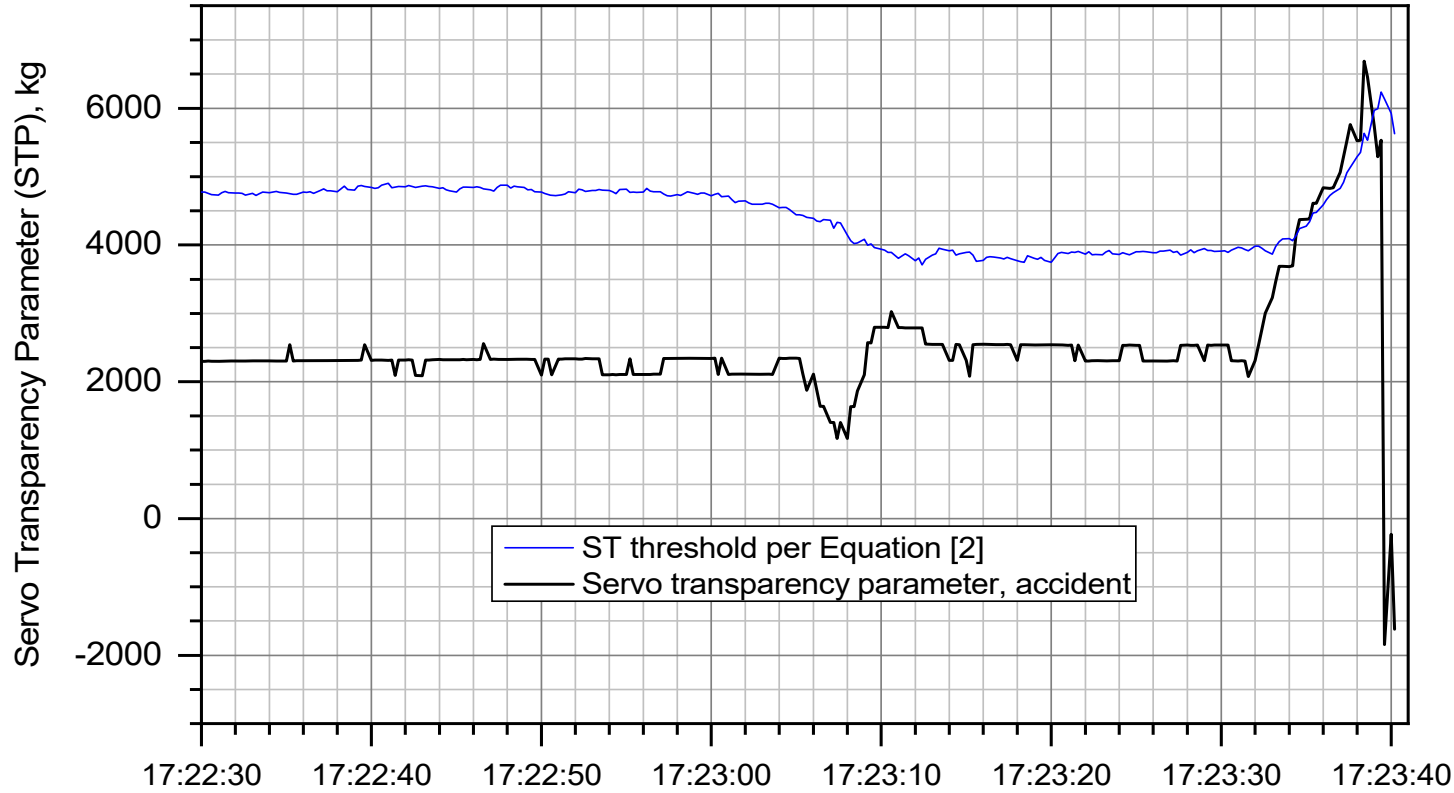
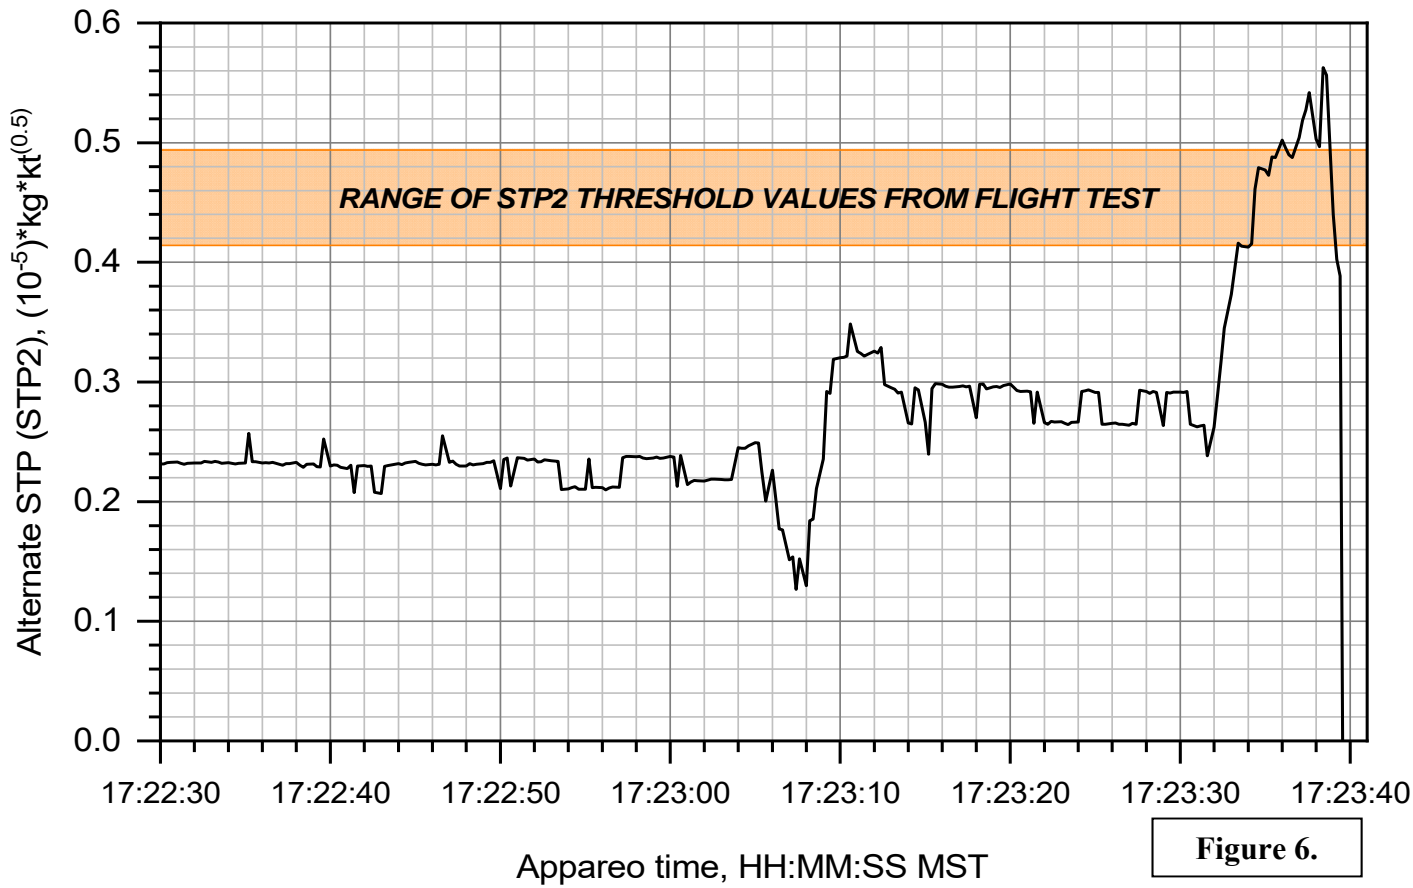
The accident values of  $STP$  as defined by Equation [1], and the “threshold” values of  $STP$  and  $STP2$  defined by Equations [2] and [3], are plotted as a function of time in Figure 6. The top plot in Figure 6 compares the actual  $STP$  condition of the helicopter, evaluated using Equation [1] and the values of  $n$ ,  $M$ , and  $\sigma$  as determined above, with the threshold values of  $STP$  defined by Equation [2] corresponding to the  $V_T$  at each time point.<sup>6</sup> Equation [1] is represented in Figure 6 by the heavy, black “Server transparency parameter, accident” line, and Equation [2] by the blue “ST threshold per Equation [2]” line. The “Servo Transparency margin, kg” parameter used to color the altitude line in Figure 4 is given by

Note that the actual  $STP$  of the helicopter crosses the ST threshold at about 17:23:34 (6 seconds before the end of the data).

The bottom plot in Figure 6 compares the in-flight values of  $STP2$  defined by Equation [3] (with  $STP$  in this equation defined by Equation [1]) with the range of  $STP2$  values indicating the servo transparency condition, per the bottom plot in Figure 5. The  $STP2$  enters this range at about 17:23:34, coincident with the crossing of the ST threshold in the top plot.

Servo Transparency Parameters vs. time

The jumps in the recorded pitch and roll rates at 17:23:32 are of interest, and are consistent with a cyclic control input both aft and to the right, which as indicated in Reference 1 are characteristics of the servo transparency condition. However, as shown in Figure 6, at 17:23:32 the STP is below

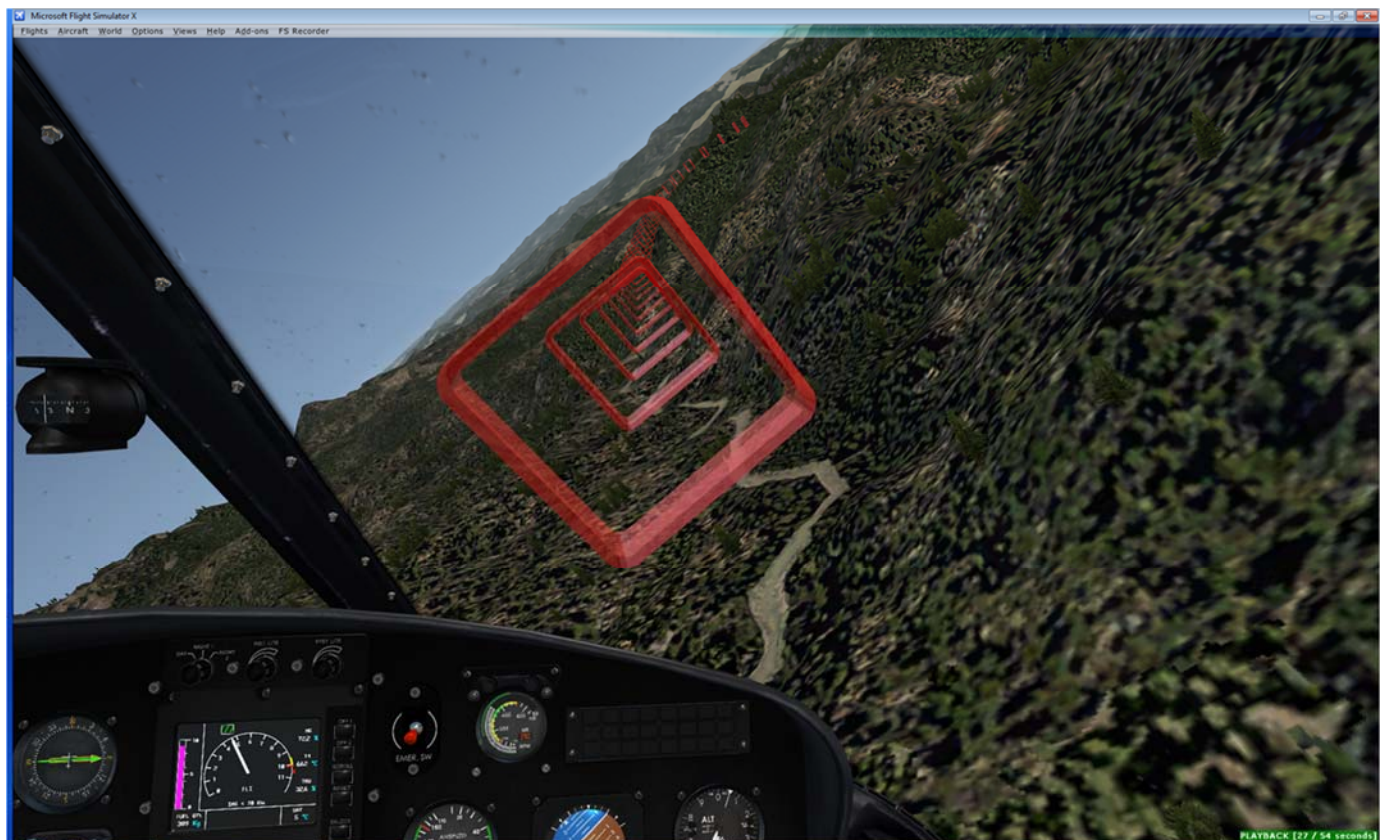
Finally, the pitch angle was also estimated by “hand flying” a model of an AS 350 helicopter through target points placed coincident with the recorded GPS positions in the *Microsoft Flight Simulator X* computer program (*FSX*; see Figure 8). While not derived from a rigorously correct (or skillfully flown) model of the AS350, the pitch angles required by the helicopter in the simulation program should be more representative of the actual pitch angles than those computed from the “airplane” model.

**Figure 8.** Screenshots of manual flight through GPS “targets” in *FSX*. Top image: external view. Bottom image: cockpit view.

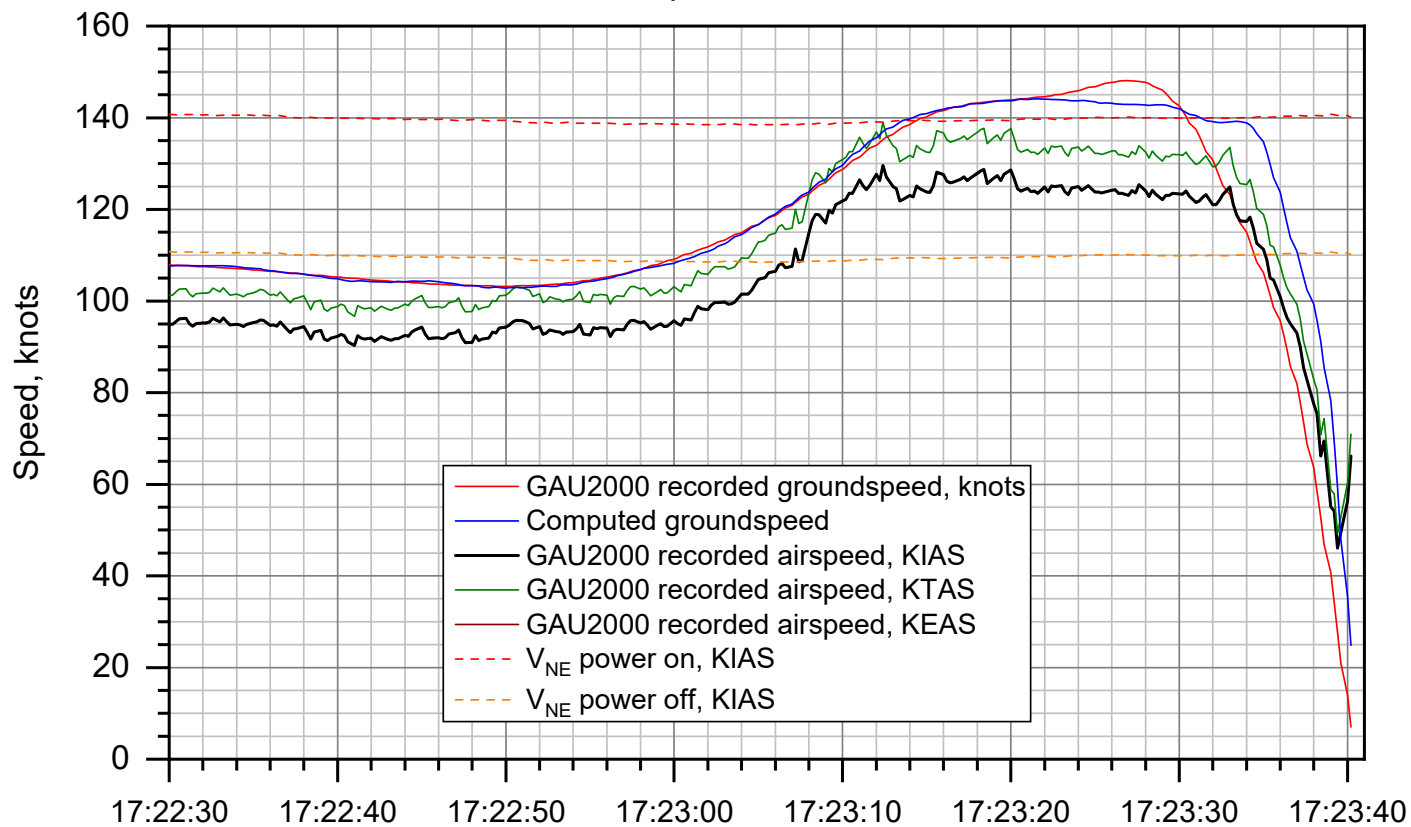
Figure 10.

Speeds vs. time

<sup>8</sup> In this case, the computed groundspeed shown in Figure 10 is used in Equation [8] instead of the groundspeed recorded on the GAU2000, since the latter is not consistent with the recorded GPS coordinates near the end of the flight; see further discussion below.

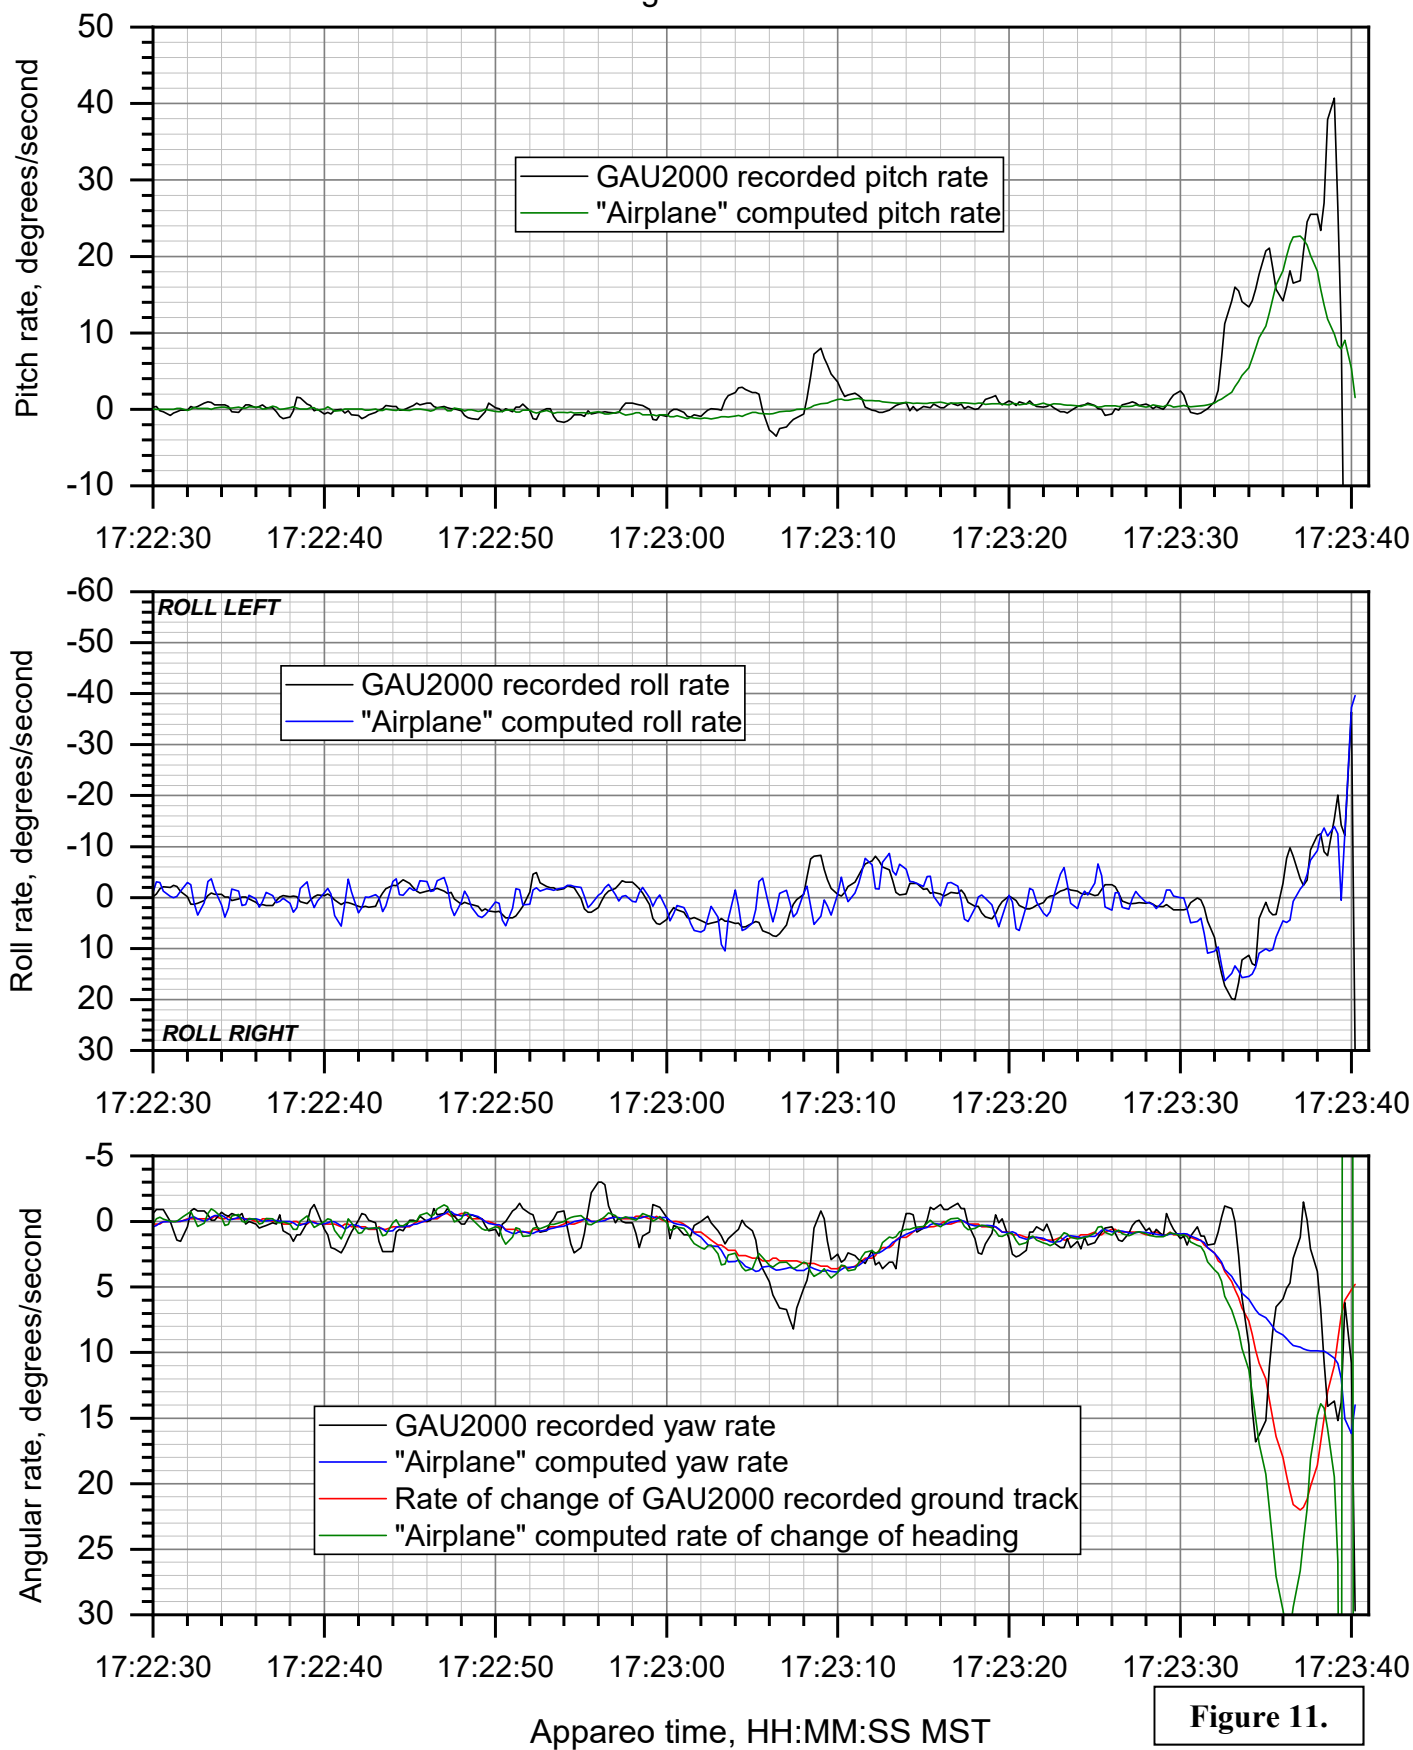
Figure 11.

The pitch, roll, and yaw rates recorded by the GAU2000 are plotted in Figure 11, and compared to the “airplane” angular rates, and to the rates of change of the recorded ground track and computed heading. The recorded and “airplane” roll rates match relatively well, but the recorded and “airplane” pitch and yaw rates differ significantly. The high angular rates recorded by the GAU2000 after 17:23:34 are notably larger and more erratic than the “airplane” rates; this suggests that the helicopter motion may not be coordinated in this region (and the excursions in the recorded longitudinal and lateral load factors ( $n_x$  and  $n_y$ ) after 17:23:37 are consistent with this observation; see Figure 7).

Angular rates vs. time

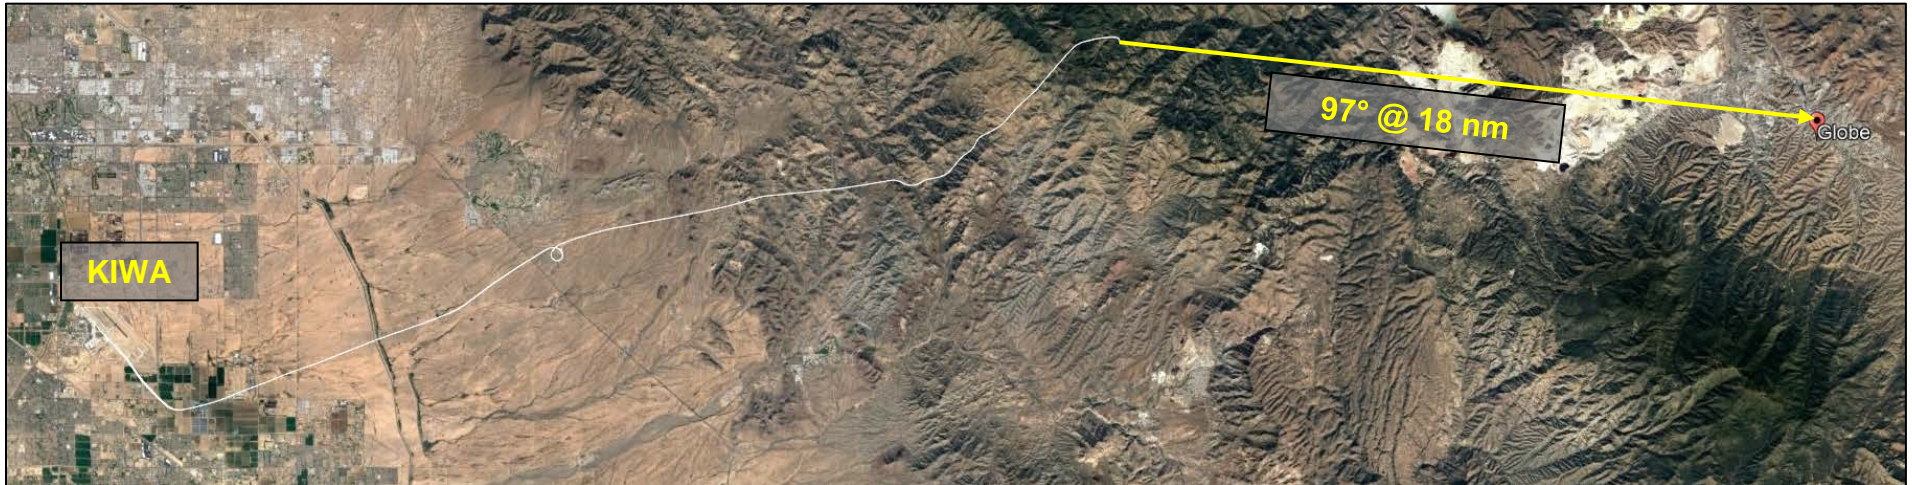
The destination of the flight was the operator's base at Globe, AZ. The location of Globe relative to KIWA, the route of flight, and the accident flight is shown in Figure 12. Figure 13 is an image from *Google Earth* depicting the helicopter's flight path, with annotations every 2 seconds displaying information in the following format:

**Figure 12.** Overview of flight from KIWA to intended destination of Globe, AZ, showing distance and bearing of Globe from the crash site.

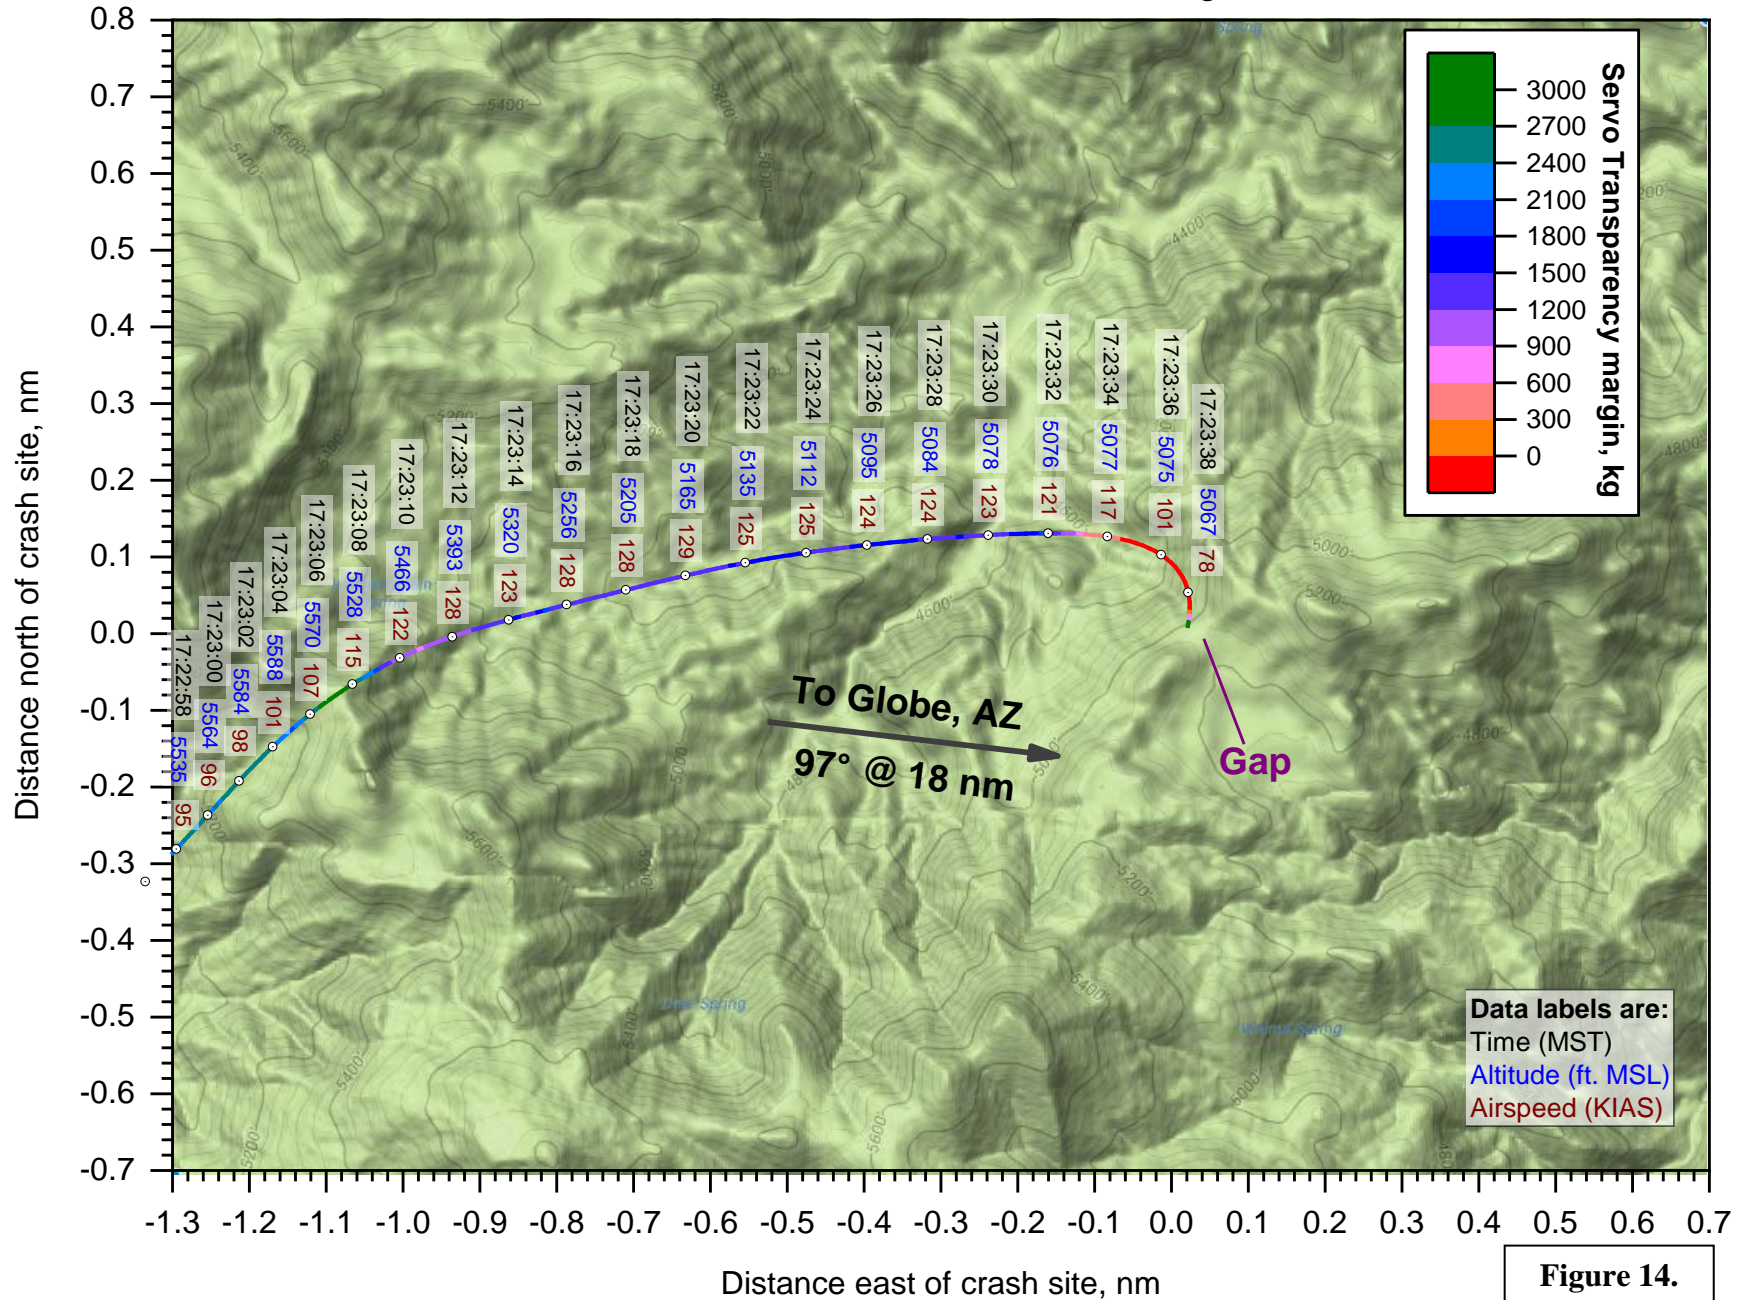
Figure 14 is a plan-view of this area, similar to Figures 1 and 2, and shows the local summits and the ridge between them more clearly. The direction towards Globe, the helicopter's destination, is also shown (18 nm away on a 97° bearing). A right turn through the gap may have appeared to the pilot like a more "direct" route to Globe than passing to the left of the eastern summit; and "shaving" a ridge by a few tens of feet would be consistent with maneuvers the pilot had already performed three times earlier in the flight. Consequently, a possible motivation for the turn, given the nature of the flight in general, was a desire by the pilot to pass through the gap "shaving" the ridge, thereby putting the helicopter on a more direct track towards Globe.

Plan view of final 40 seconds of flight
