NATIONAL TRANSPORTATION SAFETY BOARD

Performance Study

A. ACCIDENT: DCA02MA054

Location: Tallahassee, FL
Date: July 26, 2002
Time: Approximately 05:37 Local (9:37 UTC)
Airplane: FedEx, N497FE

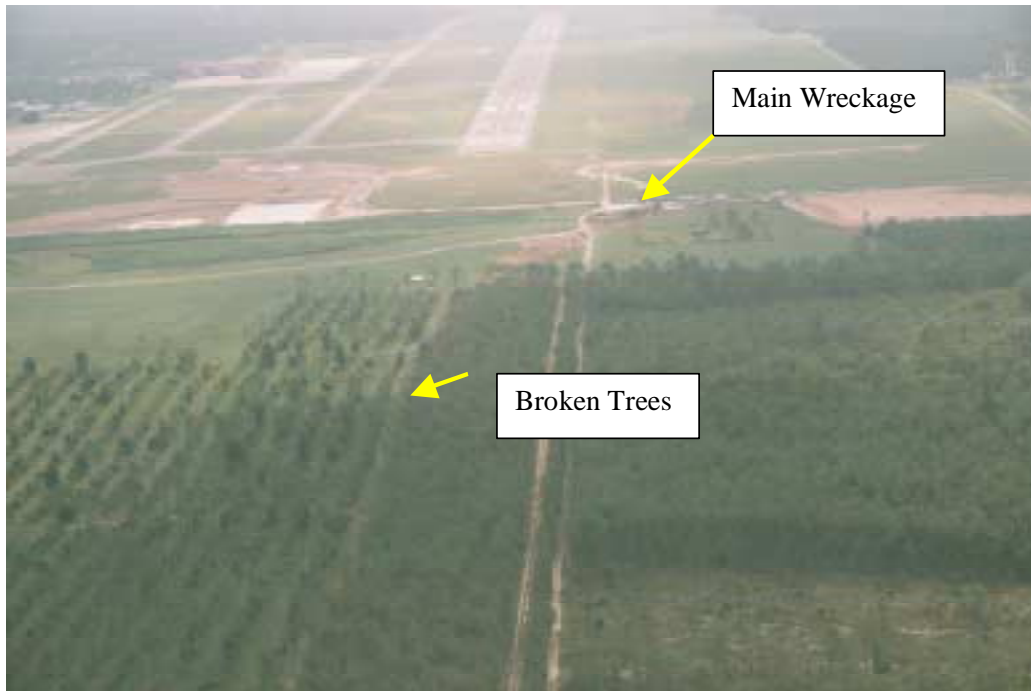
Figure 1: Accident site looking east

A swath of broken trees was found aligned with runway 9, the intended landing runway. A ground scar began near the edge of the forest and bent to the southeast towards the main wreckage location (figure 1).

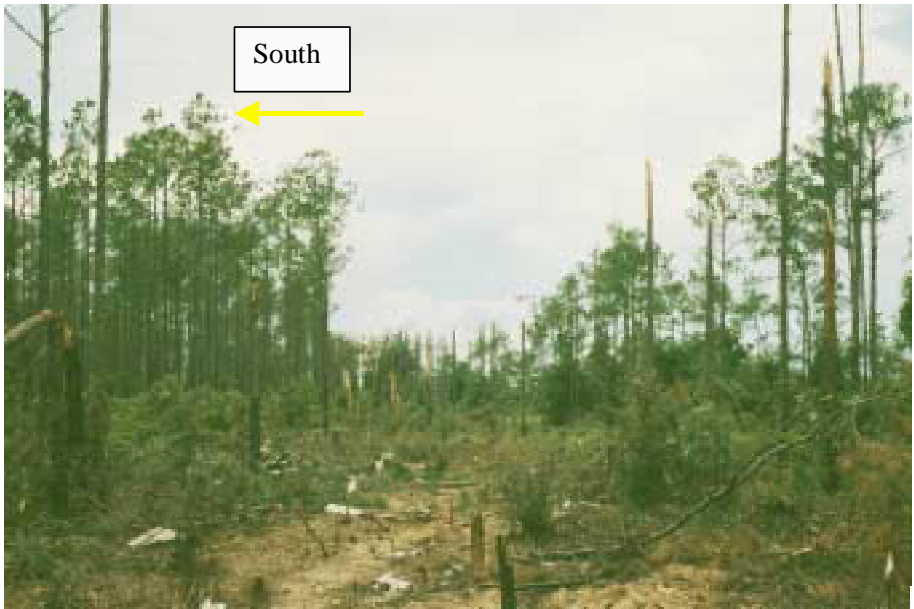
Figure 2: tree swath looking west

Figure 2 shows the view looking west (away from the runway and toward the foreground forest in figure 1) at the broken tree swath. As can be seen, height of the tree breaks on the trees on the south side of the swath are lower than the tree breaks on the north side of the swath on the east end (towards the runway) of the path. This also can be seen in figure 3 which shows an aerial view of the tree swath looking west, away from the runway.

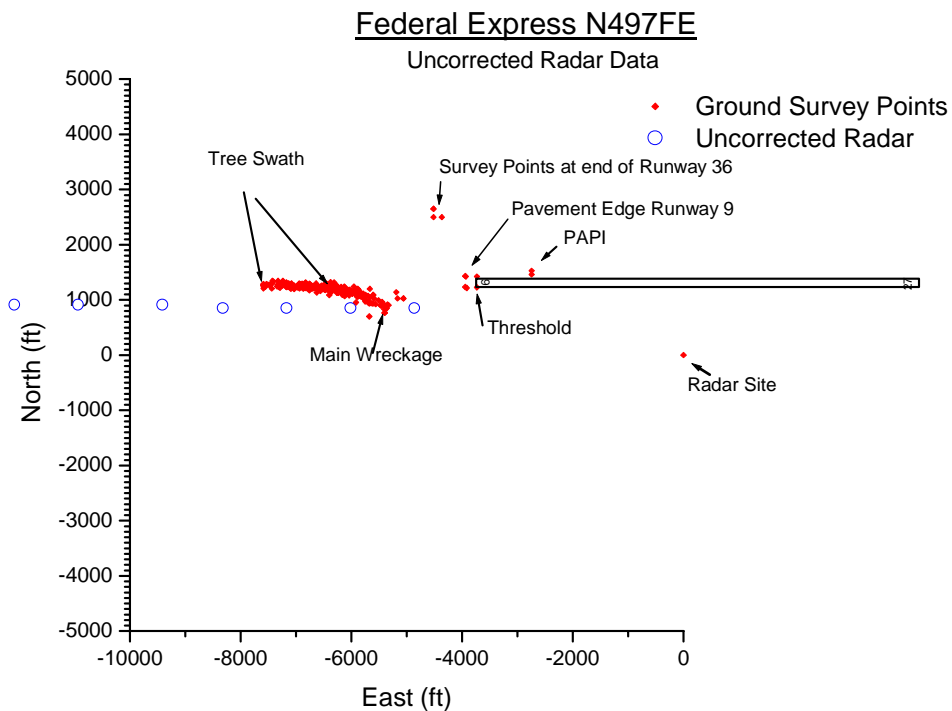
Figure 5: Uncorrected Radar

The uncorrected radar data are used to show the aircraft's approach to runway 9 in figure 5. This figure also shows the runway position from the airport layout plan and points from the wreckage site surveys.

As can be seen in Figure 5, the uncorrected radar data places the last radar point past the main wreckage location. Further, the uncorrected radar path is south of the actual path as recorded by the broken tree swath. These inconsistencies require that the radar data be corrected to account for those differences. Since the radar path was aligned with the runway, the azimuth data did not require correction. It was concluded that the radar

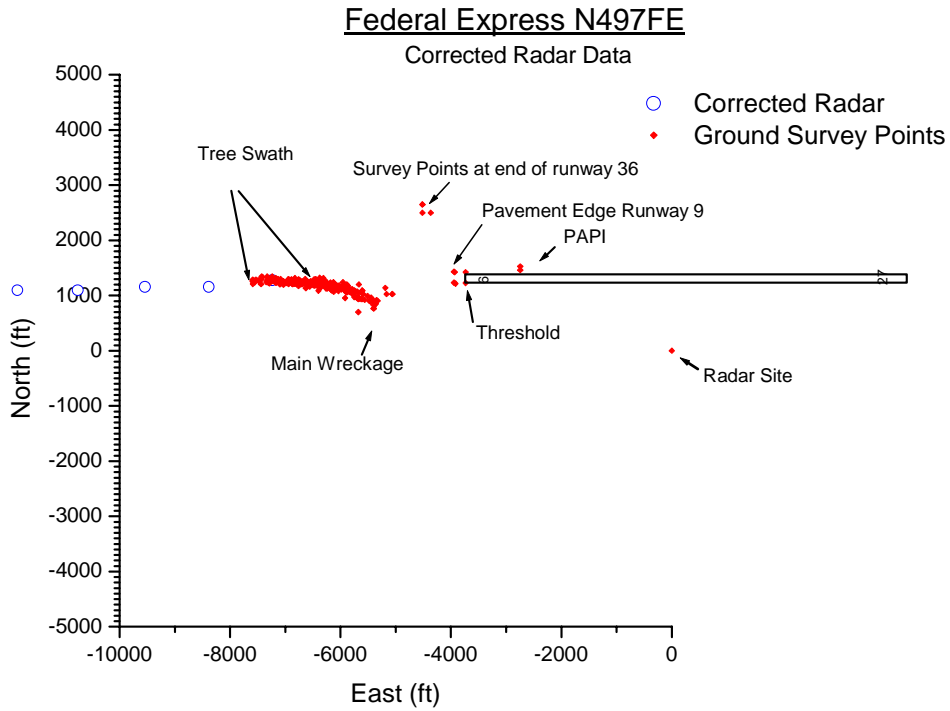
Figure 6: Corrected Radar Data

range data were incorrect³. A range offset of 2400 ft was required to bring the radar path to the actual path. The corrected radar data, which provides a consistent match between radar data and ground survey data, are plotted in Figure 6.

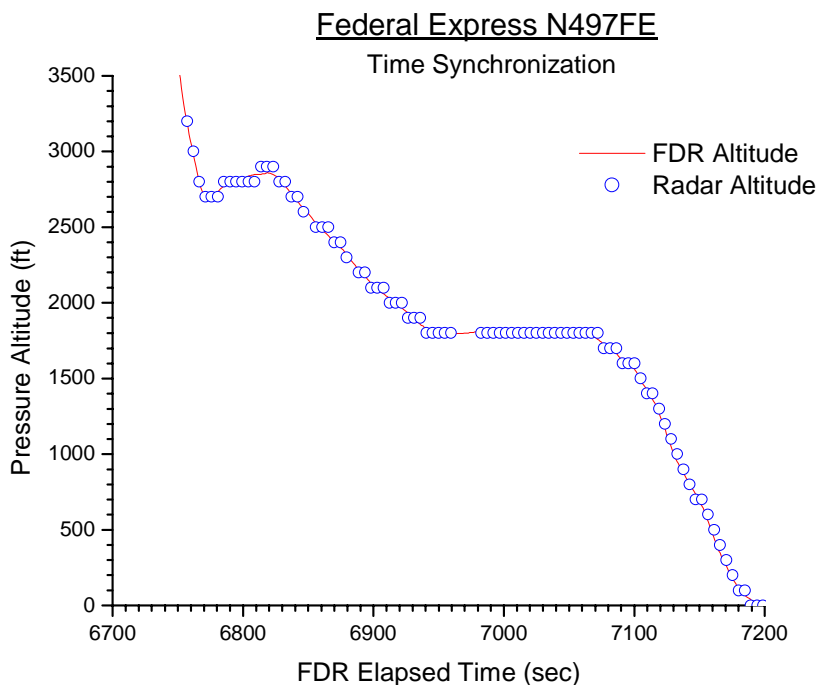
Figure 8: Pressure Altitude Time synchronization

Radar data were synchronized with the flight data recorder (FDR) data by aligning the pressure altitude. This resulted in the following time correction:

$$\text{FDR elapsed time} = \text{Radar time} - (34516.04 - 7072), \text{ in seconds}$$

where radar time is UTC time recorded by the radar converted to seconds past midnight. In addition, by examining periods of level flight, it was found that the radar pressure altitude was 100 ft higher than the altitude recorded by the flight data recorder. Accordingly, 100 ft was subtracted from the radar pressure altitude to match the FDR⁴. The synchronized and corrected radar pressure altitude time history is shown in figure 8.

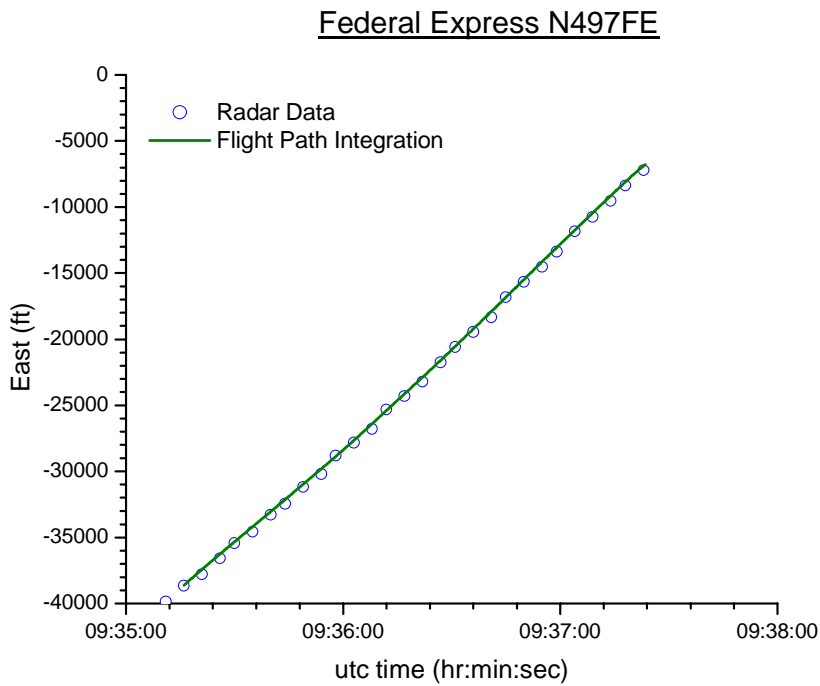
Figure 10: East position match

With the radar and FDR synchronized, data from the FDR was integrated with Kinsurf to determine the flight path to a higher resolution than from the radar data alone. The integration started from the last radar point at 1800 ft before the final descent. This point occurred at FDR elapsed time 7072 seconds when the corrected radar data shows the airplane at -38644 ft East, 15190 ft North (relative to the radar antenna).

A flight path integration is dependent on angle of attack and sideslip. These quantities are typically (when not recorded) derived from an aerodynamic model. The aerodynamics for a 727-200 was approximated with a 737-200 using scaled input⁵. Initially, the input aircraft weight was factored down by multiplying by the ratio of the wing area of a 737-200 to the wing area of a 727-200. However, a further reduction in input weight to 50000 lb was necessary to match the radar integrating the flight path using the 737-200 aerodynamic model. Radar was matched with an East position vs. time plot and a North position vs. time plot. These plots are shown in figures 10 and 11. An offset of 6.0 degrees was subtracted from FDR magnetic heading to obtain true heading for the integration (3 degree magnetic variation and an instrument offset (see figure 15)). Further it was found that the integrated data with the original wind estimate showed a slower ground speed than the radar. Accordingly, a tail wind component was

added to get the integrated path through the radar data at the correct times. The winds required for the match are summarized in the following table.

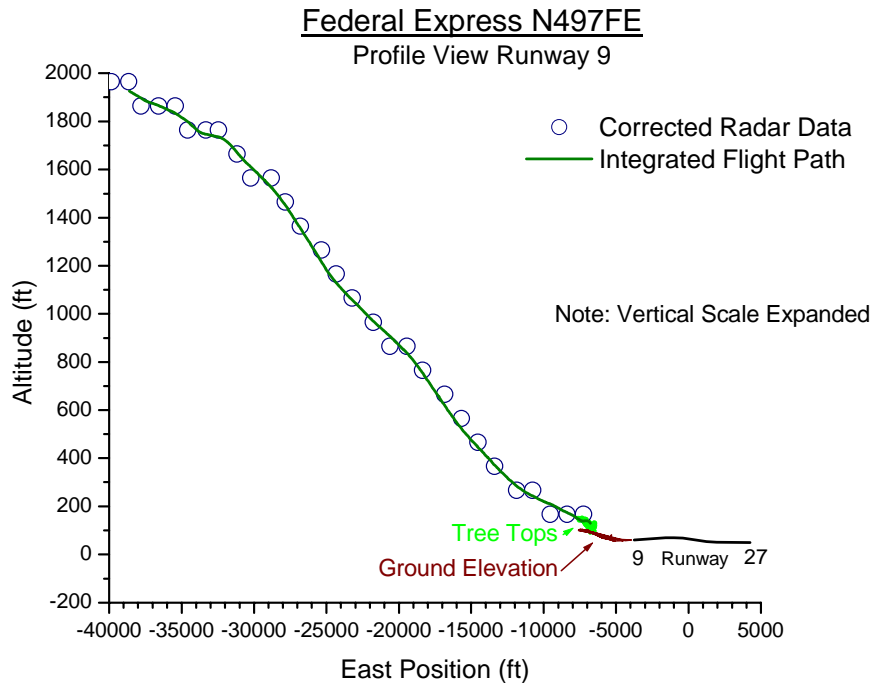
Figure 12: Altitude match

The integrated flight path is compared with corrected radar with MSL altitude in figure 12.

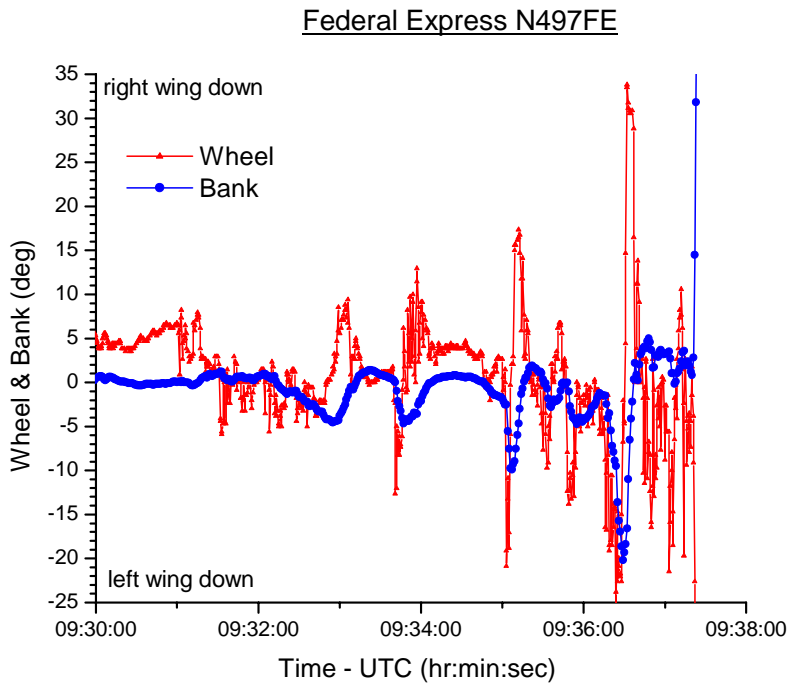
Figure 14: Wheel & Bank

Recorded control wheel position is plotted together with bank angle in figure 14. A second version of the plot focusing on the last seconds of the flight is presented in figure 15.

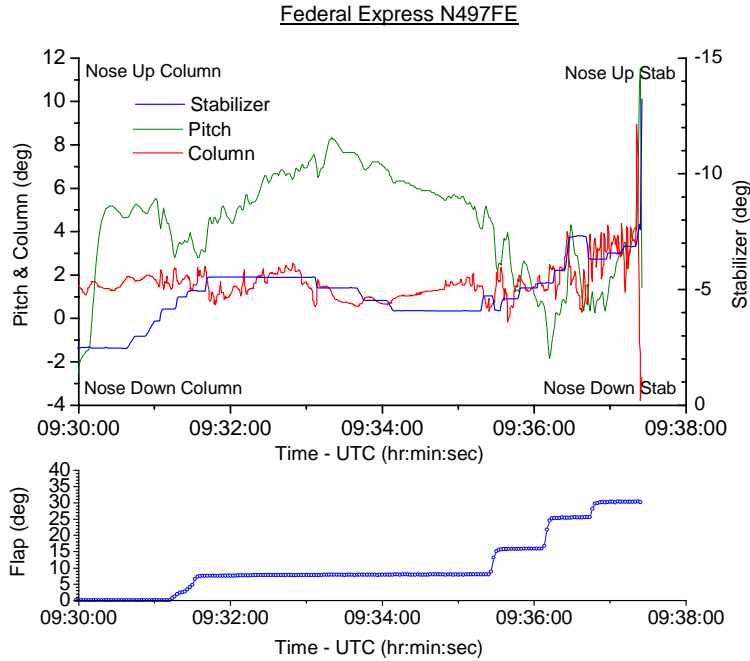
Figure 19: Pitch and control effectors

Recorded pitch angle is plotted together with recorded control column, stabilizer incidence and flap position in figure 19. A second version of the plot focusing on the last seconds of flight is presented in figure 20.

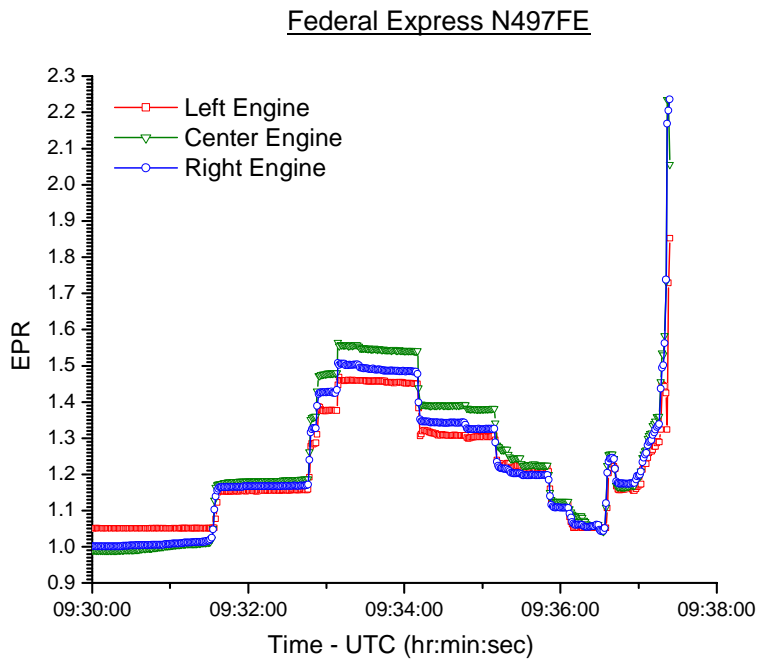
Figure 23: EPR

Recorded Engine Pressure Ratios (EPR) for the three engines in plotted in figure 23 while recorded calibrated airspeed is plotted in figure 24.

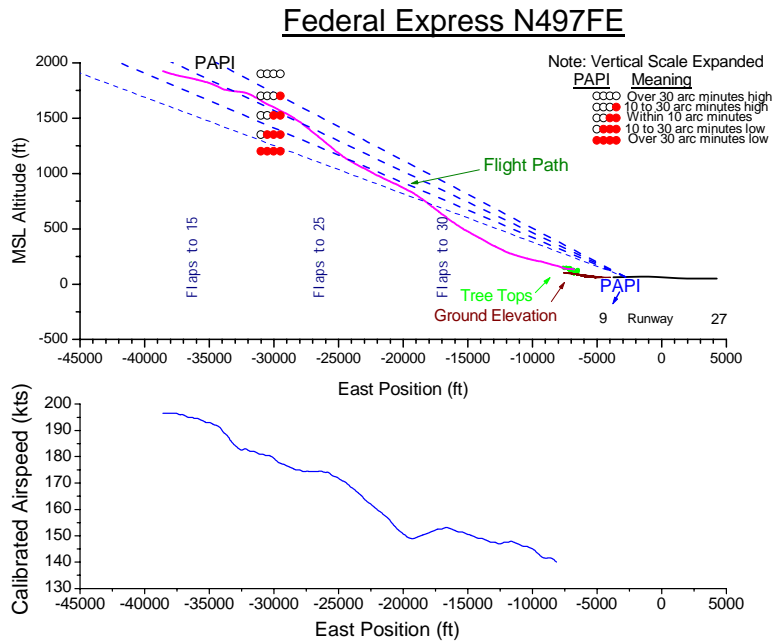
Figure 26: Flight Profile Airspeed Comparison

Airspeed and EPR from the FDR were mapped into East position from the integration to allow comparison of these parameters to the position during the approach. Airspeed is plotted with the flight descent profile in figure 26. EPR is plotted with the flight descent profile in figure 27.

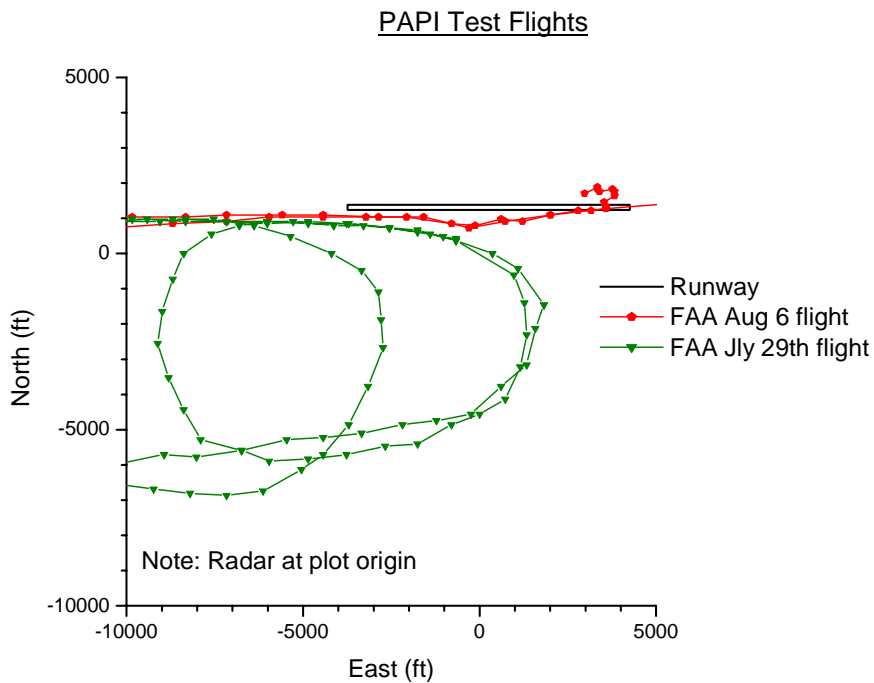
To investigate the repeatability of the range offset seen in the accident radar data, the FAA provided the NTSB with radar data for both the July 29th and August 6 PAPI flight test. As can be seen, the July 29th flight shows two approaches to runway 9. The radar records both approaches about the same distance south of the runway centerline as the uncorrected accident radar data. Similarly, the August 6th test shows two approaches to runway 9 south of the runway centerline. The second approach appears to be a full landing with a return to the ramp.

Radar returns consist of an azimuth and a range to a target. Consistent with the accident radar data, the south shift in the flight path in these flights indicates a correct azimuth but an incorrect range. The range offset of the same magnitude seen in the accident flight.

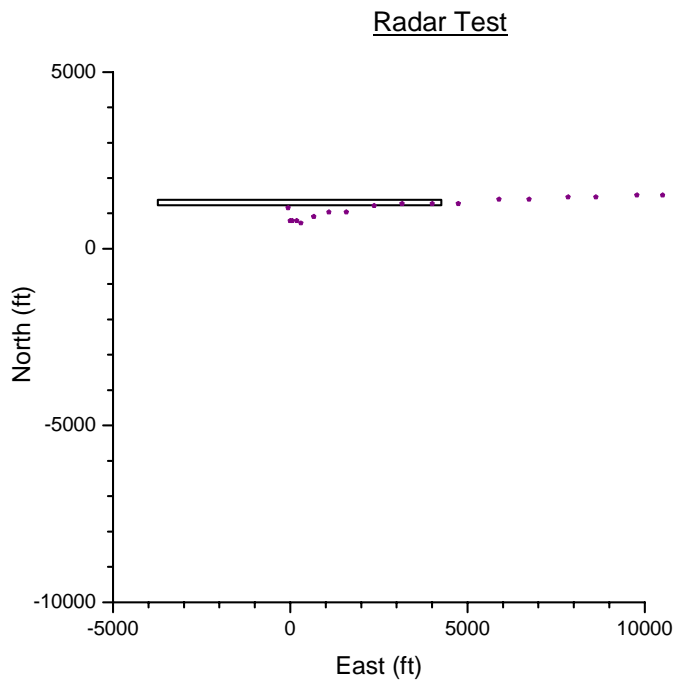
As a further diagnostic, the FAA provided the Safety Board with radar for an aircraft (a Dash 8) landing on runway 27. These data are shown below. Note that the radar antenna is at the origin for this plot. The bend of the recorded flight track towards the antenna near the end of the track is again consistent with a range offset.
