National Transportation Safety Board

Performance Study

Specialist Report

Location: Cleveland, Ohio
Date: December 29, 2016
Time: 2257 EST, (0357 UTC, December 30, 2016)
Airplane: Cessna 525,
NTSB Number: CEN17FA072

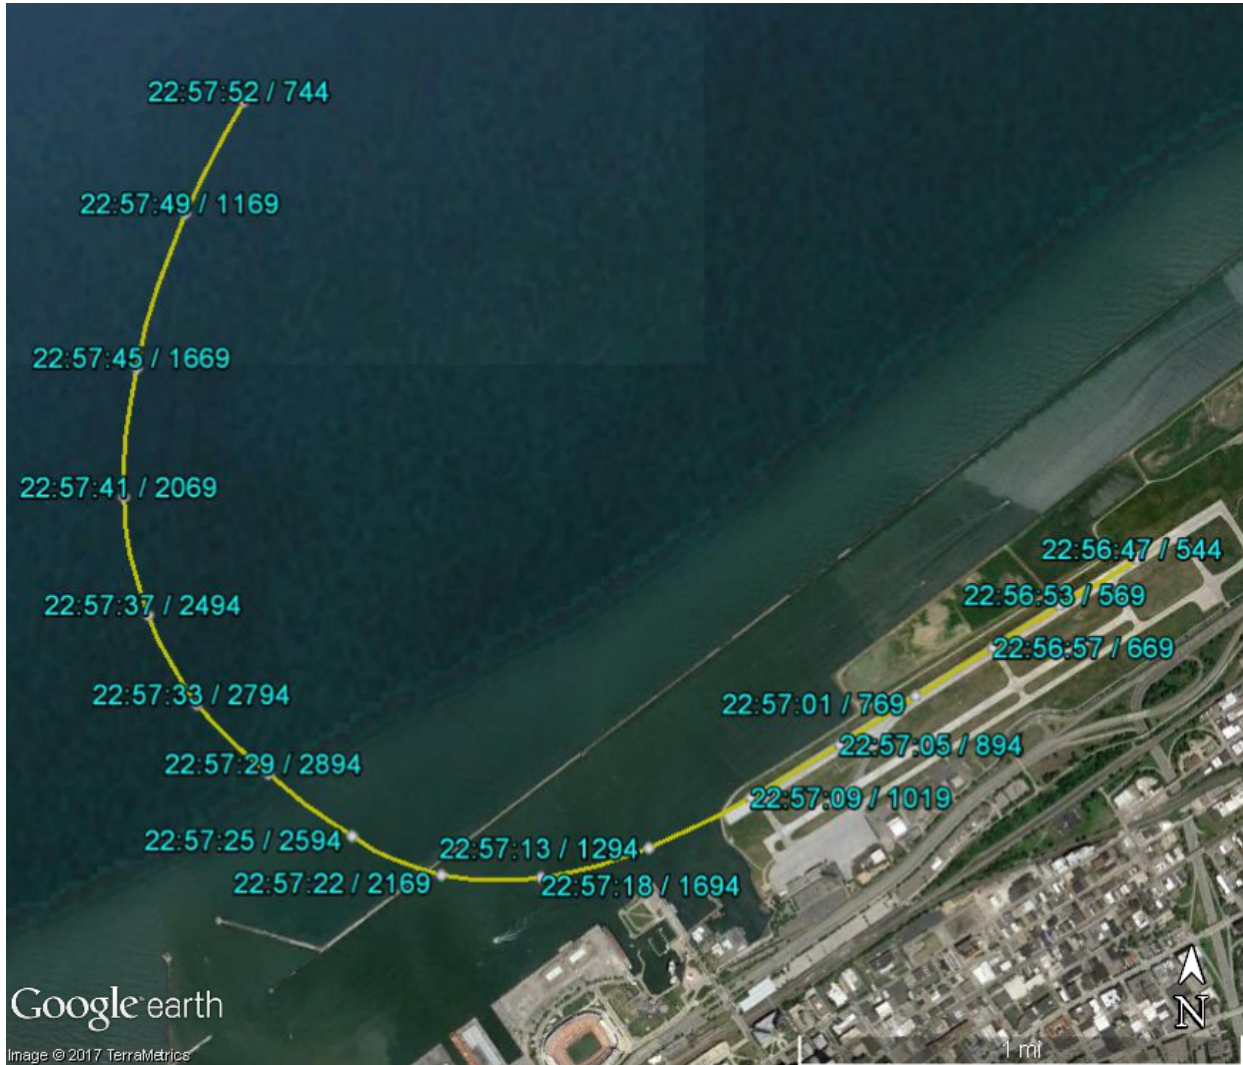
The flight path shown in Figure 1 and Figure 2 began at 22:56:47 and ended at 22:57:52 for a total recorded flight of 65 seconds. The elevation of runway 24R is 583 ft and ADS-B corrected altitude

Figure 1. Flight path with time and altitude for selected points.

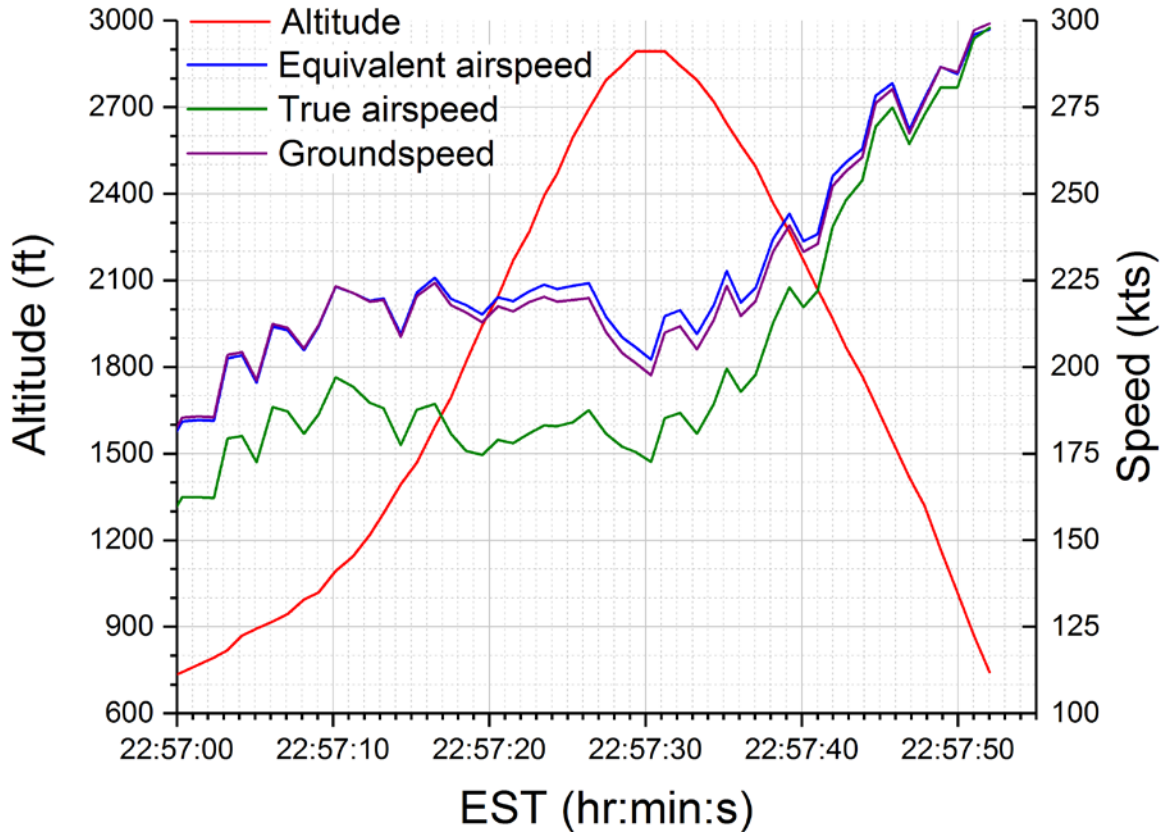
Speeds (Figure 3) were calculated from the airplane's location, altitude, and the winds aloft data provided. The airplane accelerated from take-off to about 215 kts airspeed as it passed over the end of the runway. The speed then leveled off until 22:57:29 when the airplane reached its maximum altitude of 2,893 ft. The airplane then began to rapidly descend and gain airspeed. The final ADS-B record at 22:57:52 was an altitude of 744 ft and the calculated airspeed was 300 kts.

Figure 3. Altitude and calculated air and groundspeeds versus time.

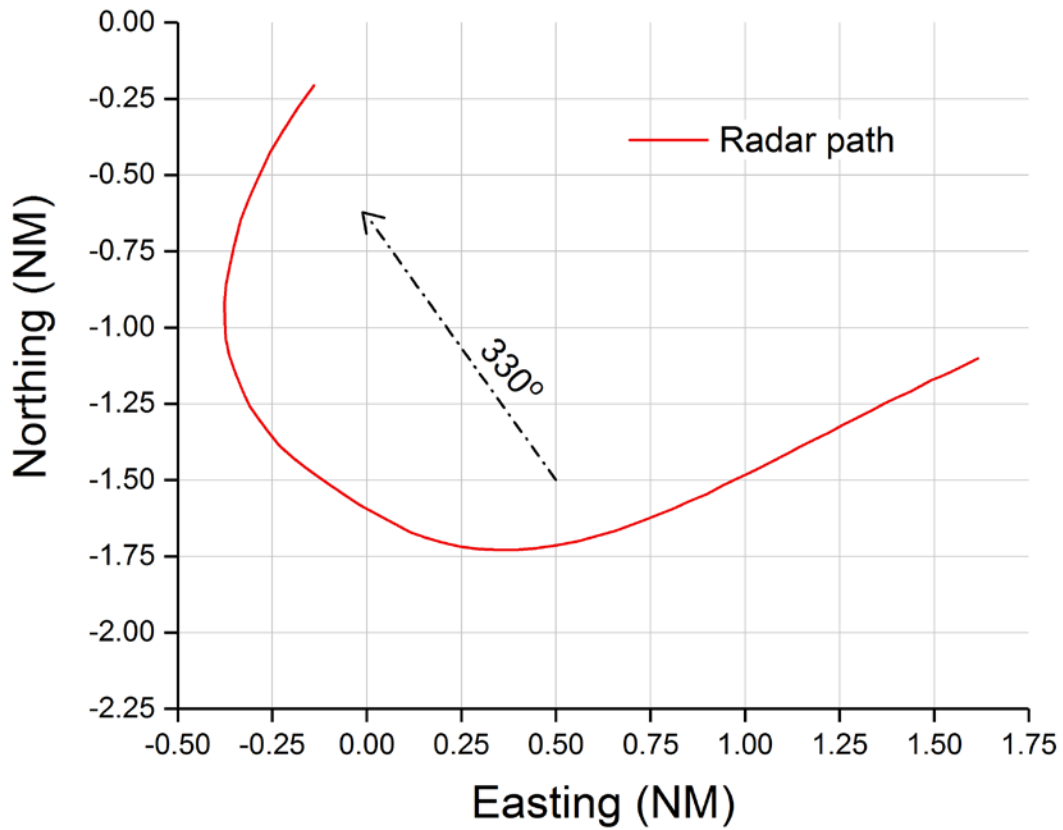
Figure 5 shows the airplane's path in Easting and Northing with the 330° heading that had been instructed by ATC noted. The airplane passed the 330° heading at about 22:57:37. At this point the airplane was descending below 2,500 ft and its speed was increasing.

Figure 5. Radar path in Easting and Northing with 330° heading shown.

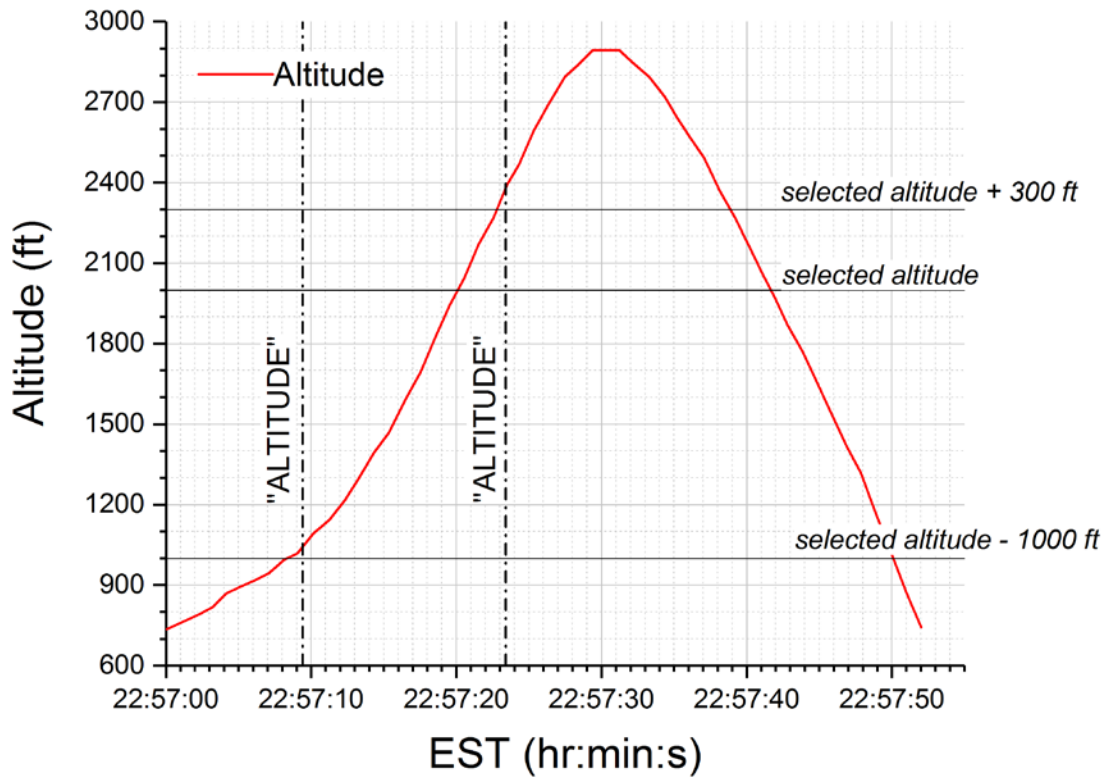
The Citation’s autopilot system was installed to voice “ALTITUDE” 1,000 ft prior to a selected altitude and again if the airplane deviated over 300 ft past the selected altitude [3]. Two “ALTITUDE” annunciations were heard on the CVR: the first was at the CVR recorded time of 22:57:09.4 and the second at 22:57:23.4. The pilot’s initial instruction was to turn right onto 330° and to maintain 2,000 ft and ADS-B recorded a selected altitude of 2,000 ft. For a selected altitude of 2,000 ft, the system would annunciate at 1,000 ft and 2,300 ft. Figure 7 shows the two “ALTITUDE” annunciations from the CVR and the ADS-B recorded altitudes. Both annunciations come less than 0.5 seconds after the airplane passed the 1,000 and 2,300 ft altitude marks. It was determined that the time recorded by the ADS-B and the CVR were in good agreement, assuming the autopilot annunciation had a short delay.

Figure 7. CVR "ALTITUDE" annunciations and ADS-B altitude.

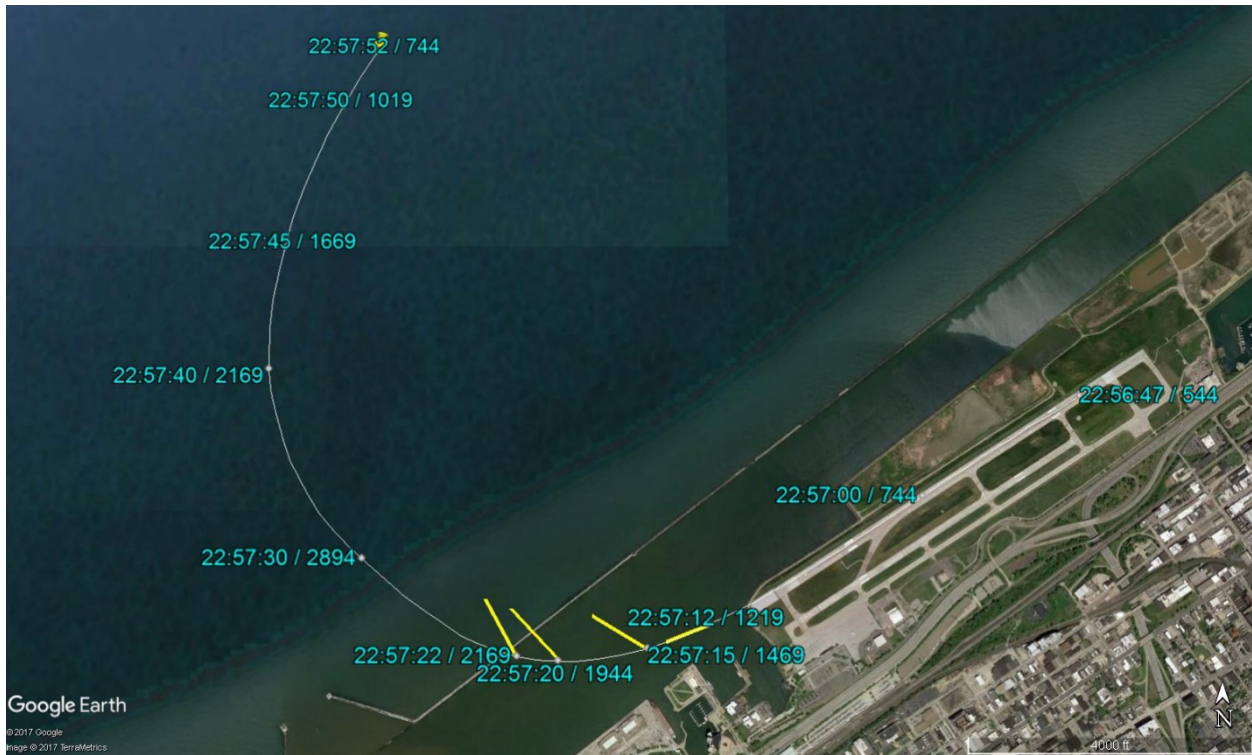
ADS-B data also recorded selected heading which changed throughout the climb portion of the flight. The configuration of the input data is not known, but it was confirmed to the NTSB by Rockwell Collins that changes in the parameter indicated active pilot selection as the other avionics could not have changed the value of that parameter. Figure 8 shows four selected headings in yellow. The yellow line points towards the heading selected and intersects the flight path at the point in time when it was recorded. The last yellow line along the flight path is on the 330° heading.

Figure 8. Selected heading shown as yellow lines at time of change/selection. The yellow line points towards the heading selected and intersects the flight path at the point in time when it was selected.

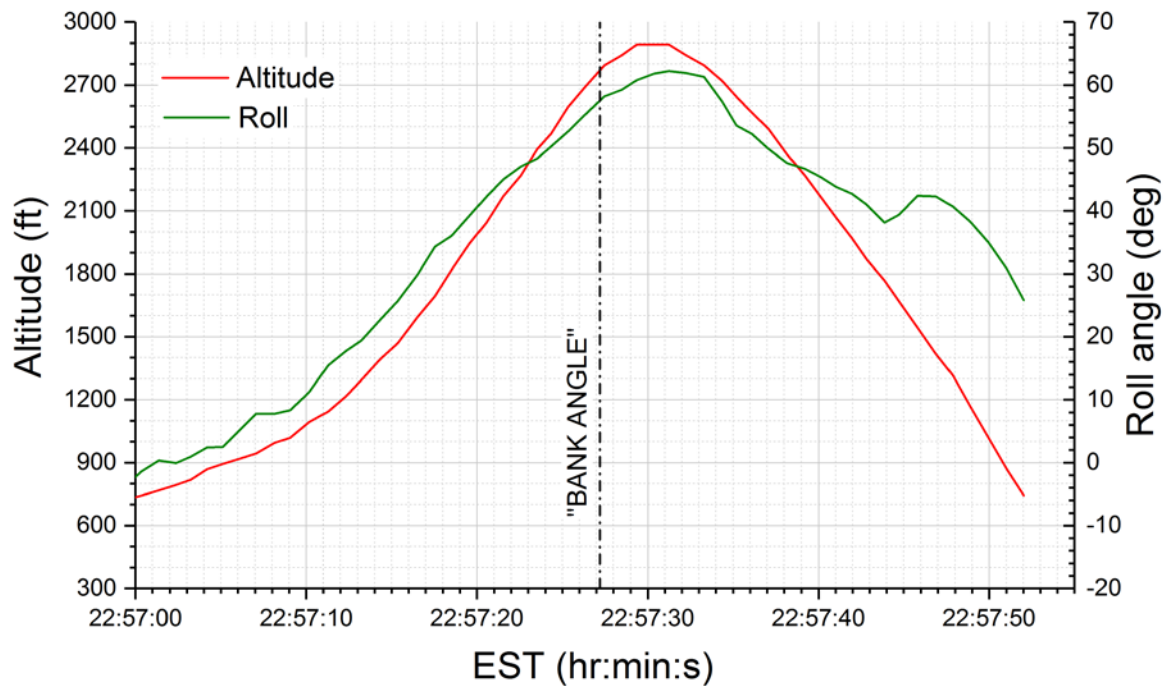
Figure 9 shows the calculated bank angle and altitude versus time. On the CVR, an automated annunciation of “BANK ANGLE” was heard at 22:57:27.2. According to the documentation for the ground proximity warning system (GPWS) warnings and cautions [3], the automated bank angle warning annunciates when the airplane reaches a bank angle greater than 55°⁴. This is consistent with the calculated bank angle, which surpassed 55° at 22:57:26. The peak roll angle was calculated to be 62° right wing down at about 22:57:31, about four seconds after the “BANK ANGLE” annunciation.

Figure 9. Altitude and roll versus time with bank angle call out from CVR.

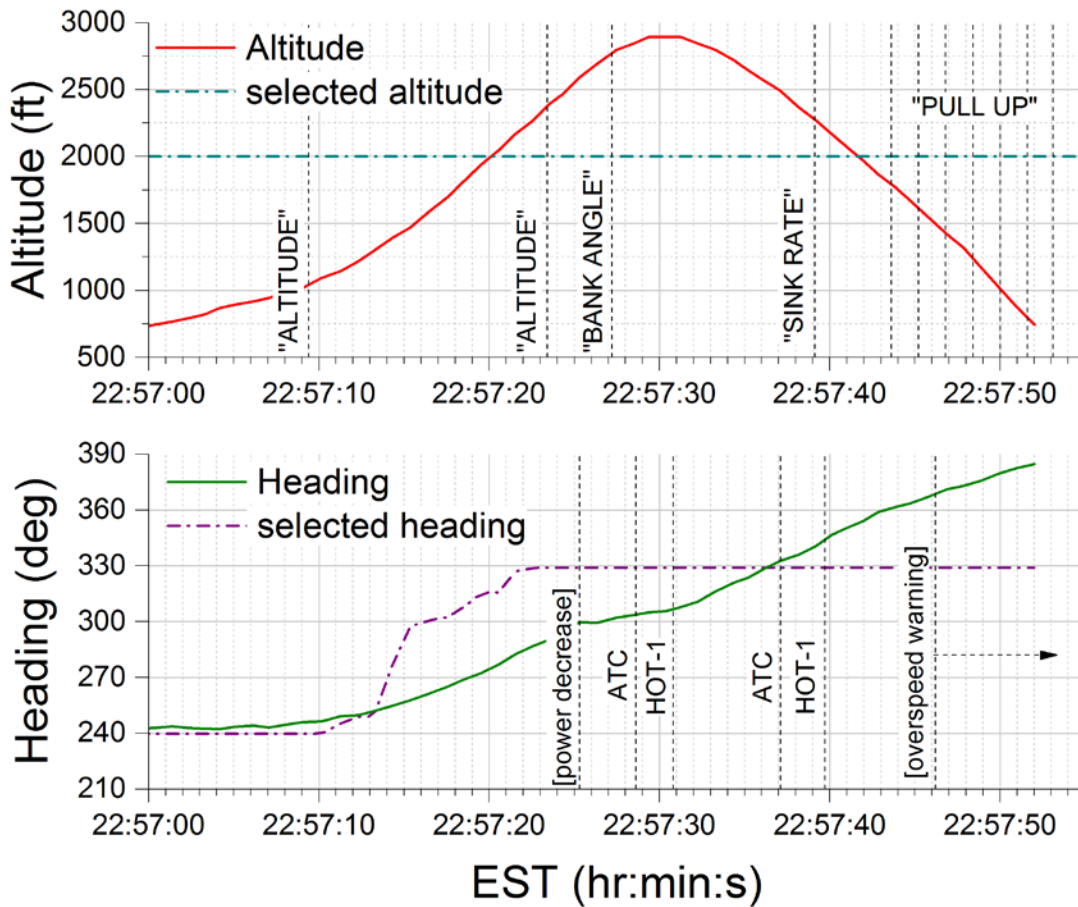
Figure 10 shows all the annunciators and comments internal to the cockpit during the flight. The two “ALTITUDE” annunciators were followed by a sound consistent with a decrease in engine power two seconds later. The “BANK ANGLE” annunciator followed. ATC called (at 22:57:28.6 and 22:57:37.1) and the pilot spoke twice during the flight (at 22:57:30.8 and 22:57:39.7), in apparent response to radio calls from the tower, but the microphone was not keyed to transmit. At 22:57:39.1 there is an annunciator for “SINK RATE” which coincides with the rate of climb falling below -6,000 fpm and an altitude of 2,250 ft (Figure 4). Starting at 22:57:43.6, the TAWS announced “PULL UP” seven times, the last at 22:57:53.1. From 22:57:46.2, when the airspeed increased past 275 kts, until the end of the recording there was a sound similar to an overspeed warning.

Figure 10. Altitude and heading with annunciations and comments from the CVR.

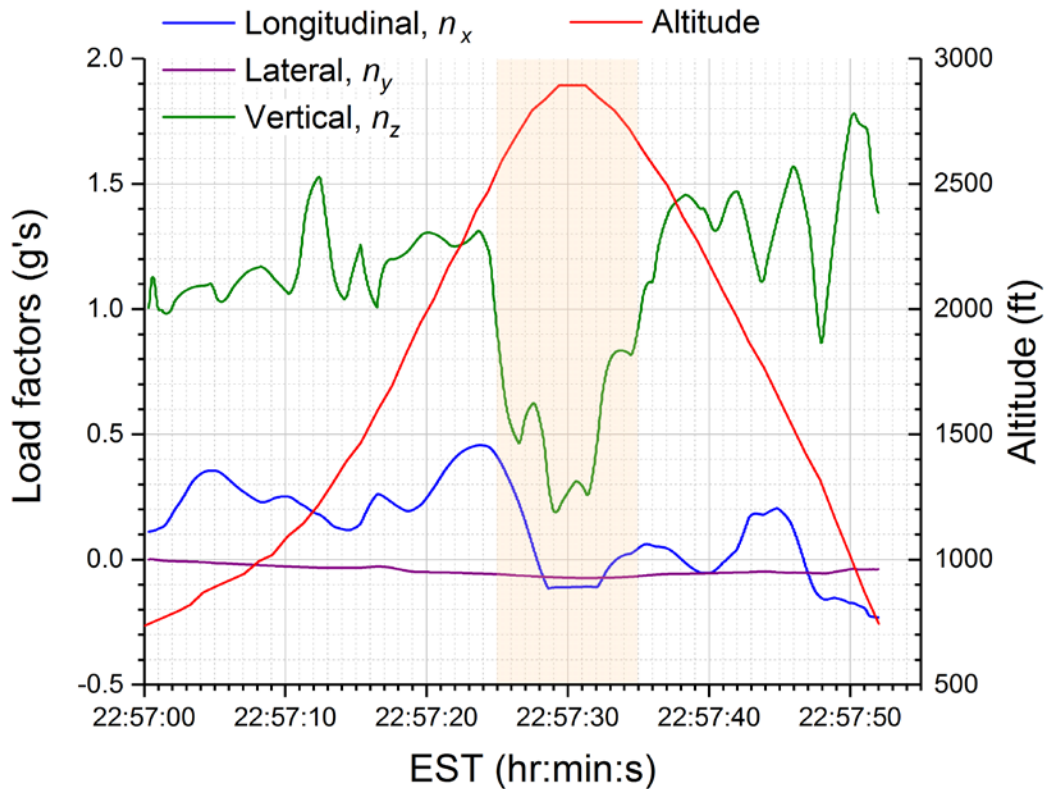
The simulation also calculated airplane load factors for the flight. Figure 12 shows the calculated longitudinal, lateral, and vertical load factors and the recorded altitude. The vertical load factor goes below 1g from 22:57:24.8 to 22:57:35.2 as the airplane transitions from climbing to descending and is highlighted in orange in the figure. The load factors calculated during the flight path simulation will be used to determine the “apparent” pitch and roll angles which are discussed in the next section.

Figure 12. Longitudinal, lateral, and vertical load factors from the simulation and altitude.

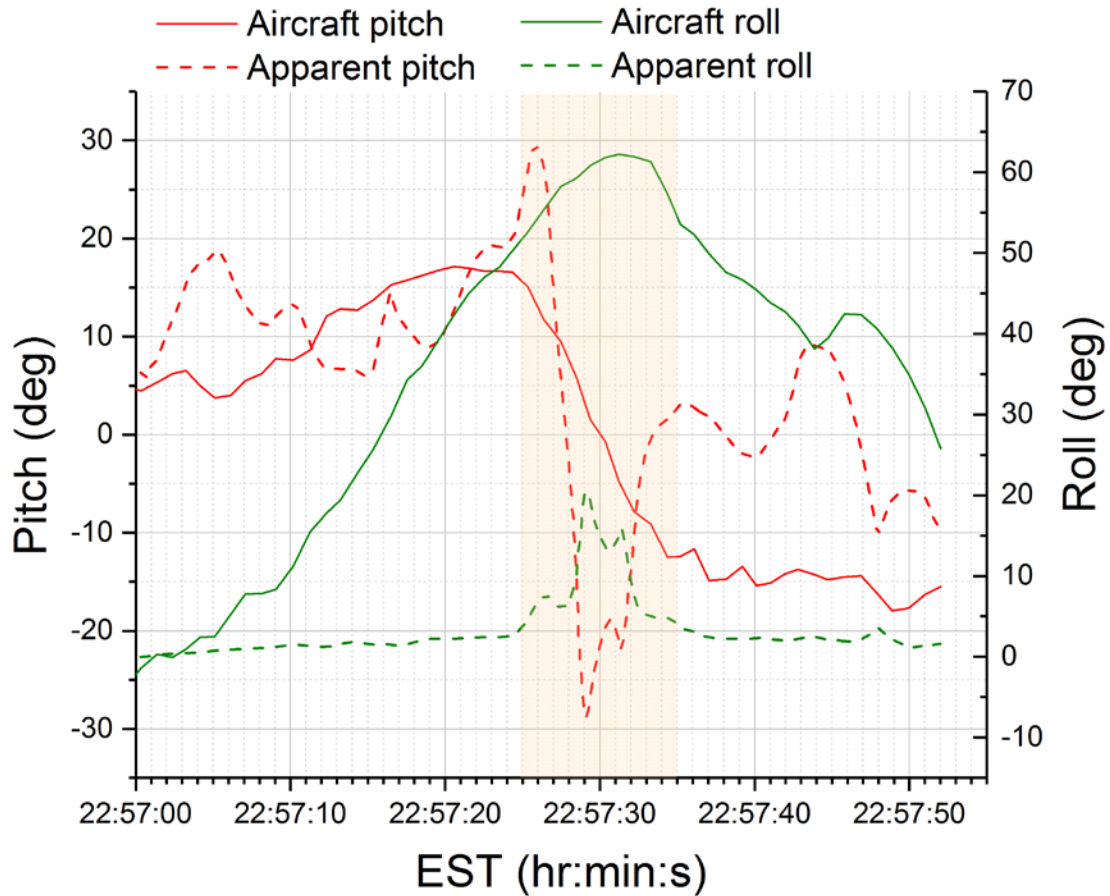
Figure 14, below, shows the actual and calculated apparent pitch and roll angles. The orange highlighted area is the same as Figure 12, when n_z dropped while the airplane reached its maximum altitude and nosed over. As the load factor \vec{n} became less than one (1), the apparent roll angle increased and the apparent pitch dropped. This portion of the apparent angle calculation should be treated as more uncertain than the initial climb and later descent.

During the descent, it was possible that the pilot perceived that the aircraft was nose-level rather than nose-down. Throughout the whole of the flight, it was possible that the roll angle could have felt much less extreme than it actually was.

Figure 14. Actual and apparent pitch and roll angles.

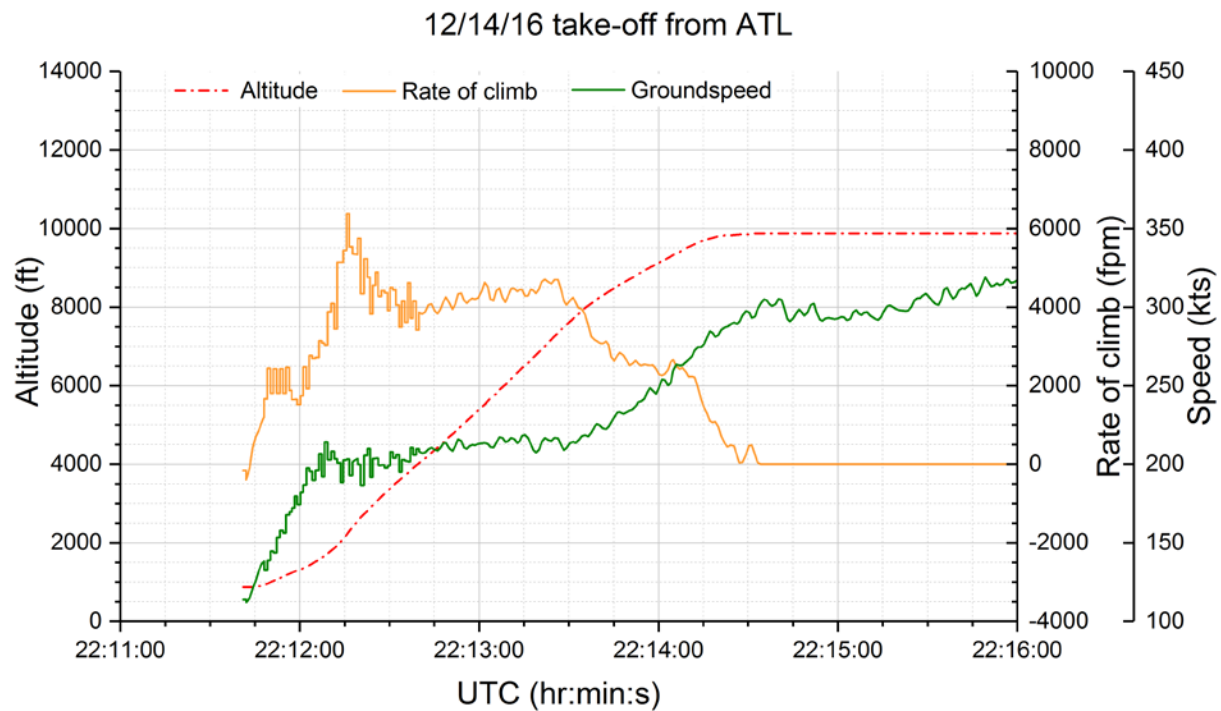
Figure 18. Altitude, rate of climb, and groundspeed of 12/14/16 take-off from ATL.

During the accident flight, the airplane gained 100 kts of groundspeed (100 kts to 200 kts) in just over 23 seconds of flight. The December 14th flight (Figure 18) showed a similar increase in groundspeed from 100 kts to 200 kts in 25 seconds. The other flights showed significantly lower gains in groundspeed.

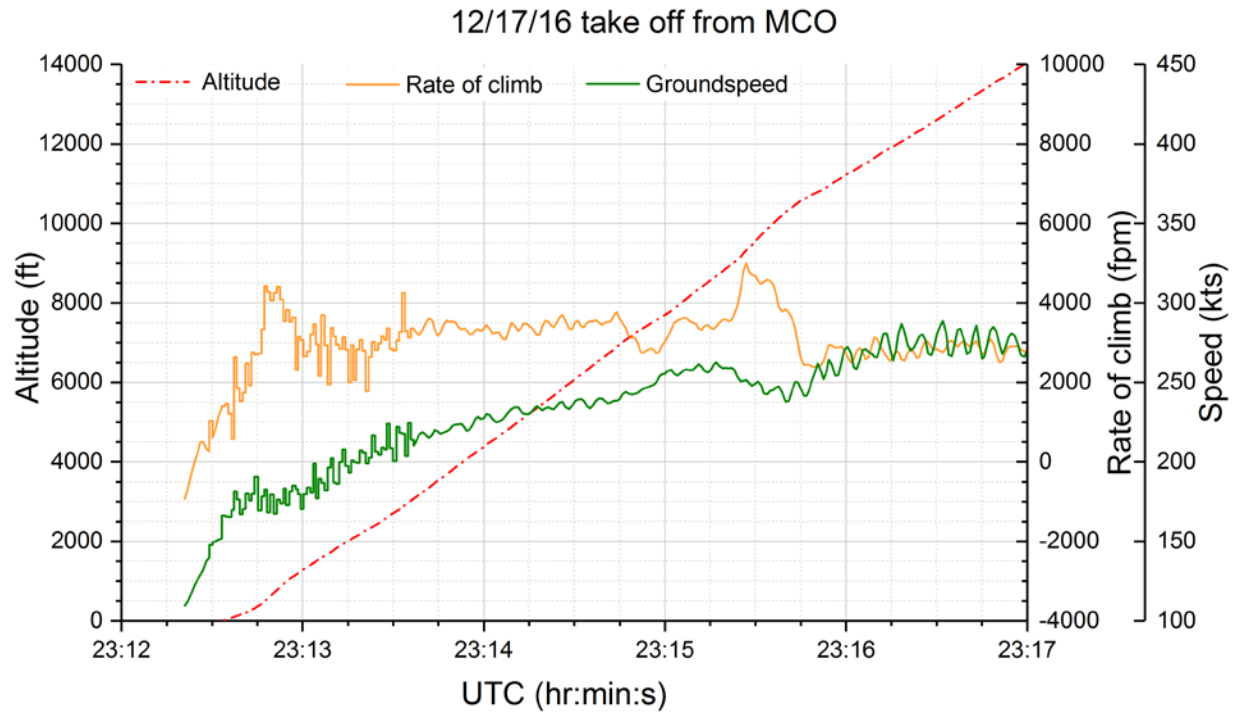
Figure 21. Altitude, rate of climb, and groundspeed of 12/17/16 take-off from MCO.

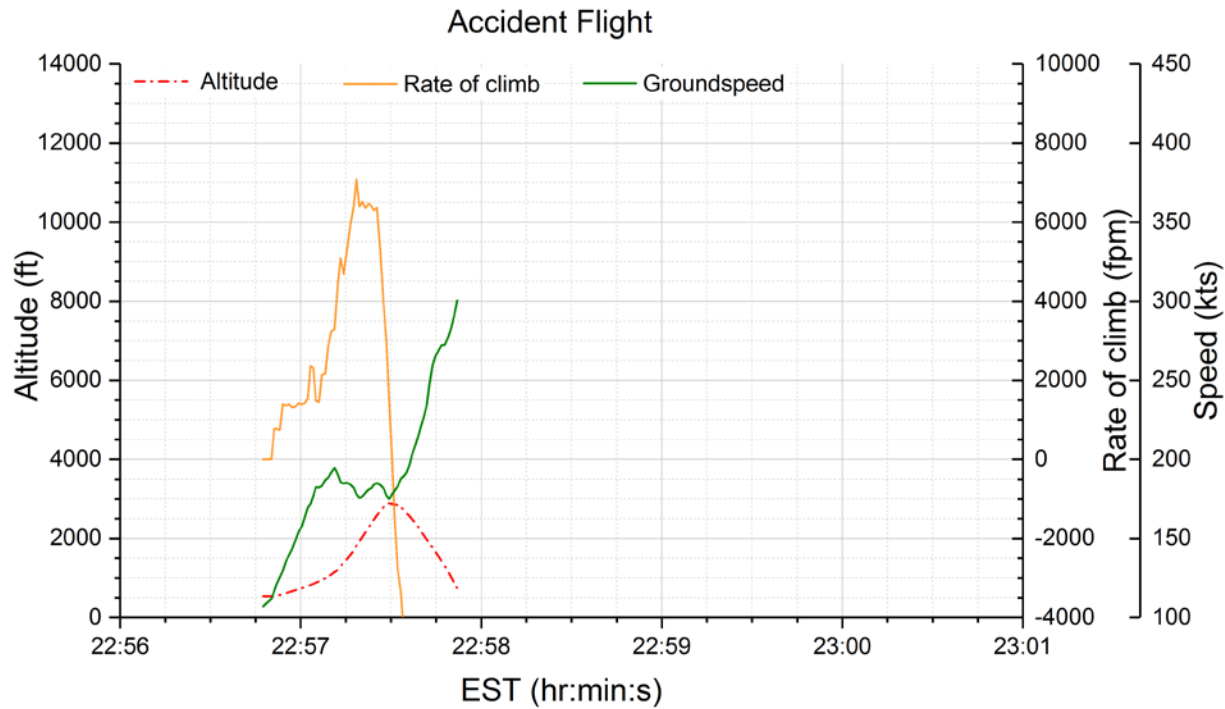
Figure 23. Altitude, rate of climb, and groundspeed of accident take-off for comparison.
