National Transportation Safety Board
Office of Research and Engineering
Washington, D.C. 20594

Airplane Performance Study

Location: West Columbia, SC
Date: May 23, 2015
Time: 0921 EDT (1321 GMT)
Airplane: Experimental BR Legend LLC Turbine Legend, Registration N42BR
NTSB Number: ERA15FA221

ERA15FA221, Experimental BR Legend LLC Turbine Legend, N42BR, 5/23/2015

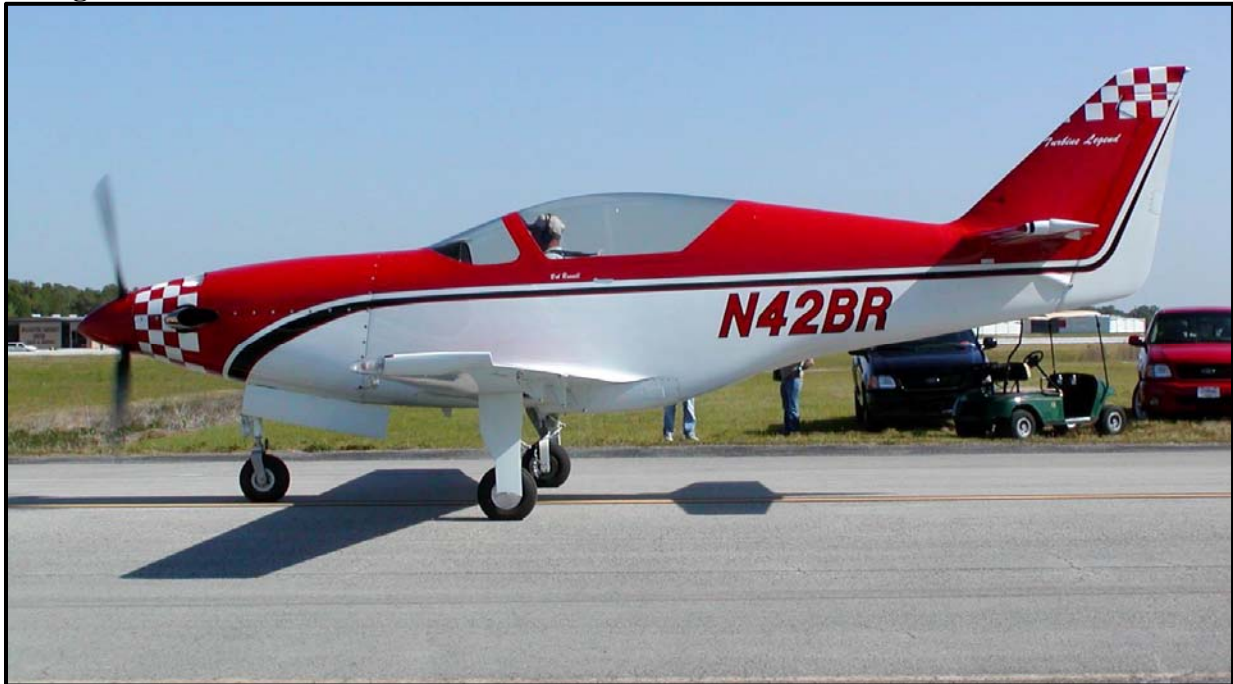
Figure 1: Accident Airplane N42BR, an Experimental BR Legend LLC Turbine Legend

The flight originated from CAE about 0914 EDT. See Figures 1 and 2 for pictures of the accident airplane and the accident site.

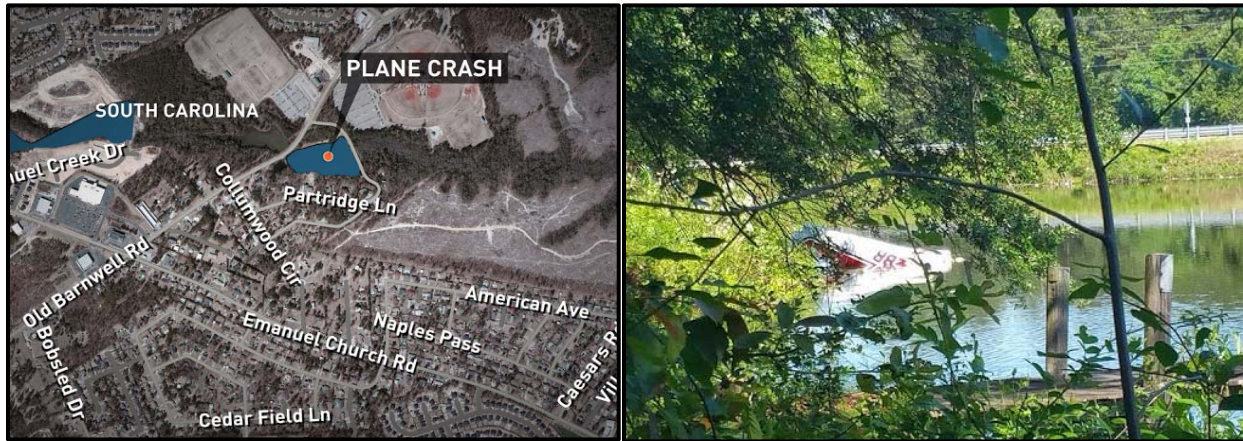
Figure 2: Accident Site (source: Kathryn's Report
<http://www.kathrynsreport.com/2015/05/br-legend-turbine-legend-n42br-fatal.html>)

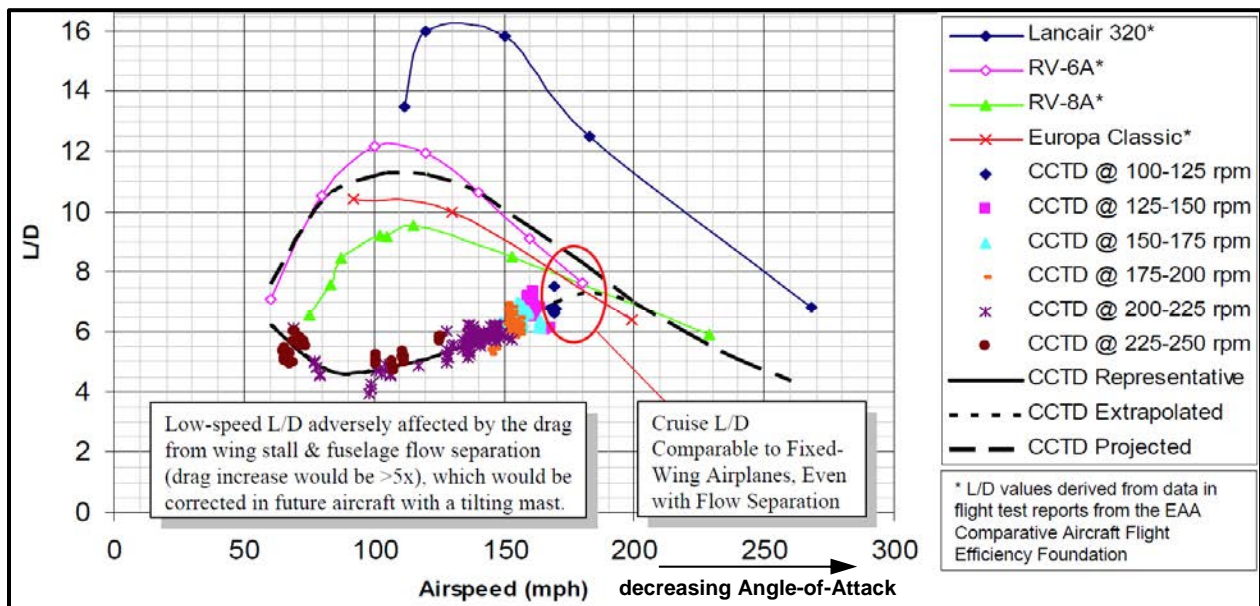
In order to assess the impact of propeller blade angle on the accident flight, the glide ratio was first estimated from radar and then compared to the airplane (L/D). Figure 8 depicts (L/D) ratios for various airplanes.

Figure 8: Lift to Drag Ratio for Various Airplanes

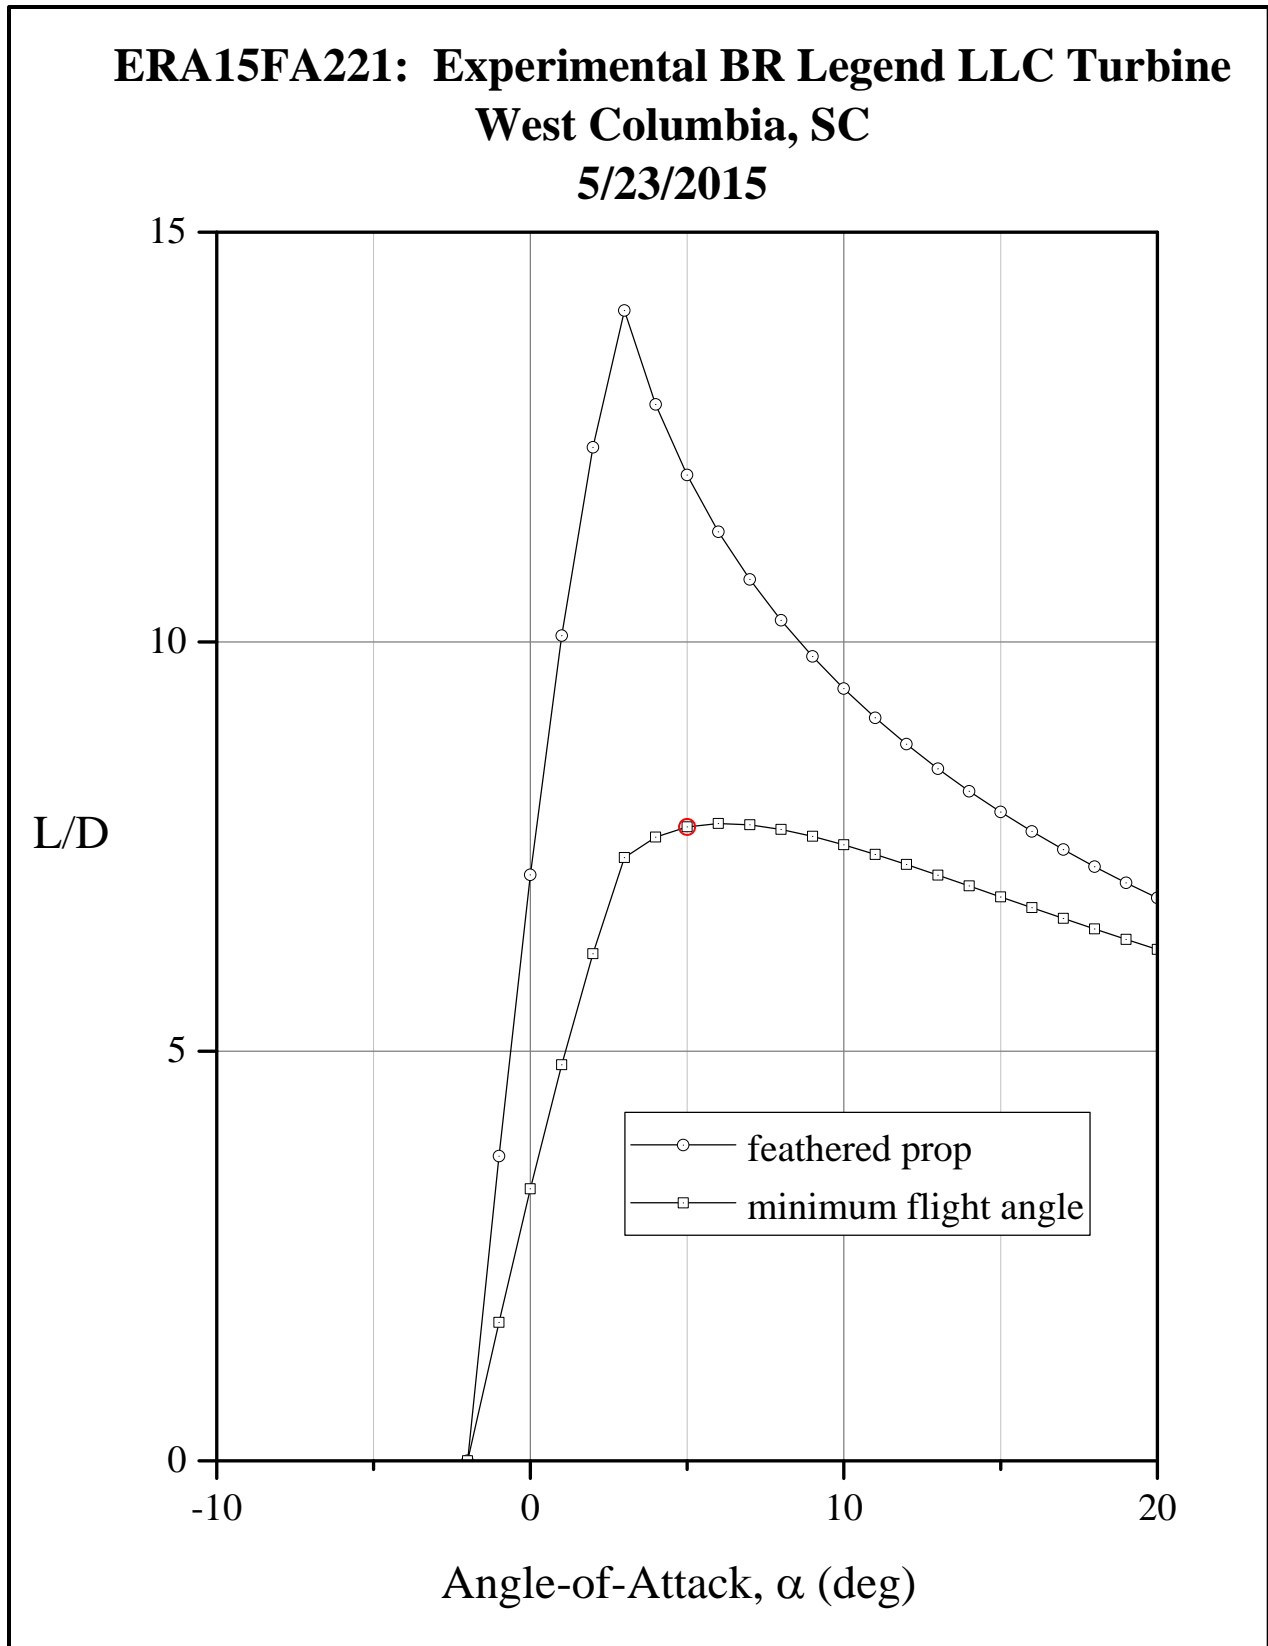
From the aerodynamic data used in the study and shown in Figure 9, (L/D) with the propeller at the minimum flight angle is also 7.5 at 5° angle-of-attack⁵. Therefore, the glide ratio estimated from radar and the (L/D) from aerodynamic data with the propeller at minimum flight angle are the same or very close.

Likewise, the aerodynamic data used in the study from Figure 9 shows an airplane (L/D) of 12.0 with the propeller feathered. This is 60% greater than the (L/D) of 7.5 estimated in the accident. The feathered (L/D) results in a power-off glide distance of approximately 12.8 NM from an initial altitude of 6,500 ft:

Figure 9: Lift to Drag Ratio As a Function of Angle-of-Attack

$$\begin{aligned}\Delta x/\Delta y &= 12.0 \\ \Delta x &= (12.0)\Delta y = (12.0)(6,500 \text{ ft}) \\ \Delta x &= 78,000 \text{ ft} = 12.8 \text{ NM}\end{aligned}$$

The results of the study indicate that the accident airplane propeller blade angle was likely not in the feathered position. As a result of the increased drag, N42BR did not make it back to the airport after the pilot reported an engine problem. Had the propeller been feathered, the airplane could have made it back to CAE runway 11 using the best glide airspeed of 130 KIAS.
