**NATIONAL TRANSPORTATION SAFETY BOARD**

**Airports Specialist Report**

**DCA17IA148**

On July 7, 2017, about 2356 Pacific daylight time, Air Canada flight 759 (ACA759), an Airbus A320, Canadian registration C-FKCK, was cleared to land on runway 28R at San Francisco International Airport, San Francisco, California, but instead lined up on parallel taxiway C, where four air carrier airplanes (a Boeing 787 followed by an Airbus A340, another Boeing 787, and a Boeing 737) were awaiting takeoff clearance. ACA759 overflew the first airplane on the taxiway and descended below 100 ft above the ground, and the ACA759 flight crew initiated a go around. The flight was operated under the provisions of 14 *Code of Federal Regulations* Part 129 as an international scheduled passenger flight from Toronto/Lester B. Pearson International Airport, Toronto, Canada, with 135 passengers and 5 crewmembers on board. Night visual meteorological conditions prevailed at the time of the incident. The airplane was not damaged, and no injuries were reported.

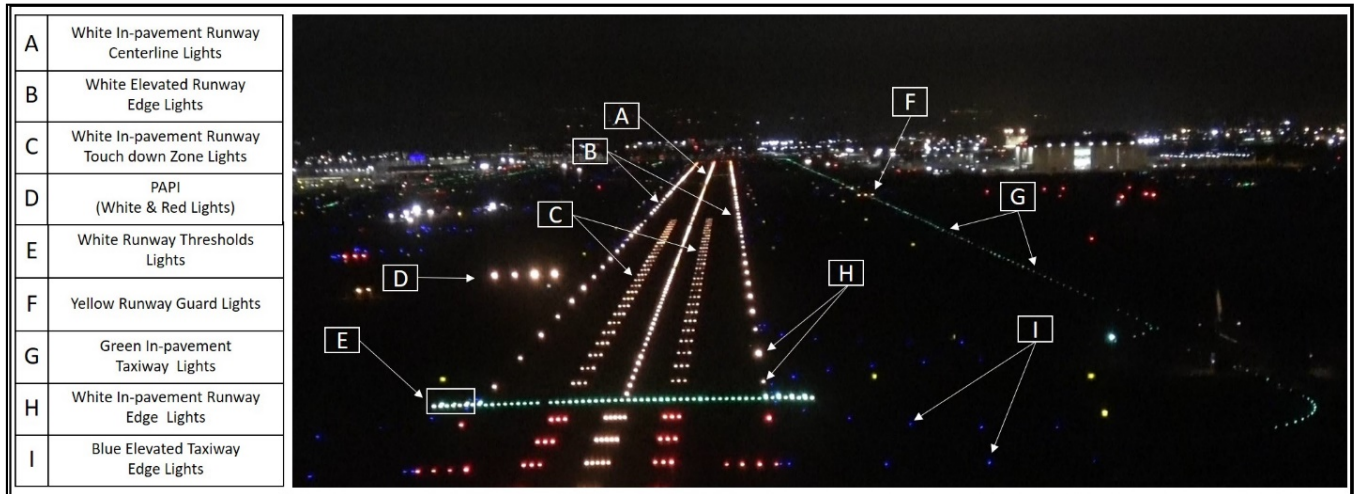
**Photograph 1<sup>5</sup> – SFO airport lighting on runway 28R and taxiway C.**

Runway 28R was 11,870 feet long by 200 feet wide and was open at the time of the flyover. Photograph 1 illustrates the color and style of lights found on runway 28R and taxiway C and on at the time of the event.

<sup>5</sup> Photographs 1 and 2 are still images taken from a video of runway 28R recorded after the flyover event.

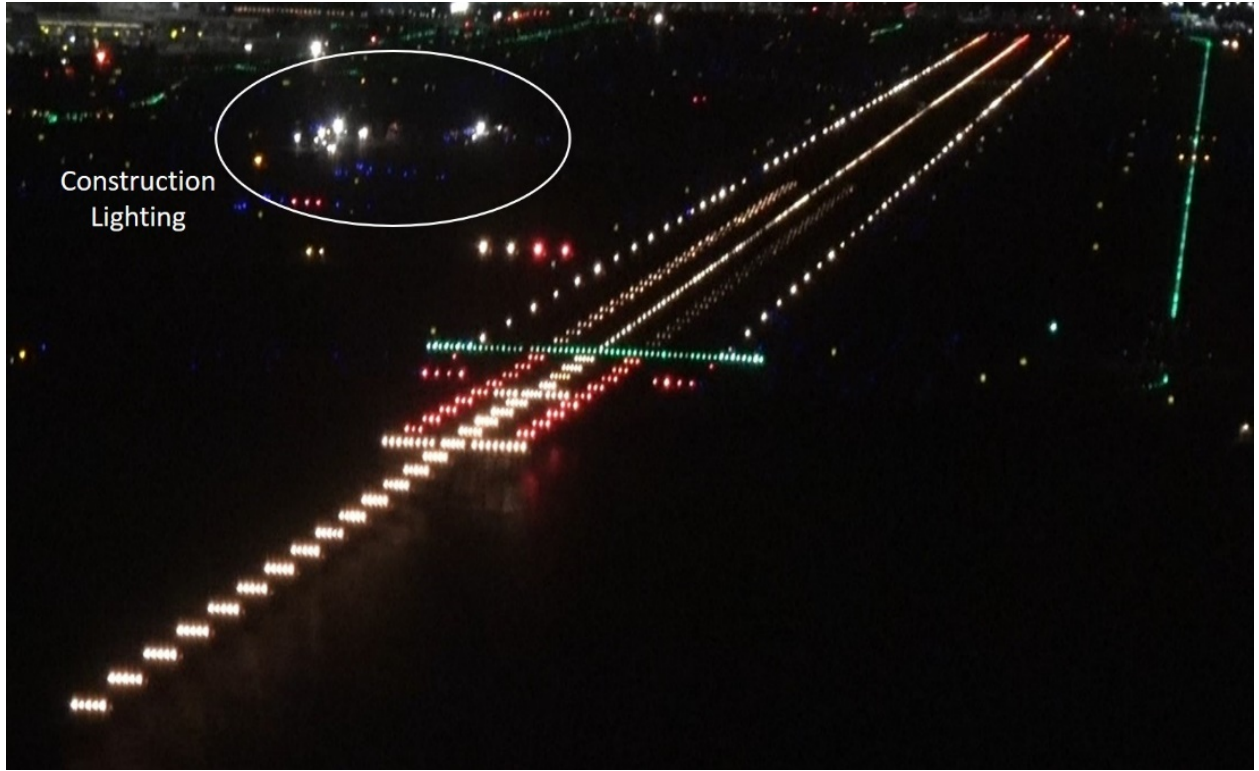
**Photograph 4 – Construction Zone on runway 28L.**

Runway 28L was undergoing a resurfacing construction project (photograph 4) with lighting improvements at the time of the event. The purpose of the project was to rehabilitate runway 28L and to replace existing light fixtures. Additional lighting improvements included new runway to taxiway lead on/off lights, new takeoff-hold lights, and new runway entrance lights. The work required the closure of runway 28L on a nightly basis with 7 weekend closures. The project started on February 21, 2017 with an expected duration of 300 days. On the night of the flyover, runway 28L was closed and workers were actively on site at the intersection of 28L and taxiway F (figure 4). Twenty-eight portable light plants<sup>12</sup> (photograph 5) had been placed around the construction zone to provide nighttime visibility for the construction workers.<sup>13</sup>

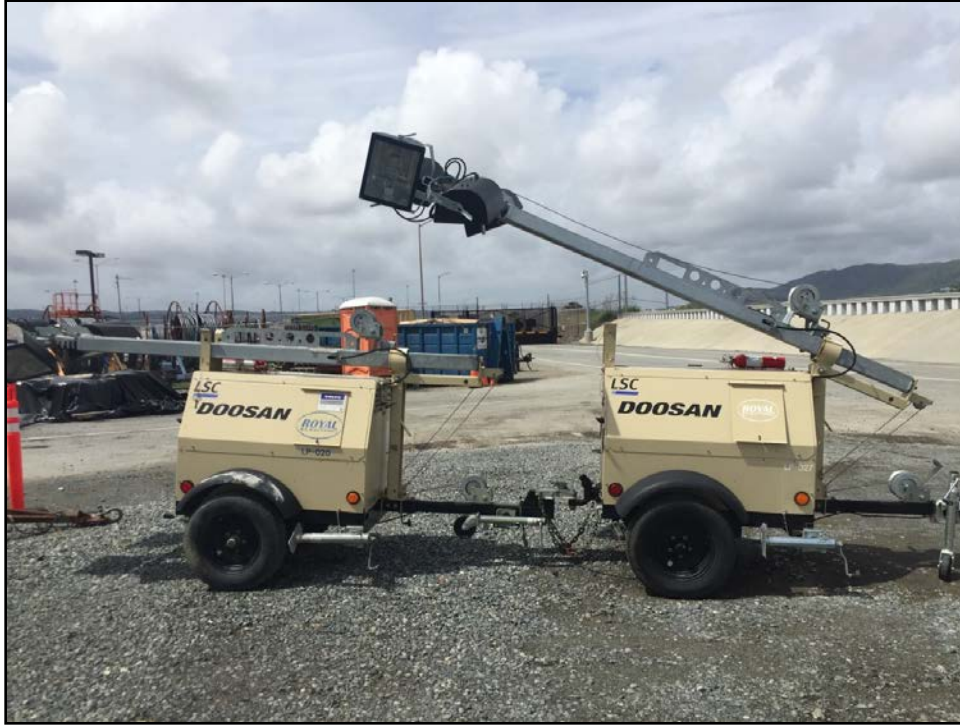
**Photograph 5 – Exemplar construction light plant.**

<sup>12</sup> The construction area was lit with 28 Wacker Neuson LTN6, Doosan LSC, or Allmand Bros Night Light Pro light plants. Each extended up to 30 feet and consisted of 4 elliptical light fixtures with 1000W (4000W total) metal halide light bulbs in each elliptical light fixture.
