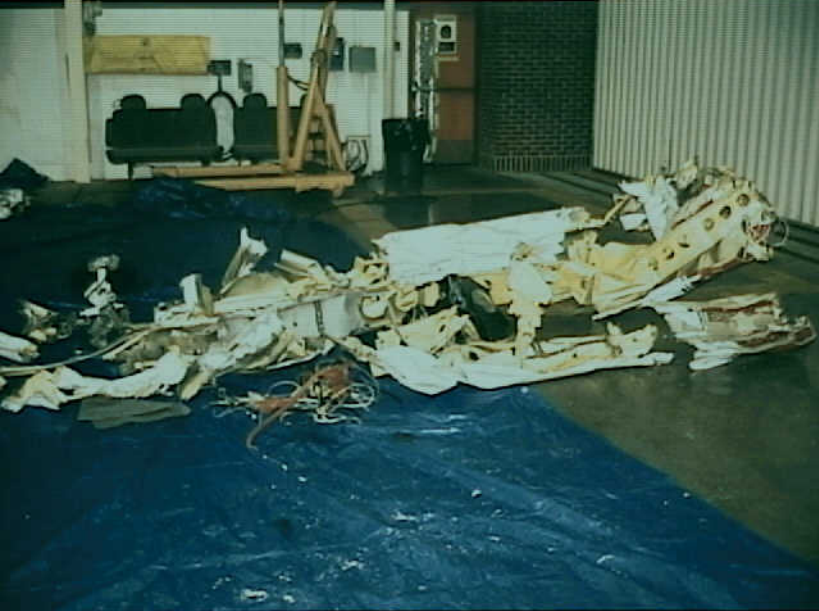
Airworthiness - Photo 9. Close-up view of the leading edge skin of the left wing (view from forward looking aft). Note hydrodynamic deformation in aft direction. (NTSB-I12)
