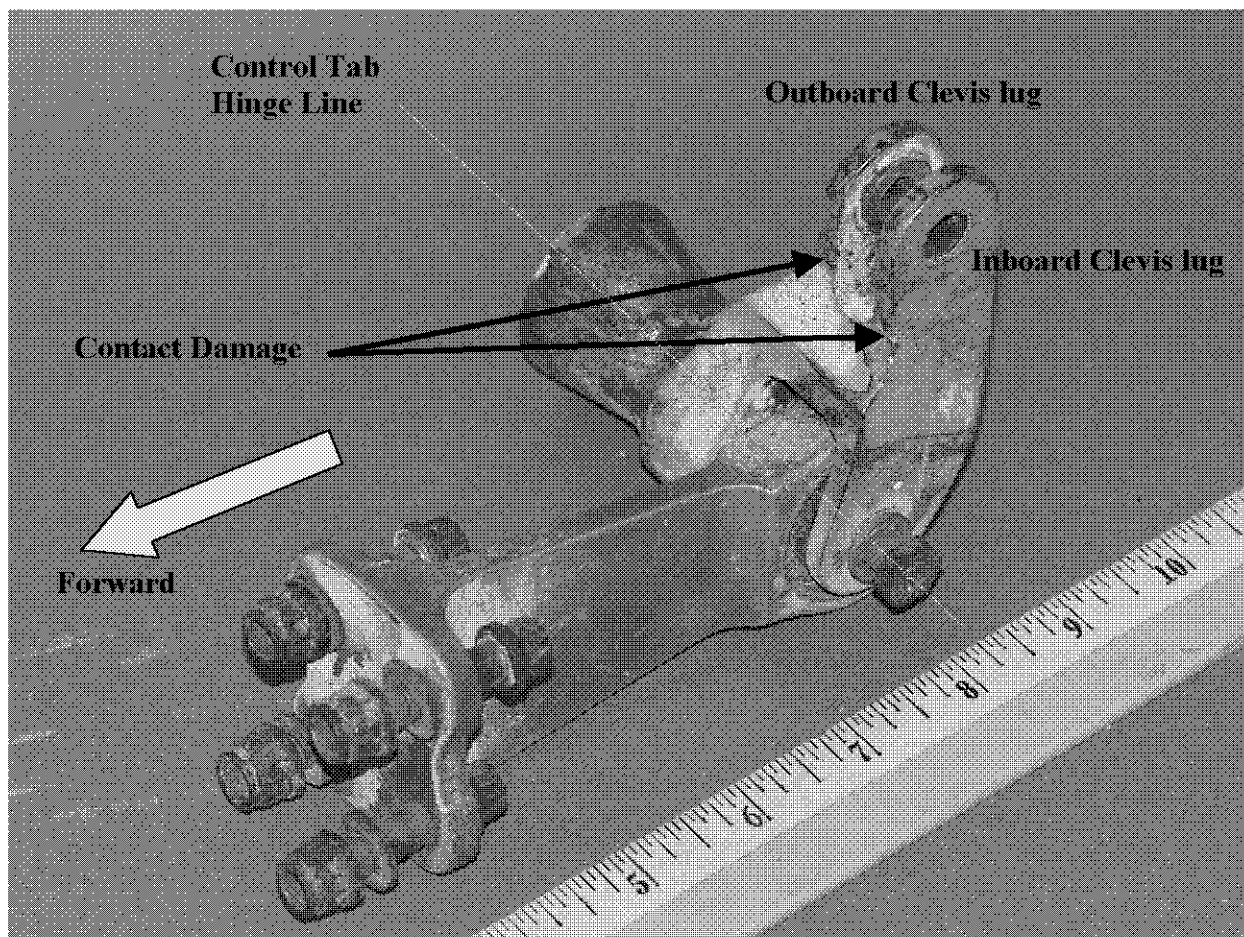
Photo 5: Digital photograph of the R/H Control Tab clevis fitting. View looking aft and outboard. Note the damage to the forward face of the clevis lugs.
