**NATIONAL TRANSPORTATION SAFETY BOARD**

**SUB-GROUP CHAIRMAN'S ADDENDUM TO FACTUAL REPORT,  
DOCUMENTING EXAMINATION OF INSTRUMENT GAUGES**

ANC10MA068

Location: Aleknagik, AK  
Date: August 9, 2010  
Airplane: de Havilland DHC-3T, N455A

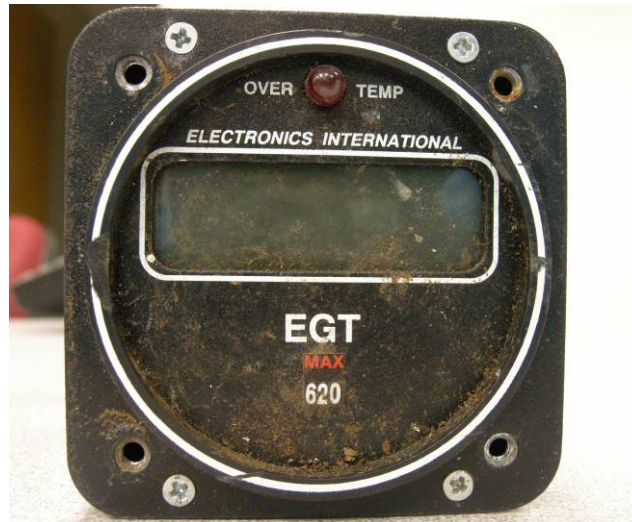
**Figure 1: EGT Gauge**

The EGT gauge provides temperature readings in one-degree increments on a digital display. The unit features an over-temp light that will illuminate if the temperature exceeds a designated limit. The unit is designed to an accuracy of 1/2 percent in accordance with TSO C43a. See Figure 1.

The EGT gauge does not record EGT values in non-volatile memory. The gauge from the event airplane was visually inspected and functionally tested. The EI part number and serial number sticker, quality assurance sticker, and installation warning stickers were still intact. The face was dirty and there were nicks on the ring around the display. The cover appeared in good condition and the wires were intact up to and including the slip on connectors.

The unit was powered on the manufacturer's test bench. The 24 volt (V) backlight did not function; the 12V backlight was functional. The display read 20 degrees Celsius (C) ambient temperature at an actual ambient temperature of 21 degrees C. The calibration was checked by inputting a signal corresponding to 798 degrees C; the unit display read 792 degrees C. The "over temperature" light illuminated at an input signal equivalent to 615 degrees C; the unit was originally calibrated to illuminate the light at 620 degrees C.

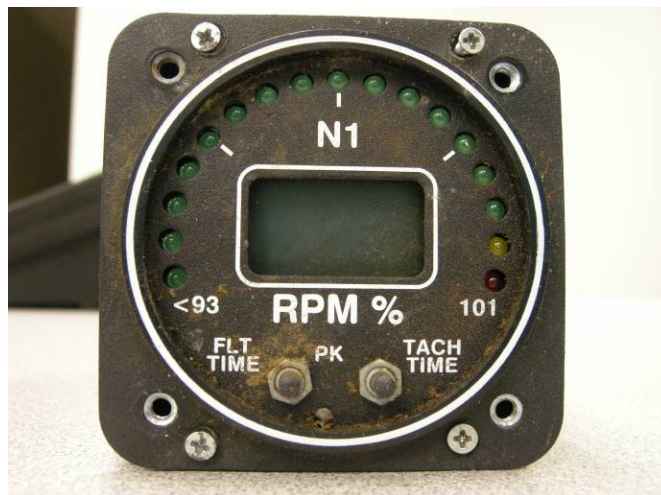
**Figure 3: Tachometer**

The engine tachometer features a digital display and an analog display that is made up of 17 LEDs arranged in a 210 degree arc. The digital display can also provide tachometer time, flight time, and the peak RPM recorded for the flight.<sup>2</sup> See Figure 3.

The engine tachometer from the event airplane was visually inspected. The unit cover had previously been removed and partially reinstalled at the NTSB laboratory. The face plate was dirty and slightly bent on the upper left and lower left corners. The rear plate was also slightly distorted. The EI part number and serial number sticker, quality assurance sticker, and installation warning stickers were still intact. “4187=100%” was hand written next to the part number. The wires and cannon plug appeared in good condition.

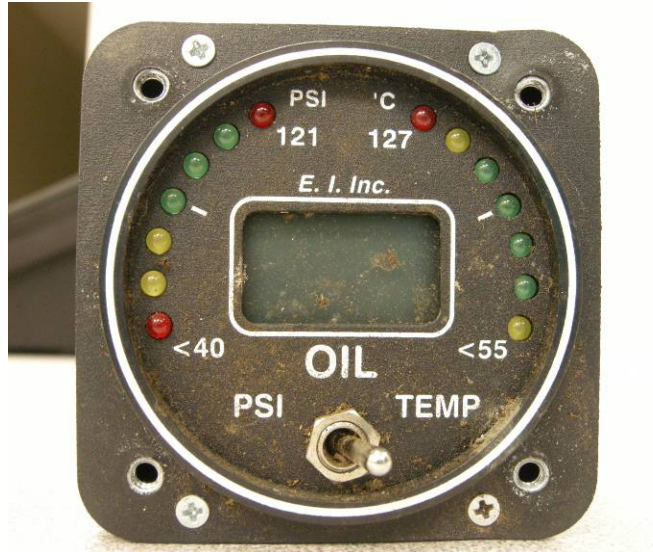
**Figure 6: Oil Gauge**

The oil gauge features dual 90 degree analog displays for oil pressure and temperature, with a digital display that shows oil pressure to 1 psi or oil temperature to 1 degree Celsius. The unit measures both pressure and temperature with an accuracy of 2% in accordance with TSO C47/C43a. See Figure 6.

The oil gauge was visually inspected. There were no part numbers, serial numbers, or warning stickers present on the unit. A quality assurance sticker was present on the bottom side of the cover. The face plate and back plate were slightly deformed and the upper and lower halves of the cover were out of alignment along the horizontal plane. The top rear of the cover had a deep gouge. The front of the unit was dirty and the switch was towards the “TEMP” side. A white/orange wire was kinked, but otherwise the wires and cannon plug appeared in good condition.

The cover was removed and an internal visual inspection was performed. The inter-connect wires supporting the S110301 circuit board were bent, such that the circuit board was positioned forward of original build. The displacement was visually similar to what was seen in the tachometer (see Figure 4). Multiple soldered locations were covered in a flaky yellow residue similar to what is shown in Figure 5.

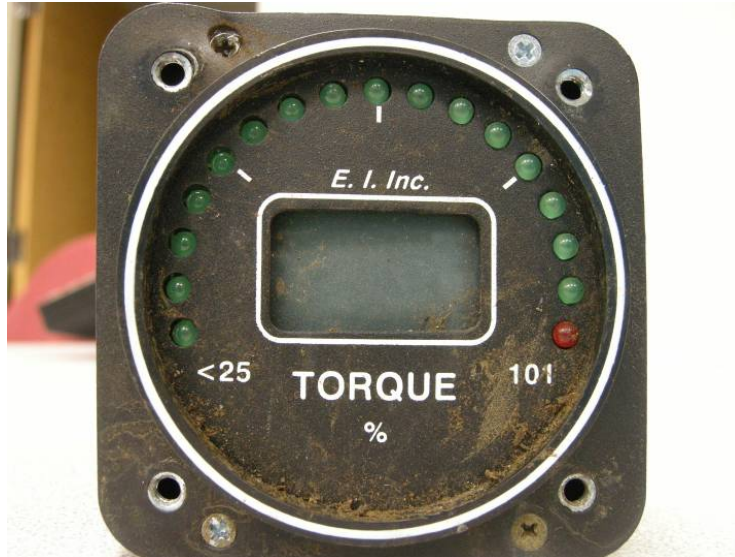
**Figure 7: Torque Gauge**

The torque gauge features a 210 degree analog LED display and a digital display. The unit is designed to be accurate to 1% in accordance with TSO C45. See Figure 7.

The torque gauge was visually inspected. The Electronic International Incorporated part number and serial number sticker, quality assurance sticker, and installation warning stickers were still intact. “60psi=100%” was hand written next to the part number. The front face was dirty and the upper left corner was deformed. The cover and back plate were slightly deformed, and when viewing the back plate there were three gouges on the lower right quadrant. A red wire and a red/white wire were found severed, approximately 4 inches from the cannon plug. Several other wires were nicked and the green wire was kinked in this general area. The cannon plug appeared in good condition.

The cover was removed and an internal visual inspection was performed. Multiple soldered locations were covered in a flaky yellow residue similar to what is shown in Figure 5.

Analog LED arc: Passed  
Digital display operation: Passed  
12V and 24V backlights: Passed  
LED dimming: Passed  
Input signal equivalent to 100%, unit displayed 119%  
Input signal equivalent to 167%, unit displayed 217%  
Input signal equivalent to 8%, unit displayed 000%

Approximately two full turns of the potentiometer adjustment were required to calibrate the unit to display “167%” when a signal equivalent to 167% was inputted from the test bench.

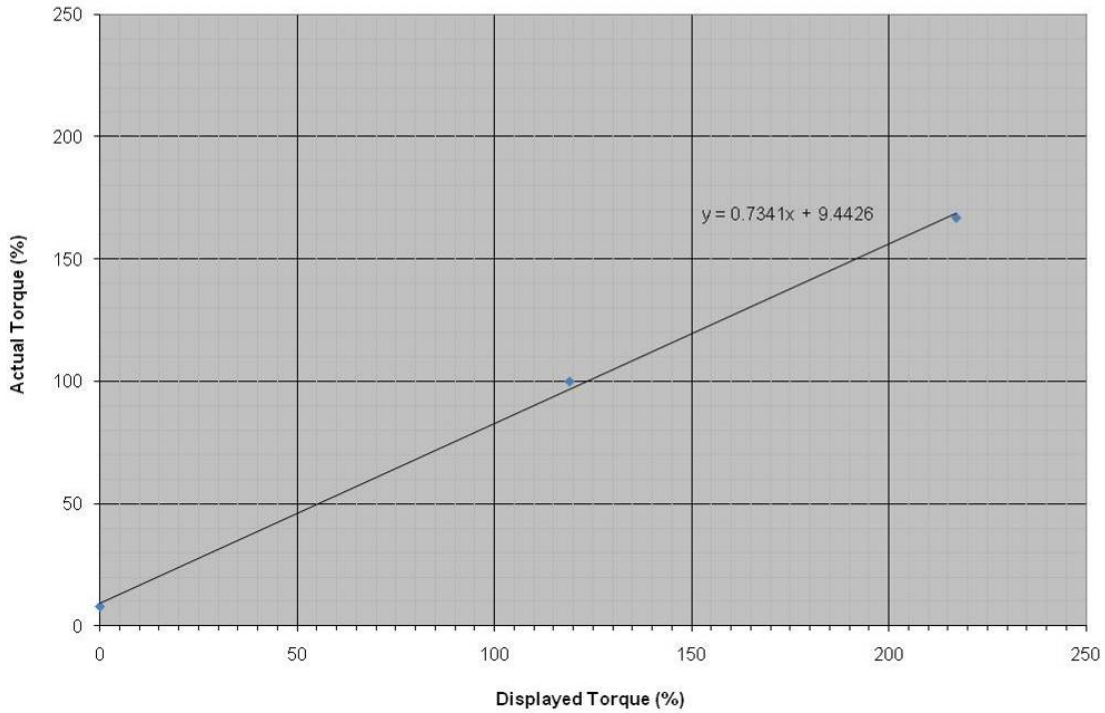
**Figure 9: Actual Torque vs Displayed Torque for Torque Gauge S/N 064583**

A linear model was derived from the differences in the actual torque and the displayed torque discovered during the functional testing of the torque gauge (see Figure 9). The torque values obtained from the memory download were then applied to this model and additional approximate “actual torque” values were obtained. Hartzell Propeller Inc. provided Figure 10 as an engineering estimate of thrust performance for a DHC-3T based on these additional actual torque values. Figure 11 depicts estimated thrust performance for all six torque values.
