**NATIONAL TRANSPORTATION SAFETY BOARD**  
Office of Aviation Safety  
Washington, D.C. 20594

**AIRWORTHINESS GROUP FACTUAL REPORT ADDENDUM 1**  
March 26, 2007

**A. ACCIDENT      DCA06FA058**

Location:            Memphis, Tennessee  
Date:                July 28, 2006  
Time:                1125 Central Daylight Time (CDT)  
Aircraft:            FedEx Express Flight 630, McDonnell-Douglas (Boeing) MD-10-10F,  
                          N391FE

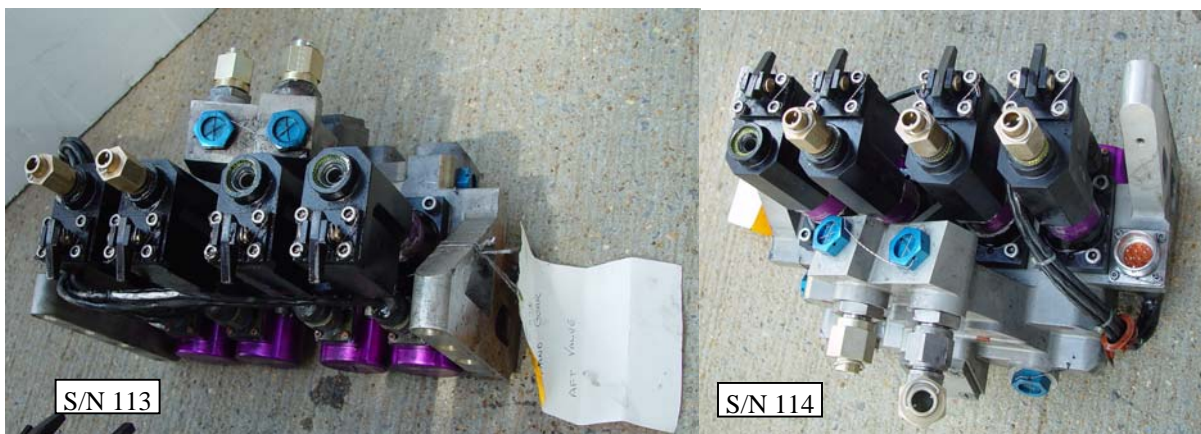
ASM, P/N 33-177, S/N 114

The unit was received with the D port fuse fitting broken and pulled from the unit and the servo cover on servo D was gouged. A broken airplane mounting bolt was located in the middle mounting thread on the A port side of the unit. The fuse was replaced in order to run the test. Numerous failures were noted during the test. The plot of current versus brake pressure at port A indicated a pressure shift such that the maximum pressure obtained was 2300 psig at the 5 mA quiescent current. The plot of port C indicated an infinite gain (loss of control) at approximately 1850 psig to 3000 psig. The plot of port D indicated an infinite gain (loss of control) at approximately 2000 psig to 3000 psig. The internal leakage of port C was measured to be 860 cc, the maximum allowed is 800 cc. The high flow fuse shutoff leakage at port A was measured to be 1360 cc, the maximum allowed is 1310 cc. The test results are in Attachment 5.

ASM, S/N 114, was removed and subjected to the acceptance test procedure. The results from the C and D ports exhibited no pressure control. The valves acted like solenoid (on or off) valves instead of pressure control valves. The C and D valves were disassembled for examination. The flapper-armatures exhibited cracks at the upper braze joint between the flexure and the armature. The A and B valves were also disassembled for comparison. The pressure nozzle on the A port exhibited heavy damage (flattening). The B port exhibited normal wear for a valve of its age.

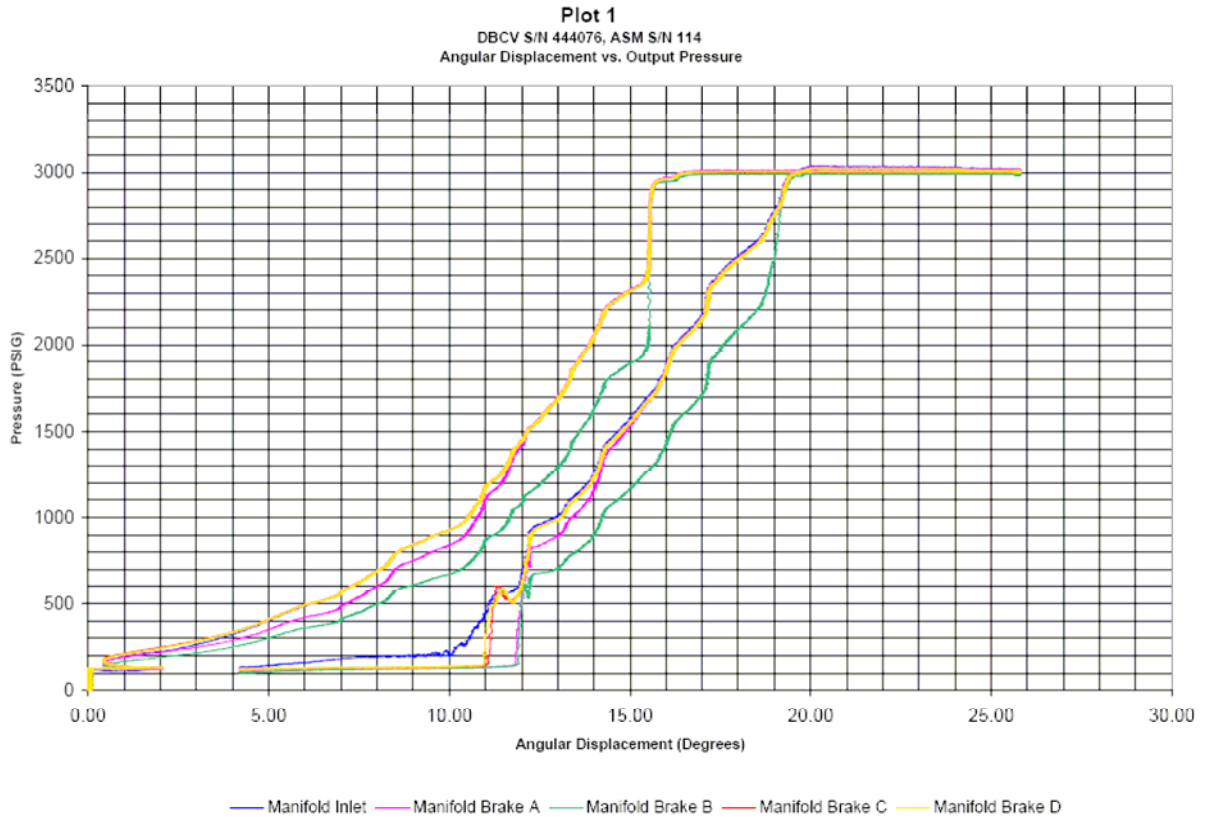
The test was performed 7 times on DBCV, S/N 444076. The first two tests yielded similar results, the data from the second test is shown in Plot 1. As the input angle increases from zero there is no response from the valves until about 11 degrees when the C and D brakes exhibit a step response up to about the input pressure level. Slightly less than 1 degree of additional input yields a step response of the A and B brakes up to about the input pressure level. As the DBCV is actuated to its full travel and back to zero the response from all four brakes is smooth and matches the input pressure in slope. The A and B brakes exhibit pressures less than the input pressure with the B brake exhibiting more pressure loss. The A brake pressure loss is more pronounced below about 1500 psi. The C and D brake response matches the input pressure very well.

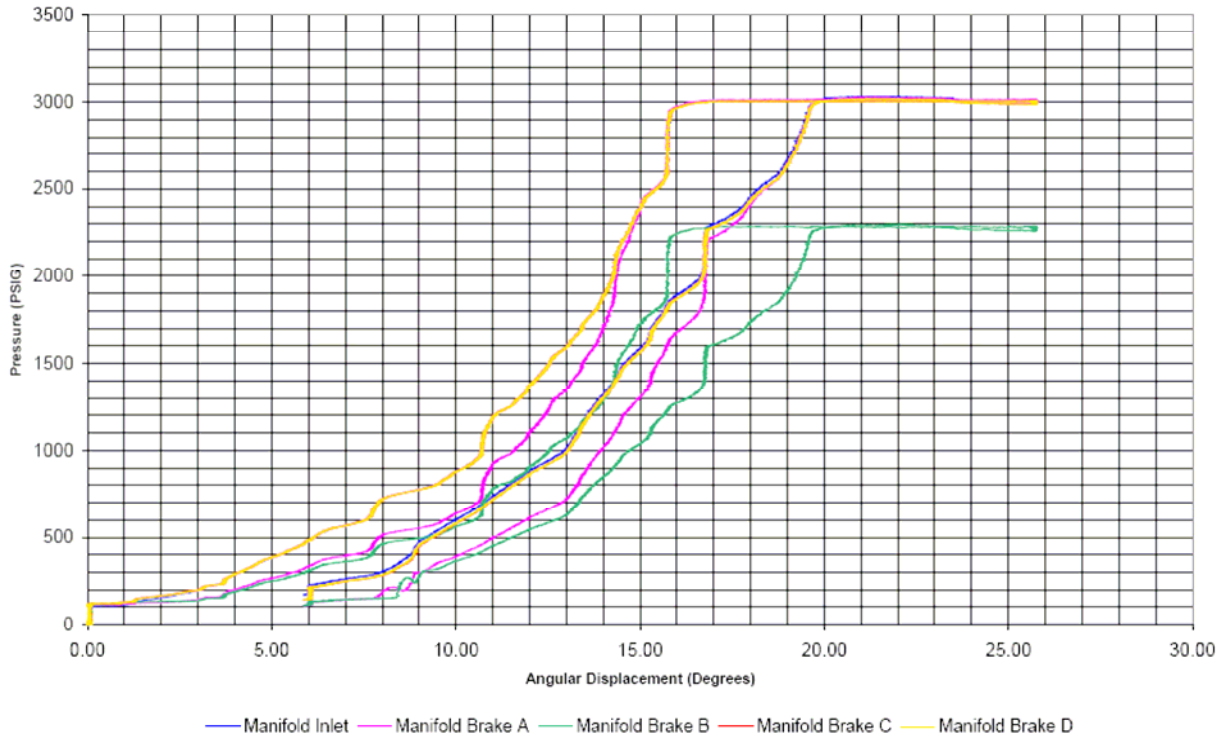
**Plot 3**  
DBC/S/N 444076, ASM S/N 114  
Angular Displacement vs. Output Pressure

The results from tests 4 – 7 were similar and thus only the results from test 4 are shown in Plot 3. There is no step response of the brakes in these tests. The C and D brakes exhibit a response that matches the input pressure very well through the entire range. The A and B brakes exhibit a response that is less in magnitude and the B brake exhibits a cutoff such that the maximum pressure attained is about 2300 psi. The A brake pressure difference is much more pronounced below about 200 psi.

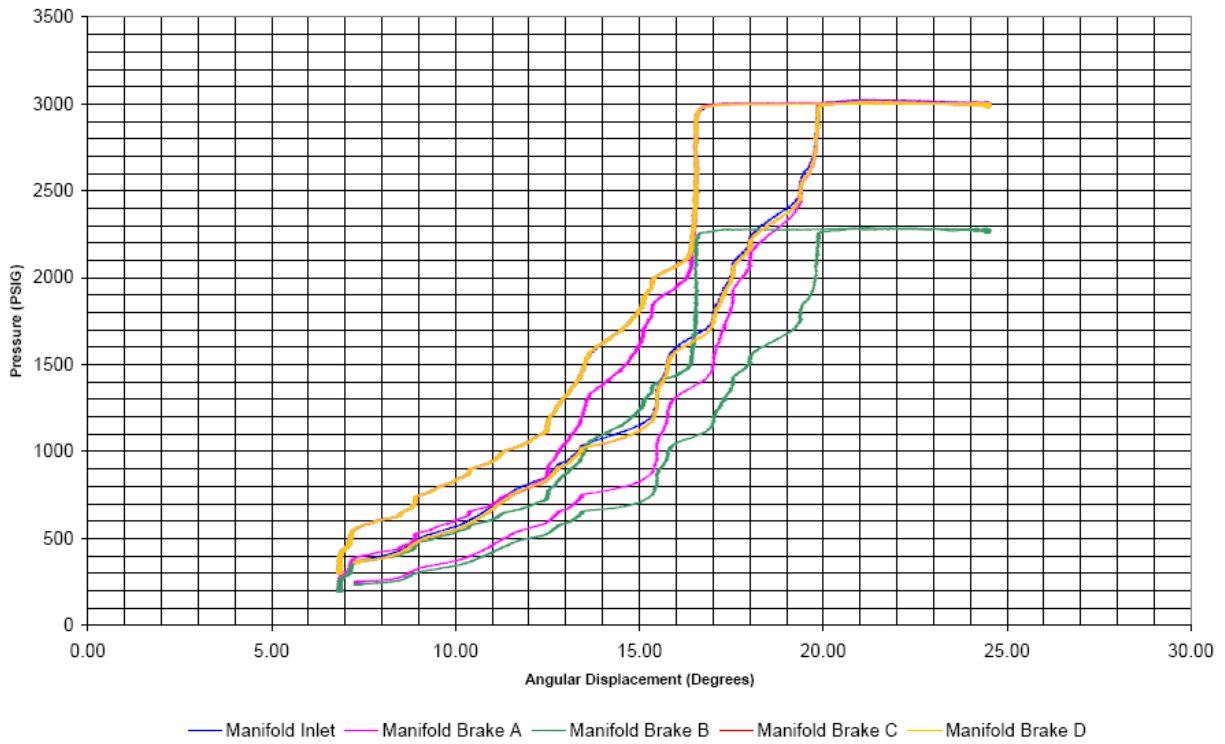
**Plot 5**  
DBC/S/N 438942, ASM S/N 114  
Angular Displacement vs. Output Pressure

The results from test 2 on DBCV, S/N 43892, are shown in Plot 5. The results for all 4 brakes

are smooth with no step response and the C and D brakes match very well with the input pressure. The A and B brakes exhibit responses less than the input pressure similar to test 1 and the B brake only attains a maximum of about 2300 psi.

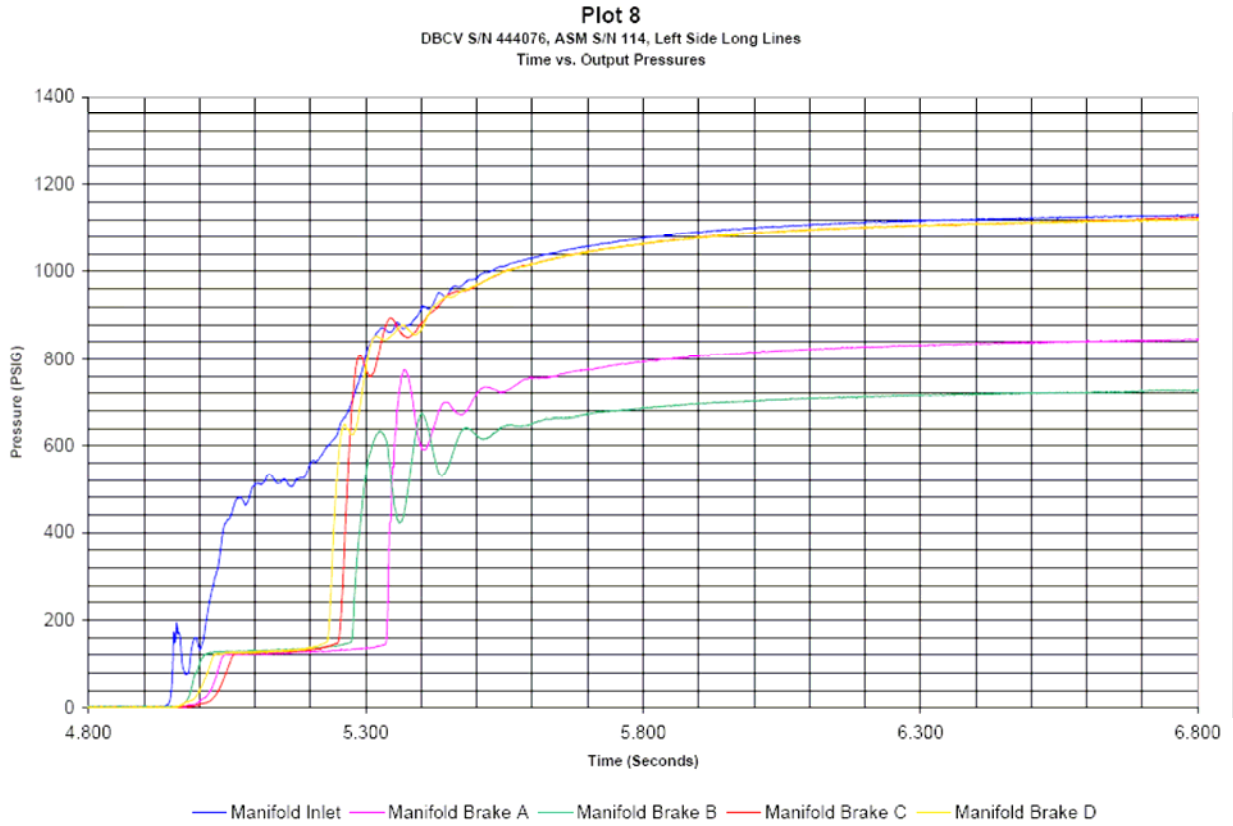
Plots 8 and 9 show the results from setups 2 and 3, respectively, with the brake valve actuated such that the output pressure was about 1100 psi. In plot 8, all four brake pressures respond at about the same time but the A and B brakes only attain 65%-75% of the DBCV output pressure. The A and B brakes again exhibit more oscillation in their response than the C and D brakes. The results in plot 9 show all four brakes responding at the same time and reaching a peak between 88%-93% of DBCV output pressure. The responses all follow the DBCV output pressure well with the exception of the initial lag in the response typical of all the results.

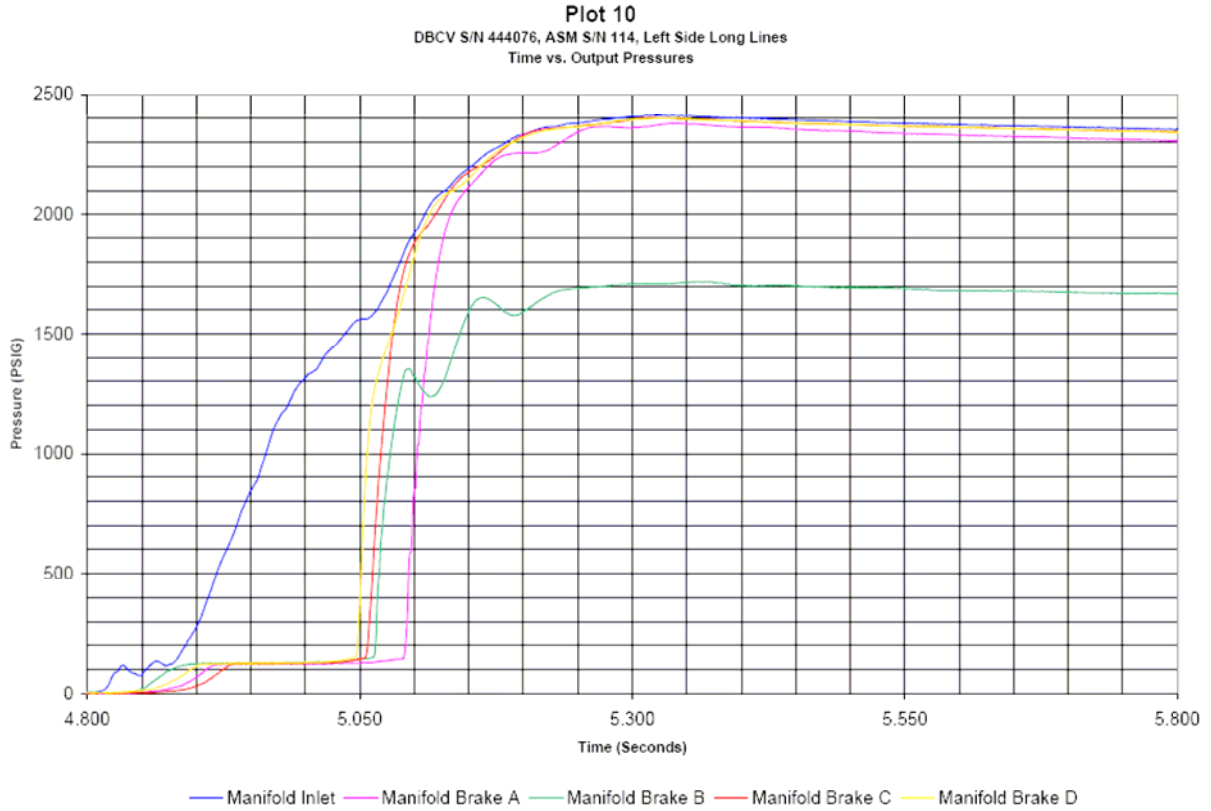
Plots 10 and 11 show the test results from setups 2 and 3, respectively, with the brake valve actuated such that the output pressure was about 2400 psi and 1900 psi, respectively. In plot 10, all four brake pressures respond at about the same time and match the DBCV output pressure quite well with the exception of the B brake. The B brake only attains about 70% of the DBCV output pressure. There again is more oscillation in the A and B response. The results from setups 1 and 4 look very similar to those shown in plot 10 except the A brake pressure does not attain the DBCV output pressure. The results in plot 11 agree very well with the DBCV output pressure after the initial lag. There is a little more oscillation in the A and B response. All four

valves reach the DBCV output pressure.

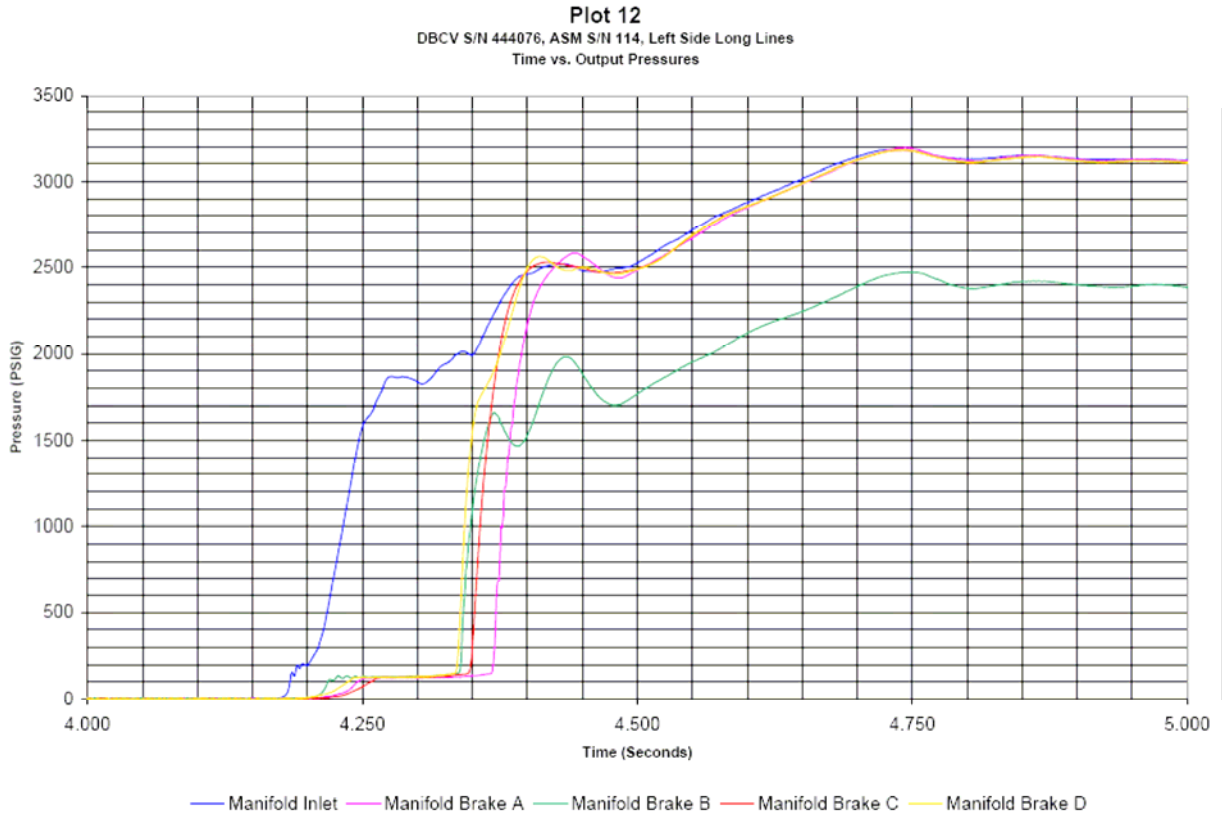
Plots 12 and 13 show the results from setup 2 and 3, respectively, with the brake valve actuated such that the output pressure was full system pressure. In plot 12, all four brake pressures respond at about the same time and match the DBCV output pressure with the exception of the B brake. The B brake only attains about 77% of the DBCV output pressure. Again, there is more oscillation in the A and B brake response. The results in plot 13 agree very well with the DBCV output pressure after the initial lag. The A and B response exhibits slightly more oscillation than the C and D response.
