MECAER AVIATION GROUP	RELAZIONE TECNICA D'INDAGINE DEFECT INVESTIGATION REPORT N°: DIR 02/12		Data: (Date): 20 Dec 2012 Aeromobile tipo: (Aircraft Type:) AW139

3. ENTI PARTECIPANTI ALL'INDAGINE (PARTICIPANTS TO THE INVESTIGATION)	MAG, AW, ANSV (20 and 22 Nov 2012)			
4. ESTREMI PARTICOLARE DIFETTOSO (DEFECTIVE PART ID DATA)	Denominazione particolare (Part Name): Main Rotor Lag Damper	NDR (P/N) M006-01H001-007 (AW 3G6220V01351) M006-01H001-009 (AW 3G6220V01352)	S.N. 1660B (Red) 1724B (White) 0557AB (Black) 1602 (Blue) MCR5027 (Orange)

8. MOTIVO DELL'INVIO IN DITTA (da S.I., N.I. o cartellino di stato) (REASON OF RETURN)	Descrizione (Description): Investigation after helicopter incident

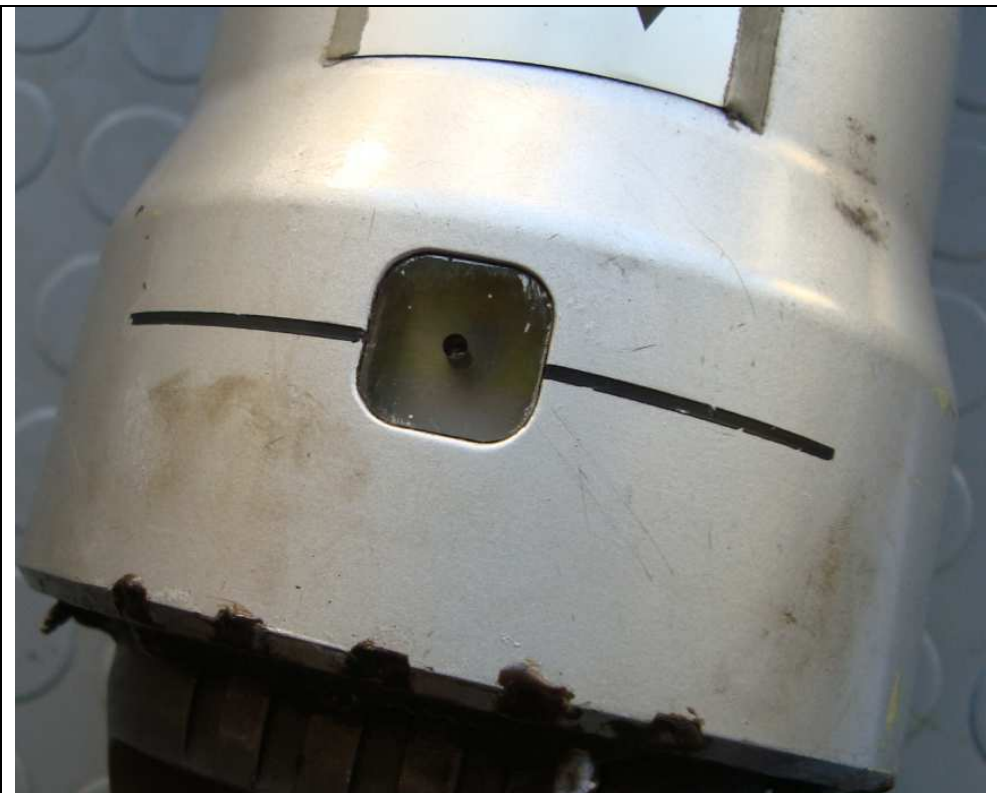
S/N 1660B - Oil Level

General Conditions	
Visible Damages	<i>None</i>
Leaks	<i>None</i>
Oil Level	<i>OK</i>
Lockwirings (HYD ports)	<i>Not MFR original</i>
Weight (5,070 kg ± 50 g)	<i>5,060 Kg</i>

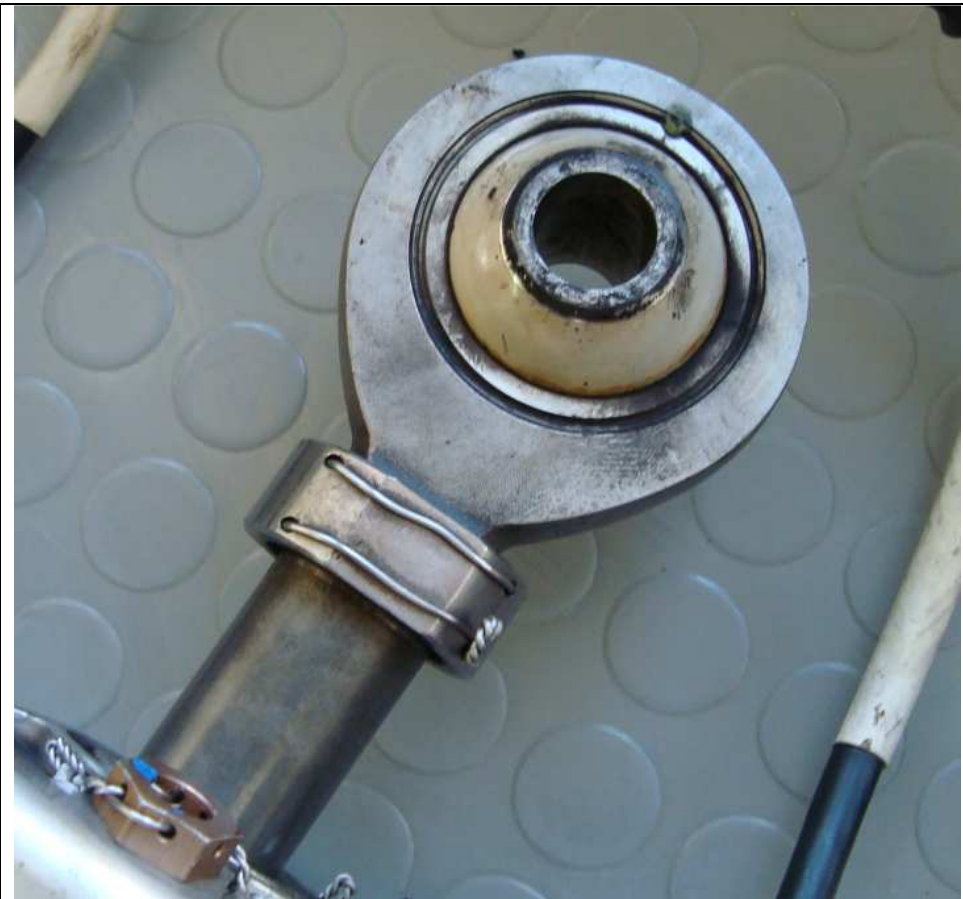
S/N 1724B - Eye End

Bearings Conditions		Max allowed	Measured	Conformance
Eye End	Flex	10 Nm	<i>0,2 Nm</i>	<i>Yes</i>
	Torq.	20 Nm	<i>0,5 Nm</i>	<i>Yes</i>
	Axial play	0.25 mm	<i>0,03 mm</i>	<i>Yes</i>
Body End	Flex	10 Nm	<i>0,2 Nm</i>	<i>Yes</i>
	Torq.	20 Nm	<i>0,5 Nm</i>	<i>Yes</i>
	Axial play	0.25 mm	<i>0,06 mm</i>	<i>Yes</i>

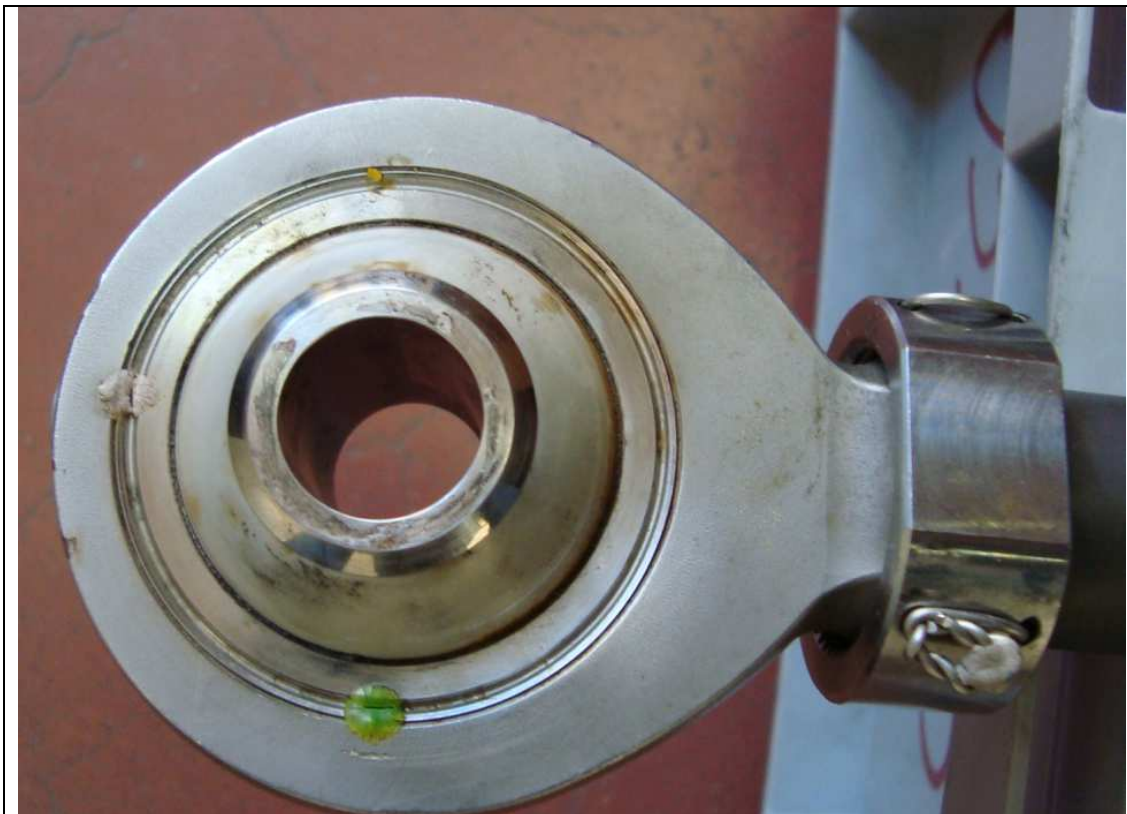
S/N 0557AB - Eye End

Bearings Conditions		Max allowed	Measured	Conformance
Eye End	Flex	10 Nm	<i>6,0 Nm</i>	<i>Yes</i>
	Torq.	20 Nm	<i>15,0 Nm</i>	<i>Yes</i>
	Axial play	0.25 mm	<i>None</i>	<i>Yes</i>
Body End	Flex	10 Nm	<i>3,0 Nm</i>	<i>Yes</i>
	Torq.	20 Nm	<i>8,0 Nm</i>	<i>Yes</i>
	Axial play	0.15 mm	<i>None</i>	<i>Yes</i>

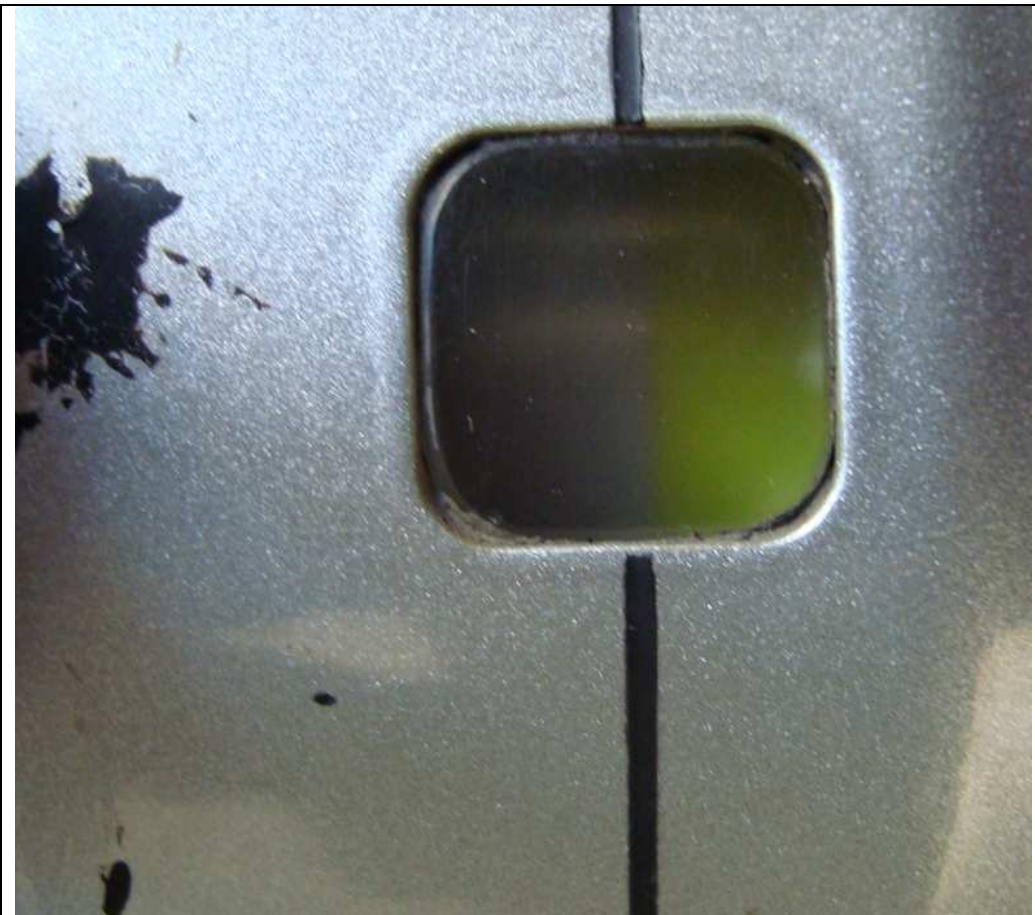
S/N 0557AB - Oil Level

General Conditions	
Visible Damages	<i>None</i>
Leaks	<i>None</i>
Oil Level	<i>OK</i>
Lockwirings (HYD ports)	<i>Not MFR original</i>
Weight (5,070 kg ± 50 g)	<i>5,080 Kg</i>

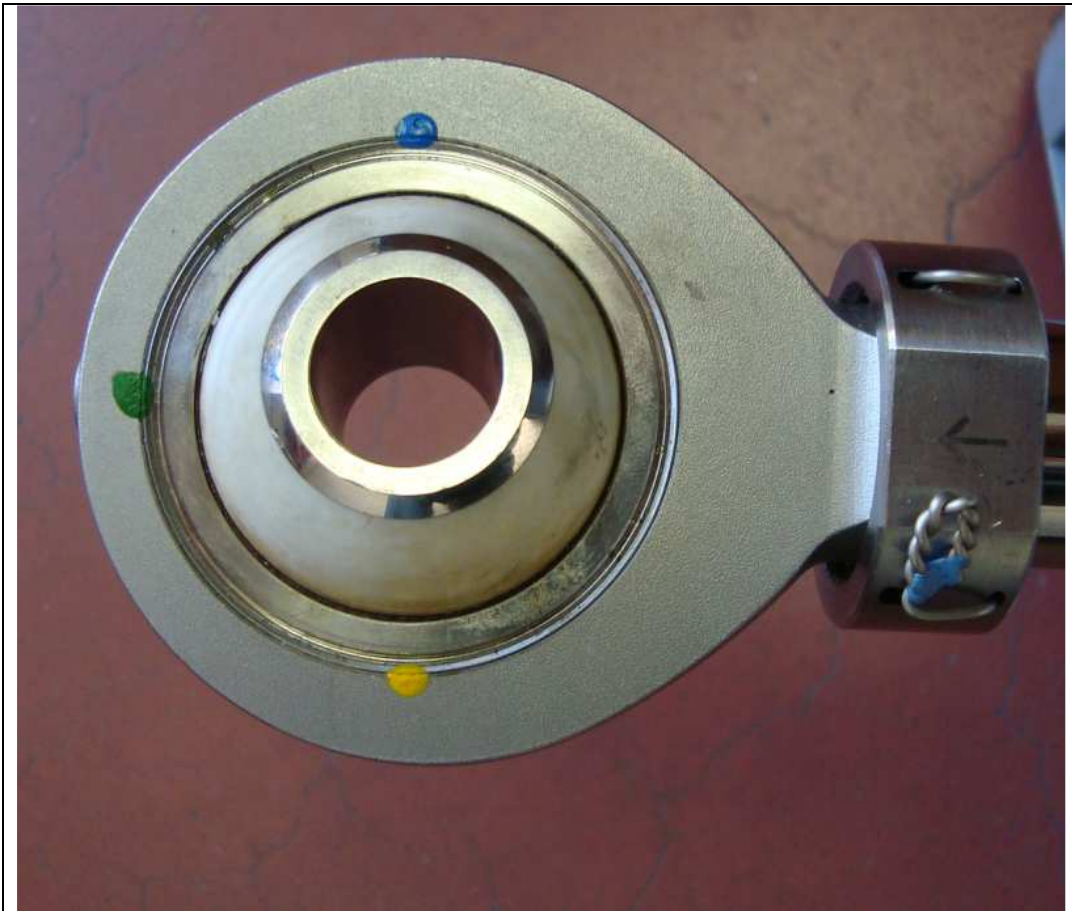
S/N 1602- Eye End

Bearings Conditions		Max allowed	Measured	Conformance
Eye End	Flex	10 Nm	<i>7,0 Nm</i>	<i>Yes</i>
	Torq.	20 Nm	<i>17,0 Nm</i>	<i>Yes</i>
	Axial play	0.25 mm	<i>None</i>	<i>Yes</i>
Body End	Flex	10 Nm	<i>15,0 Nm</i>	FAIL
	Torq.	20 Nm	<i>30,0 Nm</i>	FAIL
	Axial play	0.15 mm	<i>None</i>	<i>Yes</i>

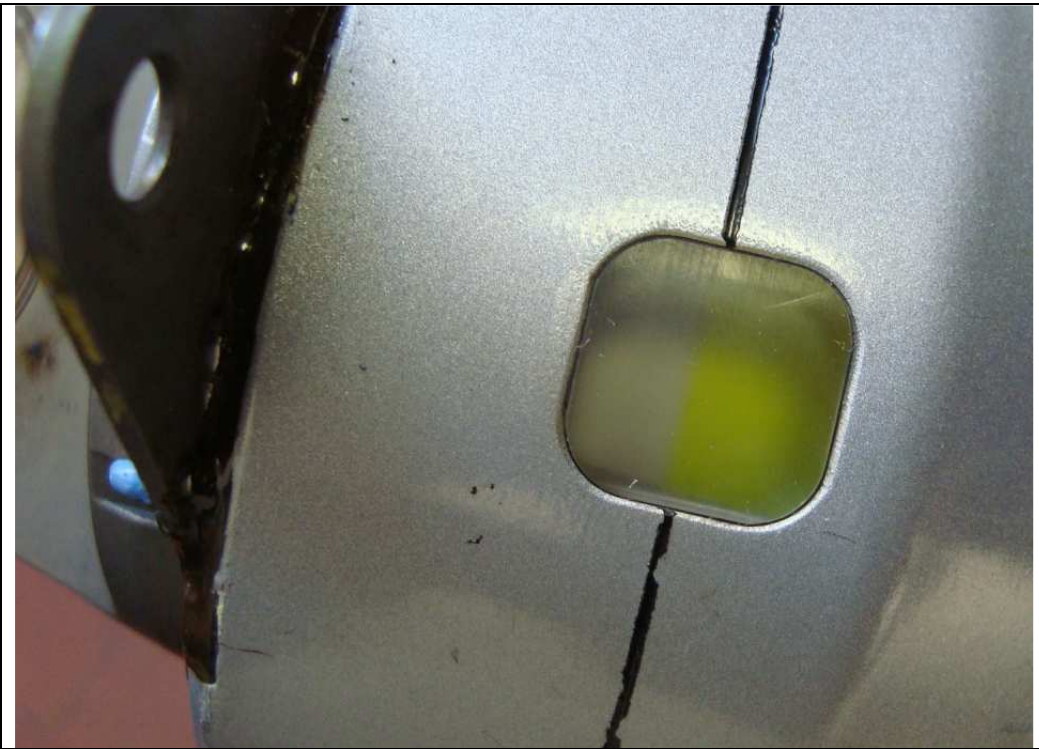
S/N 1602- Oil Level

General Conditions	
Visible Damages	<i>None</i>
Leaks	<i>None</i>
Oil Level	<i>OK</i>
Lockwirings (HYD ports)	<i>Original MRO</i>
Weight (5,070 kg ± 50 g)	<i>5,080 Kg</i>

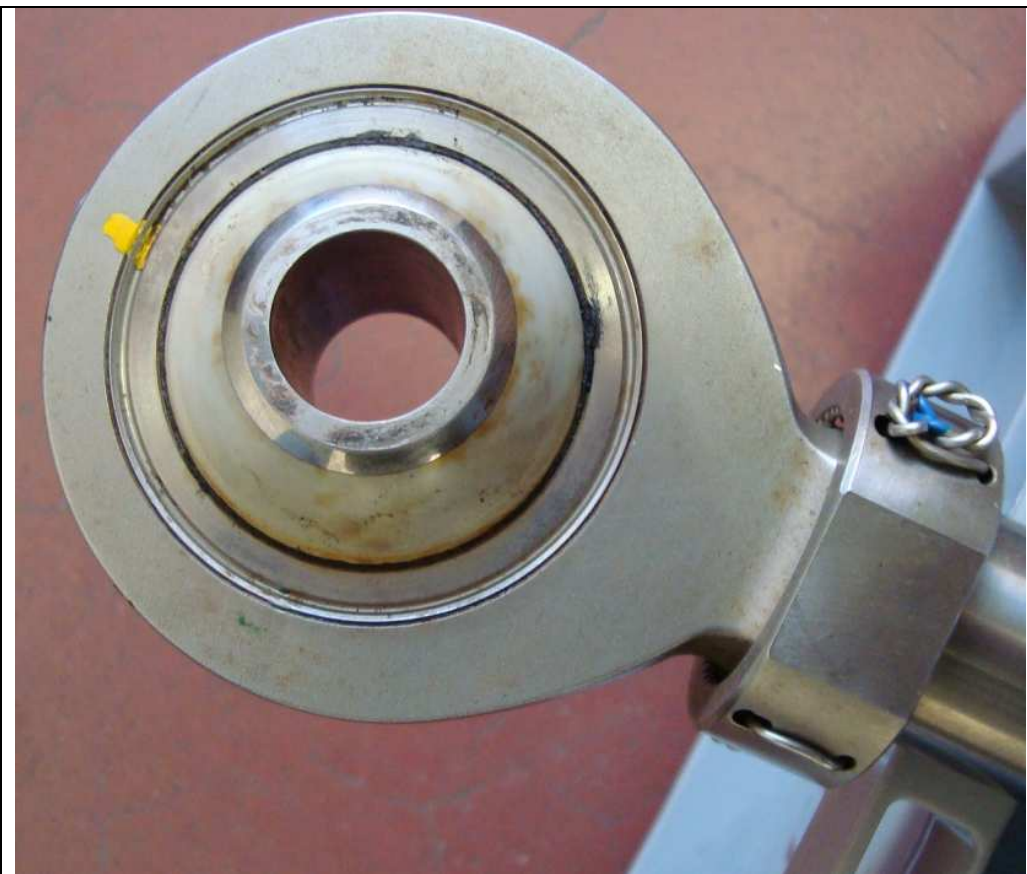
S/N MCR5027 Eye End

Bearings Conditions		Max allowed	Measured	Conformance
Eye End	Flex	10 Nm	<i>0,2 Nm</i>	<i>Yes</i>
	Torg.	20 Nm	<i>0,4 Nm</i>	<i>Yes</i>
	Axial play	0.25 mm	<i>0,015 mm</i>	<i>Yes</i>
Body End	Flex	10 Nm	<i>2,0 Nm</i>	<i>Yes</i>
	Torg.	20 Nm	<i>3,0 Nm</i>	<i>Yes</i>
	Axial play	0.25 mm	<i>None</i>	<i>Yes</i>

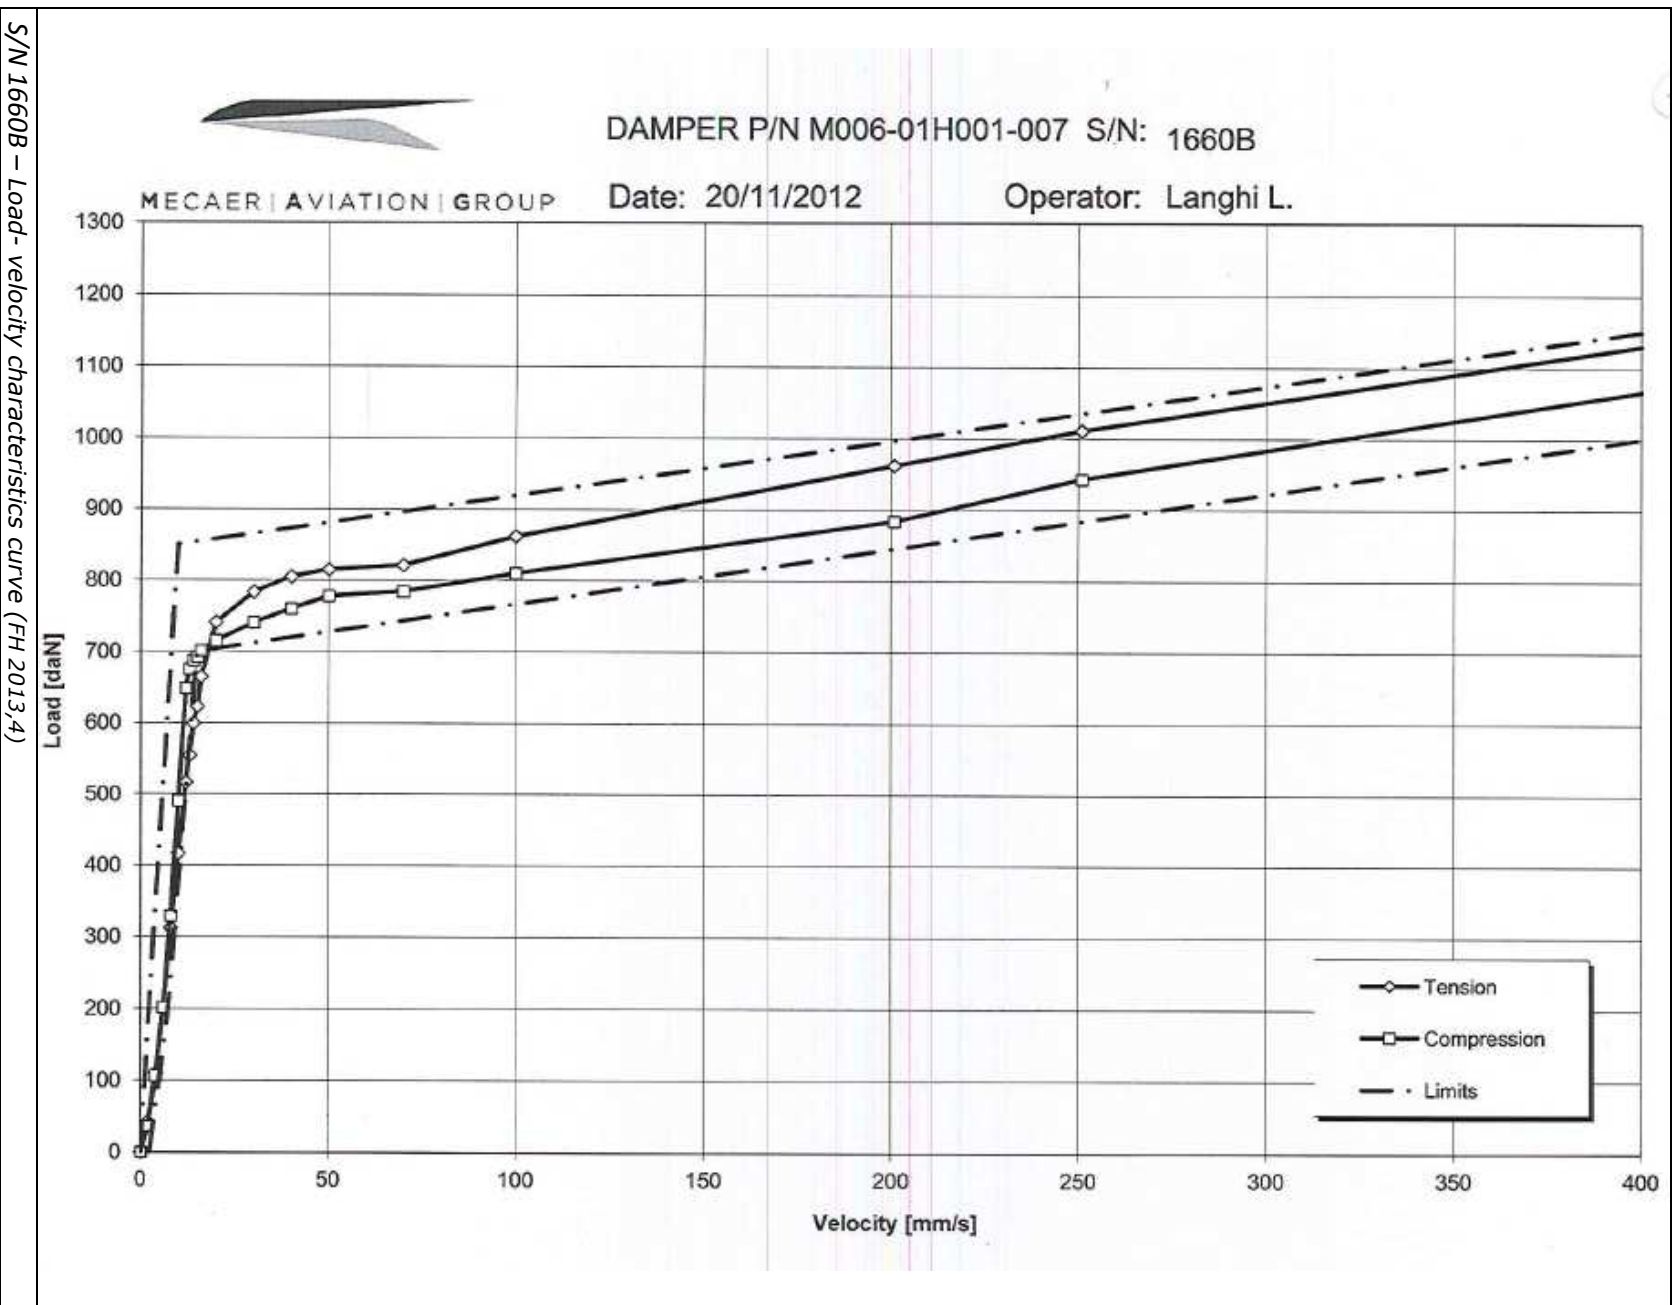
DAMPER P/N M006-01H001-007 S/N: 1660B

18. CAUSA INCONVENIENTE - OSSERVAZIONI (DEFECT ROOT CAUSE- OBSERVATIONS)	Descrizione (Description): <i>ATP "Load- velocity characteristics curve" degradation in the "knee" area may be attributed to the observed valve seat wear problems. No evident cause for the body end bearing friction out of limit, the hypothesis is that operative environment (contamination and/or vibration) may cause in the first Flight Hours a bearing friction augmentation. However the ball bearing friction out of the maximum requirement should not affect the damper functionality but an increase of the local bending stress is expected.</i>

Functional Check	
ATP Curve	FAIL

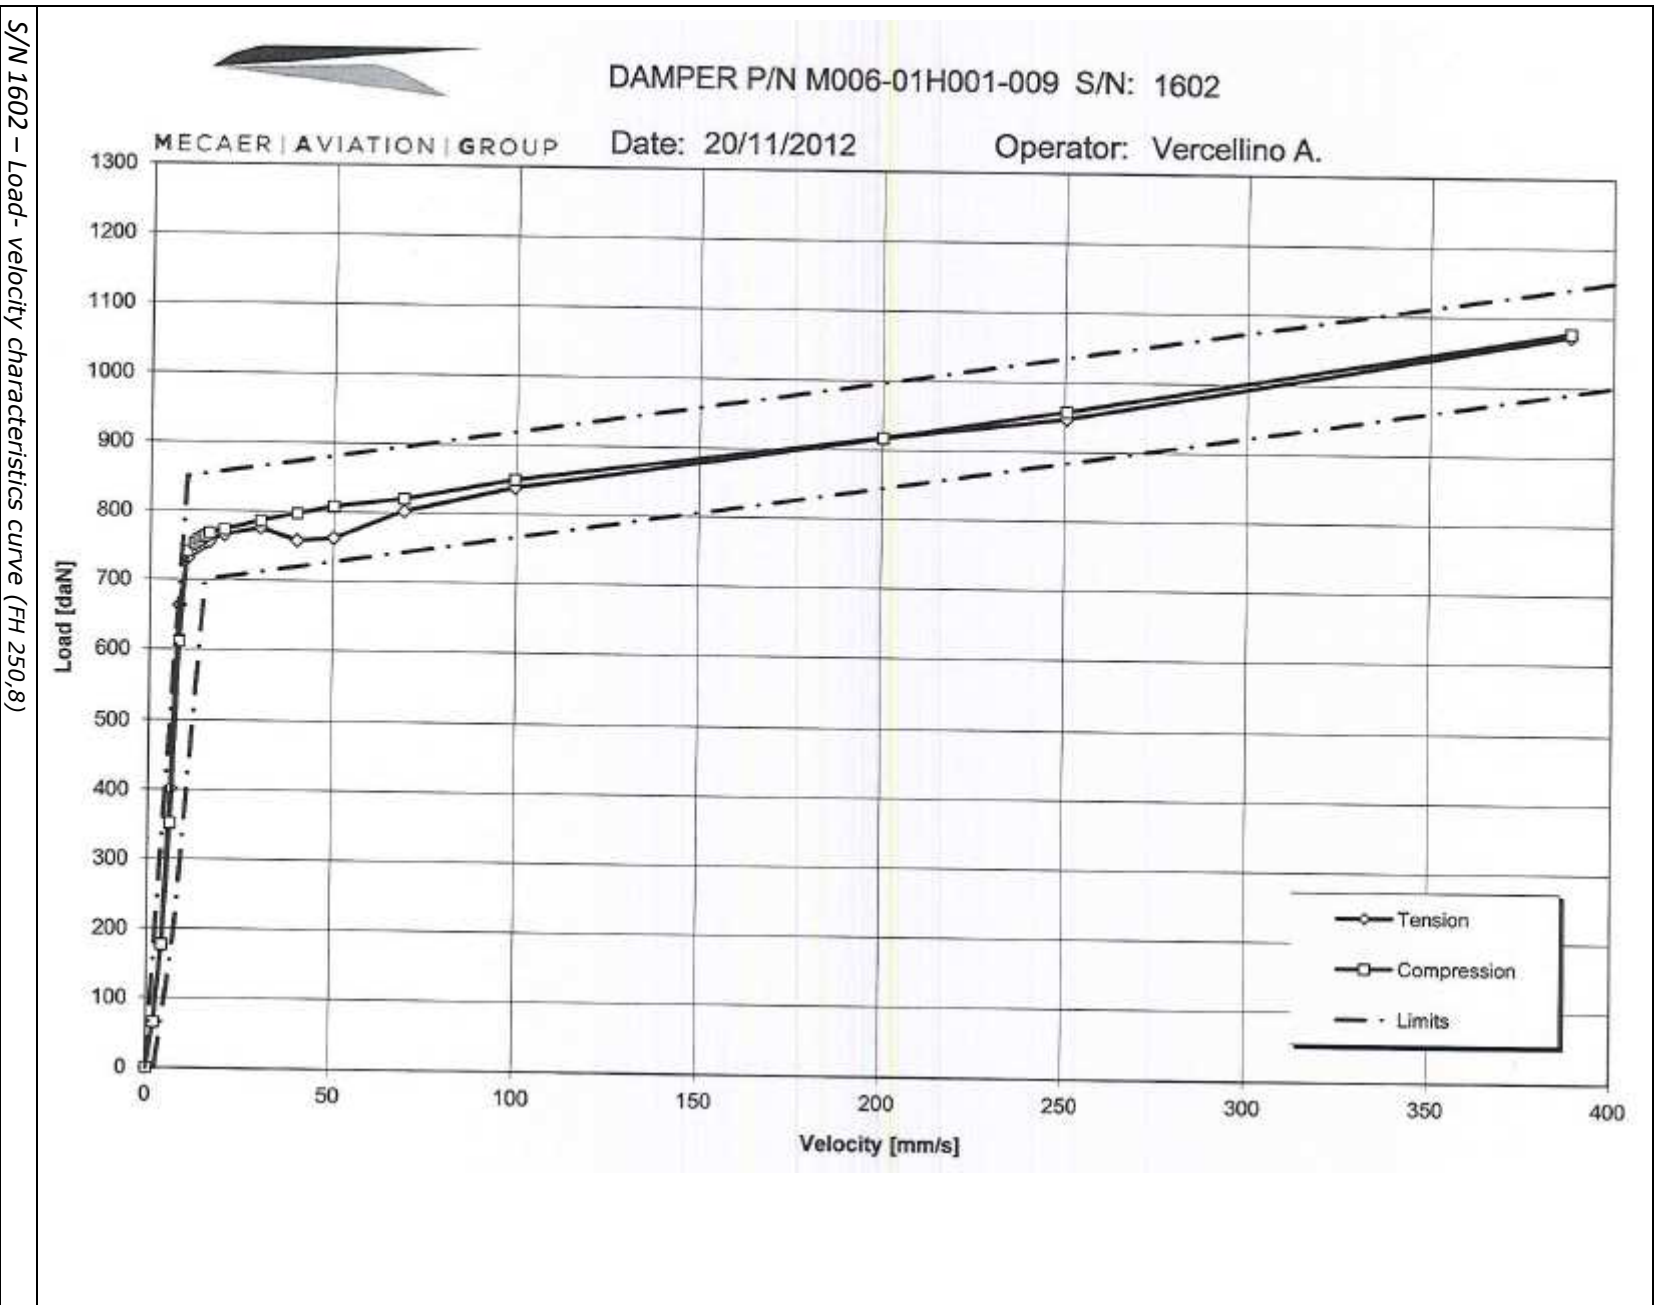
Functional Check	
ATP Curve	<i>Ok</i>

S/N 1602 – Load - velocity characteristics curve (FH 250,8)

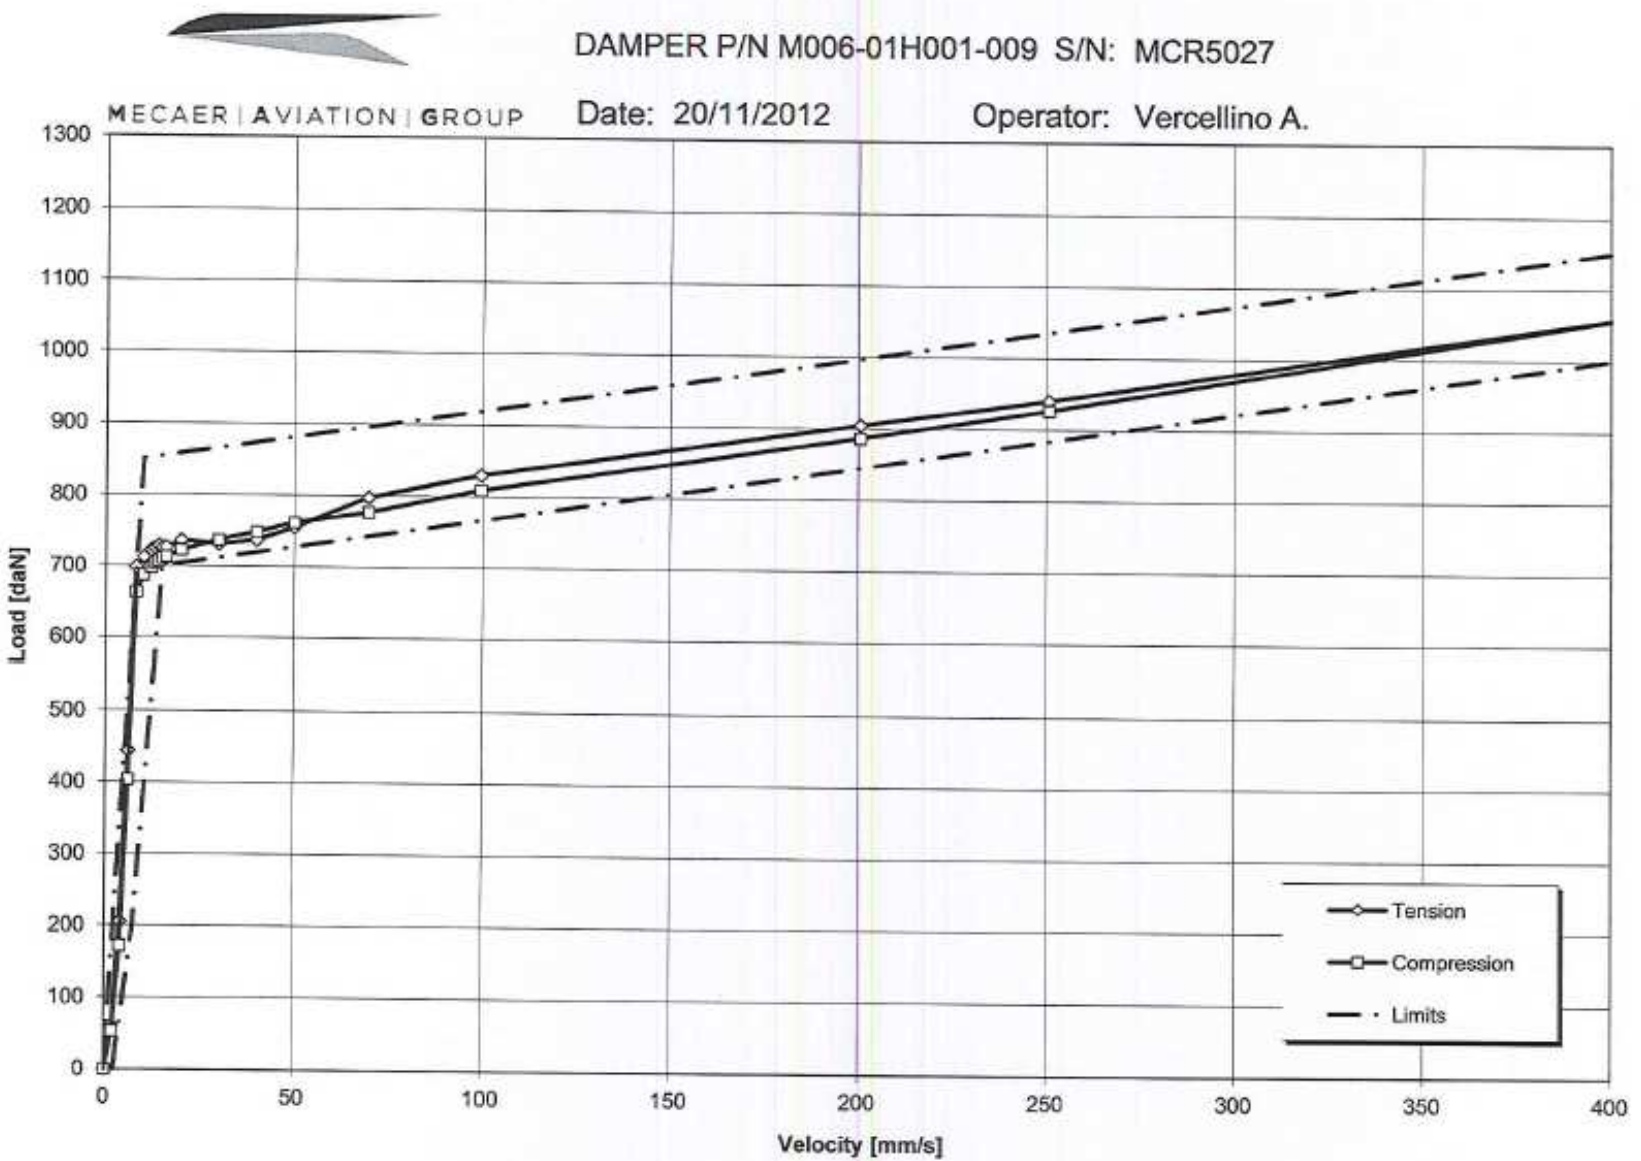
Functional Check	
ATP Curve	<i>Ok</i>

S/N MCR5027 - Load - velocity characteristics curve (FH 897,78)

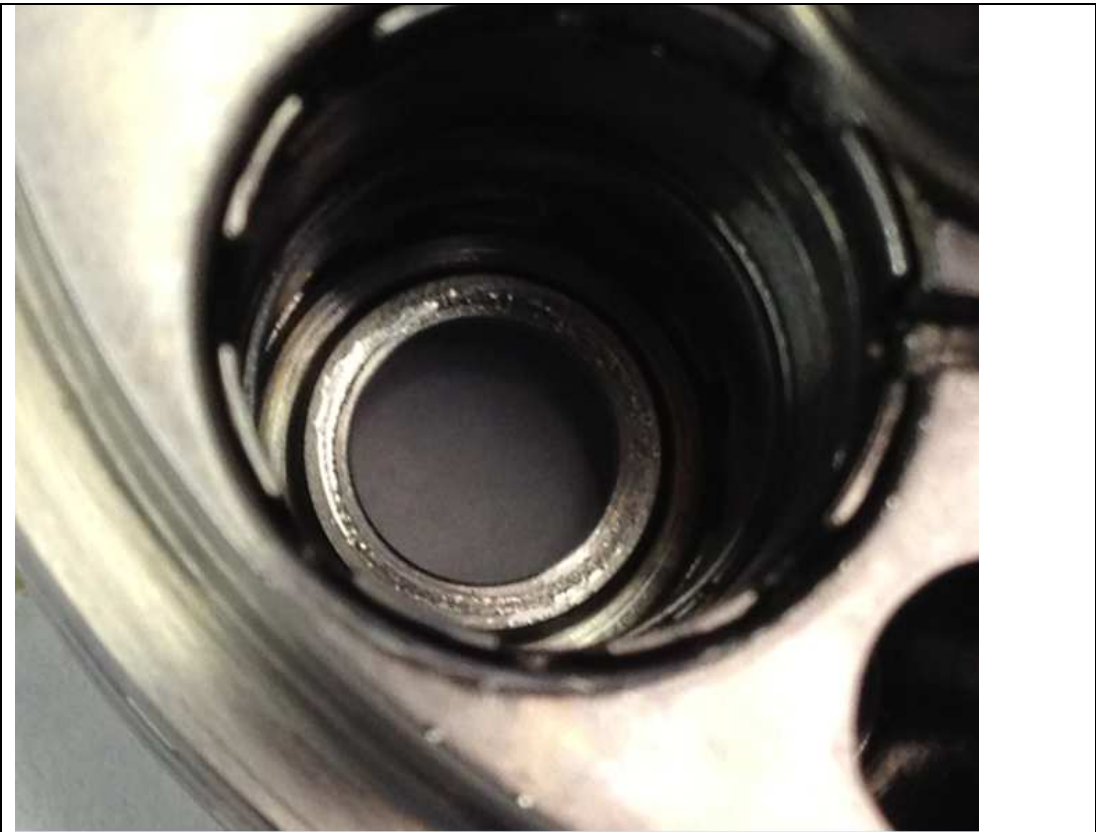
relief valve seat wear detail (Damper S/N 1660B)

RELAZIONE TECNICA D'INDAGINE DEFECT INVESTIGATION REPORT N°: DIR 02/12		Data: (Date): 20 Dec 2012 Aeromobile tipo: (Aircraft Type:) AW139
22. EVENTUALI PROVVEDIMENTI CORRETTIVI SU DATI PROGETTO (EVENTUAL CORRECTIVE ACTIONS ON DESIGN DATA)	Descrizione: (citare anche gli estremi di eventuali ECO emesse) (Description: report eventual ECO Issued) <i>Under evaluation a design change to solve observed valve wear problem.</i>

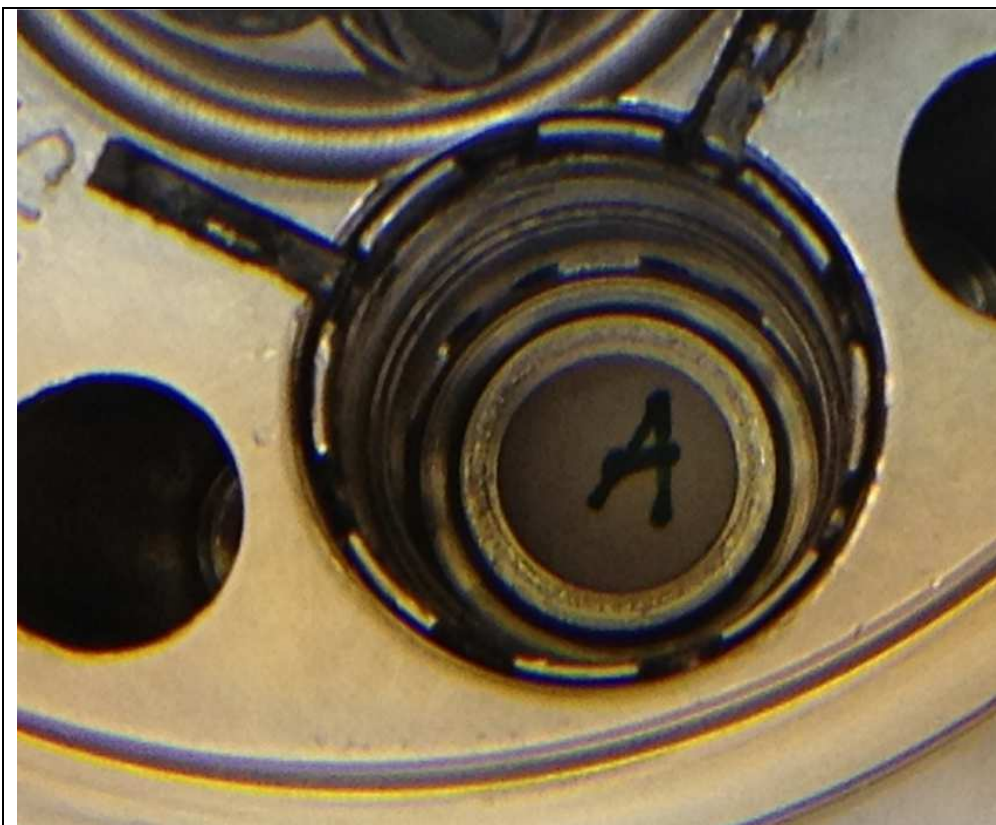
Damper S/N 1660B Valve seat - Traction

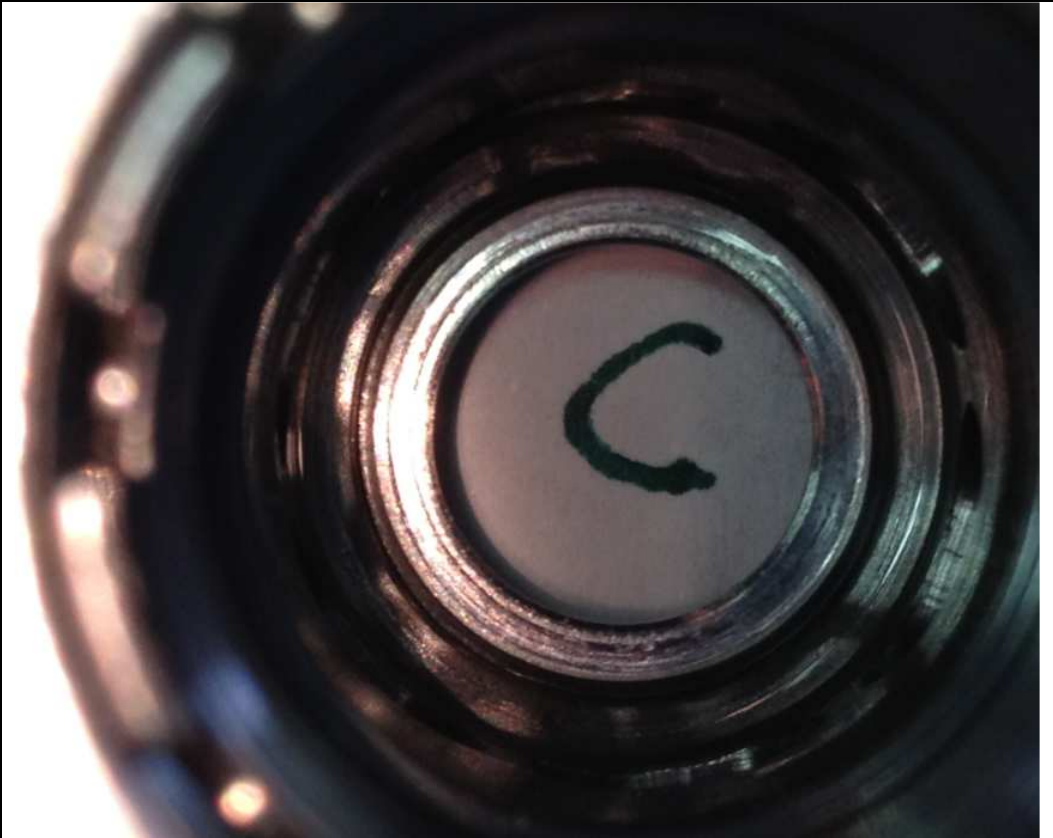
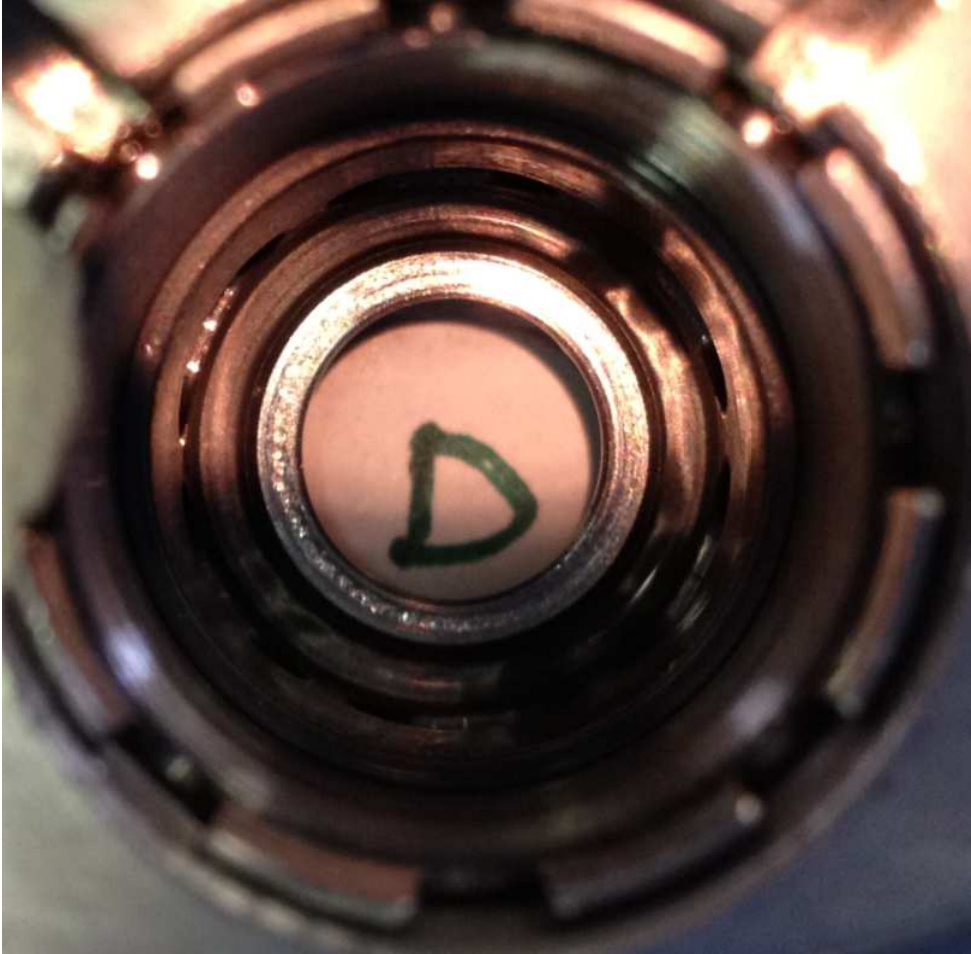
Damper S/N 1660B Valve seat - Compression

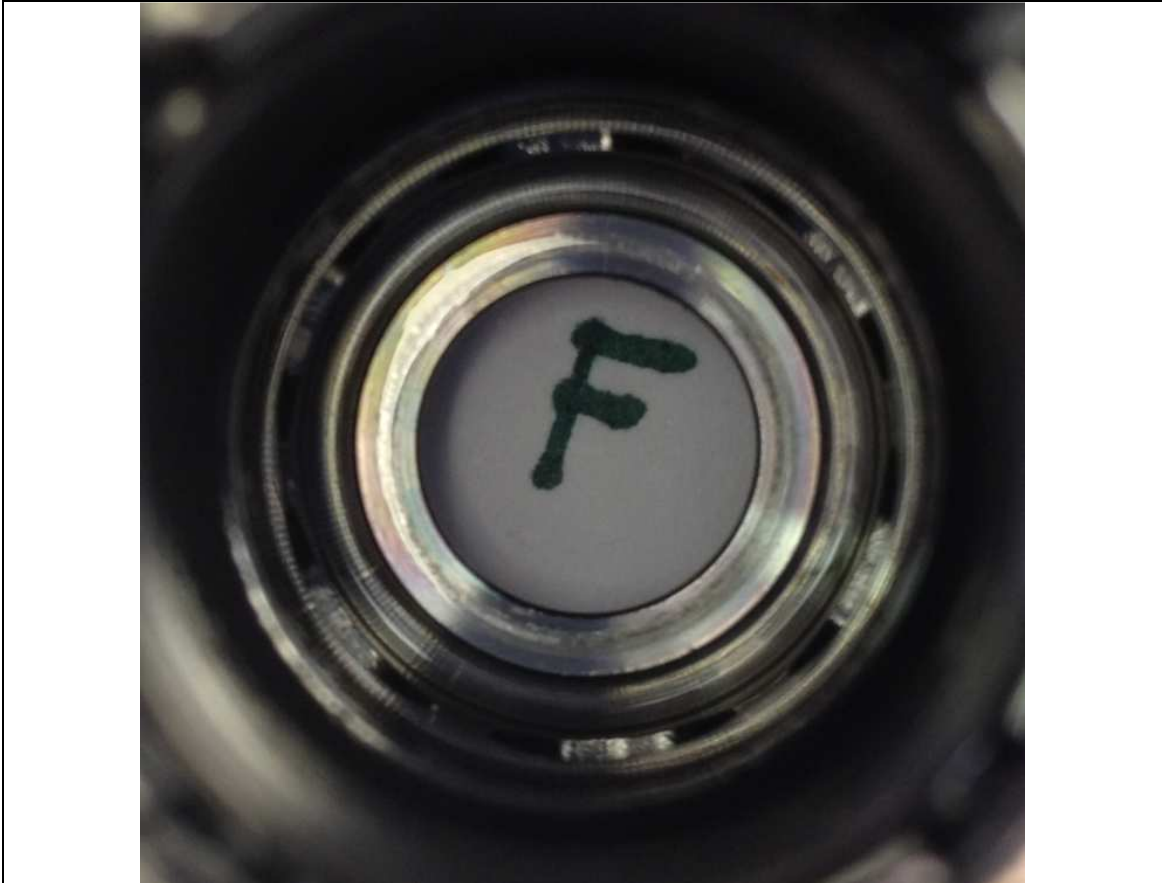
Damper S/N 1724B Valve seat - Traction

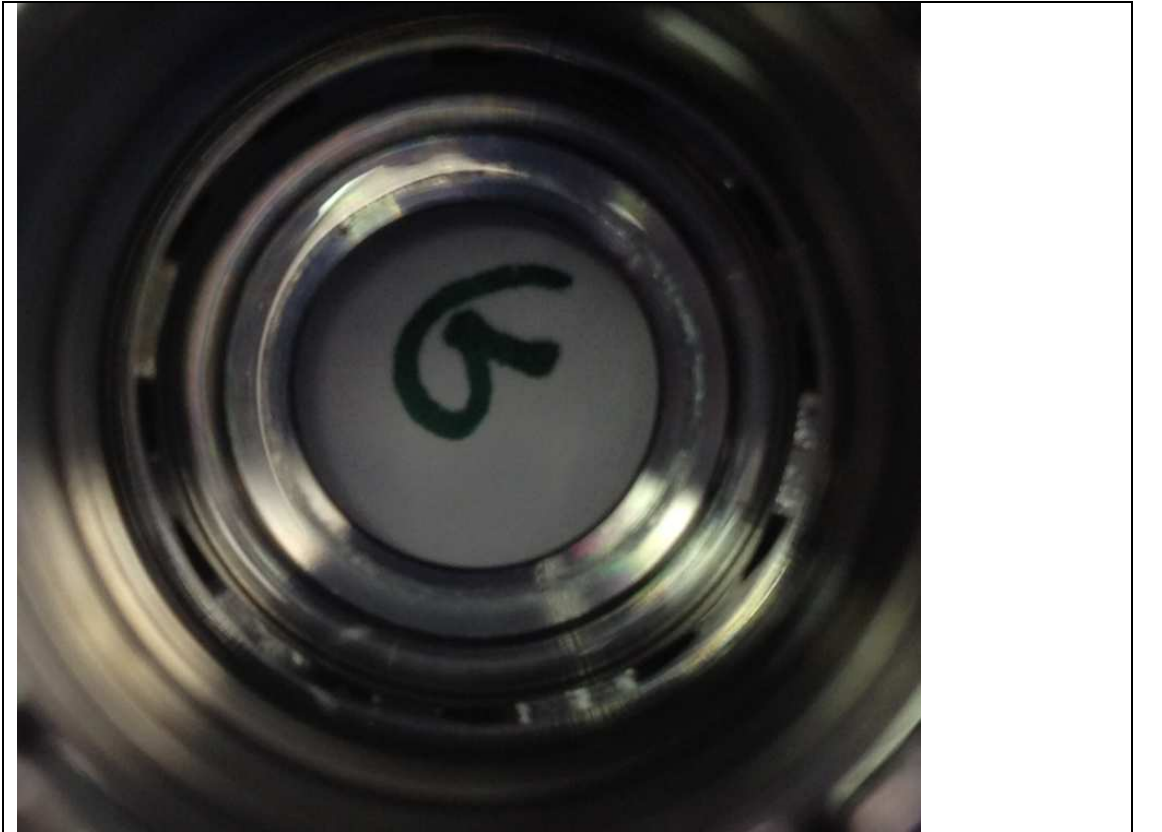
Damper S/N 1724B Valve seat - Compression

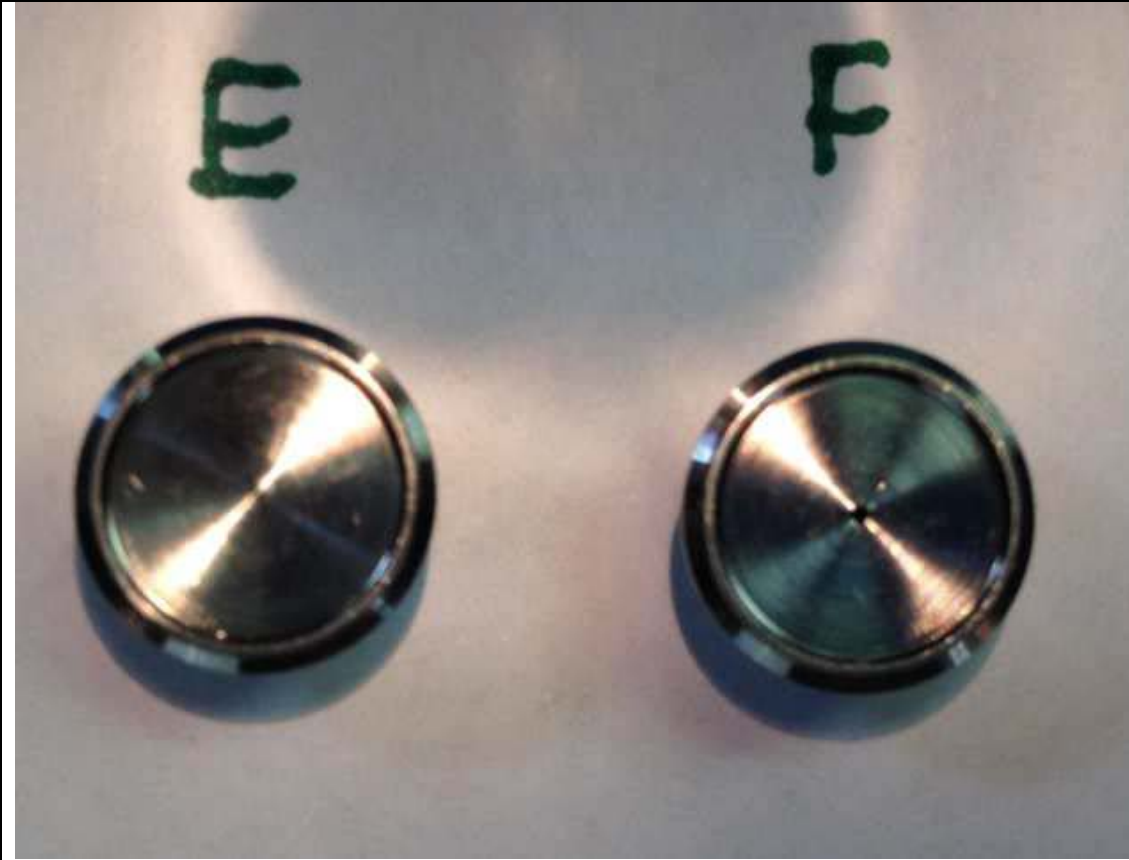
Damper S/N 1724B Valve poppets - Traction
