DCA16MR011
NJT
Collision of Train 1614
Hoboken Station
Hoboken, NJ
September 29, 2016

Attachment 5
Cab Car 6036 Alerter Test Report

<i>Alerter Indicating Panel and Controller Functionality Testing Report</i>
Report Type:		
Subject:		Cab Car 6036
Location:		S&I Shop
Date:		10/08/2016

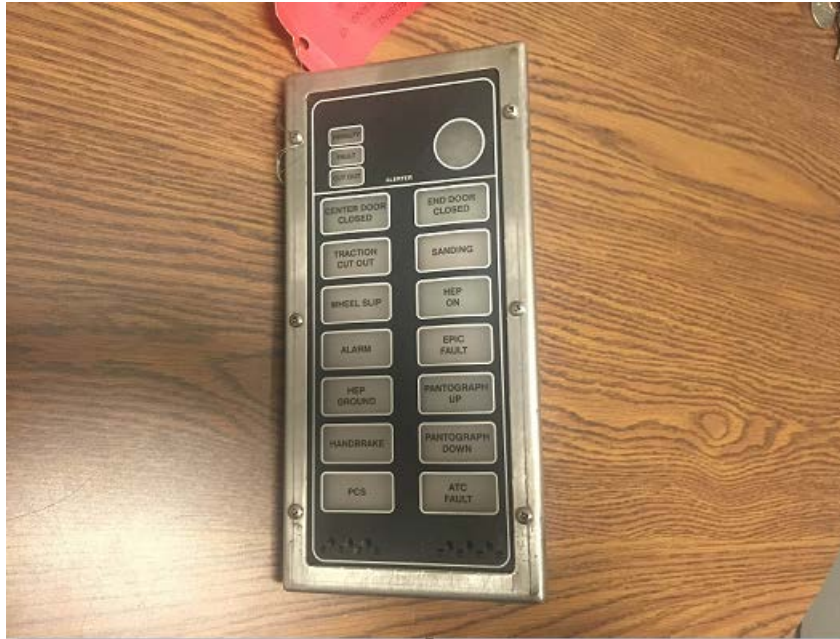
6036 Alerter Indicator Panel

During the course of testing it was discovered that the audible alarm located inside of the Alerter Indicator Panel was non-functional. To verify this, the Alerter Indicator Panel from the 6036 was replaced with a known functional panel and paired with the Alerter Indicator Control Unit from the 6036. The test was then repeated. This time the audible alarm was clearly present. From this it was determined that the fault was with the Alerter Indicator Panel and not the Control Unit.

It should be noted that the Alerter system passed all other tests and was still able to initiate a Penalty Brake Application even though the audible alarm was faulty. The fault was noted by the NTSB, FRA, and NJT, and it was agreed that further investigation into the panel was needed.

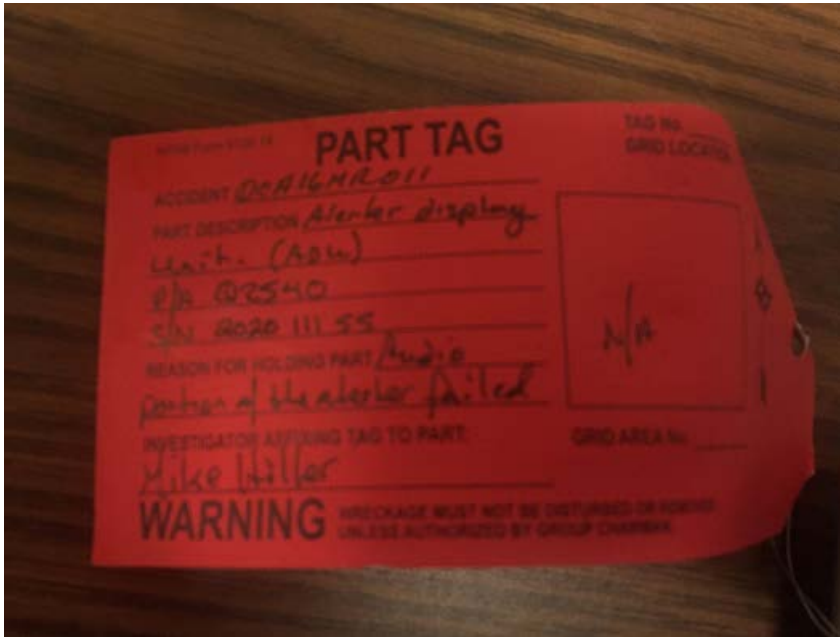
Alerter Indicator ID Tag

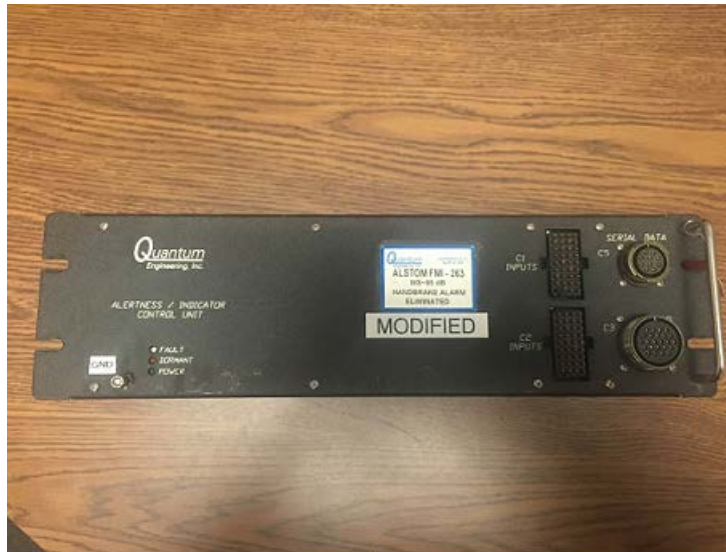
Alerter Indicator Control Unit (AICU)

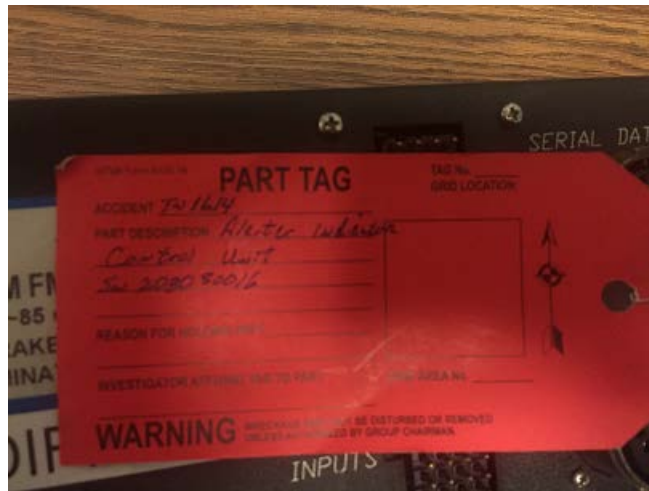
Alerter Indicator Control Unit ID Tag
