**NTSB Accident Number: DCA-12-MR-002
Class: Major**

**Proposed findings, probable cause, and safety recommendations, in connection with the
Consolidated Rail Corporation train derailment, and subsequent hazardous release with
evacuation, in Paulsboro, New Jersey.**

FINAL SUBMISSION

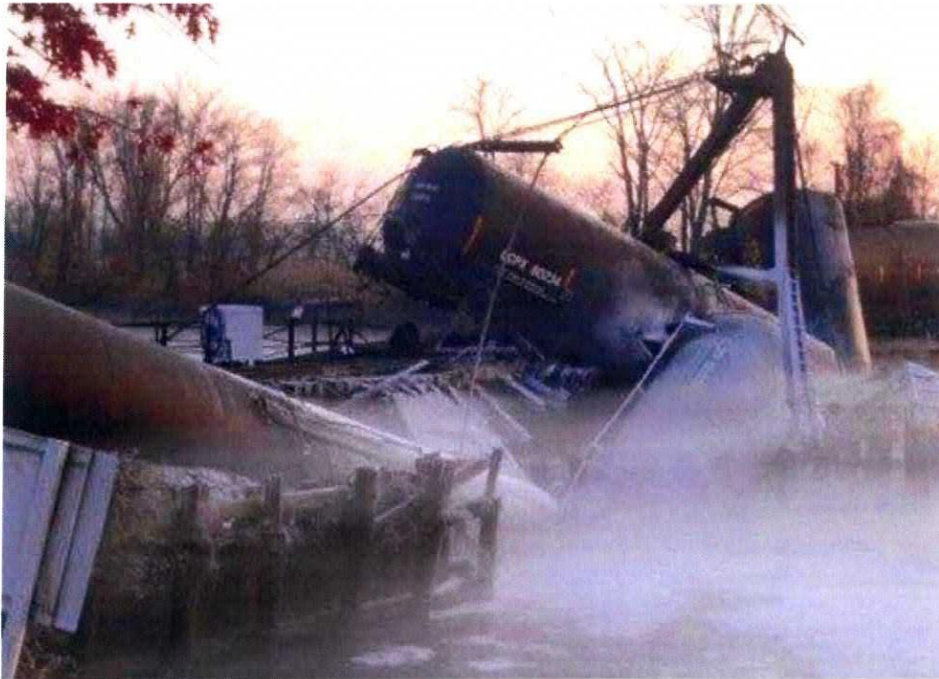
Figure 1: Derailed cars with vapor cloud

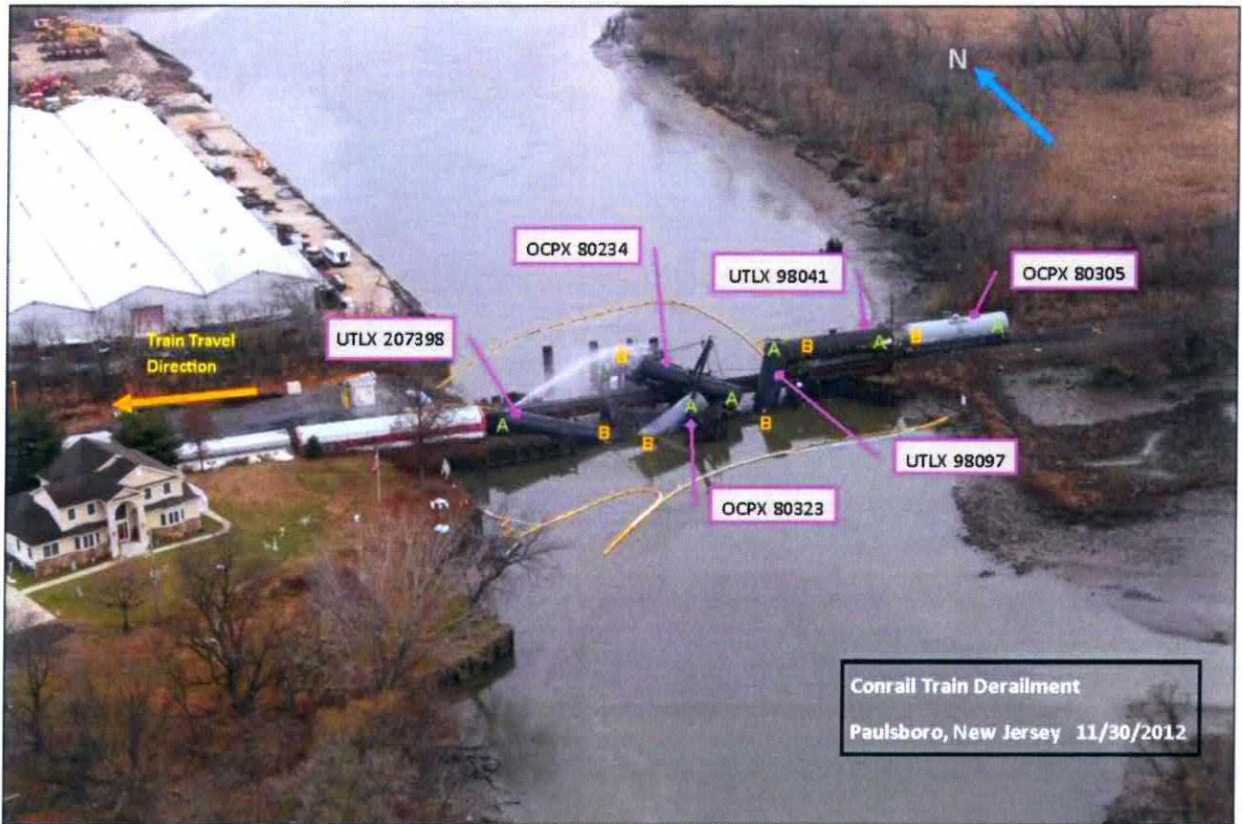
Figure 2: Aerial view of the derailment site

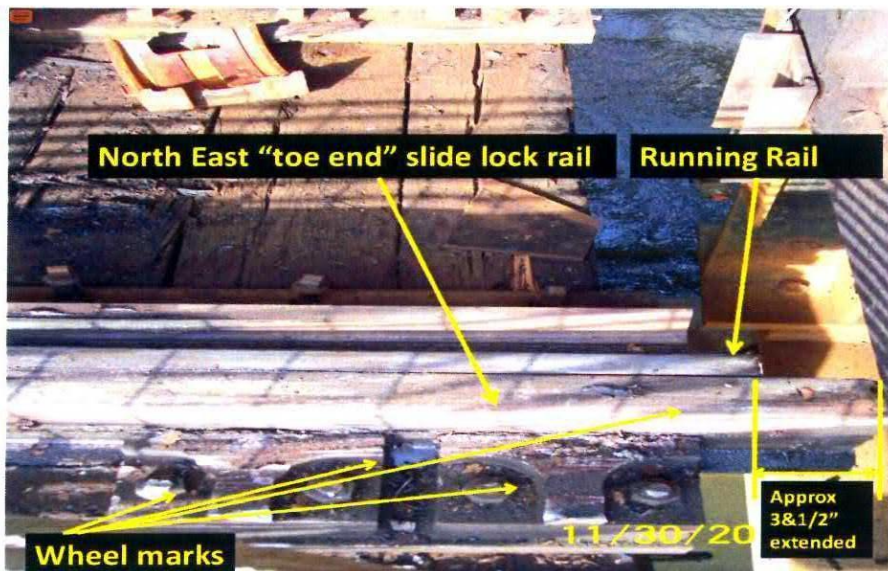
Figure 2: Bridge Slid Locks North End

It is the conclusion of the Brotherhood of Locomotive Engineers and Trainmen that the probable cause of the accident was the failure of the Paulsboro Movable Bridge to close and lock properly. It is also a contributing factor that had Conrail mandated properly trained and qualified bridge and structure personnel alone could meet the NORAC Rule 241-d requirements for a "qualified employee" in deeming a structure is secure to traverse (as Figures 2 and 3 in this report reflect), this accident would have been avoided.

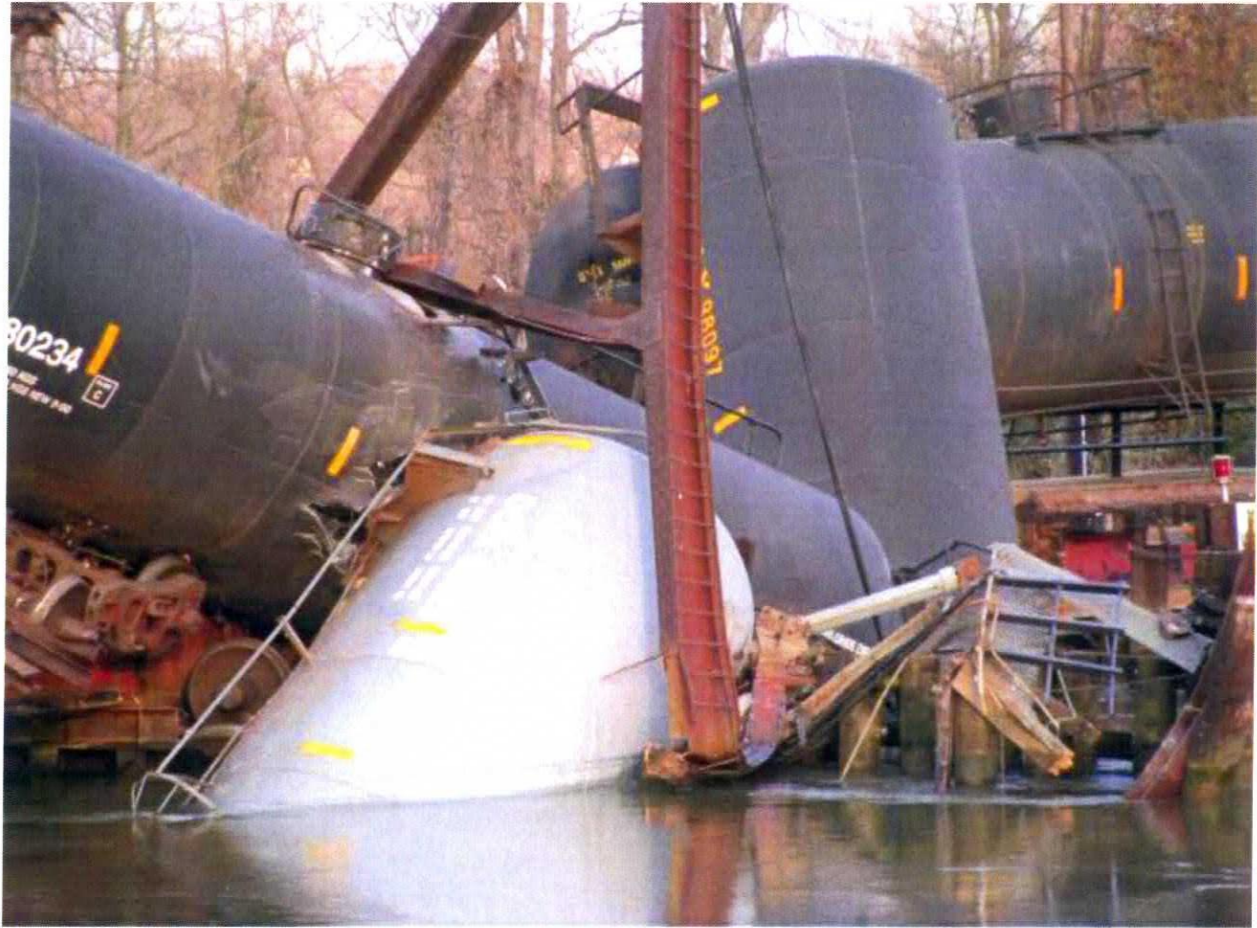
A contributing factor to the release of the hazardous material appears to have been the overloading of tank car OCPX 80323 (position 9 in the train) whose coupler and coupler shaft were found inside tank car OCPX 80234 (causing 80234 to breach and release approximately 20,000 gallons of vinyl chloride product into the atmosphere). The OCPX 80323 car (position 10 in the train) was the only car involved in the derailment which was overloaded with product (>420 gallons than other derailed hazardous material cars). The evidence suggests that this component was a contributing factor in this accident.

Figure 4: Photograph of tank car OCPX 80323 and the breach in tank car OCPX 80234
