# NATIONAL TRANSPORTATION SAFETY BOARD

## **BATTERY AND VEHICLE DOCUMENTATION** **FACTUAL REPORT OF INVESTIGATION**

A.    **ACCIDENT:**           HWY18FH013

**VEHICLE:**           2014 Tesla Model S, P85D, Florida License

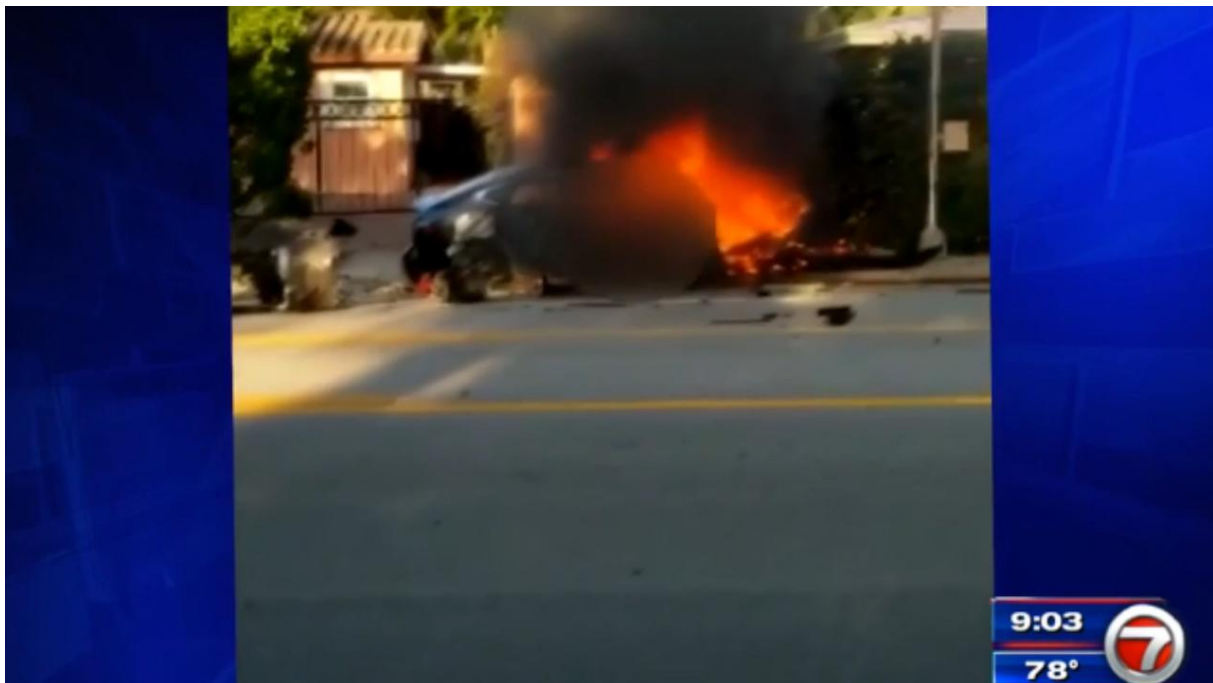
Figure 1. Still image from Florida Sun Sentinel website showing flames at front of vehicle.<sup>2</sup>

A press photo showed the vehicle in flames, apparent damage to the front right door and flames emanating from the front fender area where impact and burn damage were subsequently found to the primary 400 VDC high voltage (HV) traction battery.<sup>1</sup> An additional photo showed the vehicle interior in flames and the right front passenger door displaced. (See Figures 1 and 2)

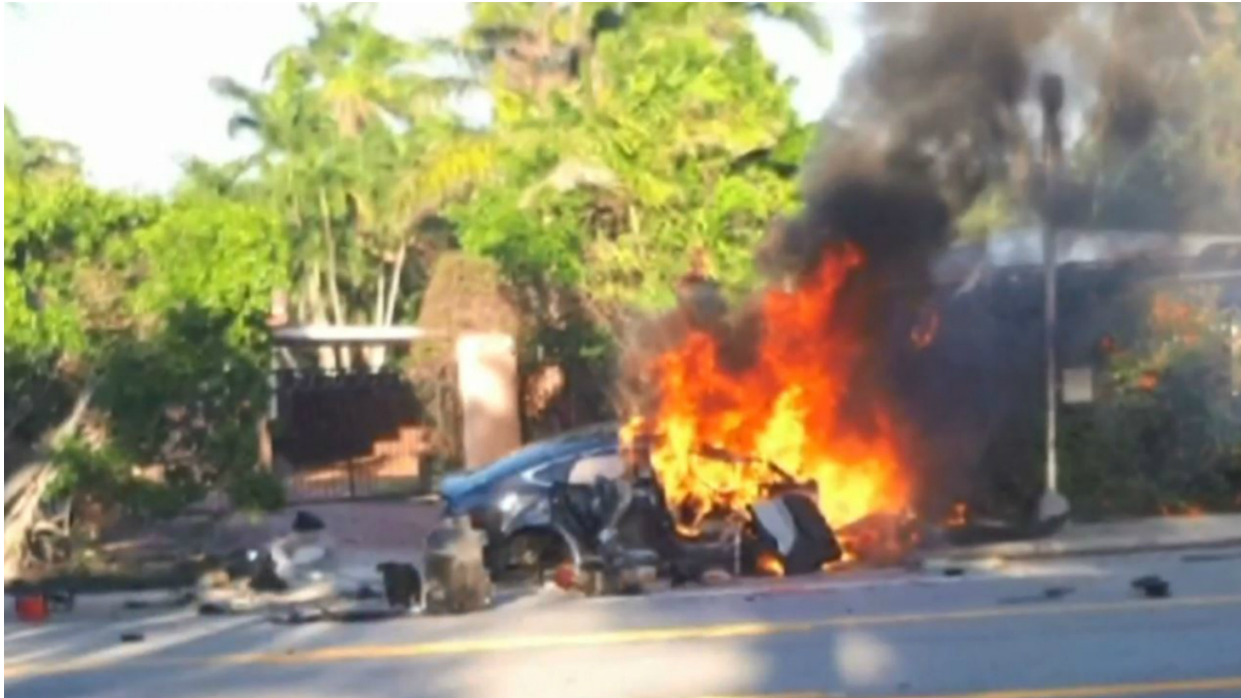
Figure 2. CBS News website photo showing vehicle interior engulfed in flames.

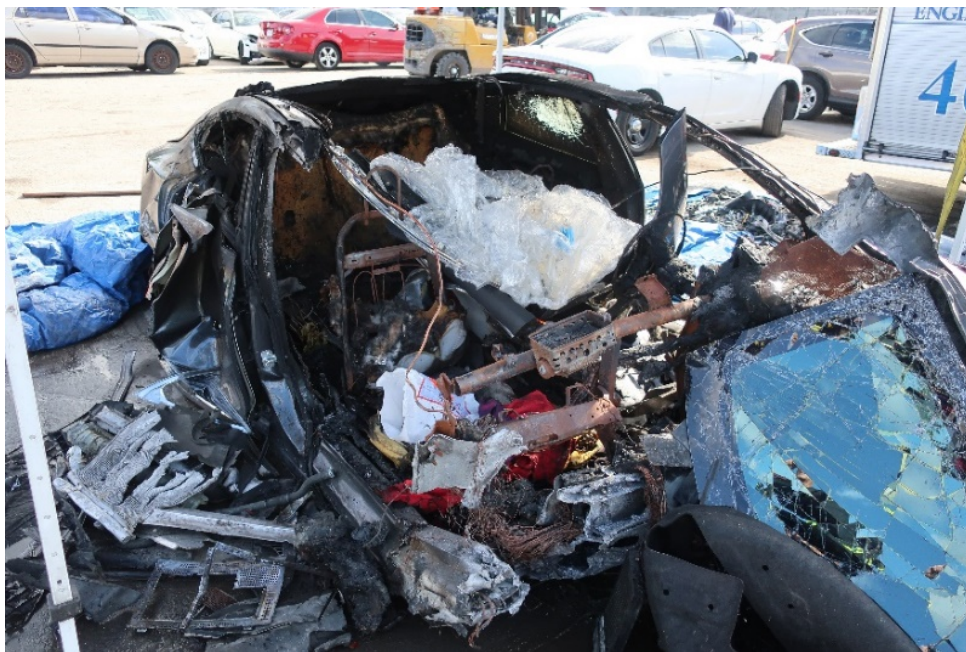
Figure 4. The overall view of right front corner.

The accident damaged the vehicle to the extent that much of the car ahead of the passenger compartment was in small fragments and/or extensively burned. The front right of the vehicle and battery had been crushed on a diagonal and the front of the bottom right passenger doorframe was bent upward. Fragments of the 12 VDC battery, front drive motor, hood, fenders, front suspension, and supporting structure were accounted for. (See Figures 4 through 10)

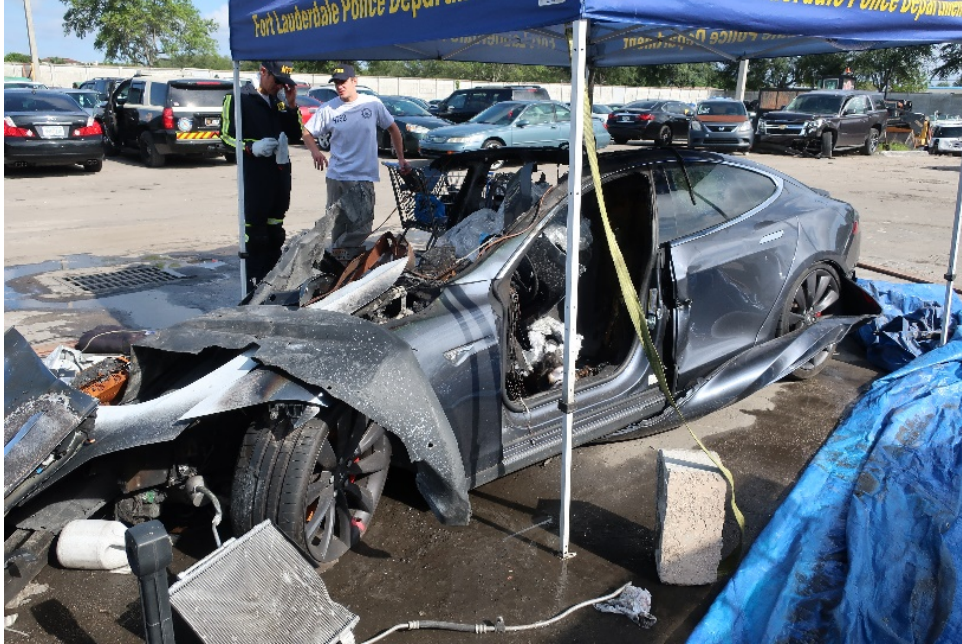
Figure 10. The overall view of the front left corner.

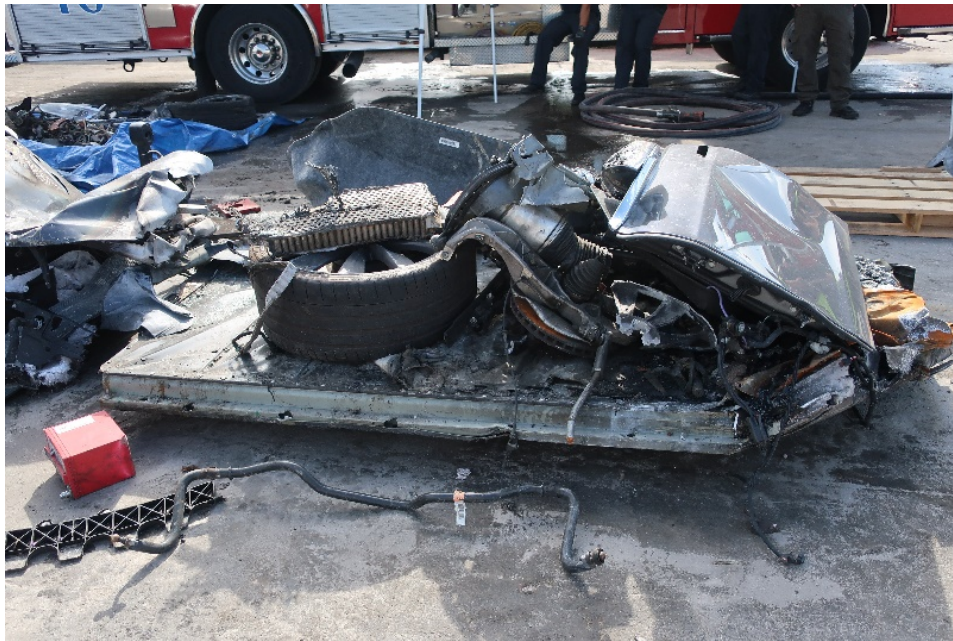
Figure 11. Right side of the 400V traction battery with debris on top. The unburned red item is the 12V systems battery.

The front drive motor and outer panel of the left front door were laying loosely on the traction battery with other loose debris. The right rear wheel/tire assembly was found on the 400 VDC traction battery, and the left wheel and tire assemblies remained attached to the vehicle. Fragments of the front right tire, loose battery cells, and small loose debris were found on a blue tarp to the left of the vehicle. (See Figures 11, 12, and 13)

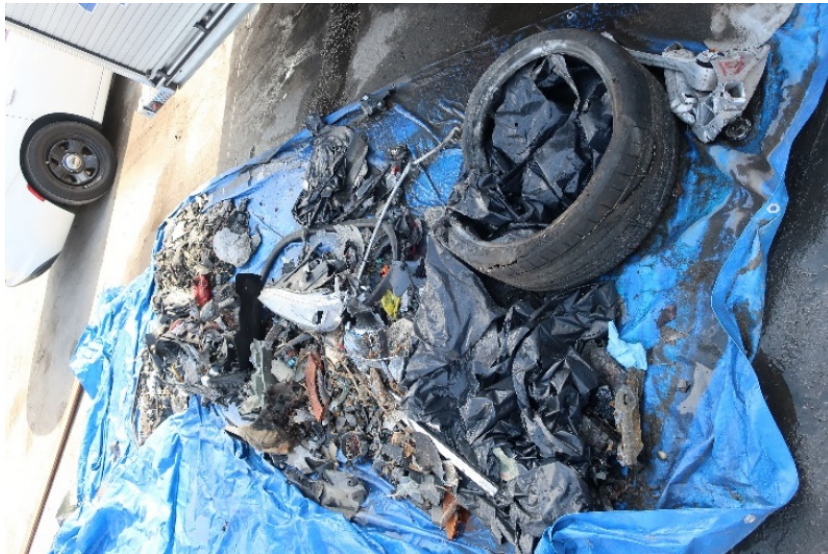
Figure 13. The torn front right tire, small debris, and loose battery cells were found on a blue tarp.

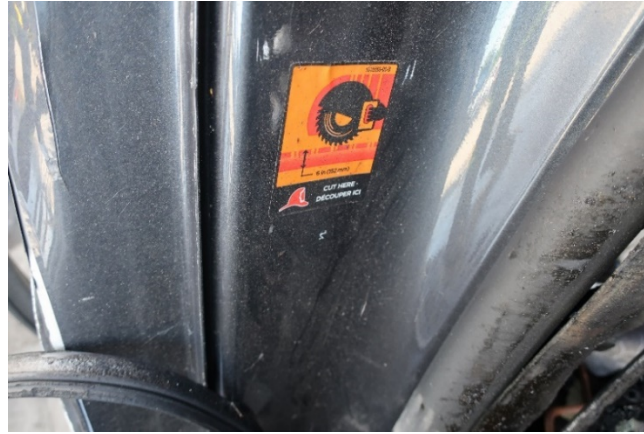
Figure 23. Circular saw sticker in right rear door frame of accident vehicle, as seen in Figure 5.

The sticker denoting the cut point was found in the right rear door pillar, not the left as shown in the ERG and QRS. The sticker calls for cutting to a specific depth to sever the circuit. Cutting the as-found location for the sticker would have left the power circuit intact in the left rear door frame. (See Figures 5, 17, and 23)

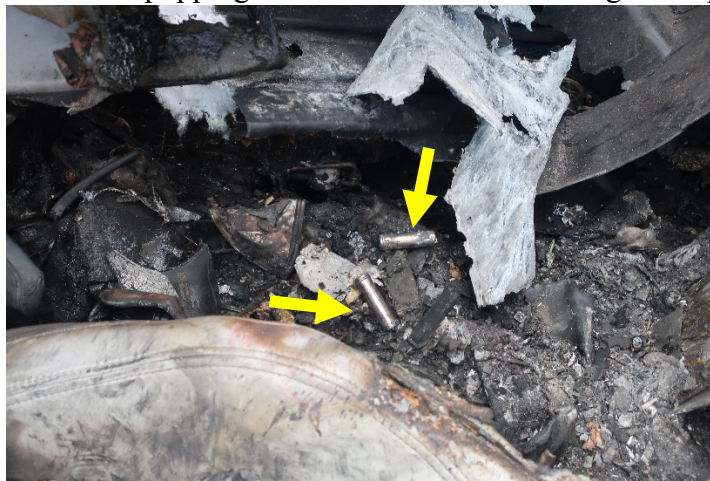
Figure 24. Loose battery cells found under the left front corner of the passenger seat. For orientation, the front of the vehicle is to the right.

Fire damage had consumed much of the passenger compartment, with the most damage and extensive melting of the structural aluminum in the right forward portion above the major opening in the battery. The front right corner of the passenger cabin was open with melted edges. (See Figures 3 and 4) Loose battery cells were found inside the cabin on and near the top of other burned debris. (See Figure 24) Witnesses to this accident and one in San Mateo, California, (See Footnote 6) had described popping after the accident and seeing small parts fly.

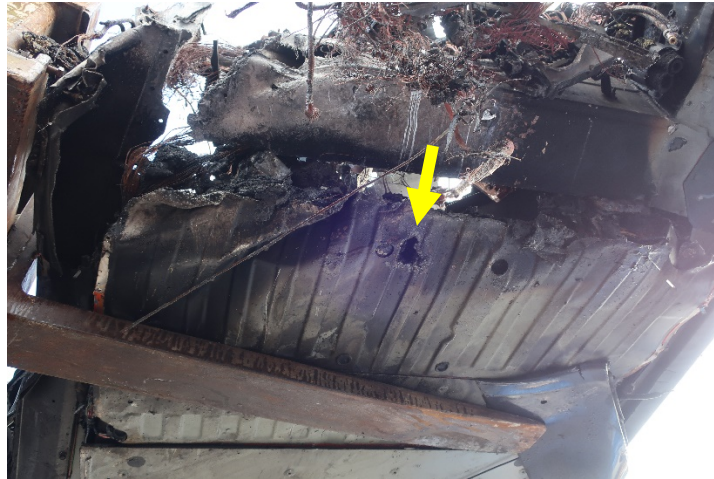
Figure 25. Bottom of passenger cabin, showing hole melted in floor of passenger footwell. For orientation, the bottom of the photo is toward the rear of the vehicle.

Lifting the vehicle revealed a hole melted in the bottom of the passenger footwell. (See Figures 25-26)

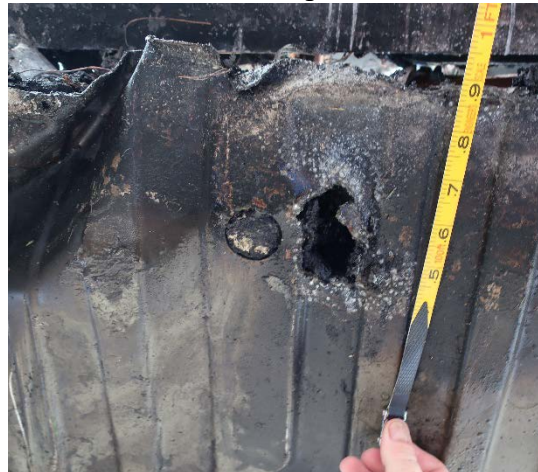
Figure 26. Closer view with scale shows the hole was about three inches in longest dimension.

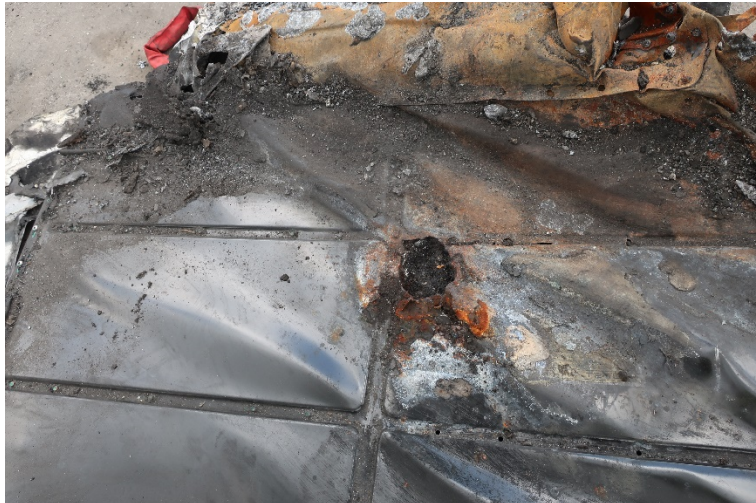
Figure 28. Closer examination found a set of oblongated holes (similar to the figure “8”) melted through the steel cover over module 11. The plastic water barrier and sheet of insulation have been removed.

Examination of the 400 VDC traction battery revealed what appeared to be an elongated single hole in the steel top of the battery case, near a major bend in the battery was found to be a set of holes. The figure 8 shape of the hole in the bottom of the passenger floorboard matched the holes in the top of the battery case.<sup>8</sup> (See Figures 27-29) The top steel cover of the aluminum battery case was removed later in the day and a high voltage connection beneath the holes was found to have been consumed. (The examination of the 400 VDC battery interior is documented later in this report.)

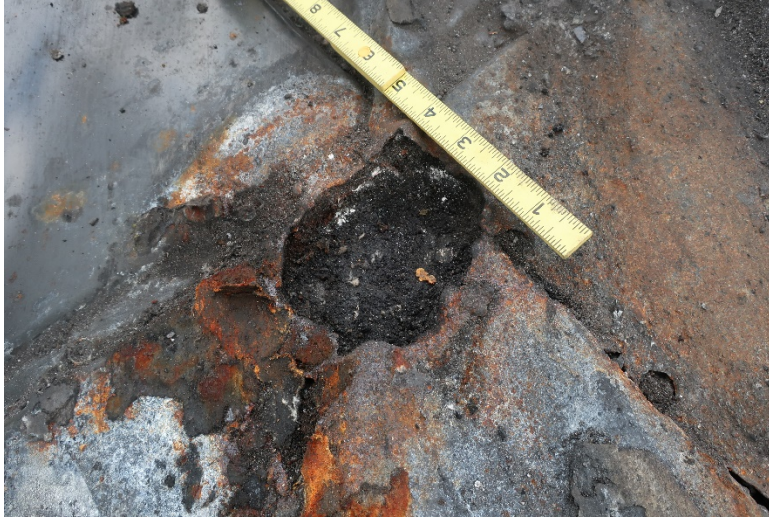
Figure 29. Close view of holes with a scale marked in inches.

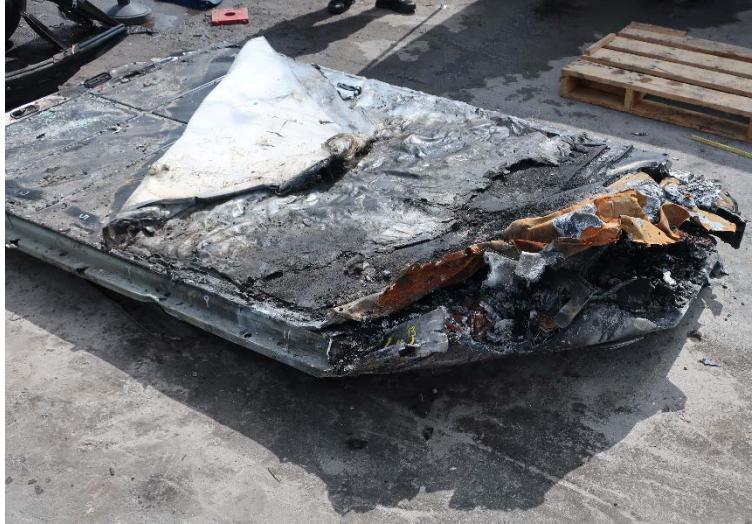
Figure 32. Twist in battery with forward right higher than the aft left.

The 400 VDC 85 kWh battery had been slightly twisted with the right front corner raised. The right front corner crushed on about a 45 degree diagonal and raised further from the rest of the battery. The steel top surface was pushed back and exhibited corrosion typical of severe heat exposure. The contents of modules 15 and 16 had been found separate (See Figure 12) and the rusted module 15/16 portion of the battery case was empty. (See Figures 32-34)

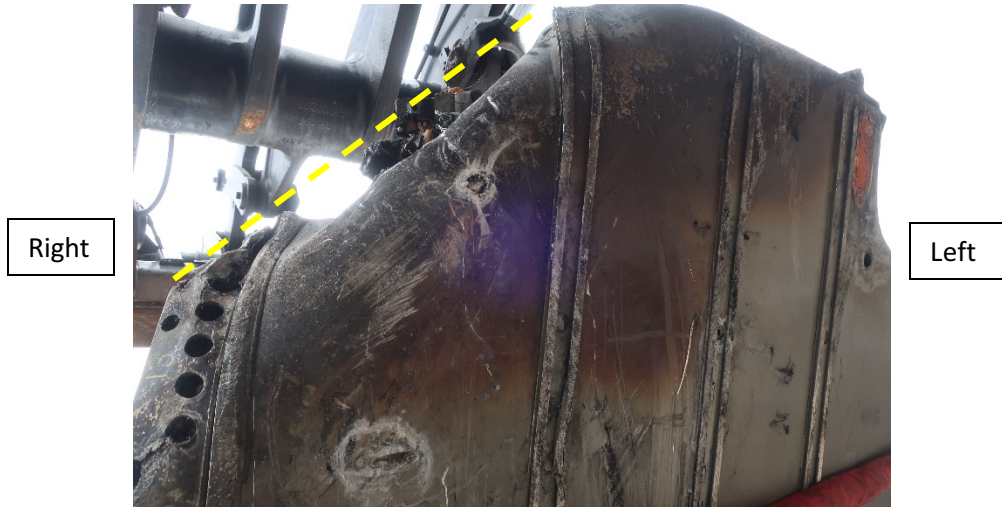
Figure 34. Looking up at the bottom of the 400 VDC traction battery with forward at the top of the photo. Yellow dashed crush line added to photo.

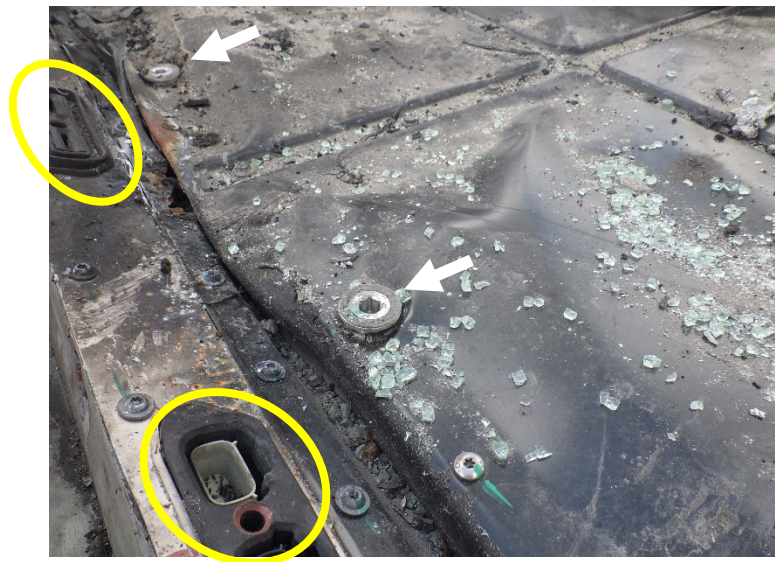
Figure 35. Two mounting bolts along the rear edge of the traction battery are shown at the arrows. (Next Figure shows closer detail of one.) The ovals show the normal battery electrical connections above the battery management system module.

Most of the battery to body mounting bolts had broken and ripped mounting material from the battery. (See Figures 35-36)

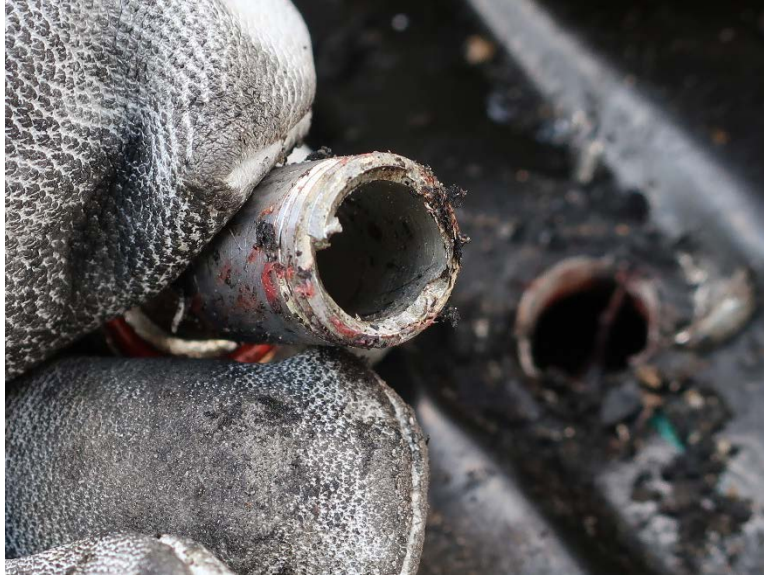
Figure 36. Fracture of a mounting bolt for the 400 VDC traction battery in gloved fingers.

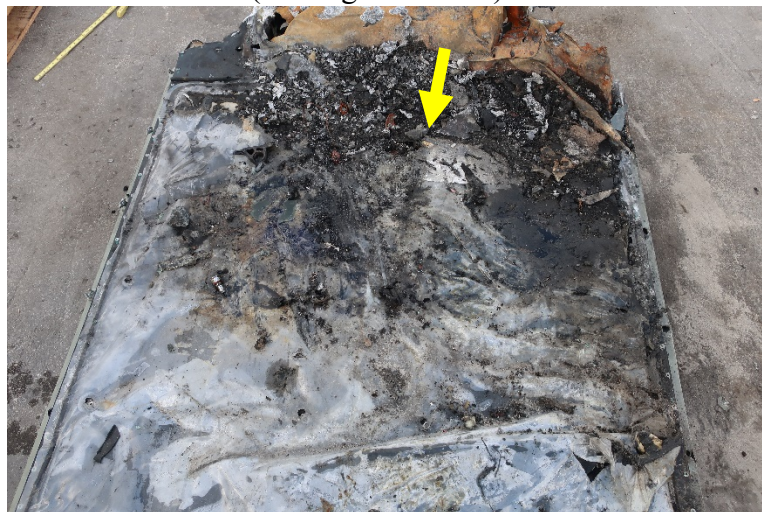
Figure 37. Insulation and plastic water liner covering forward portion of 400 VDC traction battery. The arrow points to the holes in Figures 28 and 29.

A plastic water liner and a layer of insulation covering the battery were found intact over more than half of the battery assembly. In addition to the holes burned through the layers, the set were found heat damaged on a diagonal which passed over Module 11, and were missing in the burned area over Modules 13 and 14. (See Figures 37-38)

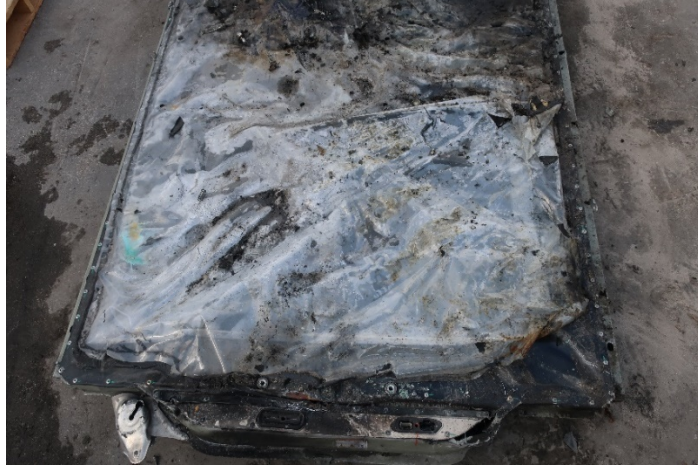
Figure 38. Intact insulation and plastic water liner layers covering rear portion of 400 VDC traction battery.

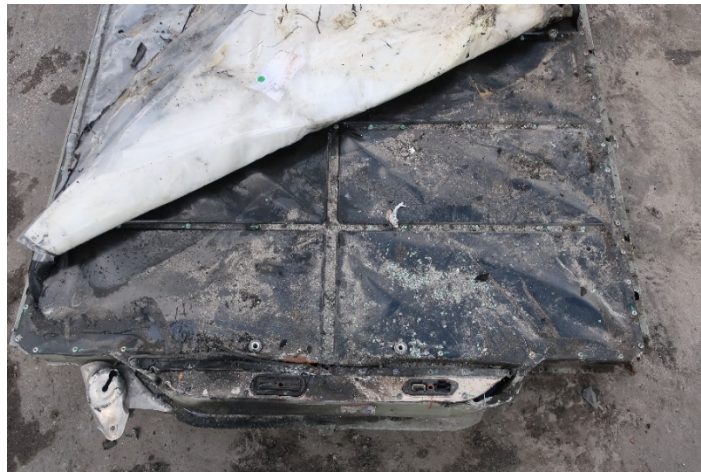
Figure 39. Rippled top steel surface of the 400 VDC traction battery after lifting insulation and water proofing layers.

When the layers of insulation and water protection material were lifted from the rear portion, ripples or buckles were found to extend across the steel top of the battery case. These were oriented aft right / forward left at greater than 0.1” in depth for each module. (See Figures 28 and 39)

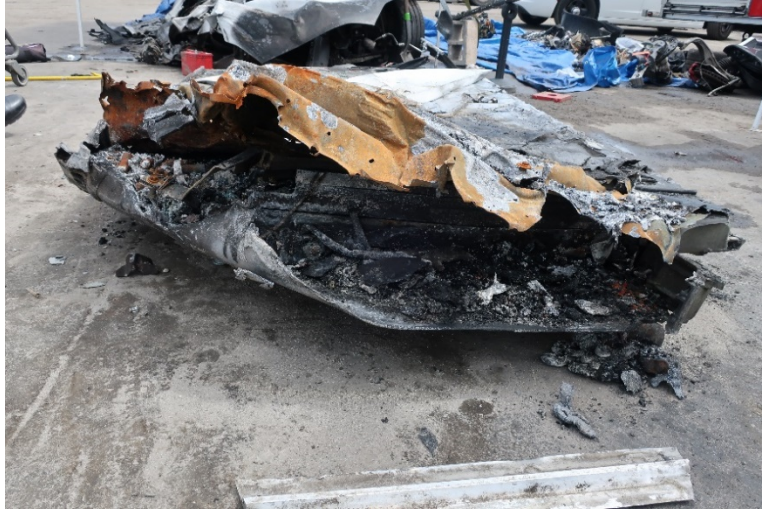
Figure 40. View from front into exposed and empty modules 15 and 16.

The rusted steel cover for module 16 had folded back over the leading edges of modules 13 and 14. (See Figure 40)

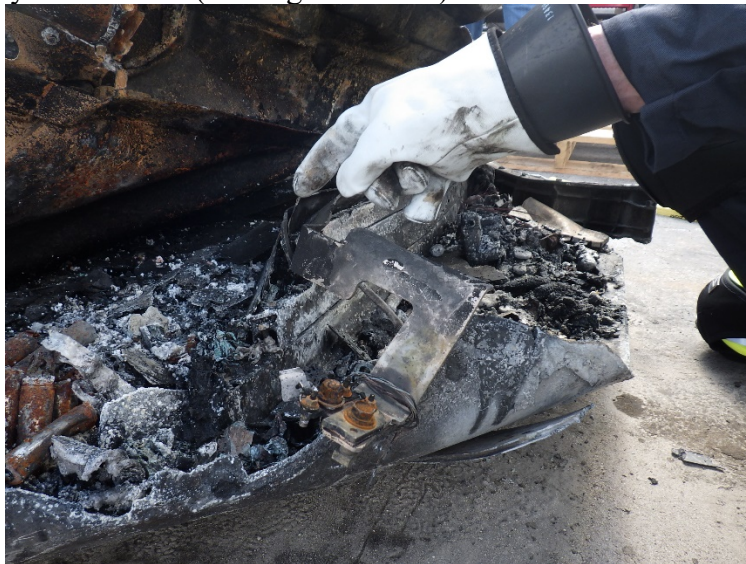
Figure 41. The photo shows the interiors of modules 13-16 after lifting the rusted battery case cover was lifted. The flat metal beneath the hand is a bus bar.

The front of the rusted cover was lifted by hand to expose the interior forward features of the battery. Two exposed bus bars extended from module 14 across the leading edge of module 13. Voltage measurements which were taken for residual energy and continuity found 0 VDC and no resistance between each bus bar to the aluminum traction battery case.<sup>9</sup> Despite finding no electrical resistance between each and the case, measuring between the two exposed bus bars found 2.7V. Only small fragments of the pyrotechnic fuse which had been contained in this portion of the battery were found. (See Figures 41-42)

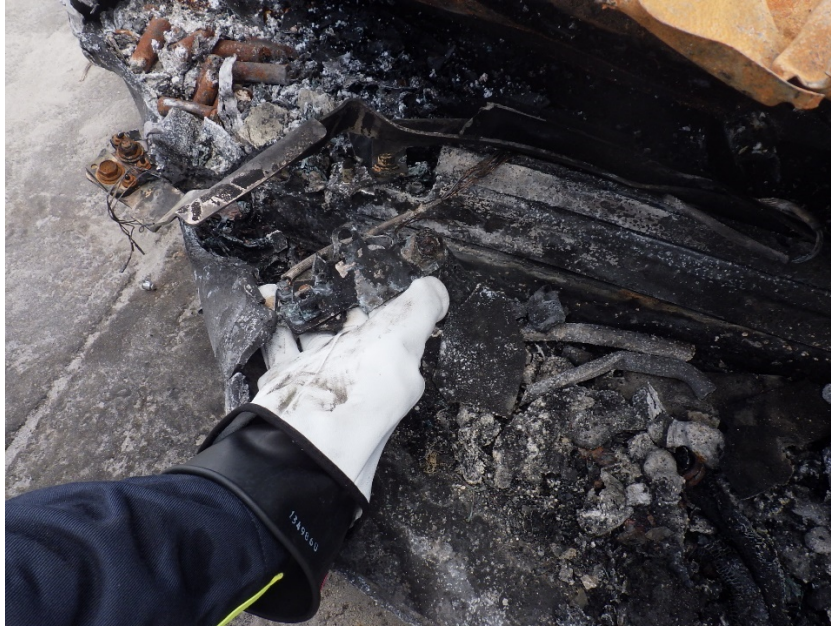
Figure 42. Remnants of the pyrotechnic fuse.

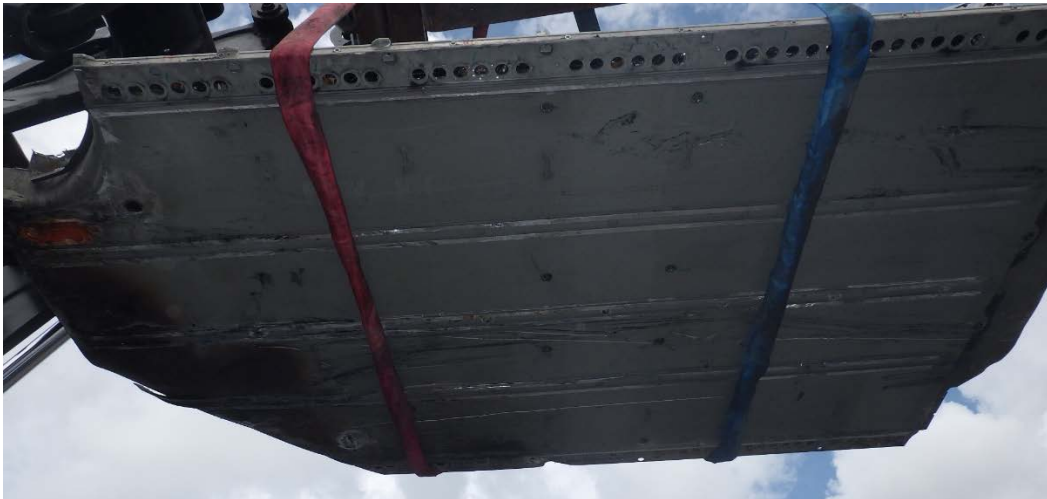
Figure 43. Bottom of the traction battery, as viewed from the left after removal of the rocker covers and vent valves.

The under-side of battery was generally flat and without local deformations, other than at least three major gouges oriented from front to rear. The right rocker cover was missing beneath module 9 and forward. (See Figure 43) The paint was browned under Module 13. There was soot present under Modules 9 and 11 (where the end of the rocker exposed the modules). The bottom of the overall battery had a slight gradual twist with the front right higher than the rear of battery. The module 15/16 orange vent grille was found intact. A burned demarcation existed between Modules 9/10 to 11/12.

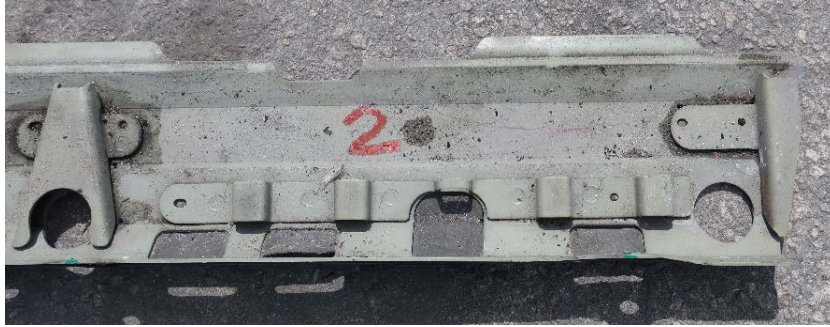
Figure 46. Rocker cover interior surface from beneath module 2.

The module 2 valves were not visibly thermally damaged. Wet tan sand-like material was found inside of each and each had a washed appearance. The color was later found to be that of the mica insulation material used in the battery assembly. (See Figure 66) Blackness existed on the outer edges (rocker cover face rather than the module face) and not on the internal features. (See Figures 44-46)

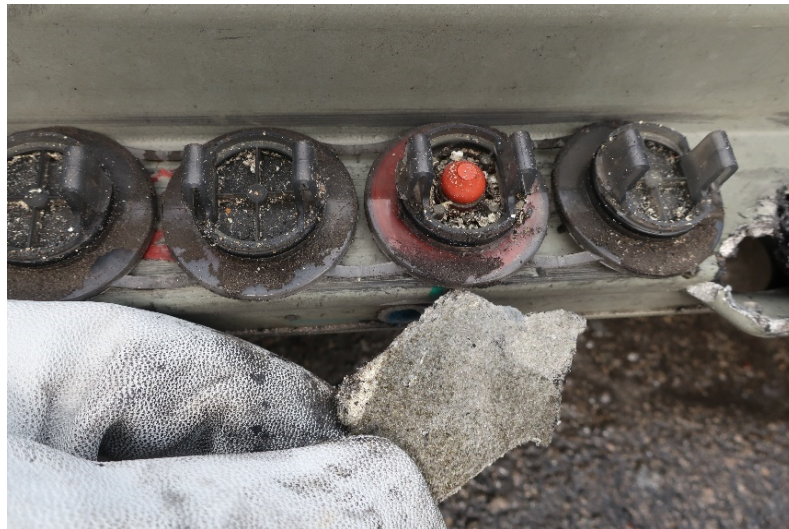
Figure 47. Module 12 valves showing larger grains of tan material and a flake of the mica-like insulation material used above and below each

The module 12 valves were removed and no water flowed from the openings. The valves did not appear thermally damaged when removed and each had a washed appearance. What appeared to be off-white dried aqueous fire fighting foam (AFFF<sup>10</sup>) was found inside the valves. Blackness existed on the outer edges (rocker cover face rather than the module face) and not on the internal features. The tan sandy material was found in larger grains. (See Figure 47)

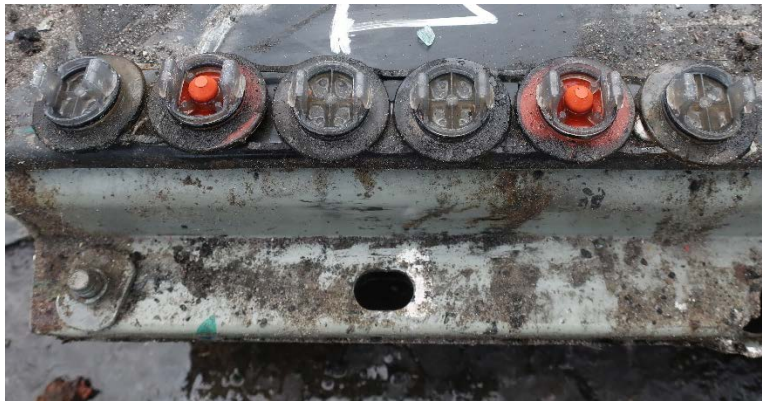
Figure 51. Module 1 valves after removal. Note extensive water on ground which was released during removal.

The module 1 valves were removed and water flowed from the openings, accompanied by a rotting smell. The valves did not appear to be thermally damaged. Little of the tan sand-like material was found inside and each valve had a washed appearance. Blackness existed on the outer edges (rocker cover face rather than the module face) and not on the internal features. (See Figure 51)

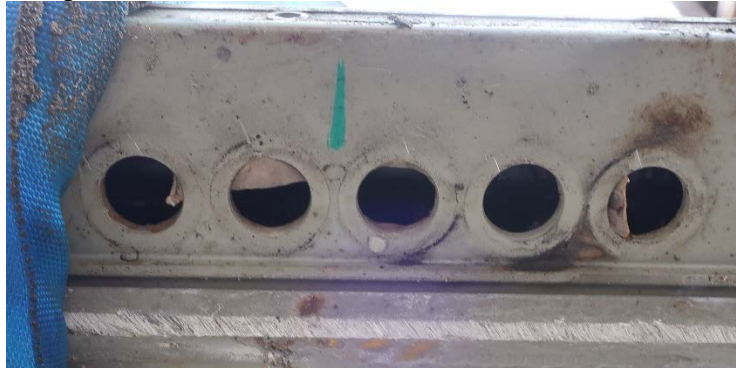
Figure 54. The remnants of internal labels partially block module 5 vent openings.

The module 5 valves were removed and water flowed from the openings. The remnants of internal labels were found partially blocking the openings when the water stopped flowing. Tan paste was found in two of the vents. (See Figures 53-54)

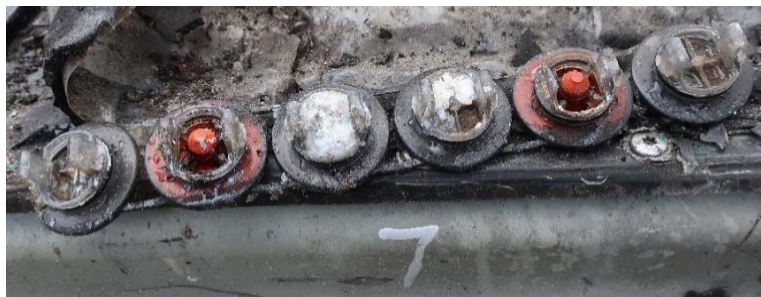
Figure 55. Module 7 valves contain material resembling nearly dried AFFF residue.

The module 7 valves were removed and water flowed from the openings. A nearly white material similar to dried AFFF was found in the valves. (See Figures 55-56)

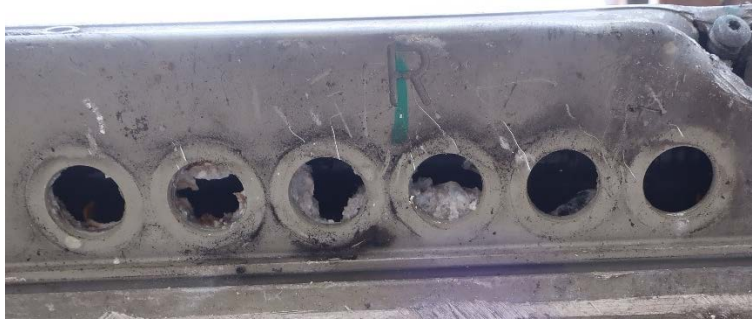
Figure 56. Dried material is visible in the open module 7 valve openings.

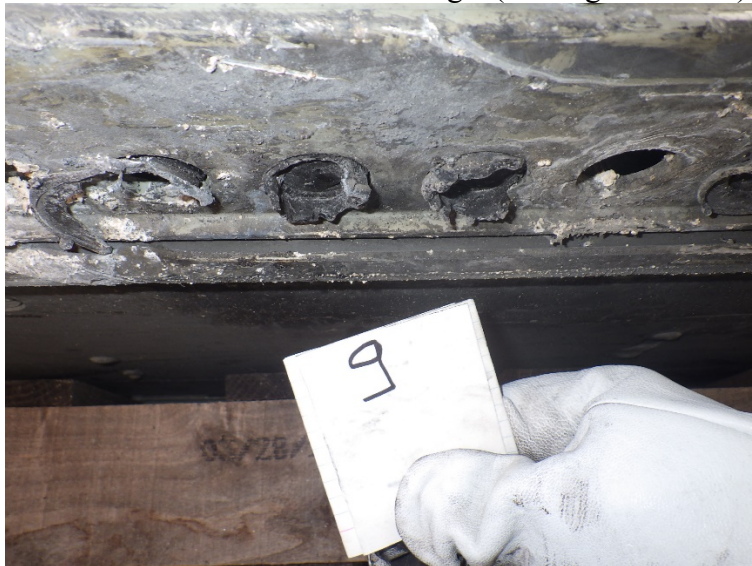
Figure 57. Module 9 valve damage prior to removal.

The module 9 valves were removed and no water was released. The module was missing two valves and had three with extensive fire damage. (See Figures 57-59)

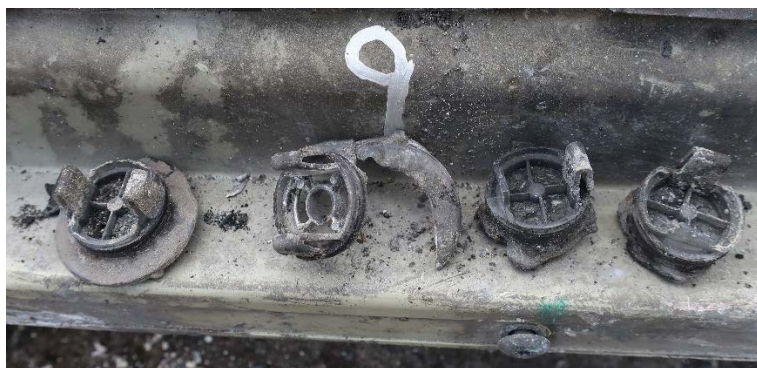
Figure 58. The four remaining module 9 valves were extensively damaged.

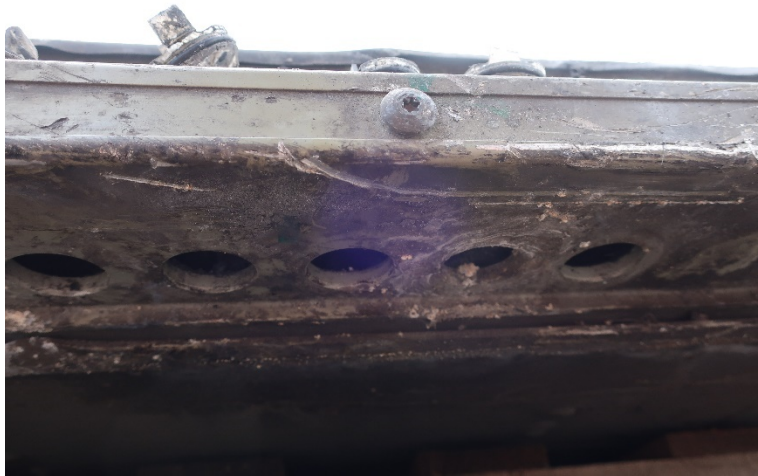
Figure 59. Module 9 vent openings.

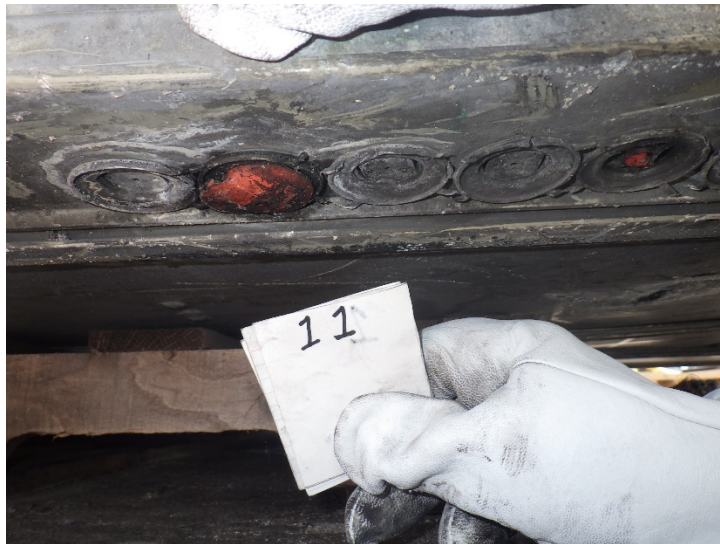
Figure 60. Module 11 valve damage prior to removal.

Module 11 contained no water when the valves were removed. The valves did not have the extent of thermal damage found to the valves from module 9. Each was found filled with fire residue and what appeared to be dried AFFF. (See Figures 60-62)

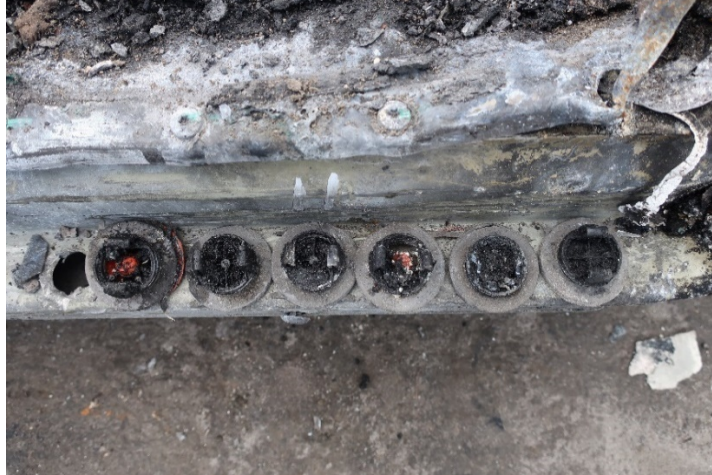
Figure 61. Module 11 valve fire residue contents.

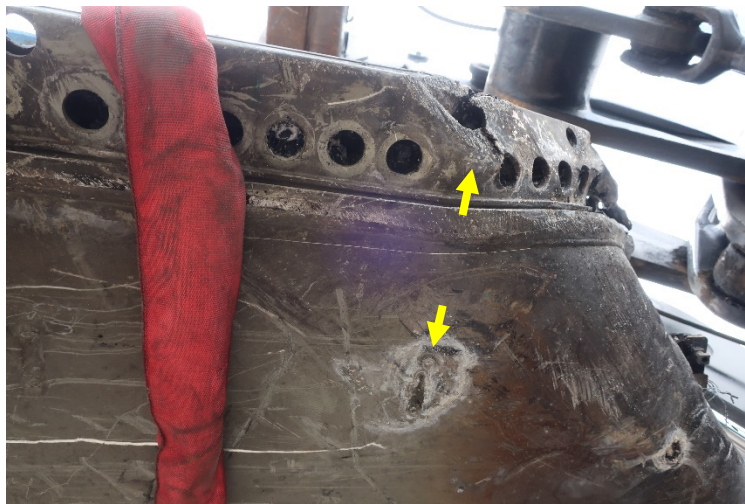
Figure 62. Module 11 vent openings. The outer edge of the buckle in the battery is along the partition between modules 11 and 13, denoted by the bolt (lower arrow) which fastens the partition internally, and spacing between the vents (upper arrow).

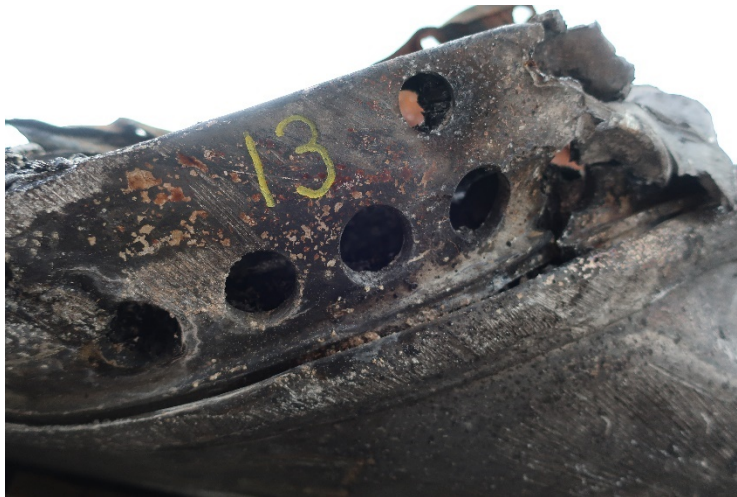
Figure 63. Module 13 vent openings.

The twisted module 13 vents contained no valves, extreme fire and mechanical damage, and fire residue. The front of the forward most opening had been destroyed and second opening was torn. (See Figure 63)

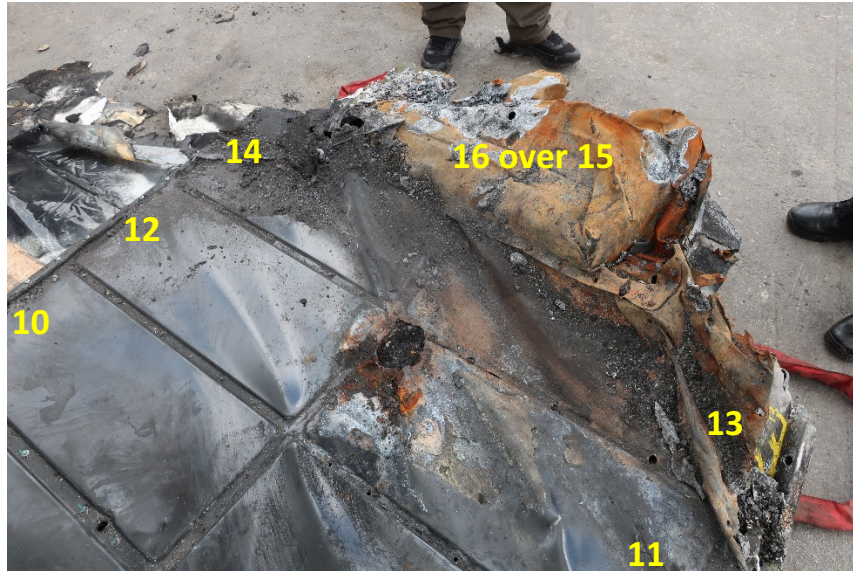
Figure 64. Forward portion of traction battery after removal of the water barrier and insulation blanket. Numbers have been added to denote modules. Note the holes at the inboard forward corner of module 11.

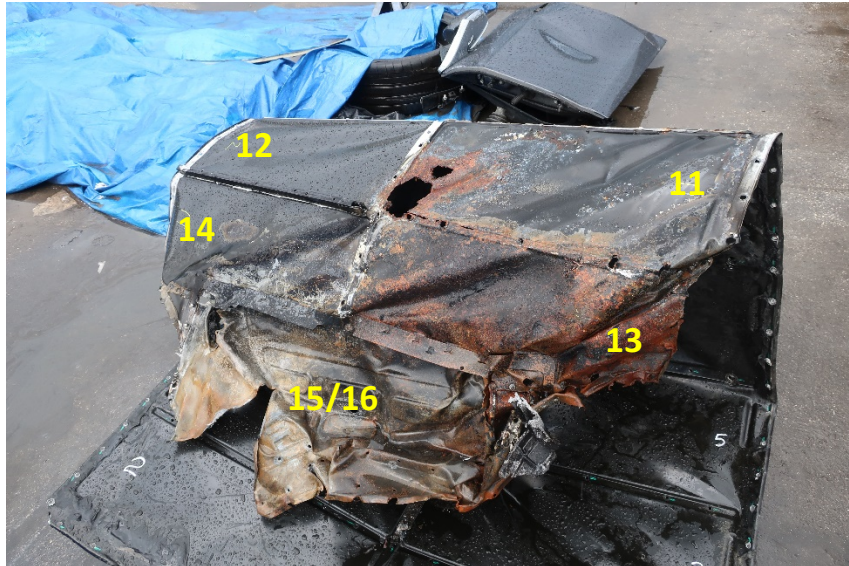
Figure 65. The inside surface of the top steel battery cover has a set of holes over where the forward terminal had been for module 11. Numbers have been added to denote modules.

The hole inside the steel top of the battery case aligned with the missing material around where the forward terminal had been on module 11. (See Figure 65)

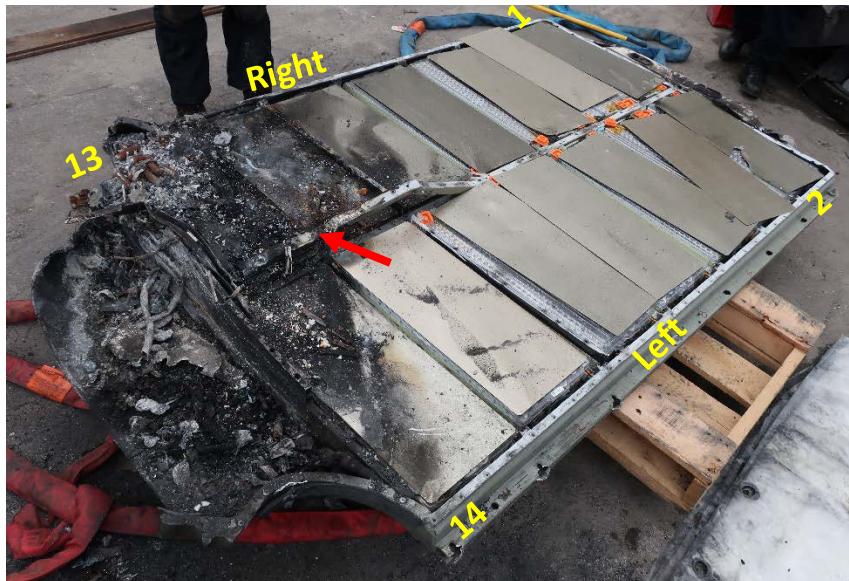
Figure 66. Mica-like sheets cover the individual modules.<sup>13</sup> Numbers have been added to denote modules. The red arrow points to the area of the missing module 11 terminal which was beneath the set of holes.

Following removal of the cover, sheets of a mica material were found covering each module. See Figures 66-67)

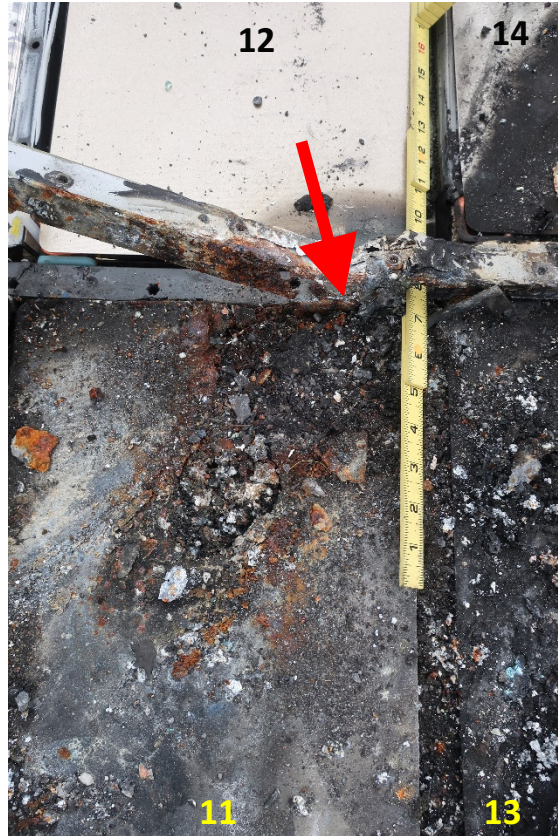
Figure 67. Close view of a hole in the mica covering module 11, the missing terminal, and surrounding damage. Numbers have been added to denote modules. The red arrow is in the same orientation as in the previous photo.

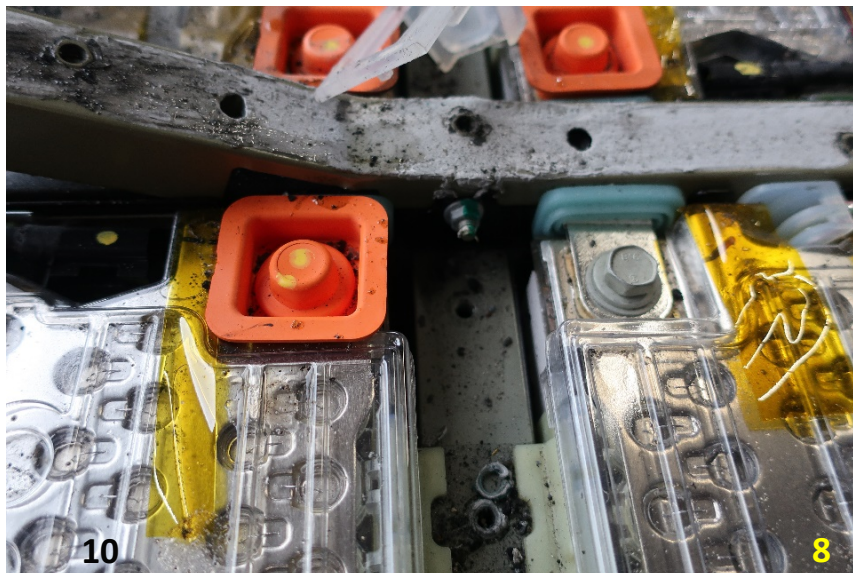
Figure 69. Clear plastic covers on each module and orange silicone-like rubber insulators were found on the terminals for each of the modules. One orange cover has been removed to show the high voltage terminal

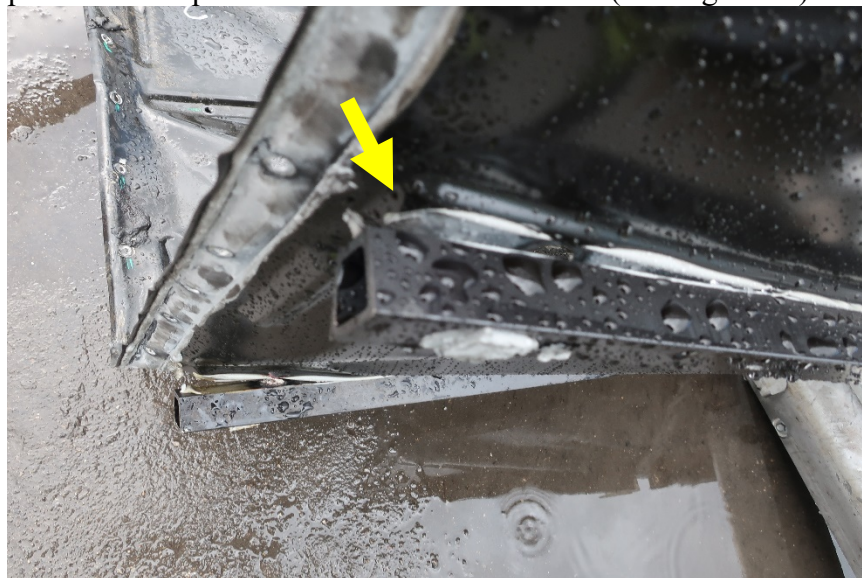
Figure 72. Outboard end of a square tube which was the upper half of a partition between modules. The arrow points to an open gap between modules. (The water visible is from a passing rain shower.)

Examination of the partitions between the modules for how water traveled through the battery found that minor passages did exist. For example, the lower half of the barriers were solid and the upper half were constructed of square tubing with gaps of up to 0.12 inches existing at the outboard ends of the tubes. Plastic clips at the inboard ends appeared to restrict inter-module communication but did not appear to be water-tight. Silicone-like material was also found between the upper and lower portions of the module dividers. (See Figure 72)

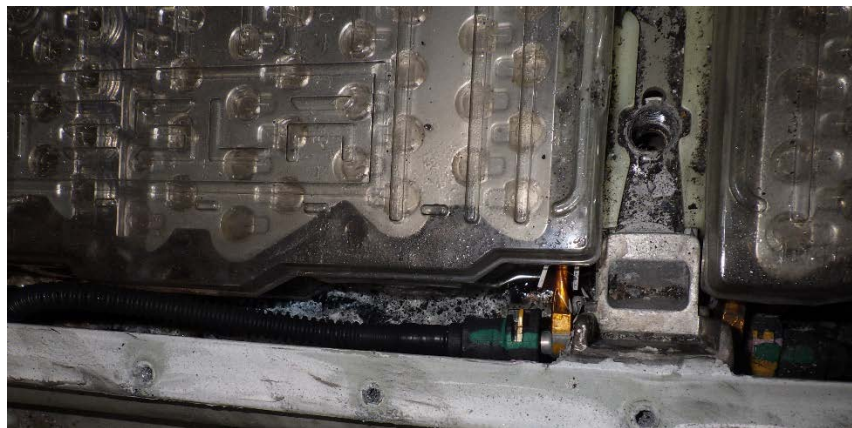
Figure 73. Outer edge of module 7, showing water droplets and light discoloration which resembled the color of dried AFFF.

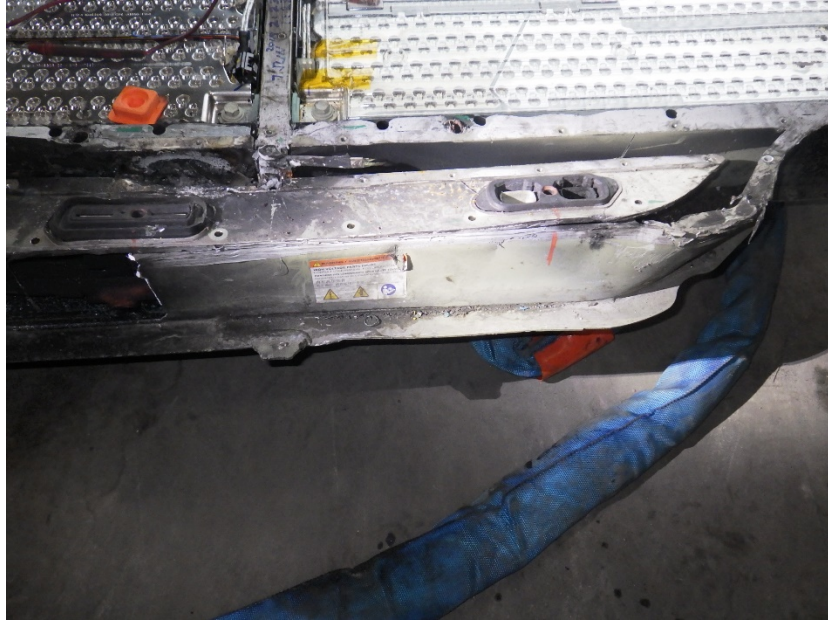
Figure 74. The BMS compartment was found with dislocated and open ends as shown. The exterior paint was had soot on the surface but was not burned.
