# NATIONAL TRANSPORTATION SAFETY BOARD

## **BATTERY AND VEHICLE DOCUMENTATION** **FACTUAL REPORT OF INVESTIGATION**

A.    **ACCIDENT:**           HWY18FH013

**VEHICLE:**           2014 Tesla Model S, P85D, Florida License

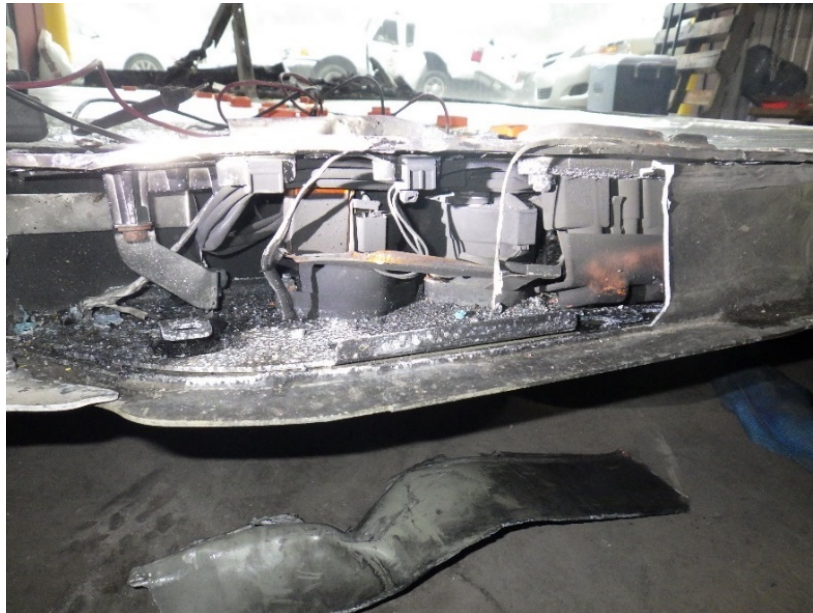
Figure 75. The end of the aluminum BMS compartment wall separated when force was used to open the top cover. This view shows the burned interior around the large contactors.

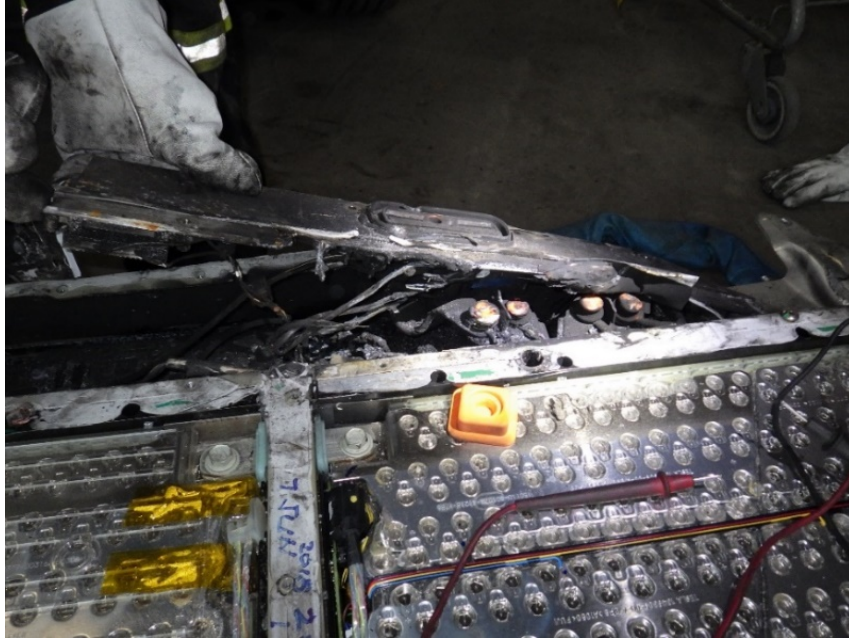
Figure 76. The burned interior of the BMS contrasted with the intact nature of modules 1 and 2.
