PRELIMINARY REPORT

HIGHWAY

HWY17MH010

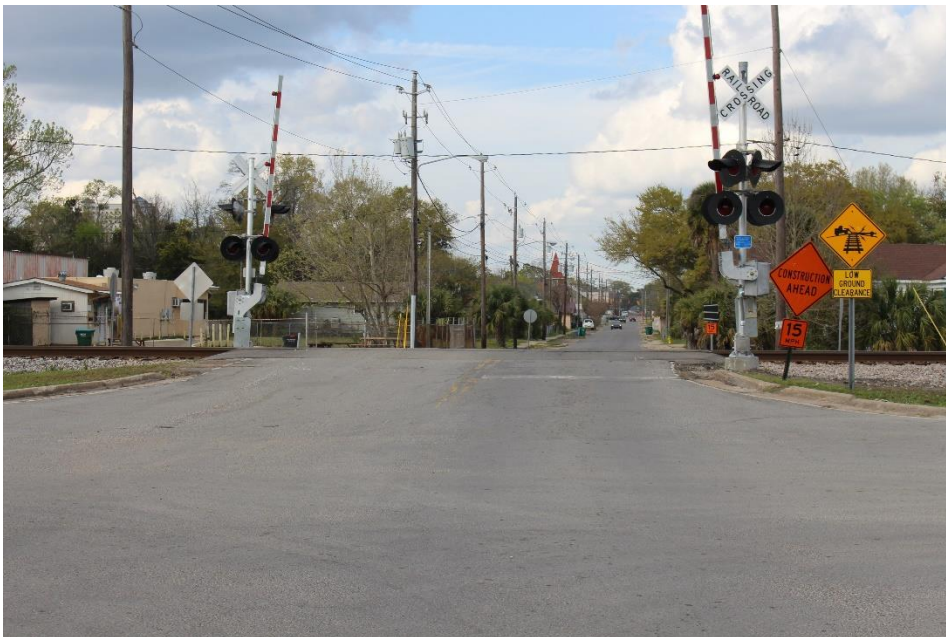
Figure 1. Northbound view of the highway-rail grade crossing at the crash site.

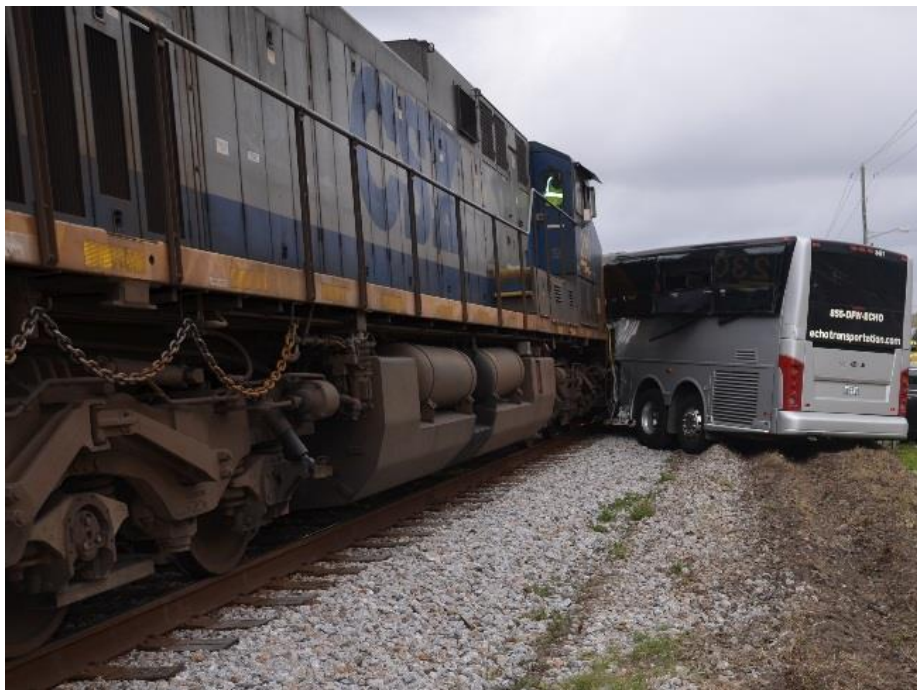
About 2:12 p.m. (local time) on Tuesday, March 7, 2017, a 2016 Van Hool motorcoach, operated by Echo Transportation and occupied by a 60-year-old driver and 49 passengers was traveling northbound on Main Street in Biloxi, Harrison County, Mississippi. The motorcoach approached and stopped in advance of a high vertical profile (humped) highway-railroad grade crossing. As shown in figure 1, the crossing was marked with 1) a crossbuck sign, 2) warning lights, 3) a gate, and 4) a low ground clearance grade crossing warning sign with a low ground clearance plaque. As the motorcoach attempted to traverse the crossing, its frame became lodged on the tracks. The driver attempted to free the motorcoach by trying to move the vehicle backward and forward. At the same time, an eastbound freight train operated by CSX Transportation—composed of three locomotives, 27 loaded cars, and 25 empty cars—was approaching the crossing at a recorded speed of 26 mph. Upon seeing the approaching train the motorcoach driver opened the entry door and told the passengers to evacuate. The train engineer sounded the train horn and put the train into emergency braking about 510 feet west of the crossing. The train had decelerated to about 19 mph when it struck the left side of the motorcoach, pushing it about 203 feet before coming to a stop with the motorcoach still engaged to the lead locomotive (see figure 2).

Figure 2. Motorcoach and train at final rest (Source: Biloxi PD)
