**NATIONAL TRANSPORTATION SAFETY BOARD**

**DCA-13-MR-002**

**BRIDGE DERAILMENT WITH HAZARDOUS MATERIALS RELEASE**

**Proximity Sensor and Micro-Switch Study**

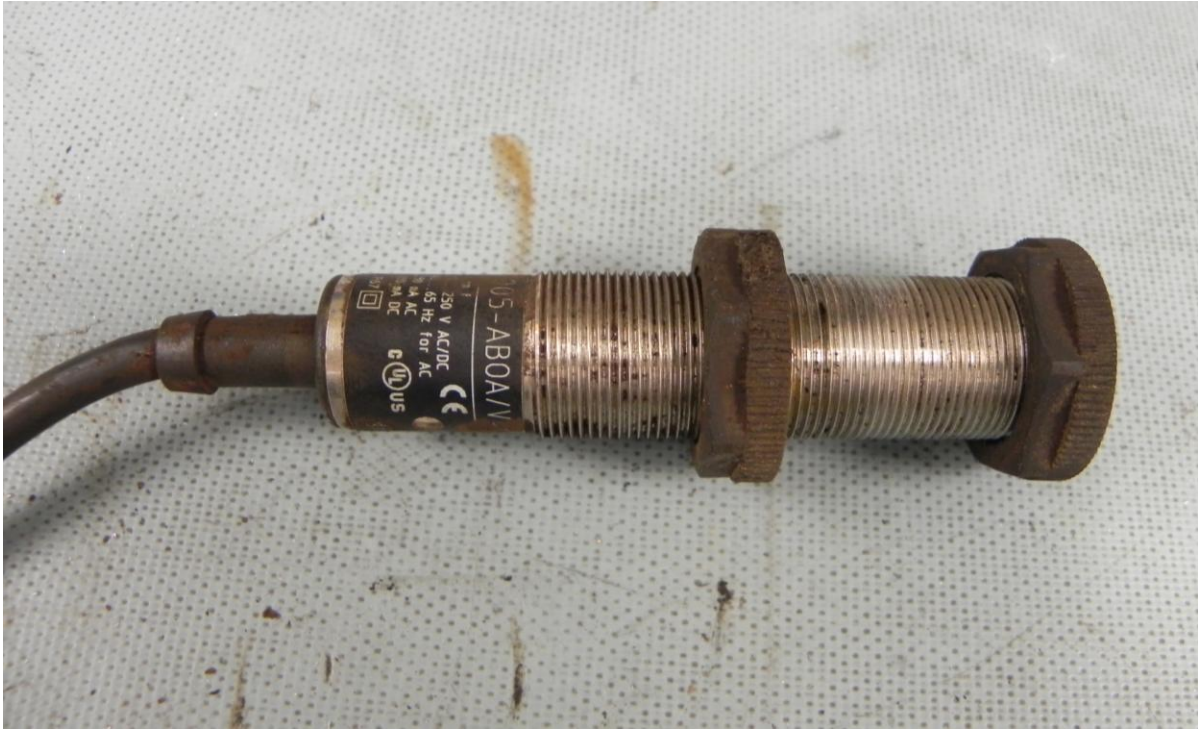
**Figure 1. Efactor® model IGO-328 inductive proximity sensor interfaced to the bridge control system and used to verify bridge closure.**

The IGO-328 inductive proximity sensors are 4-prong devices designed to be operated in several configurations. These devices were tested by applying 24 VDC in series with the proximity sensor using a 680  $\Omega$  load. The voltage across the load was monitored while a large piece of railroad steel (a mount from another proximity sensor) was brought into proximity with the head of the sensor and the distance required to obtain a response on the output was noted. One of these sensors was found to be unresponsive under any condition. The voltage across the load in this case was approximately 20 VDC. The other sensor activated repeatedly at an average distance of 5.1 mm. The voltage across the load in the closed position was found to be approximately 19.6 VDC. These parameters were all within the normal limits published for the IGO-328.

One of the IGO-328 inductive proximity sensors appeared to operate as designed and within published specifications. The other IGO-328 inductive proximity sensor failed to operate as designed, and this behavior was consistent over multiple trials.

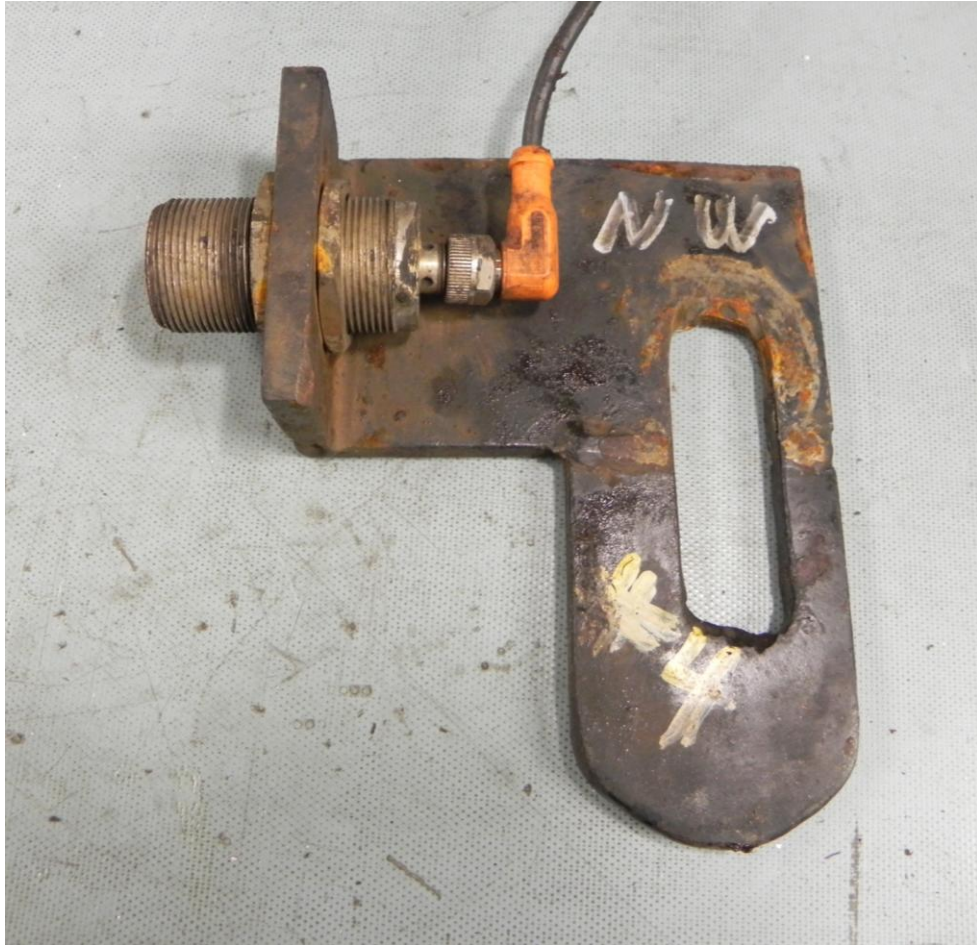
**Figure 2. Efactor® model IIM-200 inductive proximity sensor interfaced to the railroad signal system and used to verify rail slide-lock closure.**

Two of the IIM-200 inductive proximity sensors showed evidence of significant mechanical damage consistent with impact forces. The remaining two sensors appeared to be intact. Both of the IGO-328 inductive proximity sensors appeared to be mechanically undamaged. Several of the actuator arms on the mechanical limit switches showed signs of deformation and/or breakage consistent with mechanical impact forces. The switch housings for the mechanical limit switches all appeared to be undamaged.

The IIM-200 inductive proximity sensors are 4-prong devices designed to be operated in several configurations. These devices were tested by applying 24 VDC to the L+ and L- inputs to the sensor while monitoring the Output pin using an oscilloscope referenced to L-. A large piece of railroad steel (a mount from another proximity sensor) was brought into proximity with the head of the sensor and the distance required to obtain a response on the output was noted. The two mechanically damaged sensors failed to switch at any distance. One of the sensors was found to be shorted out at the power supply inputs; the other failed to activate under any condition. The two mechanically intact proximity sensors operated repeatedly and activated at an average proximity to the sensor head of 14.0 mm and 12.5 mm, respectively. In each case, the voltage at the output pin with the switch in the open position was approximate 2.3 VDC, and the voltage at the output pin with the switch in the closed position was approximate 21.8 VDC. These parameters were all within the normal limits published for the IIM-200.

In summary, the two undamaged IIM-200 inductive proximity sensors appeared to operate as designed and within published specifications. The two damaged IIM-200 inductive proximity sensors did not operate as designed.
