# Continental Motors, Inc.

## ENGINE FIELD INSPECTION REPORT

ENGINE MODEL: IO550B (4F)

EXAMINATION		ACCIDENT DATA	
Date	July 30, 2013	NTSB Accident #:	WPR13LA321
Facility	Air Transport, Inc.	NTSB Investigator:	Patrick Jones
Address	3011 W. Buckeye Road	FAA Investigator:	Troy Lent
City	Phoenix	Law Enforcement:	M. Timmons, Churchill County Sheriff's Office
State and Zip	Arizona 85009	Coroner / Medical Examiner	N/A

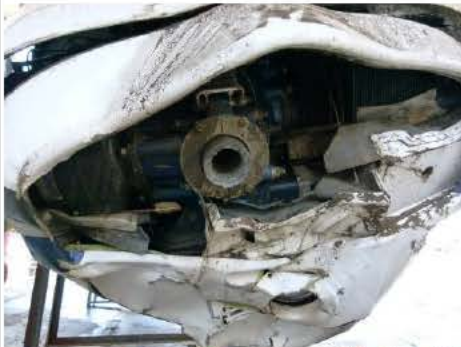
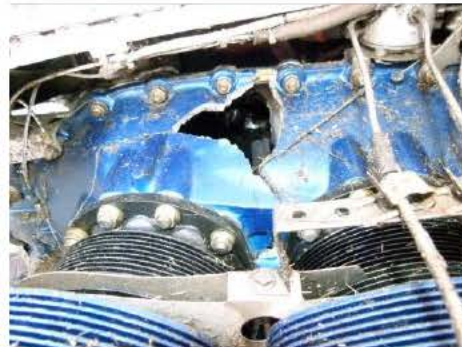
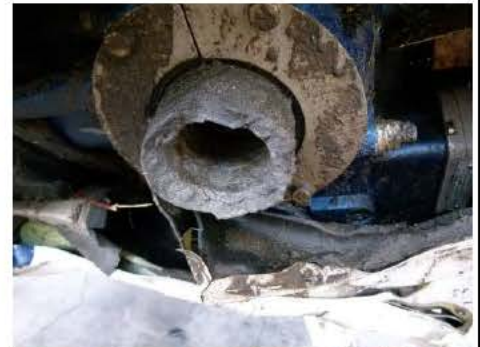
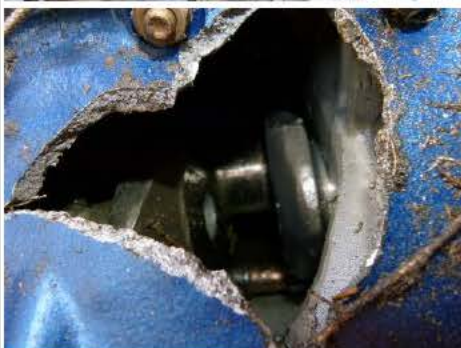
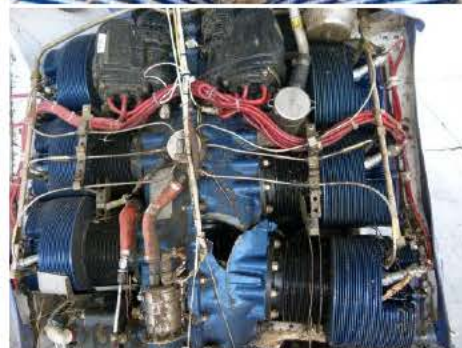
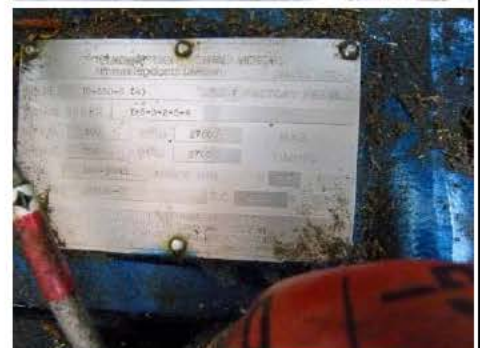
## EXTERNAL INSPECTION OF ENGINE:

The engine remained attached to the damaged airframe. A forklift was used to remove the engine and access was gained by removing the exterior cowlings.

The engine was found to have a hole in the crankcase with cylinder #5 damaged and the connecting rod missing. The # 5 crankshaft journal was visible through the hole in the crankcase. The crankcase was broken with material missing between the cylinder bases of cylinders four and six.

The engine driven fuel pump remained attached and undamaged. The engine oil pump remained attached and undamaged as did the alternator, magnetos, induction system and fuel injection system. The exhaust system remained intact with the exception of the mufflers and tailpipes which were missing. The cylinders are Superior brand aftermarket cylinders with rocker covers depicting the word "Millennium". Placards were found on each rocker box cover depicting "GAMI" fuel injector installation. The crankshaft was fractured aft of the propeller flange with jagged shear lips remaining. The propeller separated from the engine but was found near the main wreckage as witnessed by site photos.

The engine has been modified from its original configuration by addition of a Tornado Alley Turbo Normalizing System which includes an upper deck pressure system, turbo charger, turbo charger controller and overboost valve.

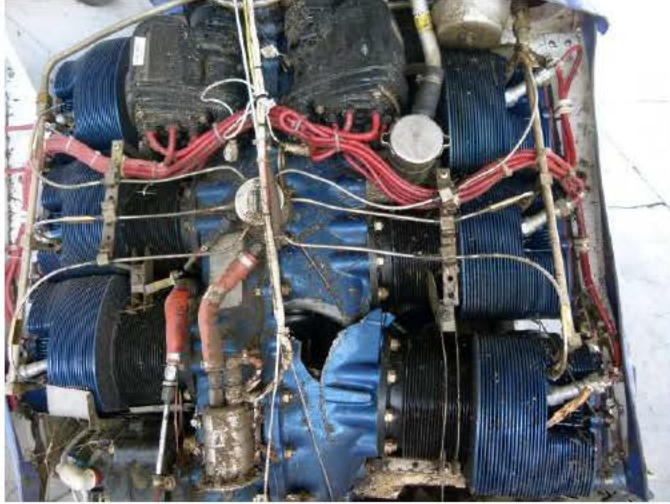
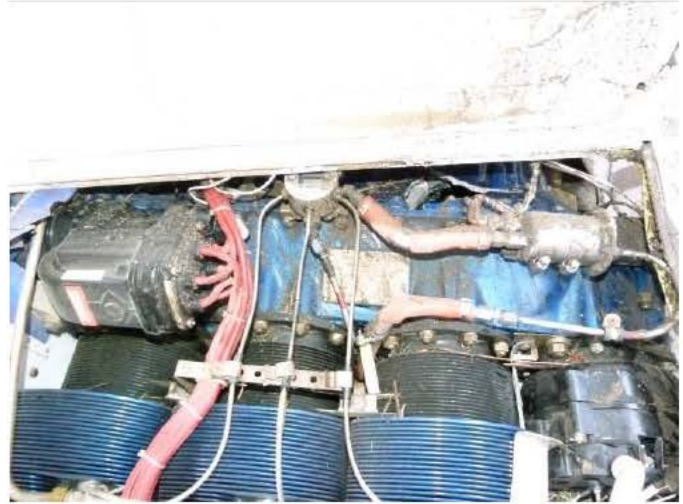
Left Magneto: 22 degrees BTDC      Right Magneto: 22 degrees BTDC

Magneto to Engine Timing  
CMI Spec. - 22 ° BTDC

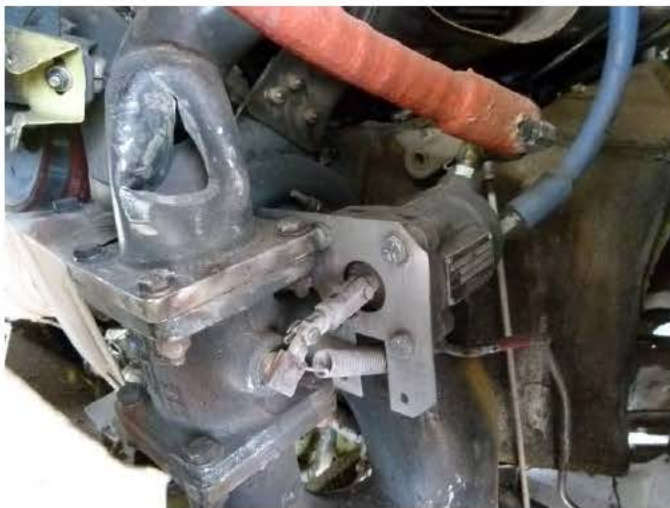
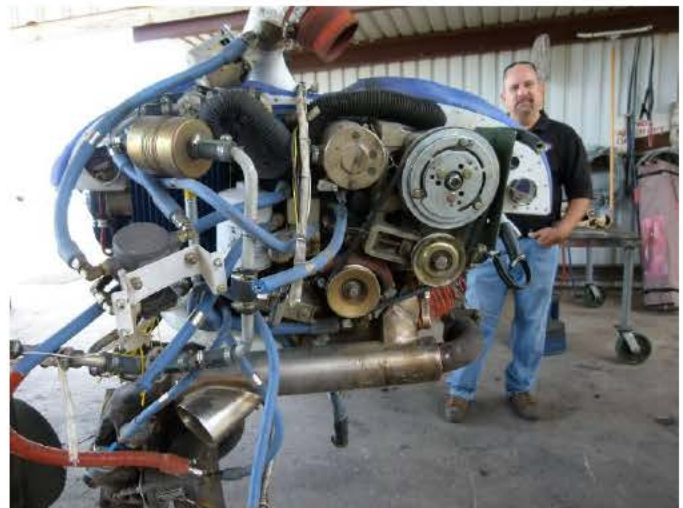
Exhaust System

Condition: The exhaust system was removed including the Turbo Alley installed turbo charger and associated hardware. The compressor wheel would not turn in the turbo housing and minor rotational scoring was noted. The tailpipe was not removed from the turbine section and the wheel was not examined. The exhaust pipe connected to the wastegate was damaged and breached.

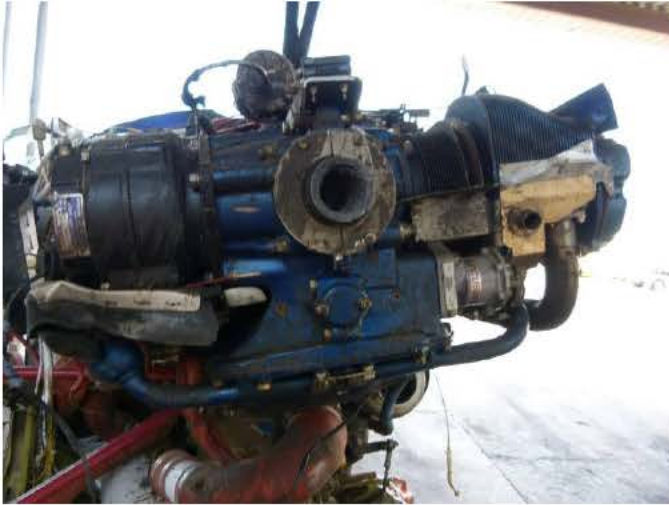
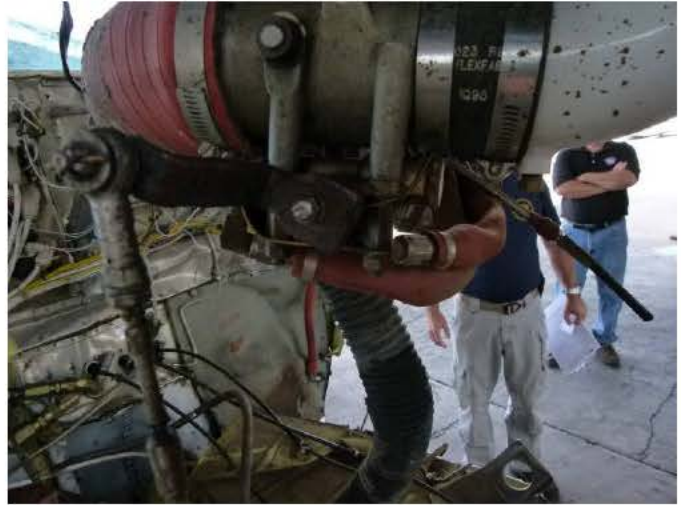
Induction System

Condition: The induction system remained attached with minor damage at the turbo inlet.

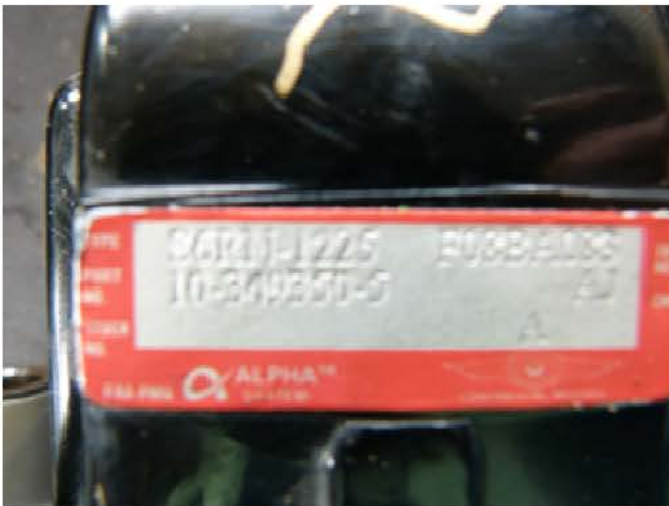
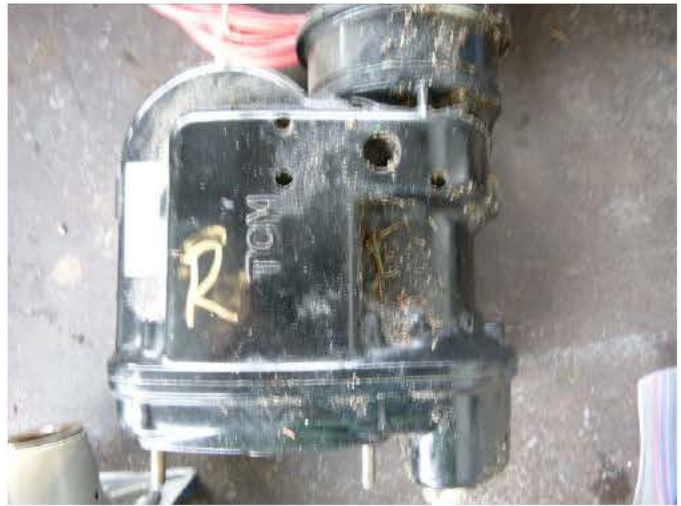
R/H Magneto      Manufacturer: TCM      Model/Part Number: S6RN1225      Serial #: F08BA083  
 Condition:      The right magneto remained attached and appears to be undamaged.

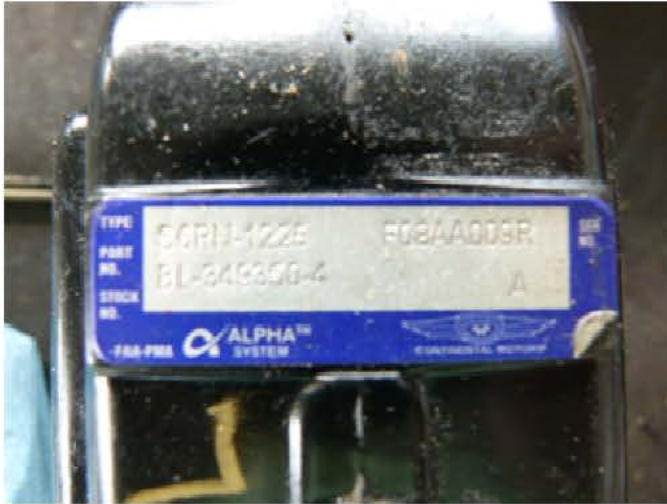
L/H Magneto      Manufacturer: TCM      Model/Part Number: S6RN1225      Serial #: F08AA009R

Condition: The left magneto remained attached and appears to be undamaged.

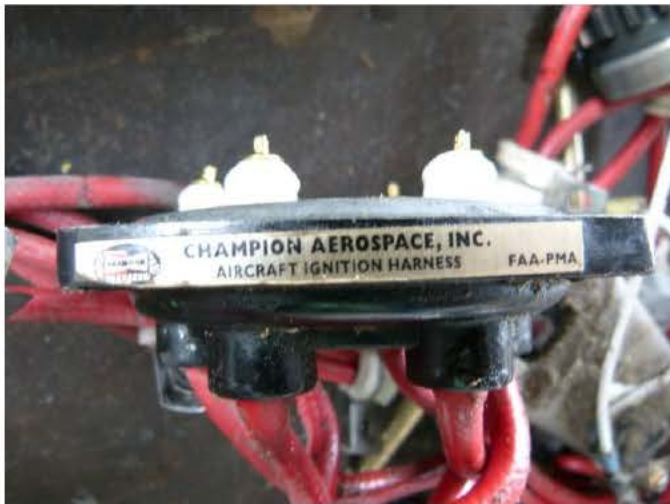
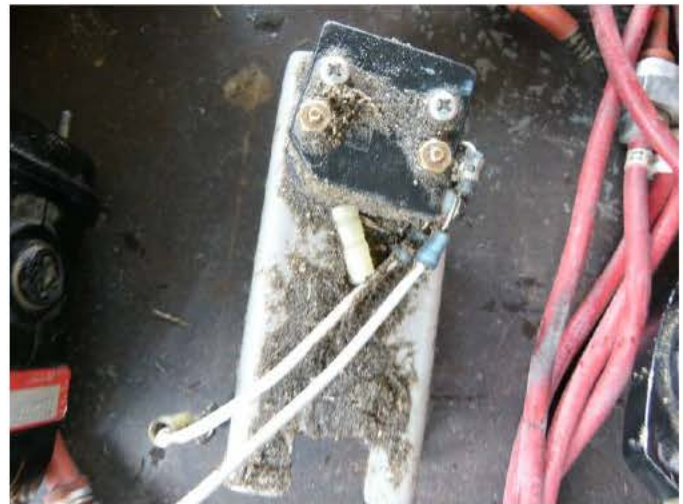
Ignition Harness

Condition: The ignition harness appeared to be in working condition and did not sustain major damage.

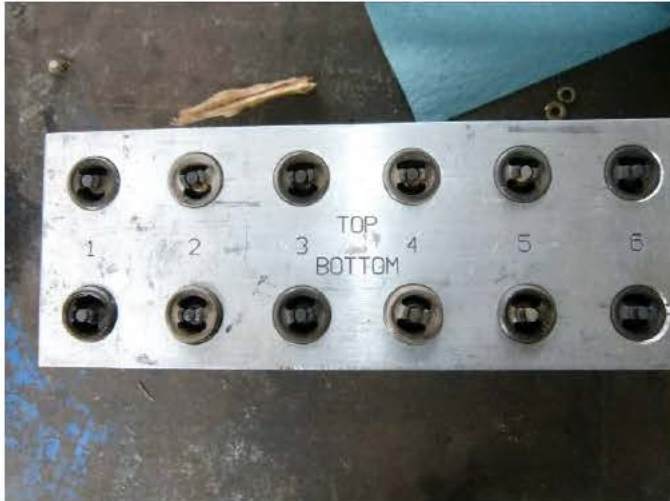
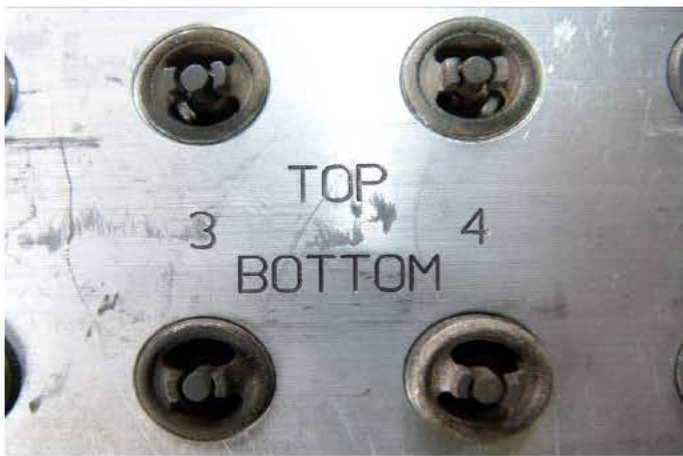
Spark Plugs

The sparkplugs were removed and compared to a Champion Check-a-plug chart. All sparkplugs appeared normal and in worn but good condition.

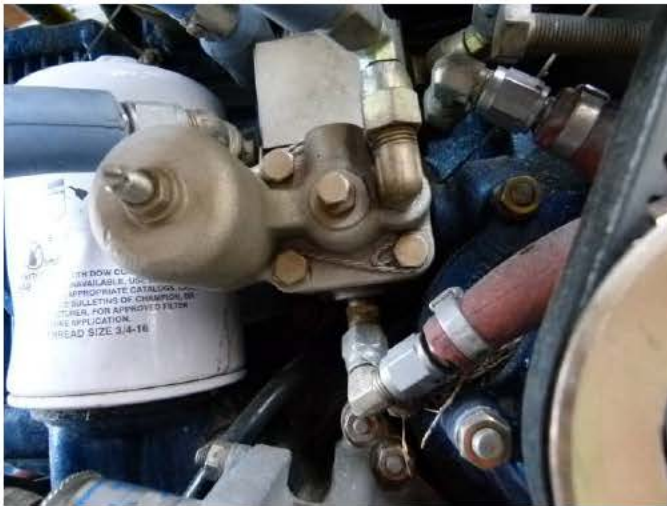
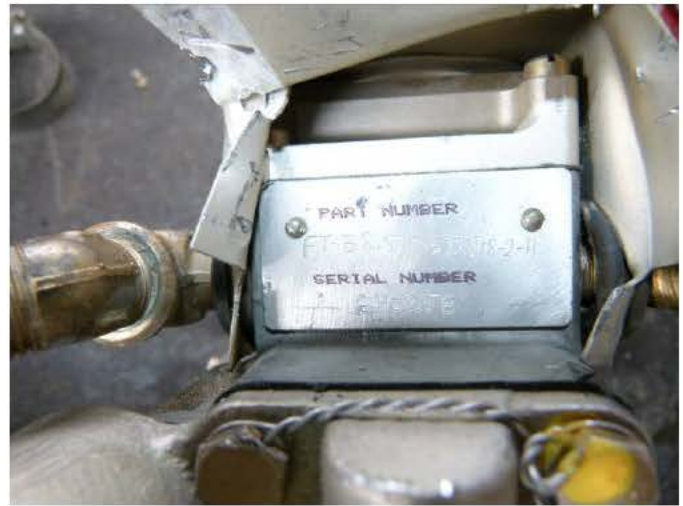
Fuel Pump

Condition: The fuel pump appears to be undamaged and the drive link was found intact. No residual fuel was noted when the fuel hoses were removed.

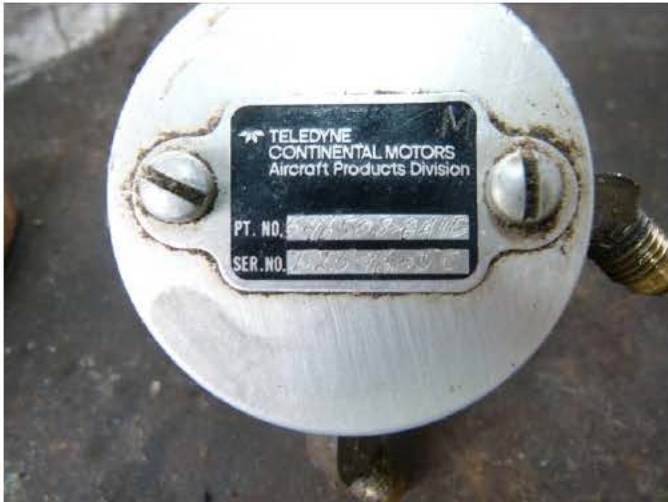
Fuel Manifold Valve    Manufacturer: TCM    Part Number: 646508-641D    Serial #: T259605C

Condition:    The fuel manifold valve was undamaged with safety wire securing the assembly screws and lead seal intact.(non TCM) No fuel staining was noted. The part number/serial number has been re-identified in the field.

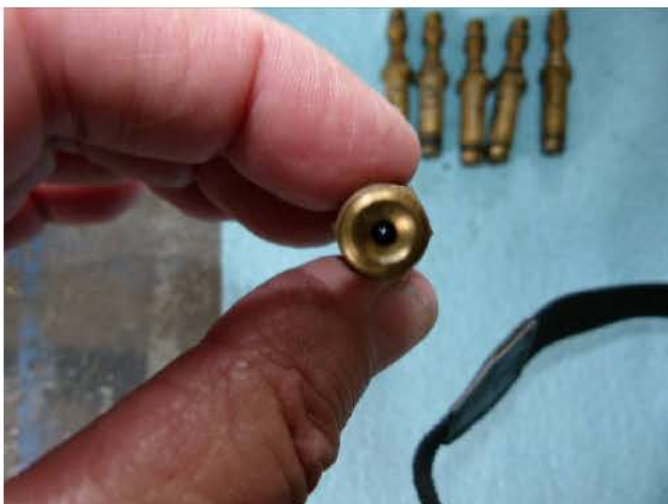
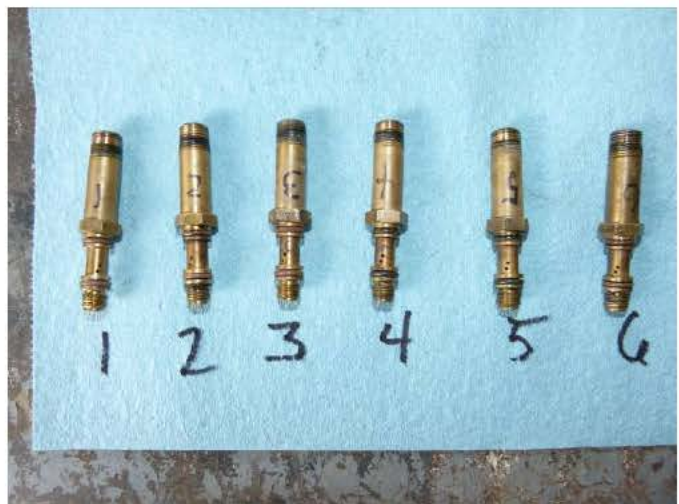
Condition:    All fuel injection lines remained attached between the fuel manifold and the individual fuel injectors. All injectors appear to be unobstructed.

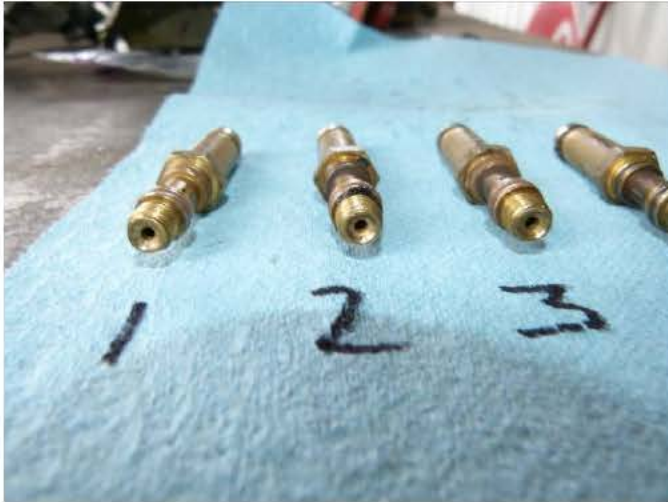
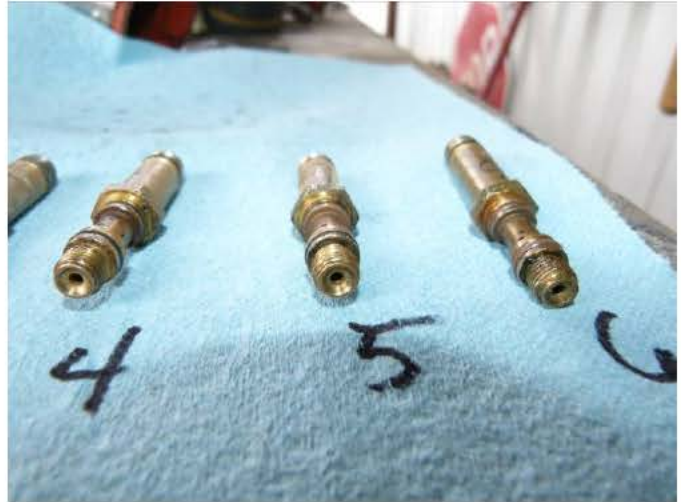
Metering Unit

Condition: The metering unit and throttle body appeared to be undamaged. The identification tag on the metering unit had been changed and the part number/serial number changed from original TCM nomenclature. The fuel control unit was removed and residual fuel tested negative for water. This liquid was light blue in color, smelled and otherwise resembled 100 low lead aviation fuel. The filter screen was removed from the fuel control unit and found to be free of contaminants.

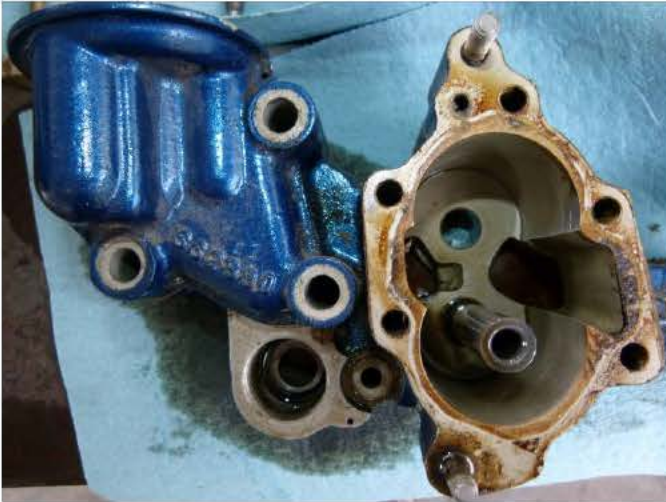
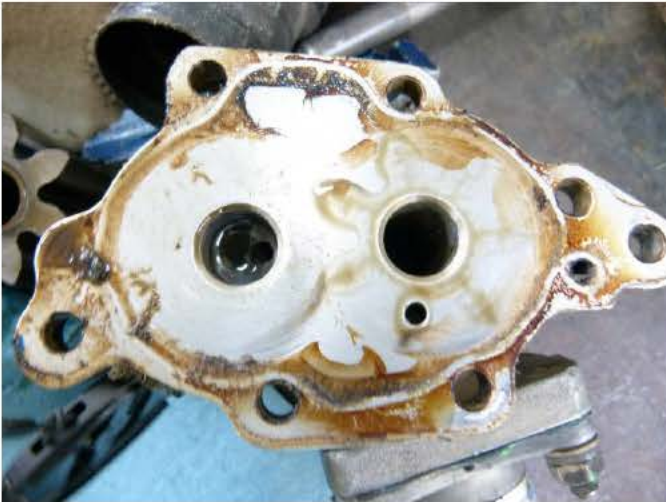
Oil Pump

The oil pump was removed and disassembled. No damage was noted and dark oily substance resembling oil was present. Minor scratching was noted in the oil pump cavity. The pressure relief valve spring was found intact and no abnormal wear was noted on the plunger.

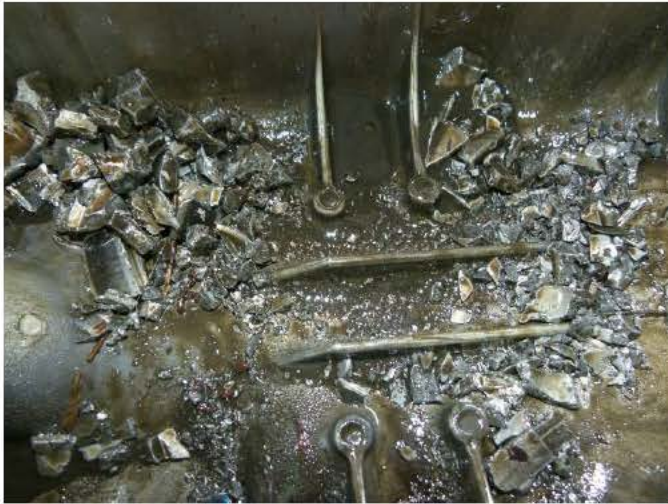
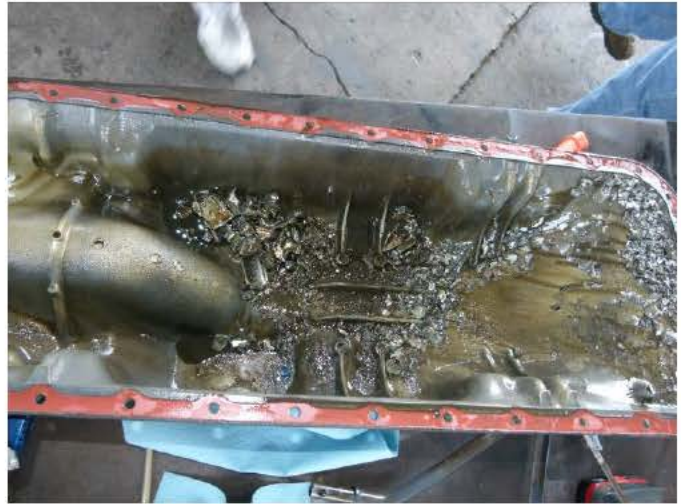
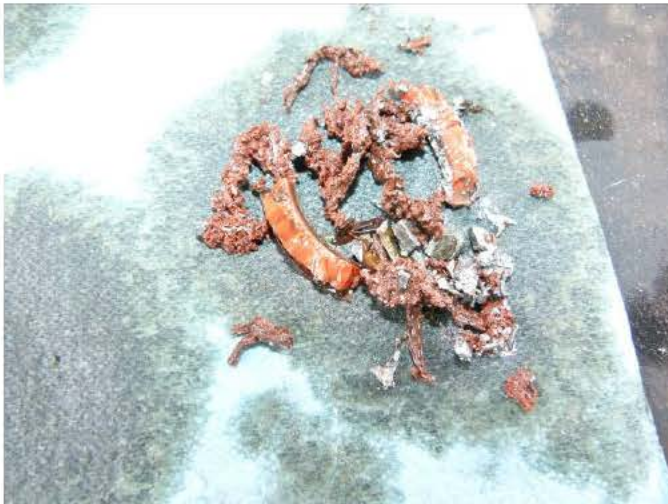
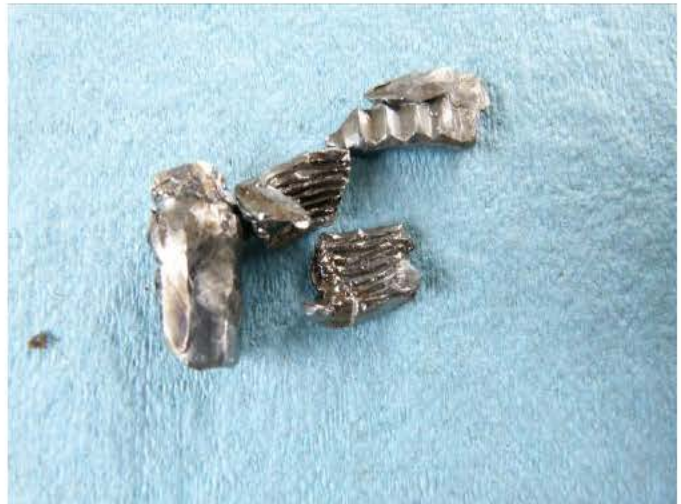
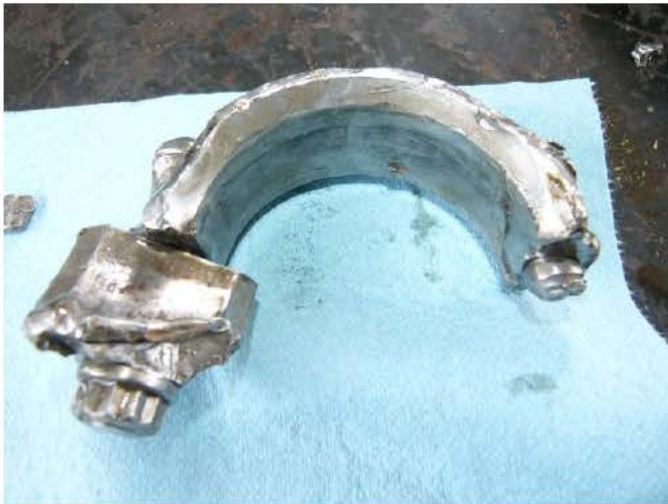
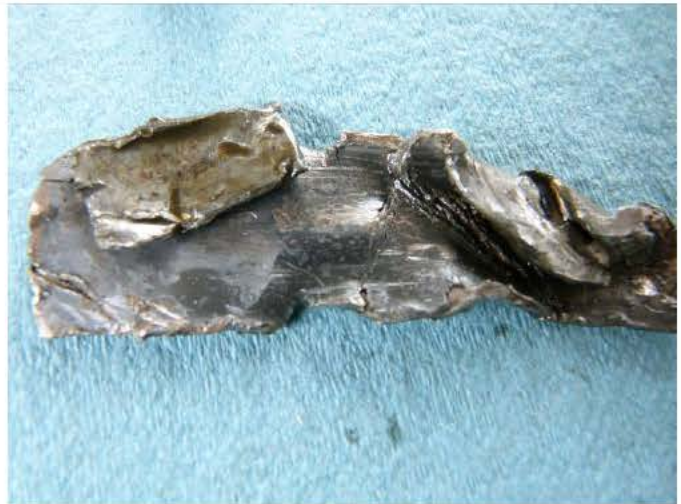
Oil Sump

Condition: The engine crankcase sump was found to contain approximately nine and one half quarts of dark, oily liquid which were drained to facilitate removal of the sump. The crankcase oil sump was removed from the engine. The connecting rod for cylinder #5 was recovered from the sump as well as the broken parts of the rod bolt and nut. The parts were retained by NTSB for analysis at the NTSB lab. Red rubber fragments were recovered from the sump which resembles fragments of an alternator drive hub materials. The NTSB IIC called the owner of the airplane who admitted that the previous alternator failed and was changed on this engine approximately 60 hours prior at hobbs time 1220.8.

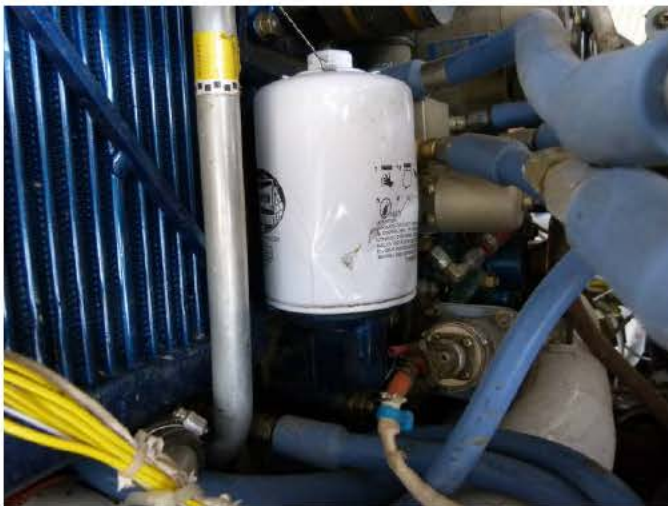
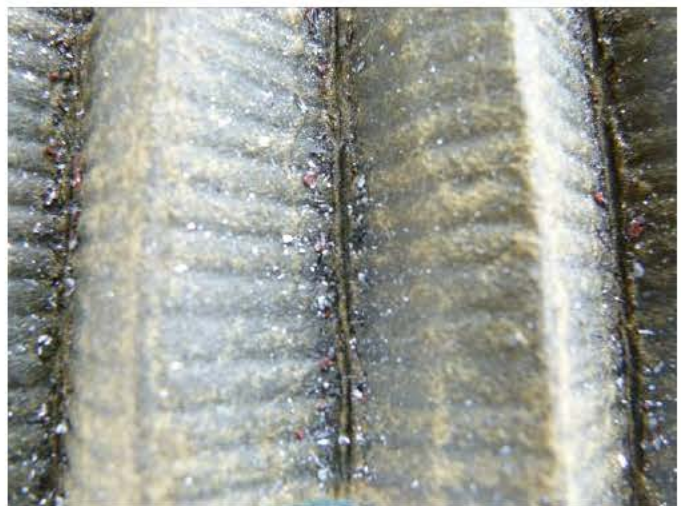
**Oil Filter**

Condition: The Champion oil filter model CH48109 was removed and opened for inspected. Both ferrous and non-ferrous metal chips and foreign particles were found. The exterior oil filter canister sustained minor damage but remained intact.

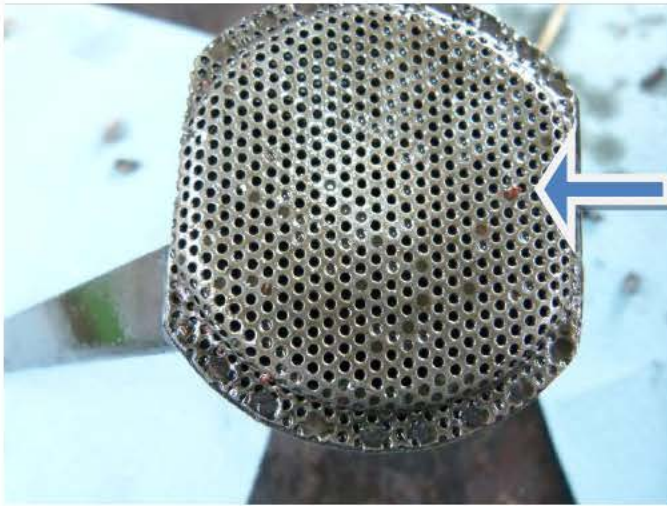
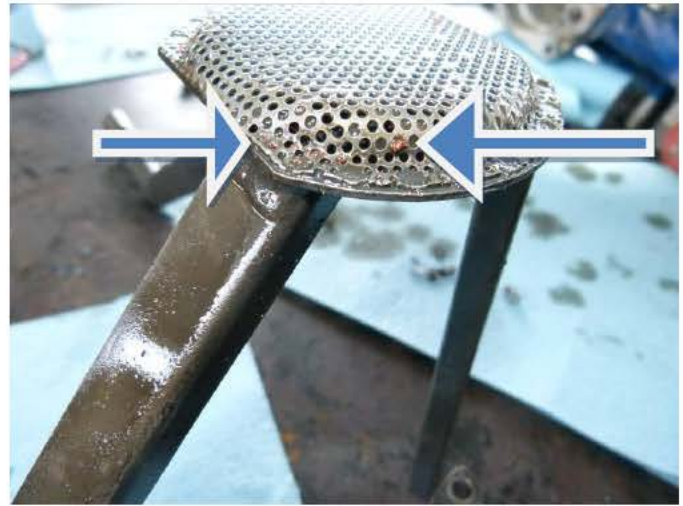
Oil Pick-up Tube & Screen

Condition: Undamaged. Note the red rubber debris particles on the screen.

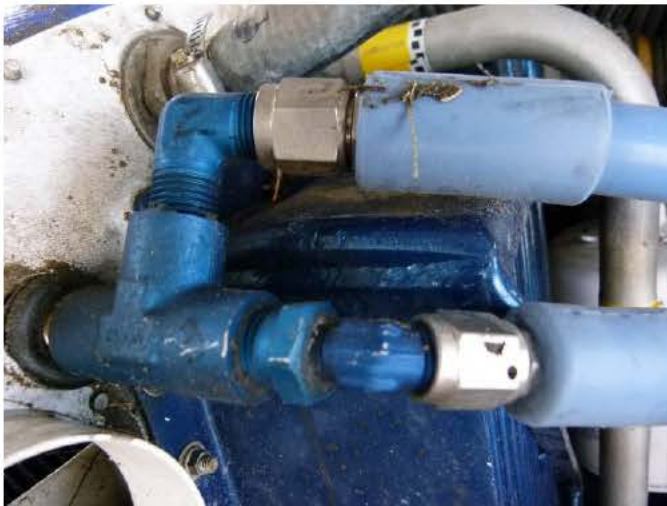
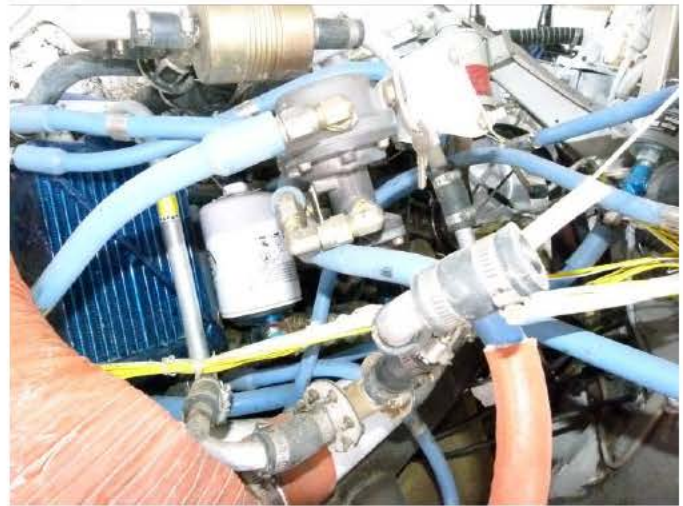
Oil Cooler

Condition: Minor damage to the lower right mounting bracket.

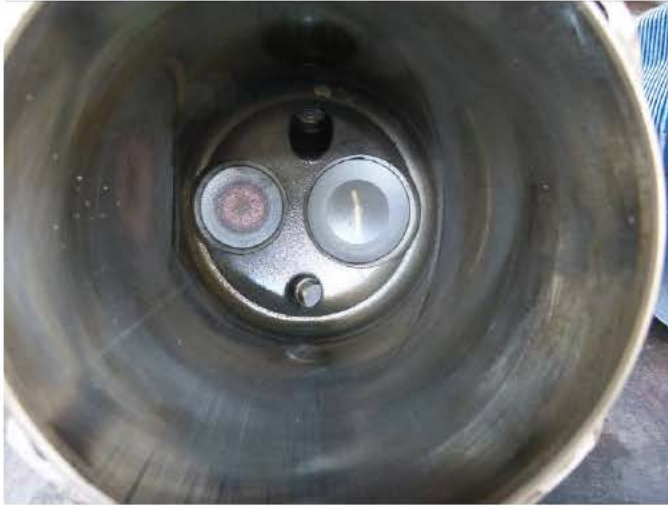
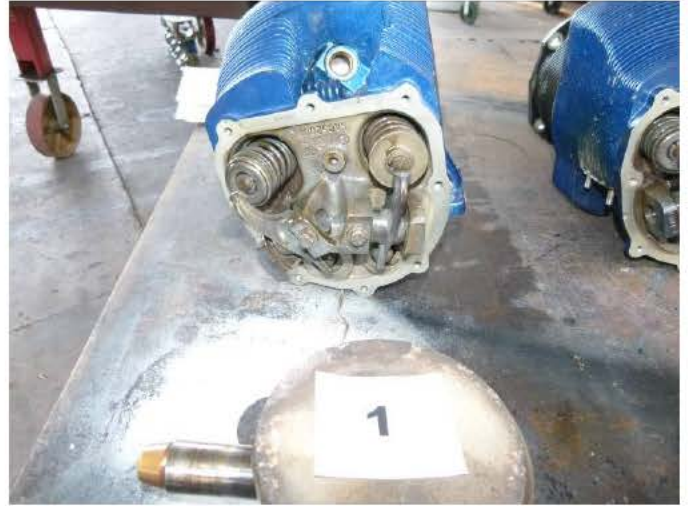
Cylinder #1 Part Number: SA52006-A1

Condition: Normal wear patterns noted. Few combustion deposits were present.

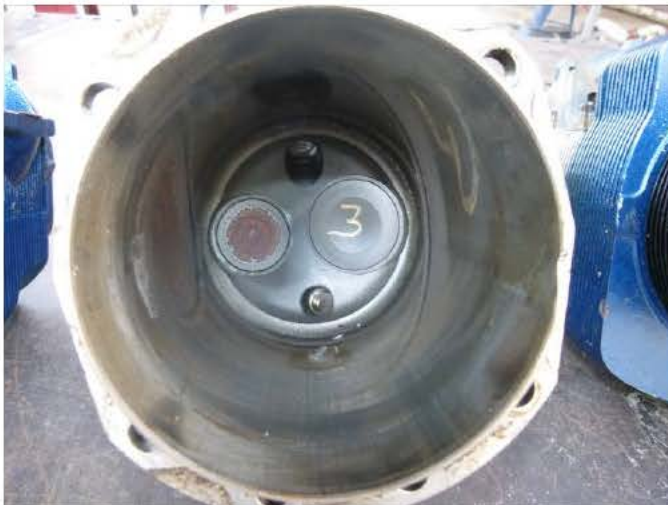
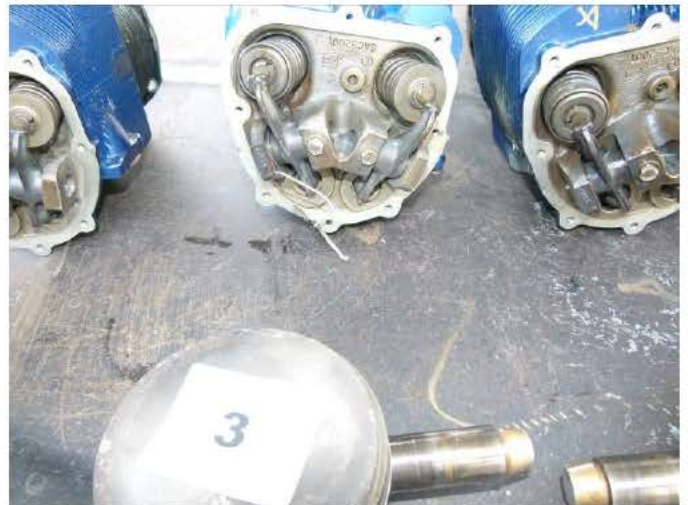
Cylinder #3 Part Number: SA52006-A1

Normal wear patterns noted. Few combustion deposits were present.

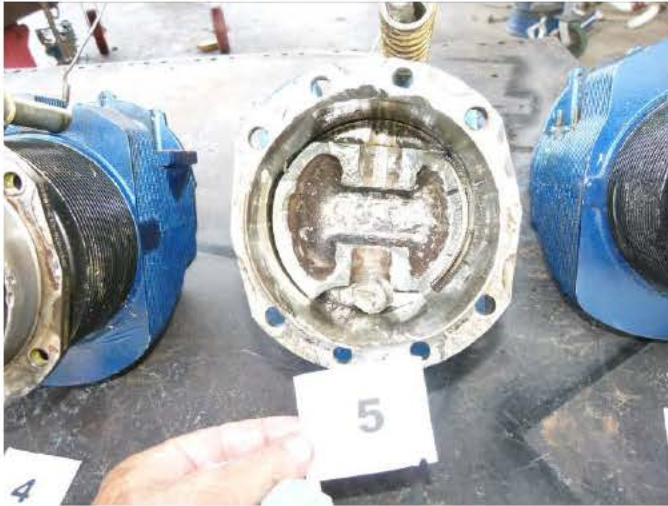
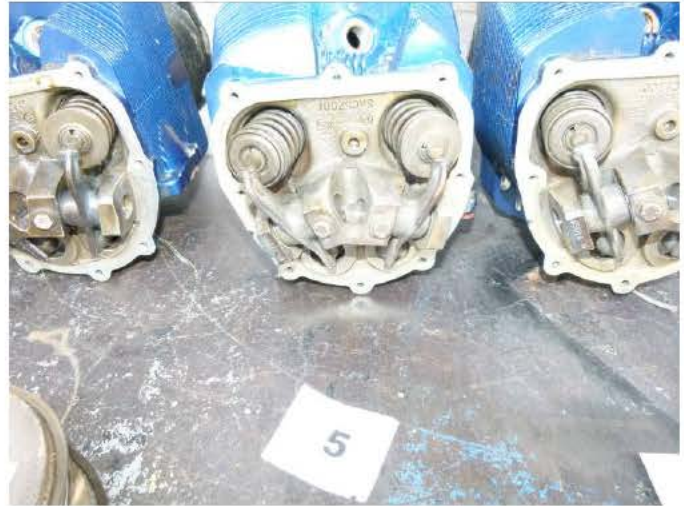
Cylinder #5 Part Number: SA52006-A1

Condition: The lower portion of the cylinder barrel was mechanically damaged and the piston could not be removed.

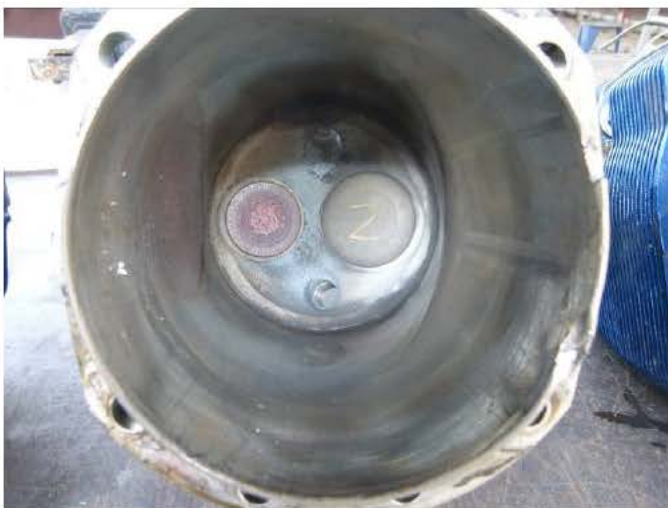
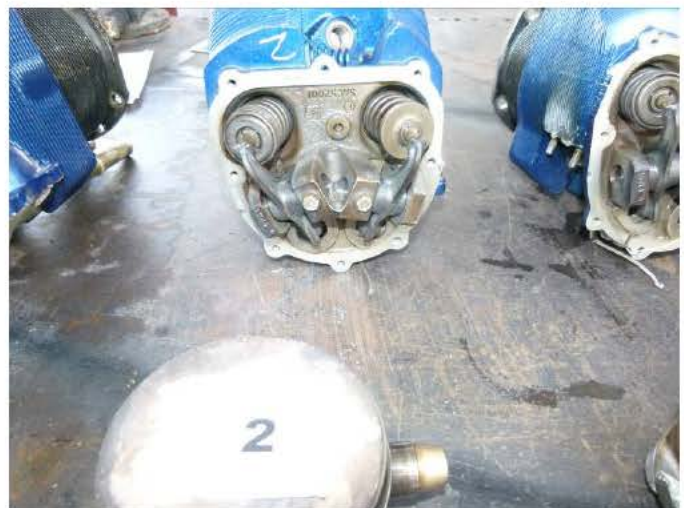
Cylinder #2 Part Number: SA52006-A1

Condition: The upper cylinder area and the head were undamaged. Mechanical damage was noted on the cylinder skirt. Few combustion deposits were present.

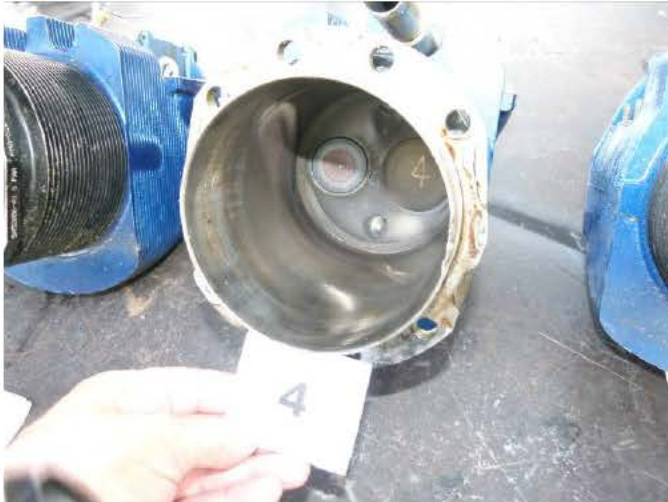
Condition: The upper cylinder area and the head were undamaged. Mechanical damage was noted on the cylinder skirt.

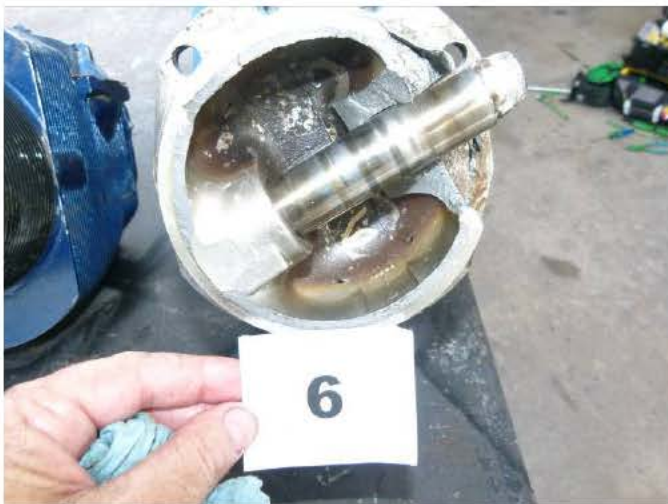
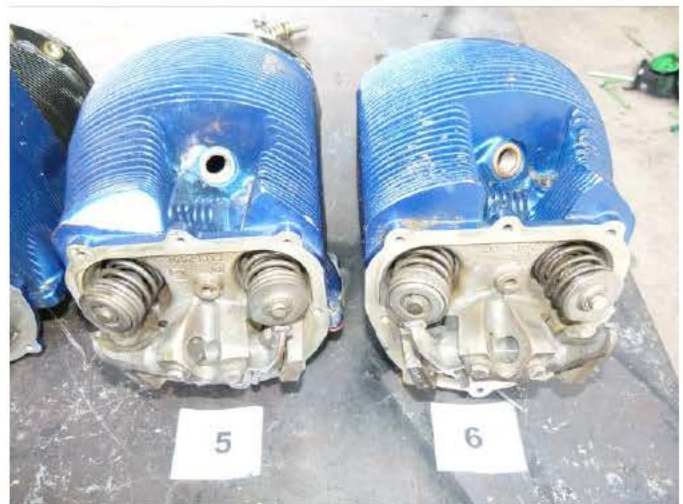
Cylinder #6 Part Number: SA52006-A1

Condition: The lower portion of the cylinder barrel was mechanically damaged and the piston could not be removed.

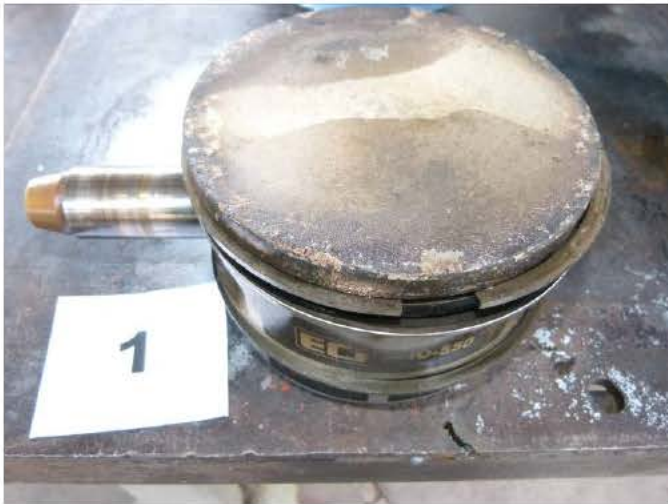
#1 Piston, Rings and Pin      Piston Part Number:    ECI    AEC654857

Condition:    The piston was found undamaged but with a very small amount of combustion deposits on the piston face.

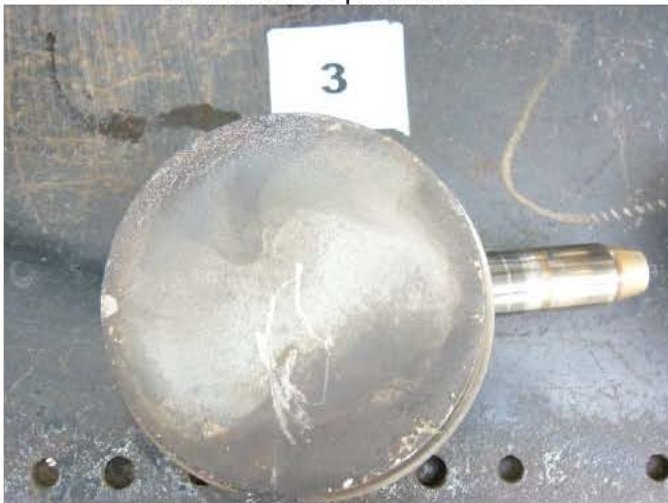
#3 Piston, Rings and Pin      Piston Part Number:    ECI    AEC654857

Condition:    The lower ring land on the piston skirt was broken. Note that there was few combustion deposits located on the piston face.

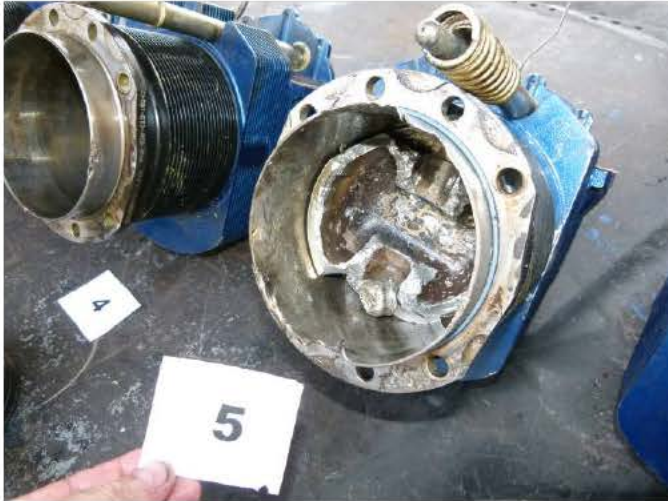
#5 Piston, Rings and Pin      Piston Part Number:    ECI    AEC654857

Condition:    The piston was heavily damaged with fracturing of the pin boss and separation of the lower piston skirt. Due to the amount of damage to the cylinder, the piston could not be removed.

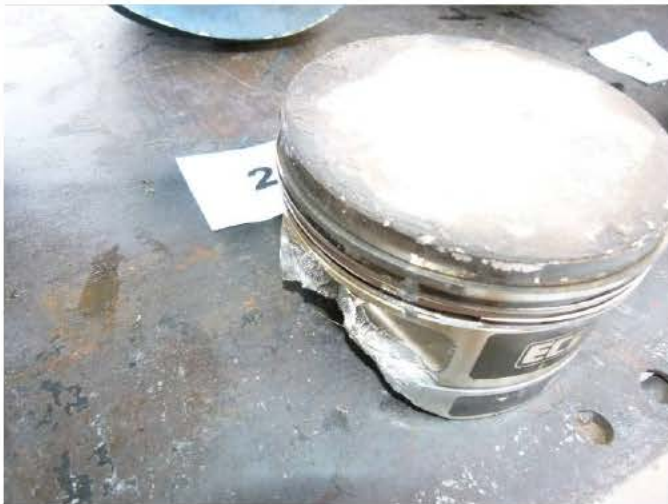
#2 Piston, Rings and Pin      Piston Part Number:    ECI    AEC654857

Condition:    The mechanical damage to the piston skirt was due to the difficulty removing the cylinder from the crankcase.

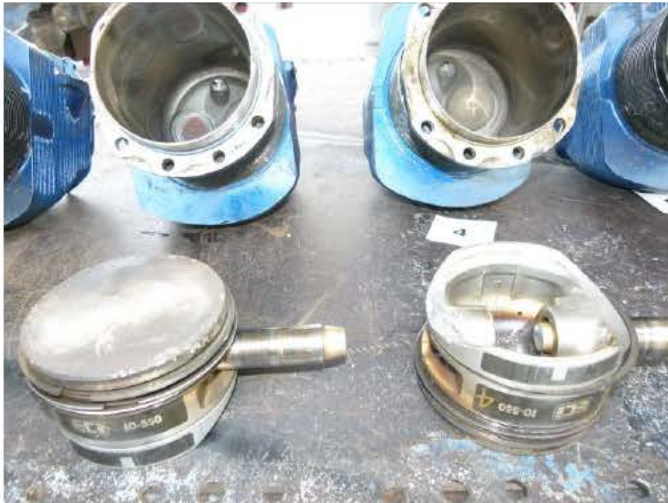
#4 Piston, Rings and Pin      Piston Part Number:    ECI    AEC654857

Condition:      Normal wear patterns were noted. There were few combustion deposits found on the piston face.

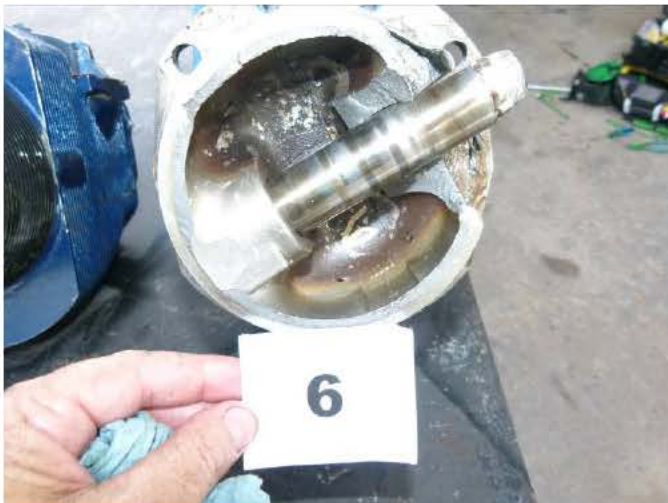
#6 Piston, Rings and Pin      Piston Part Number:    ECI    AEC654857

Condition:      The piston skirt and pin boss were heavily damaged. The piston could not be removed from the cylinder due to the amount of damage to the cylinder skirt below the mounting flange.

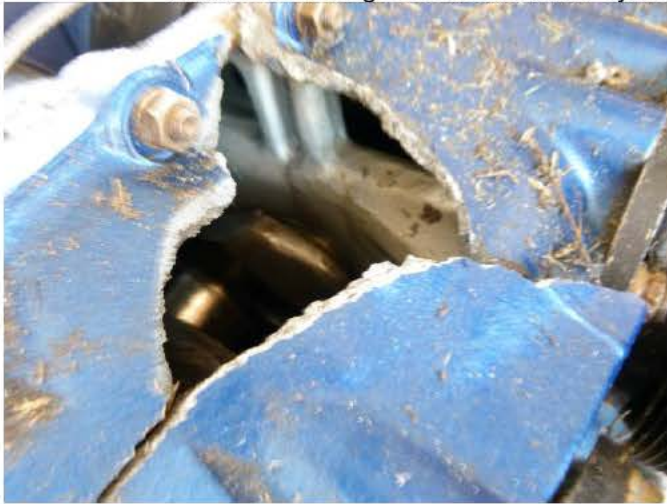
Crankcase Casting Number 1-3-5 Side: WDC61 2-4-6 Side: Ukn. Serial number: D309204RPL  
828

Condition: The crankcase was found to have a hole located between cylinders four and six cylinder bases. Additional damage was found below cylinder # 5.

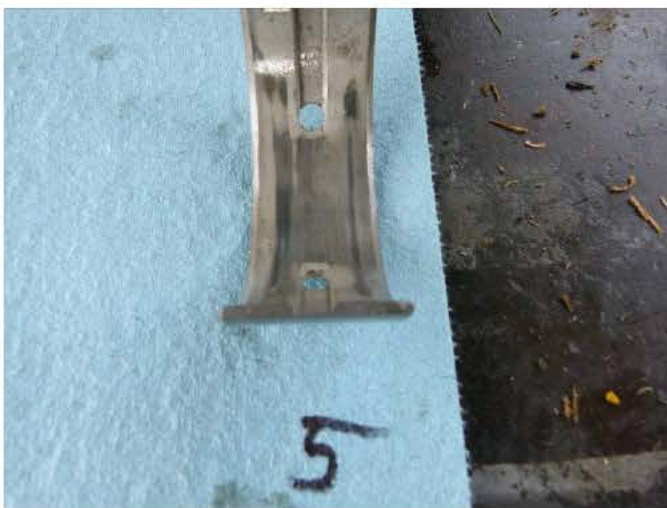
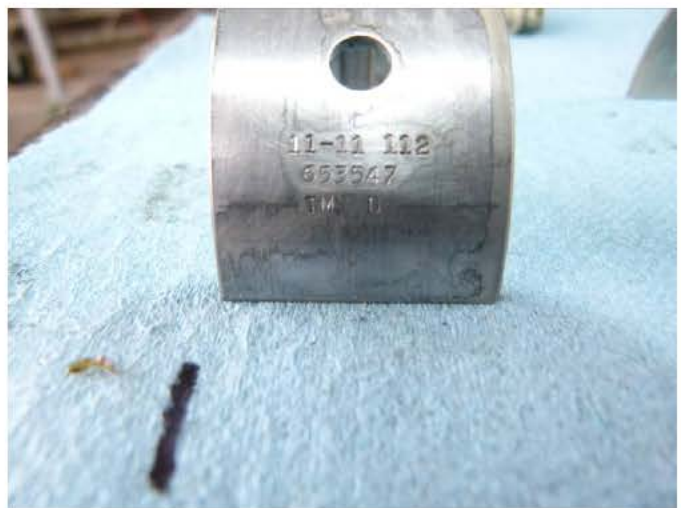
Condition The crankshaft main bearings exhibited normal operating signatures.

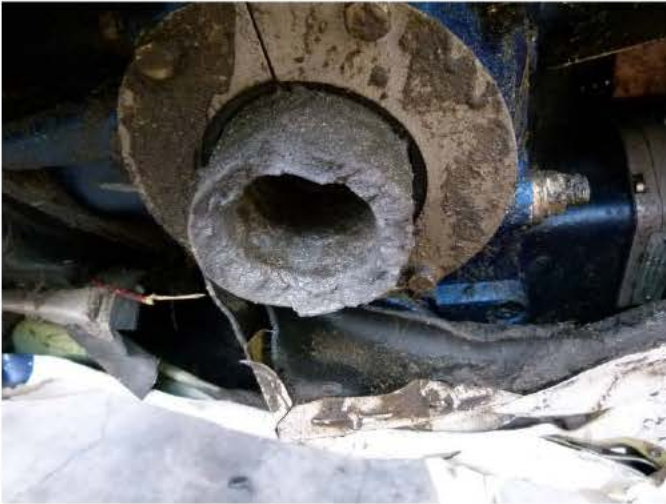
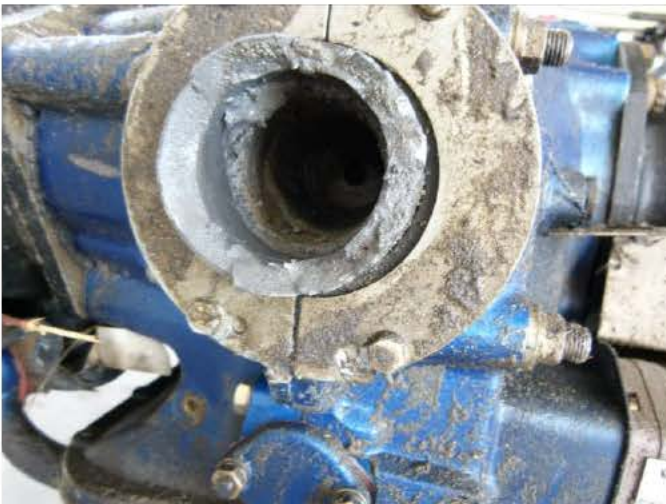
Crankshaft Forging number: 6A6126-8 Serial number: N41327 Heat code: D309204RPL

Condition: The crankshaft was found broken aft of the propeller flange.

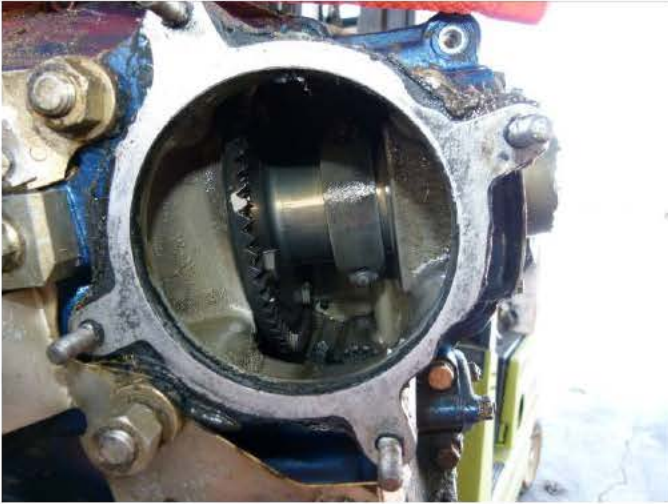
Transfer Collar: Condition: Normal wear. No damage noted.

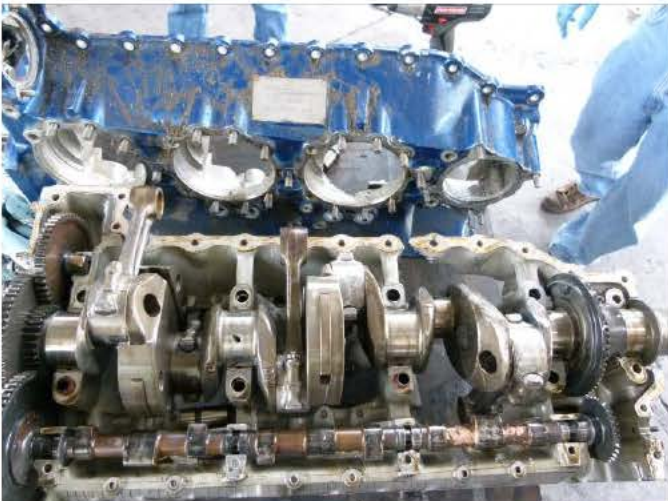
Counter Weights: Condition: Normal wear patterns
