# Continental Motors, Inc.

## ENGINE FIELD INSPECTION REPORT

ENGINE MODEL: IO550B (4F)

EXAMINATION		ACCIDENT DATA	
Date	July 30, 2013	NTSB Accident #:	WPR13LA321
Facility	Air Transport, Inc.	NTSB Investigator:	Patrick Jones
Address	3011 W. Buckeye Road	FAA Investigator:	Troy Lent
City	Phoenix	Law Enforcement:	M. Timmons, Churchill County Sheriff's Office
State and Zip	Arizona 85009	Coroner / Medical Examiner	N/A

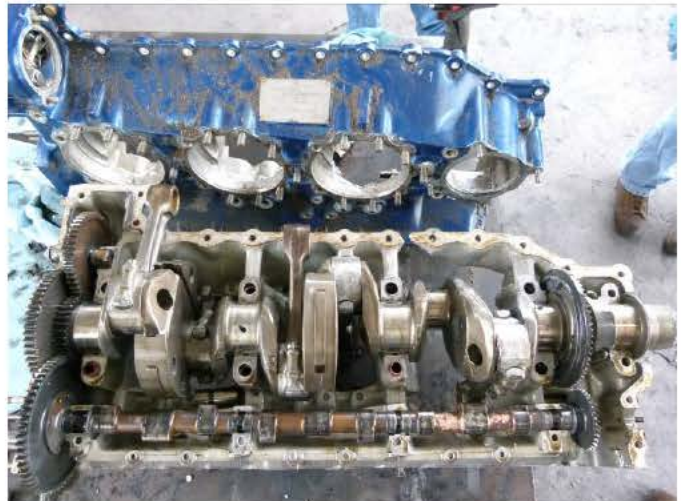
Counter Weights: Condition: Normal wear patterns

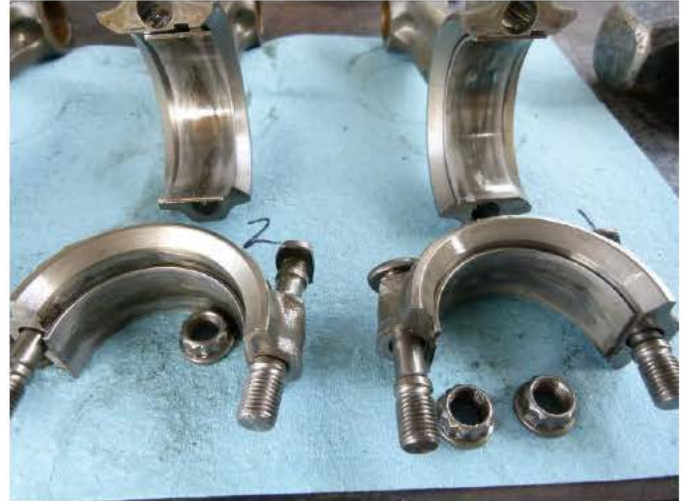
Condition: No damage noted.

Condition: Bearings exhibit accelerated wear patterns from unknown causes.

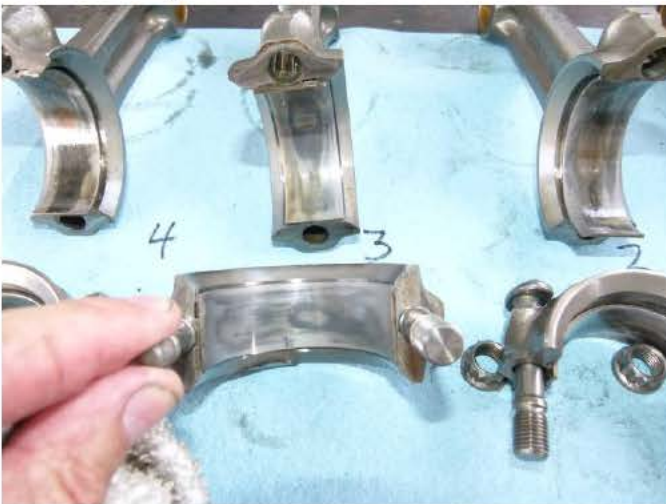
#3 Connecting Rod Bearing Part Number: 642398

Condition: Bearings exhibit accelerated wear patterns from unknown causes.

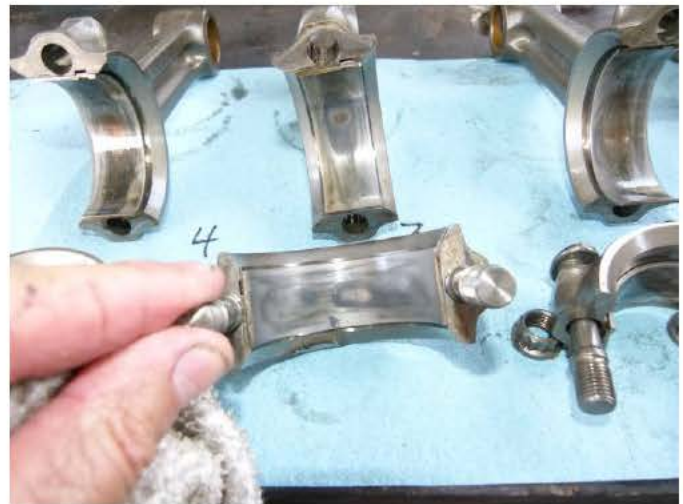
Condition: No damage noted.

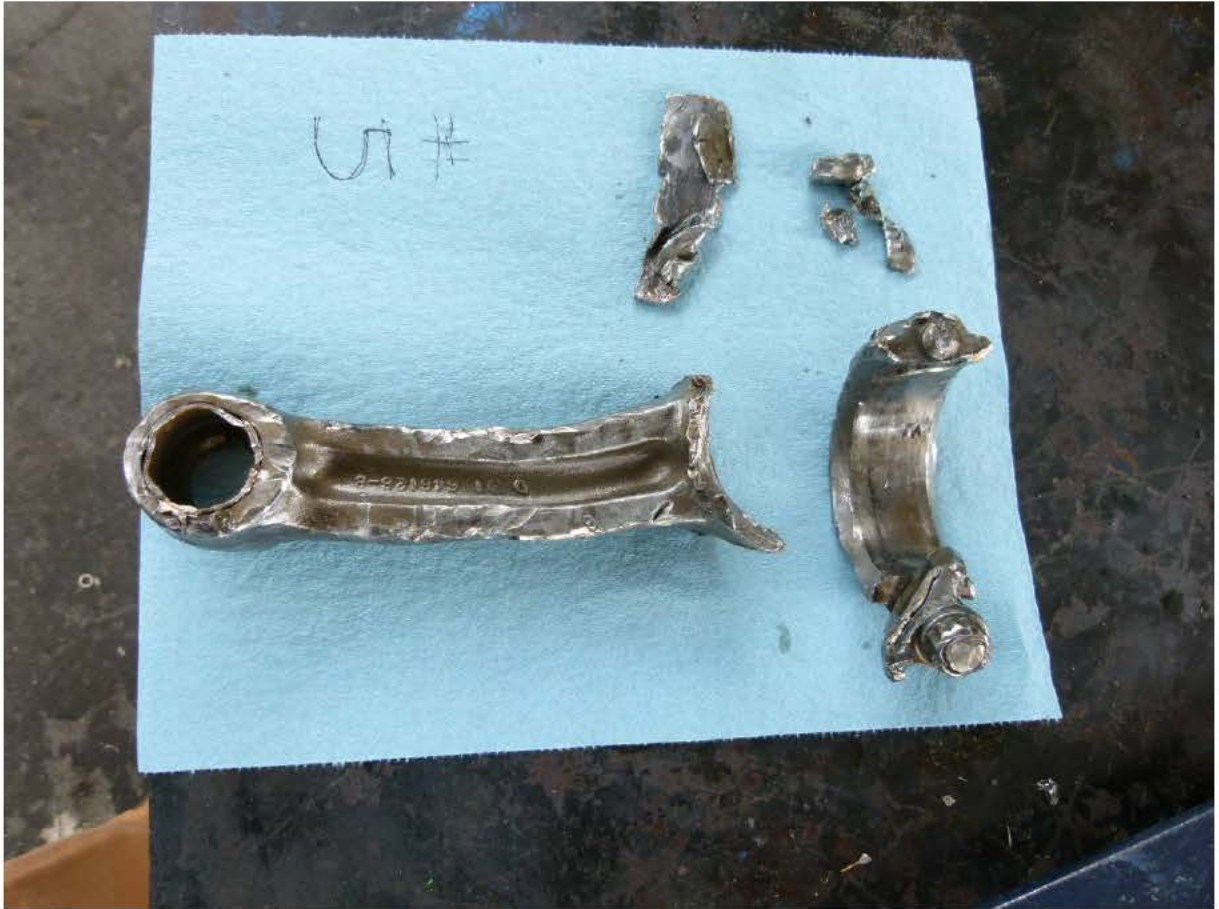
Condition: Mechanically damaged and bent. The rod cap was damaged with one rod bolt and nut remaining attached. The remains of the second rod bolt and nut were found with other debris in the crankcase oil sump. The NTSB retained these parts for analysis at the NTSB laboratory.

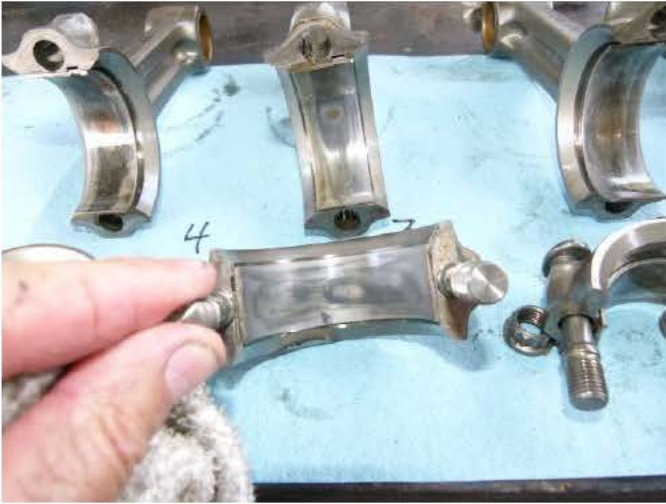
#5 Connecting Rod Bearing Part Number: 642398

Condition: Bearings exhibit accelerated wear patterns from unknown causes.

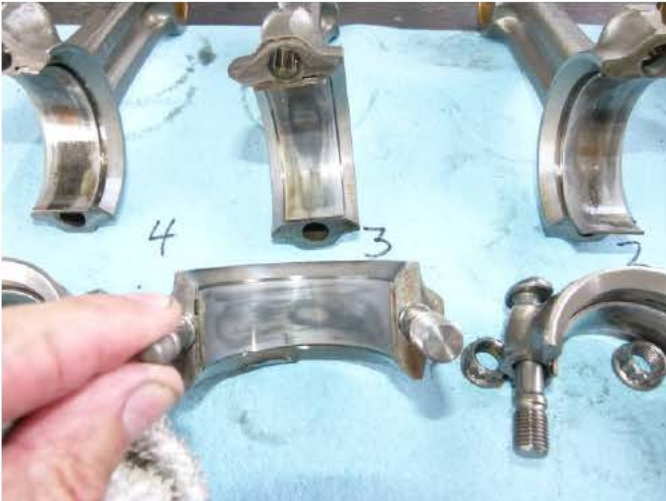
#2 Connecting Rod Bearing Part Number: 642398

Condition: Mechanical damage was found on connecting rod cap.

Condition: Bearings exhibit accelerated wear patterns from unknown causes.

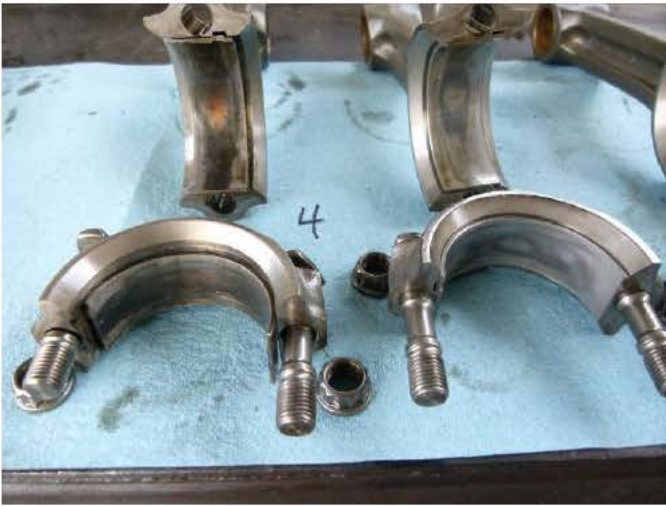
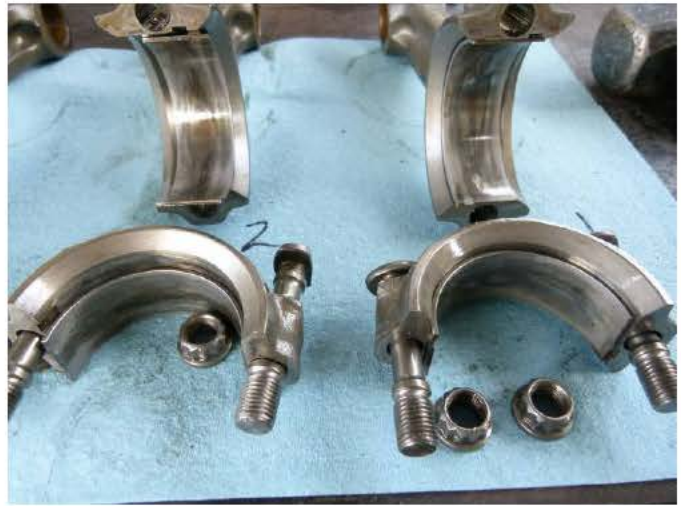
Condition: Normal wear. No damage noted.

Condition: Bearings exhibit accelerated wear patterns from unknown causes.

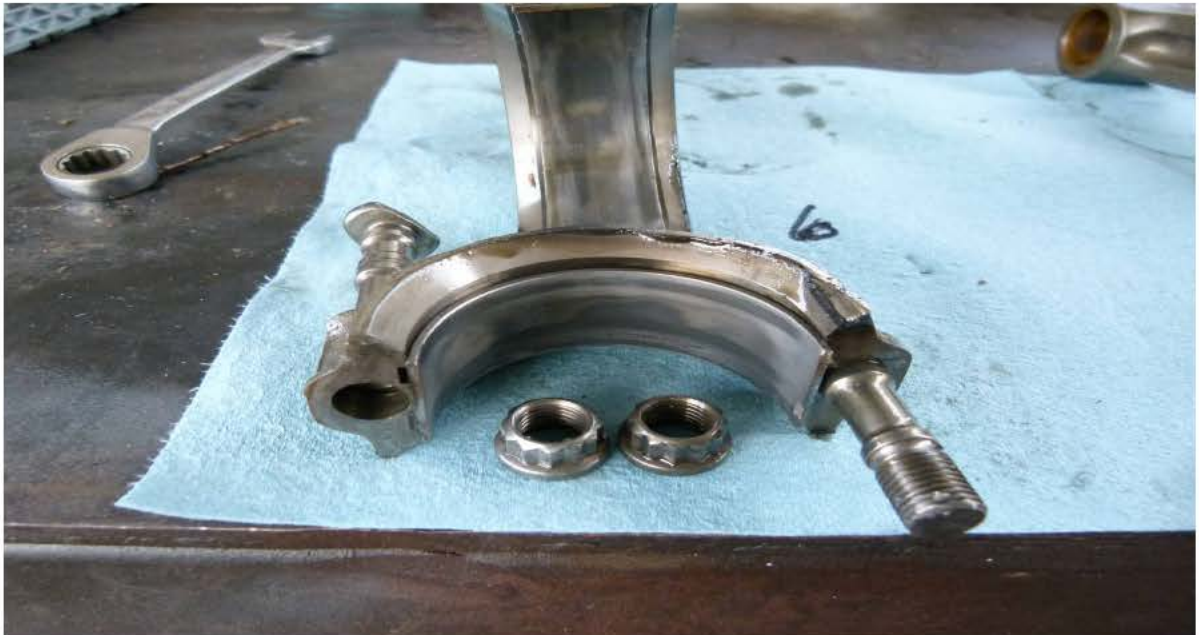
Condition: Mechanical damage was noted on the connecting rod and rod cap.

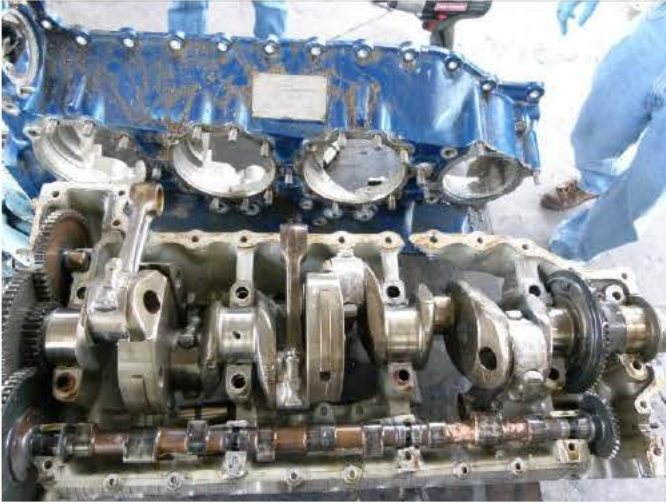
Condition: . The camshaft exhibited mechanical damage to the shaft and lifter lobes adjacent from the number 5 connecting rod location.

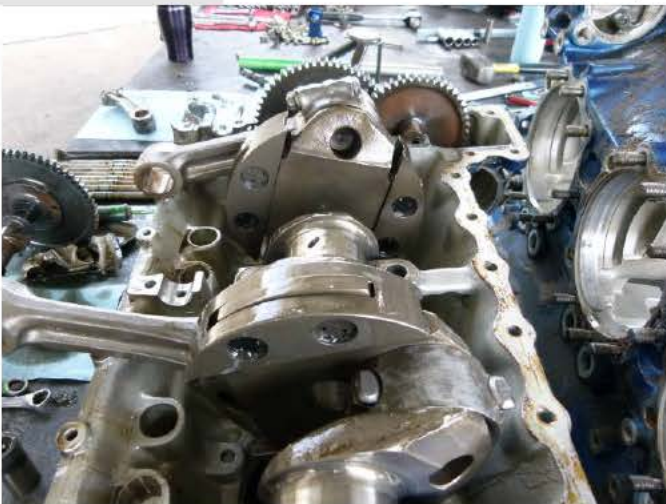
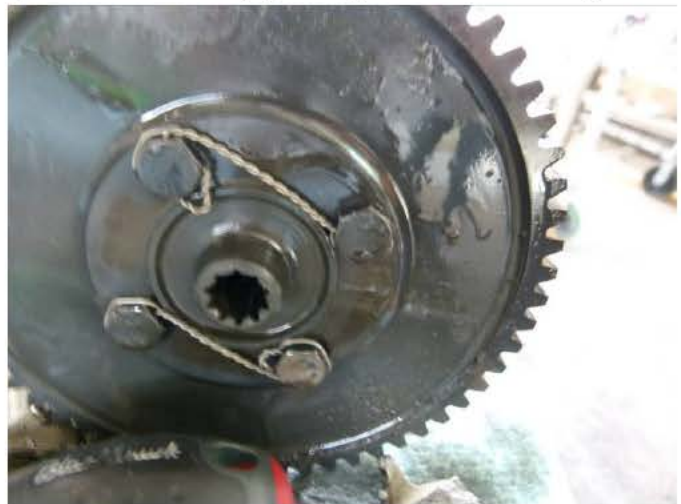
## Accessory Gears

Camshaft and crankshaft continuity was confirmed by rotating the crankshaft using an adapter inserted in the instrument air pump drive pad. The accessory gears appear to be undamaged.

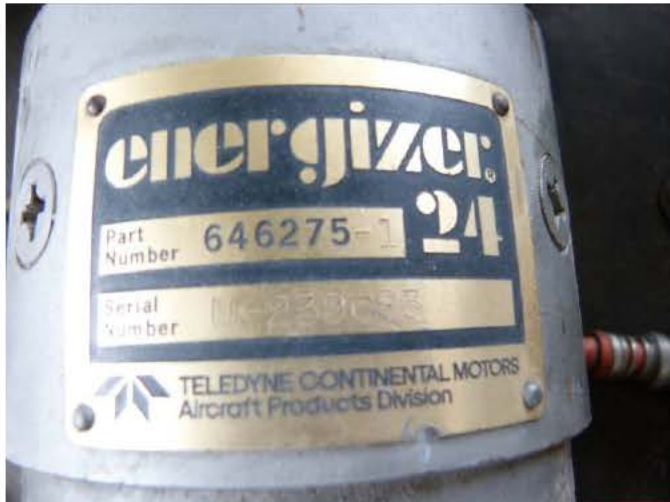
Starter Manufacturer: Part Number: 646275-1 Serial #: U239683

Condition: Starter appears to be undamaged.

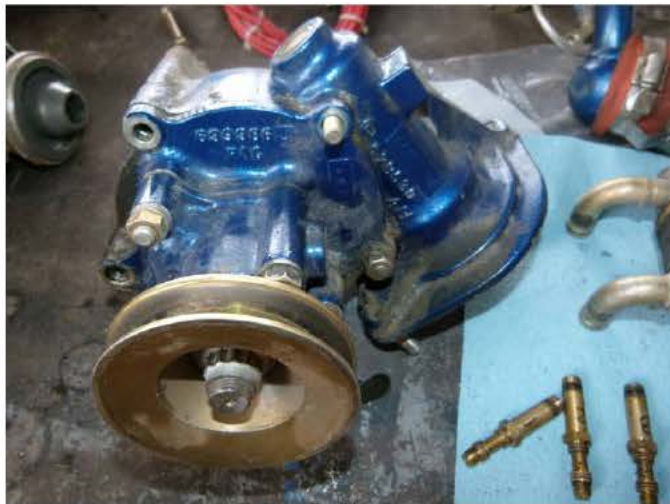
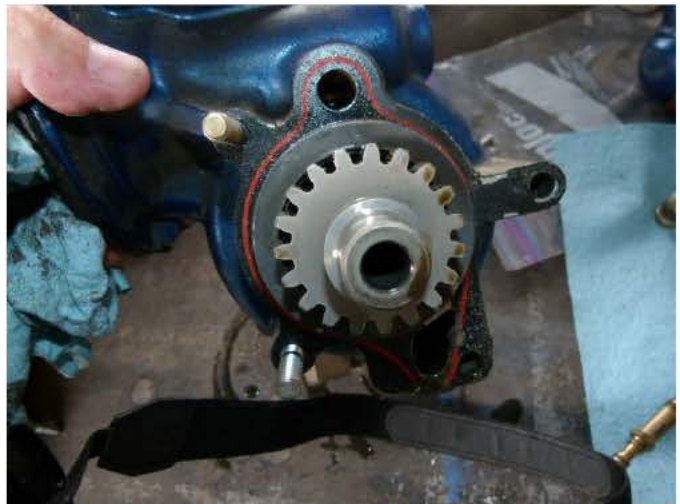
Condition: No damage noted.

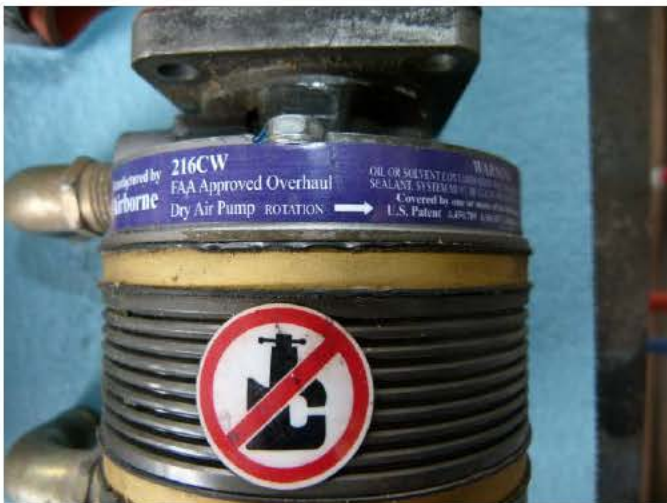
Vacuum Pump

Condition: The pump shaft turned freely and the drive link was intact.
