Continental Motors

ENGINE EXAMINATION REPORT

ENGINE MODEL	IO-550-N7B
ENGINE SERIAL NUMBER	686342
AIRCRAFT MAKE & MODEL	Cirrus SR22
AIRCRAFT SERIAL NUMBER	0293
AIRCRAFT REGISTRATION	N929DE
FILE NUMBER	17-022

EXAMINATION		ACCIDENT DATA	
DATE	October 24, 2017	NTSB ACCIDENT #	CEN17LA263
FACILITY	Continental Motors	NTSB INVESTIGATOR	Aaron Sauer
ADDRESS	2039 S Broad St Mobile, AL 36615	FAA INVESTIGATOR	Katie Sample
		ACCIDENT DATE	July 9, 2017
		ACCIDENT LOCATION	Corydon, Iowa

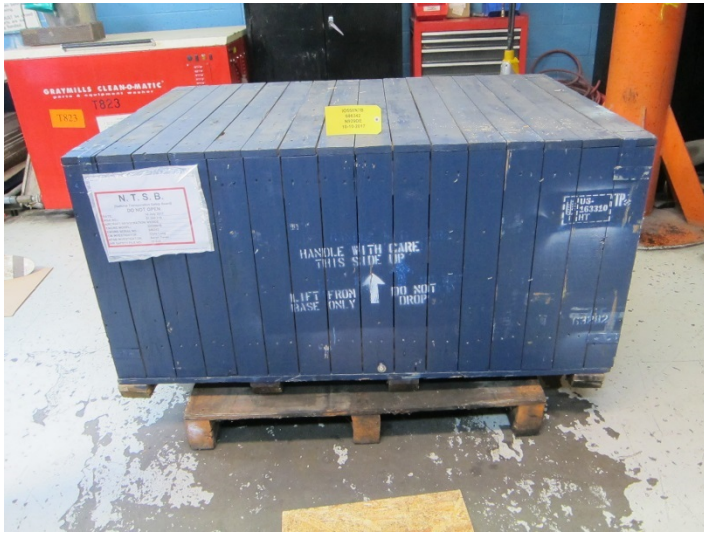
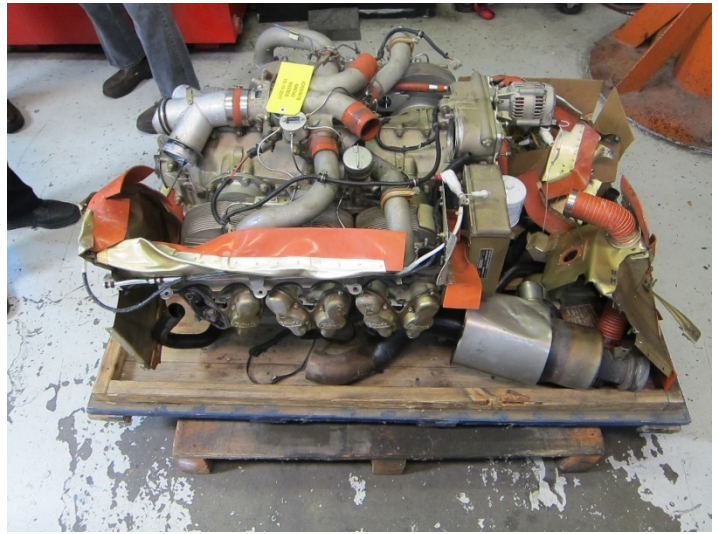
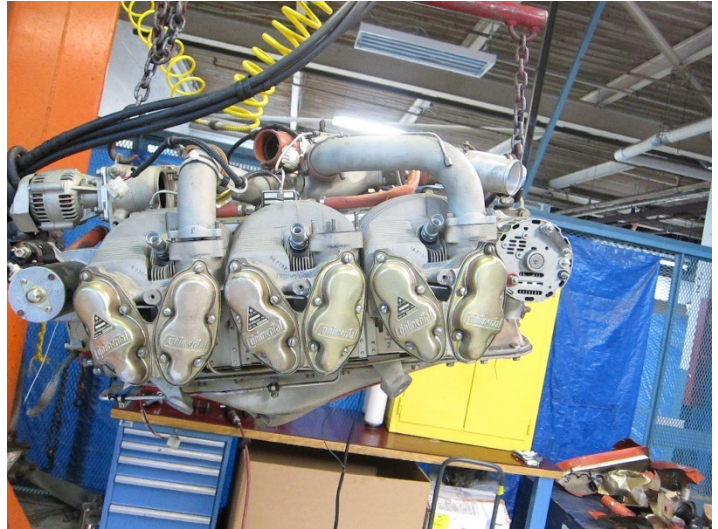
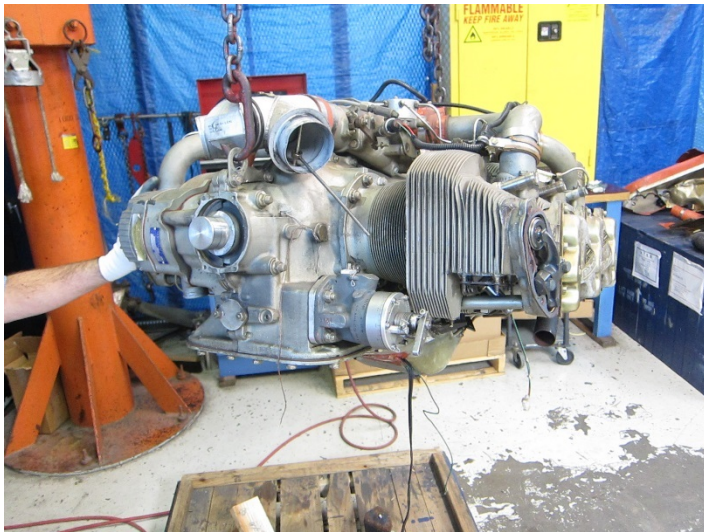
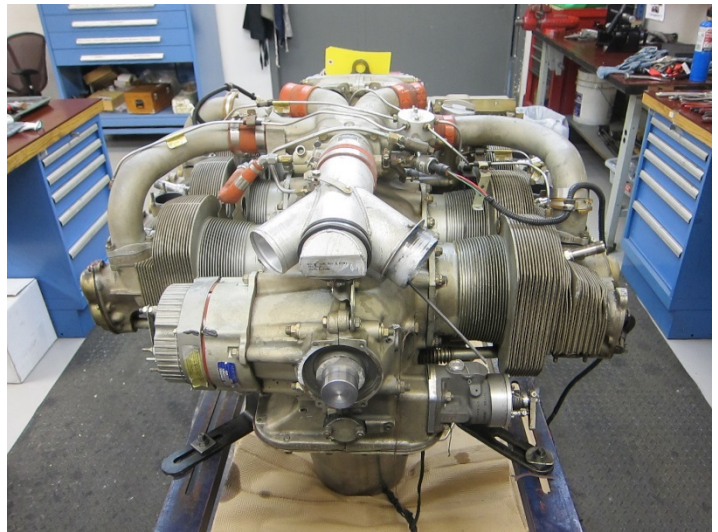
EXTERNAL INSPECTION OF ENGINE

The engine shipping crate had been opened previously under the supervision of another NTSB investigator to assess and prepare the engine for a possible test cell run. However, during work to weld the propeller flange back onto the engine crankshaft, it was discovered that the crankshaft was bent which prevented a safe test cell run. The engine was subsequently torn down during an examination on October 24, 2017 under the supervision of the NTSB investigator in charge.

The magnetos, fuel pump and fuel nozzles had been previously removed at the accident site by this writer. The left-hand side engine mount legs were fractured. The crankshaft propeller flange was fractured from the crankshaft.

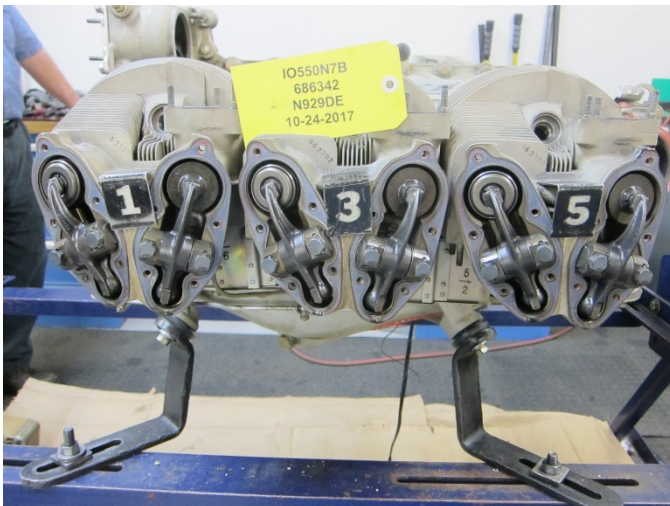
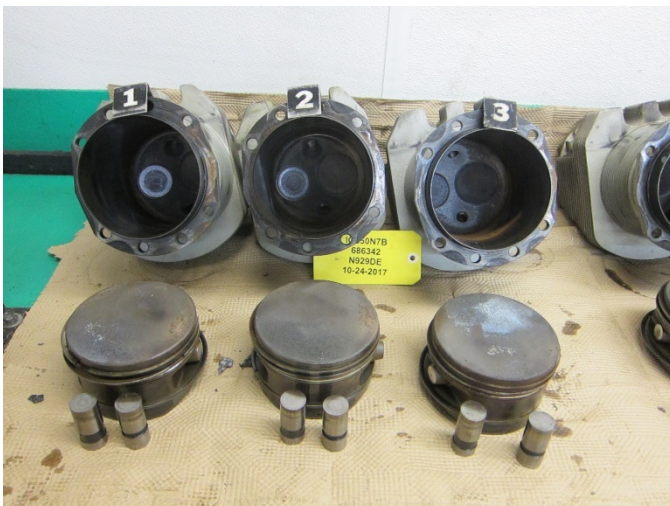
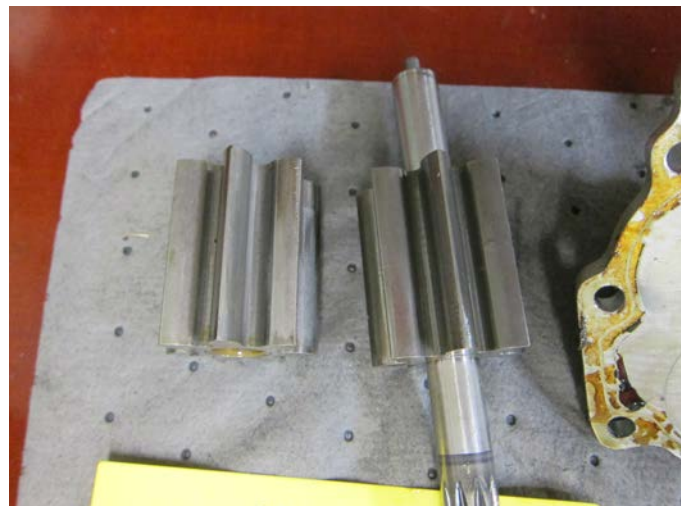
INTERNAL INSPECTION OF ENGINE

The engine was disassembled and no pre-impact anomalies were noted to any of the accessories or engine components. The magnetos and ignition harness were placed on a test bench and the magnetos produced spark on all twelve ignition leads. The fuel system components were placed on test benches.

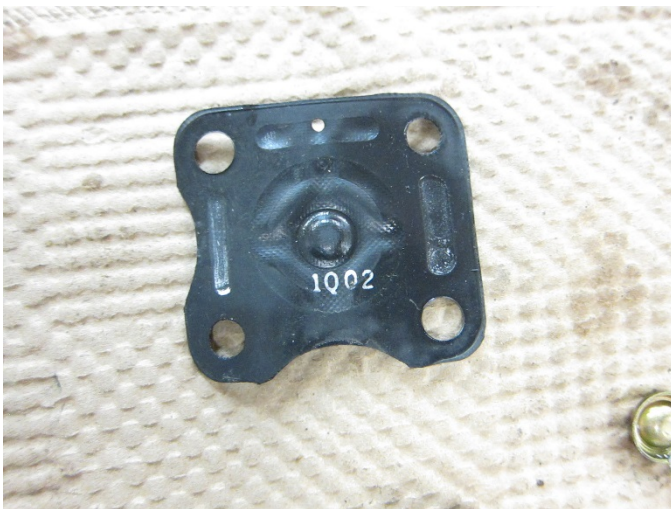
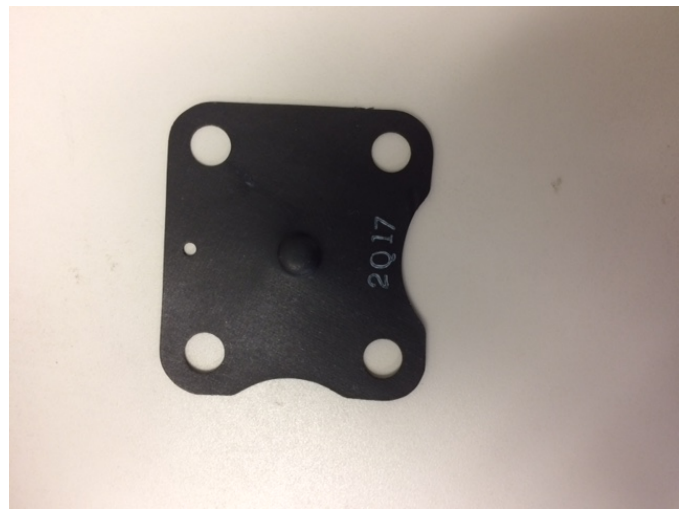
FUEL PUMP	Manufacturer: TCM	P/N: 655921-1A5	S/N: B02FA182
Condition:	The fuel pump was placed on a test bench. The mixture control arm had been bent from impact. A fuel leak was observed near the low pressure valve diaphragm. After the flow test, the fuel pump was disassembled with no pre-impact anomalies noted. There were questions about the diaphragm missing material on one edge of the diaphragm causing the fuel leak, however, it was later determined that the diaphragm was in the same shape as it was manufactured in. The cause of the fuel leak on the test stand was attributed to impact damage as there were no visible fuel stains on the fuel pump.

RPM	Specified Pressure (PSI)	Specified Fuel Flow (PPH)	*Observed PPH @ PSI
599.6	7.00-8.00	6.500-7.000	6.960PPH @ 7.62PSI
2600.9	23.50-24.50	148.00-152.00	149.050PPH @ 43.60PSI
1599.8	15.00-16.50	37.000-38.000	37.530PPH @ 18.42PSI
600.8	7.00-8.00	6.500-7.000	6.650PPH @ 7.44PSI

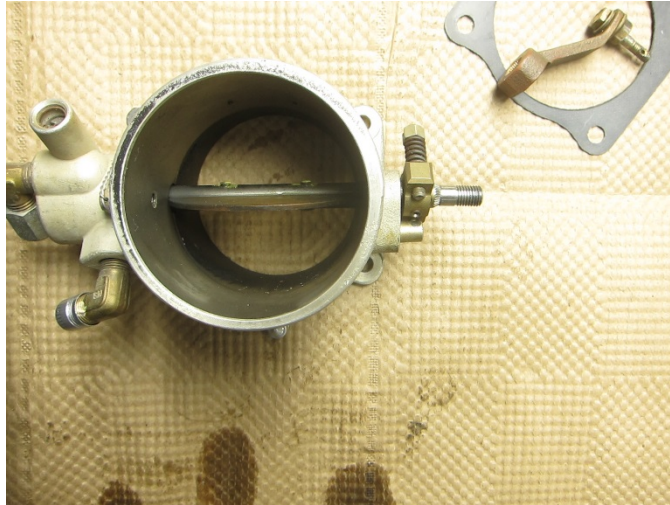
THROTTLE BODY METERING UNIT	Manufacturer: TCM	P/N: 653353-5A1	S/N: A02FA156
Condition:	The throttle control shaft was bent, but otherwise undamaged. The throttle body was placed on a test bench and flow tested.

Throttle and Metering Unit Flow vs. Pressure Test			
Throttle Angle	Inlet Pressure (PSI) Specified: 15.000 PSI	Specified Fuel Flow (min – max) (PPH)	*Observed Flow (PPH)
.035	14.799	14.000-14.700	15.855
8.791	14.931	35.500-42.600	40.071
17.761	15.010	64.500-77.400	67.469
30.071	15.011	102.000-112.200	105.789
47.781	14.981	145.800-156.700	147.721
56.776	14.872	162.400-174.600	162.091
70.631	14.978	180.000-189.000	177.697

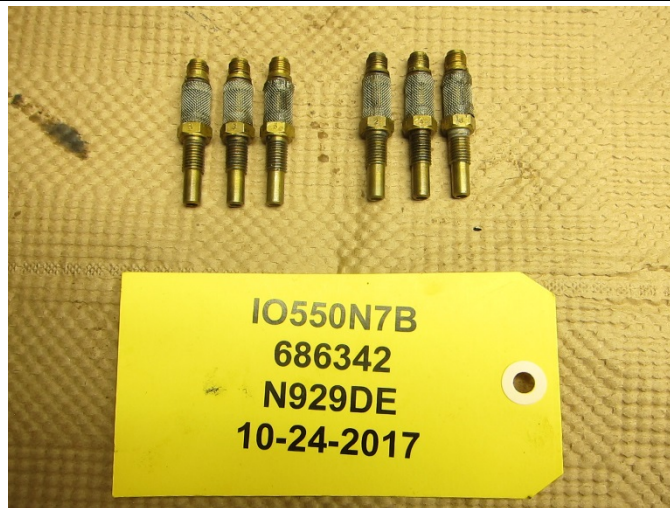
FUEL NOZZLES AND LINES	Manufacturer: GAMI					
Position	#1	#3	#5	#2	#4	#6
Size	12E	12E	12E	12E	12E	12E
Condition:	The fuel nozzles were undamaged and free of obstructions.

Specified Fuel Flow (PPH)	Specified Pressure (PSI)	*Observed Pressure (PSI)
10	3.750-4.550	4.098
50	5.790-6.590	6.071
100	10.580-10.980	10.794
150	17.710-18.510	18.075
