Continental Motors

ENGINE RUN REPORT

ENGINE MODEL	A-65-8
ENGINE SERIAL NUMBER	418476-8
AIRCRAFT MAKE & MODEL	Luscombe 8A
AIRCRAFT SERIAL NUMBER	2378
AIRCRAFT REGISTRATION	N45851
FILE NUMBER	17-012

EXAMINATION		ACCIDENT DATA	
DATE	10/18/2017	NTSB ACCIDENT #	ERA17FA226
FACILITY	CMI Analytical Department	NTSB INVESTIGATOR	Leah Read
ADDRESS	<div style="background-color: black; width: 150px; height: 15px; margin-bottom: 5px;"></div> Mobile, Alabama 36615	FAA INVESTIGATOR	Michael Baringer
		ACCIDENT DATE	07/04/2017
		ACCIDENT LOCATION	Remsen, New York

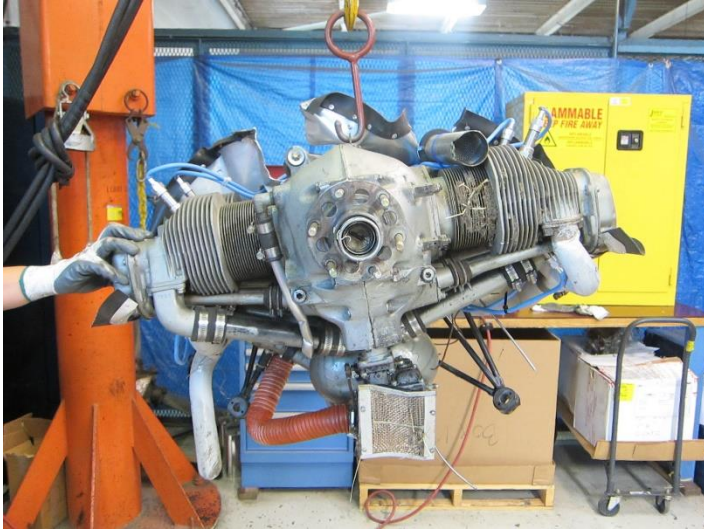
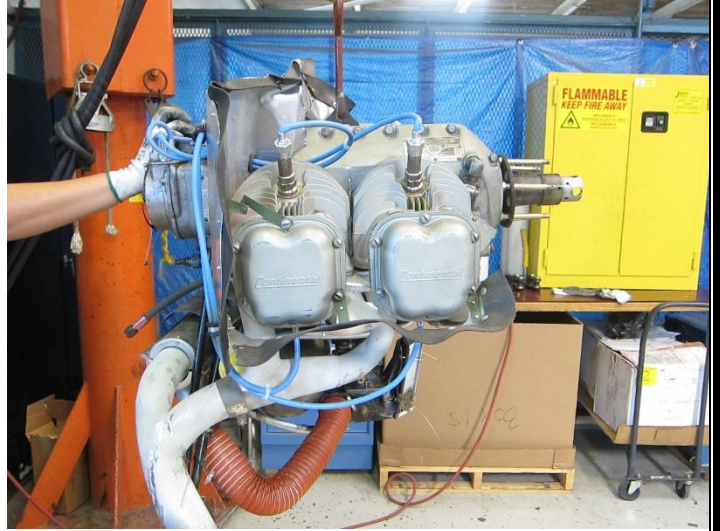
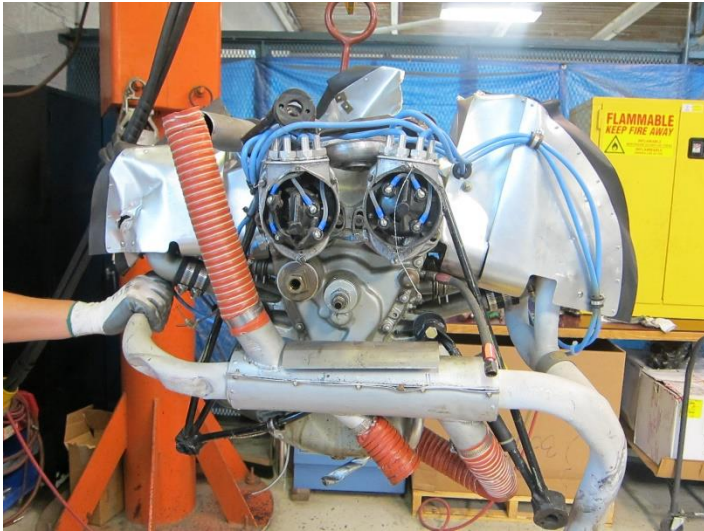
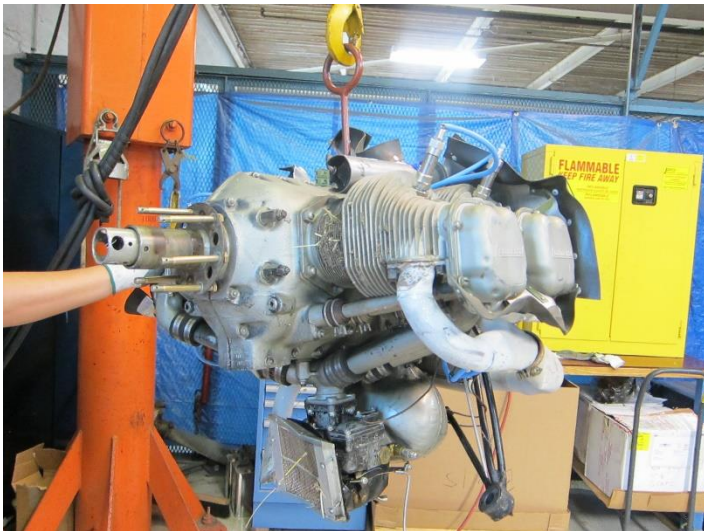
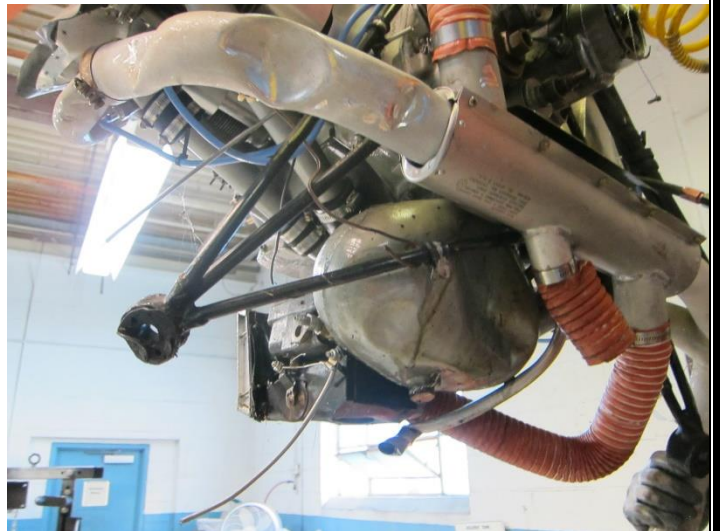
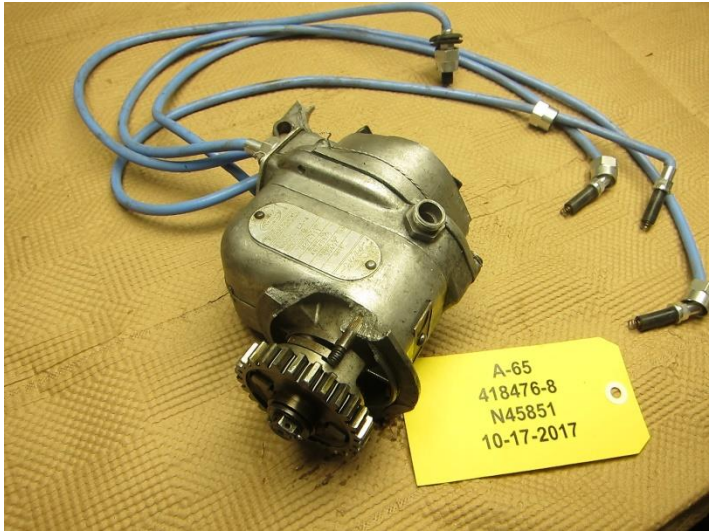
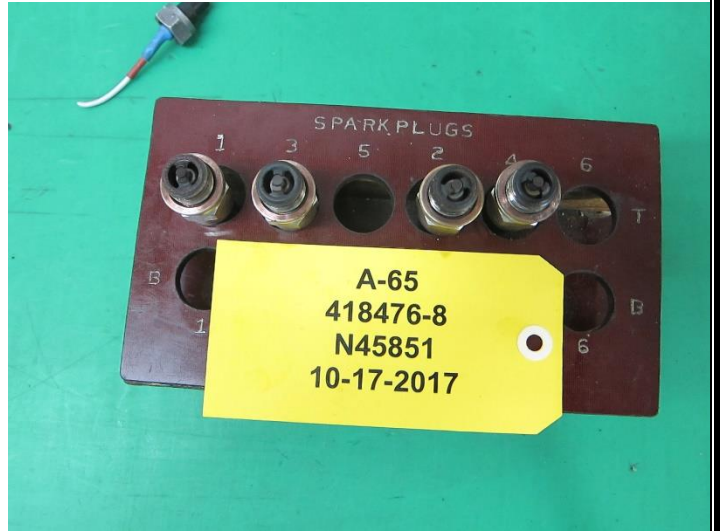
The left magneto was separated from the mounting flange, and the oil sump had heavy impact damage. All of the cylinders had chrome markings.
