NATIONAL TRANSPORTATION SAFETY BOARD

17 – Cell Phone Factual Report

Specialist's Factual Report by Bill Tuccio

Location: Lake in the Hills, Illinois
Date: May 3, 2012
Aircraft: Beechcraft S35
Registration: N176Q
Operator: Private
NTSB Number: CEN12FA271

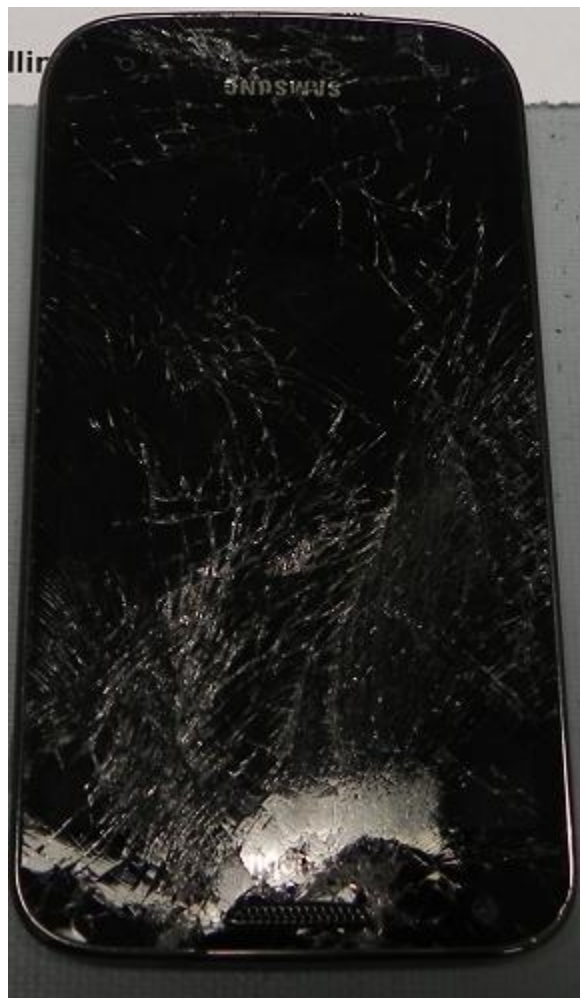
Upon arrival at the Vehicle Recorder Laboratory, an exterior examination revealed that the unit had sustained major damage from impact, including damage to the touch screen, as shown in figures 1 and 2. An internal inspection revealed no internal damage, as shown in figure 3, and a 2GB micro-SD storage card. The 2GB micro-SD card was downloaded, and information on the phone was recovered using Samsung's Kies synchronization software.

Figure 1. Samsung Galaxy S II – front of device.

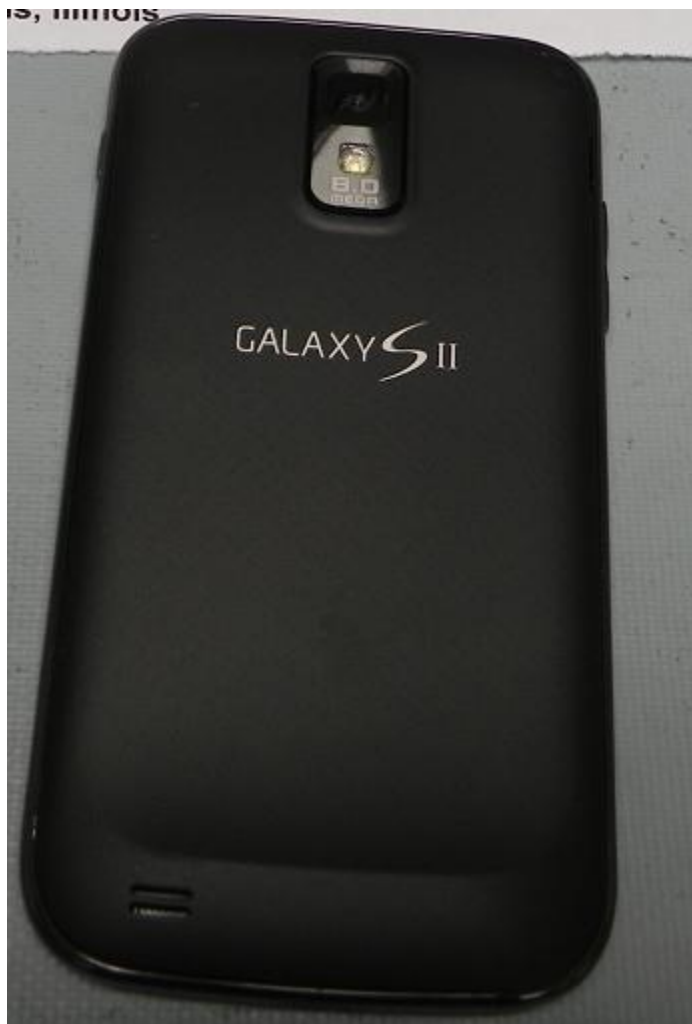
Figure 2. Samsung Galaxy S II – back of device.

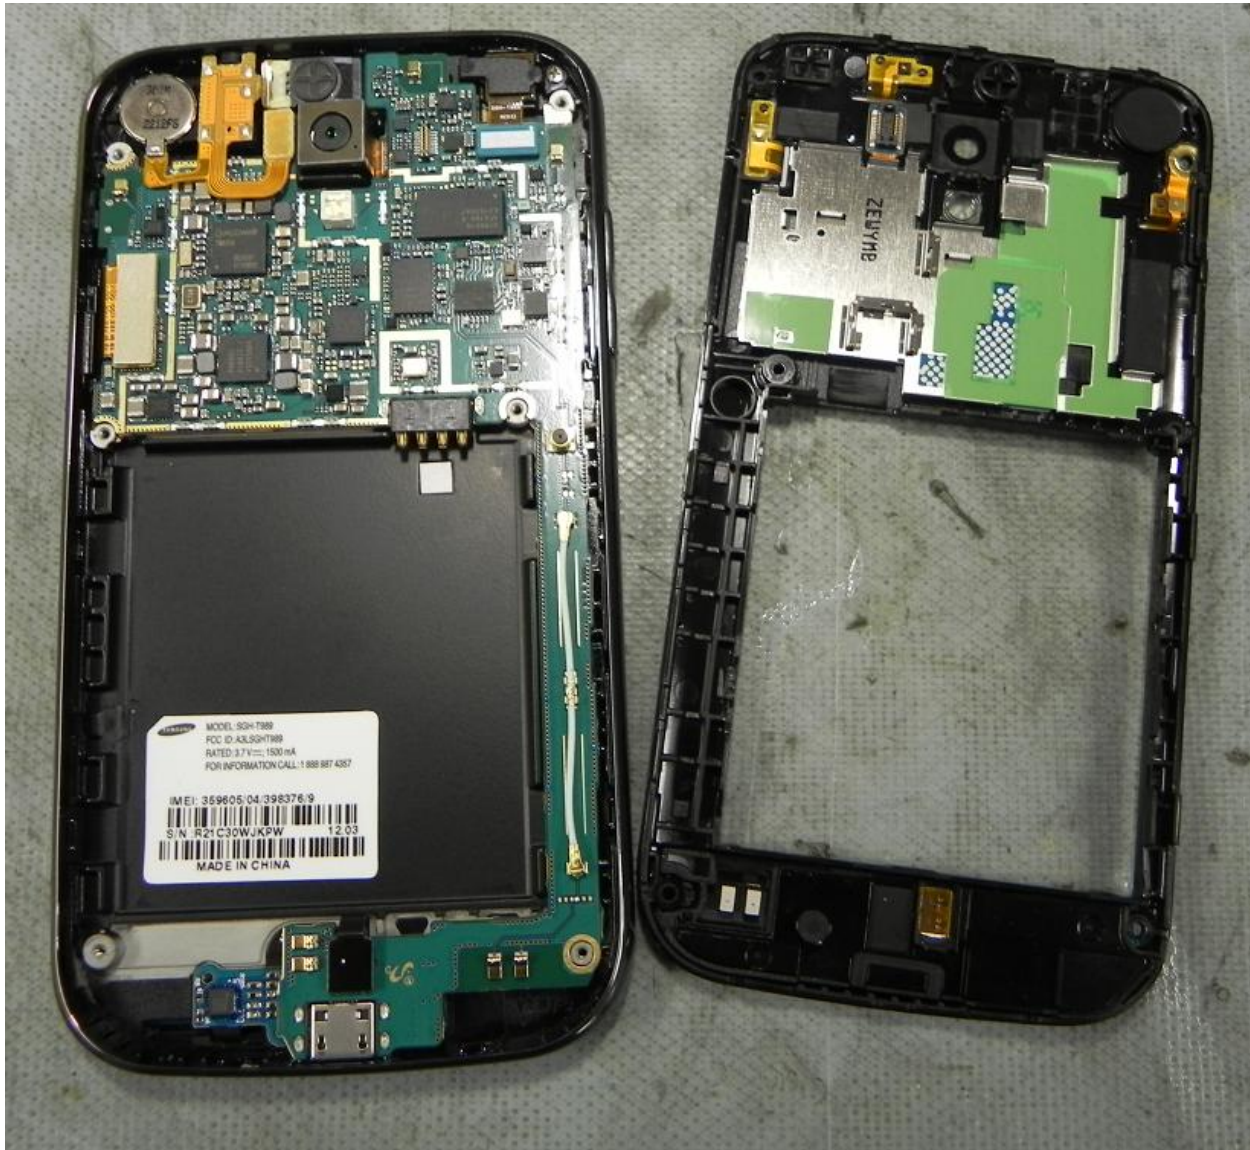
Figure 3. Samsung Galaxy S II – internal inspection.

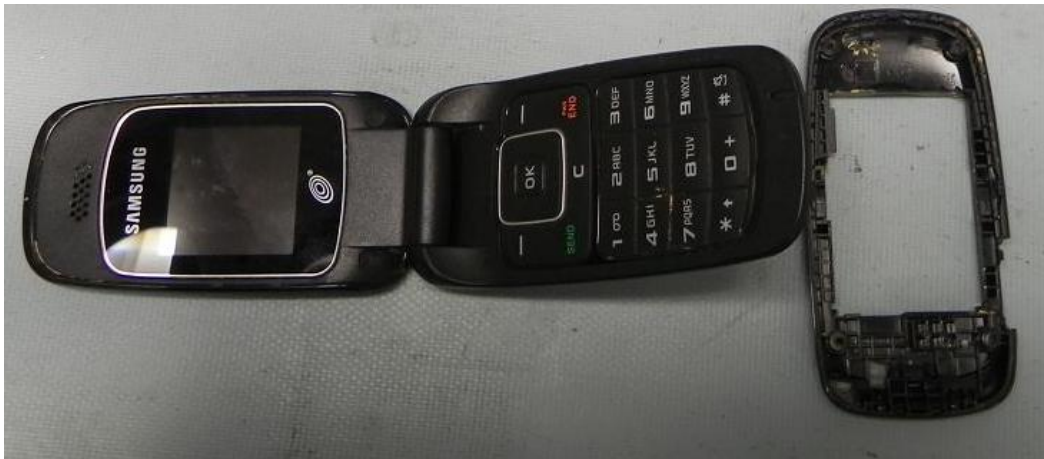
Upon arrival at the Vehicle Recorder Laboratory, an exterior examination revealed that the unit had sustained minimal damage, as shown in figures 4 and 5. The battery was missing from the phone. The phone could not be powered normally, and no extraordinary means were attempted to power the phone. However, the SIM card data was downloaded without difficulty.

Figure 4. Samsung TracFone - front of device.

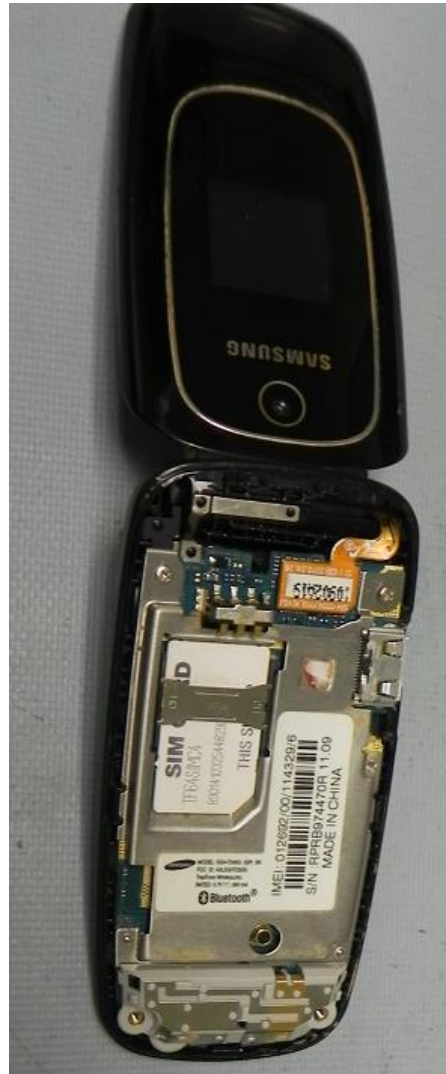
Figure 5. Samsung TracFone - back of device.
