REVISION TRANSMITTAL

FLIGHT CONTROLS - ELEVATOR TRIM-TAB PUSH-PULL TUBE HARDWARE REPLACEMENT

To replace the hardware securing the elevator trim tab push-pull tube to the elevator trim tab actuator and the elevator trim tab horn.

MEB-27-02
Page 1 of 8

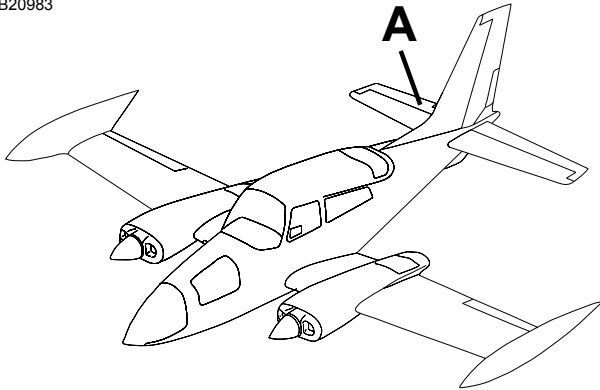
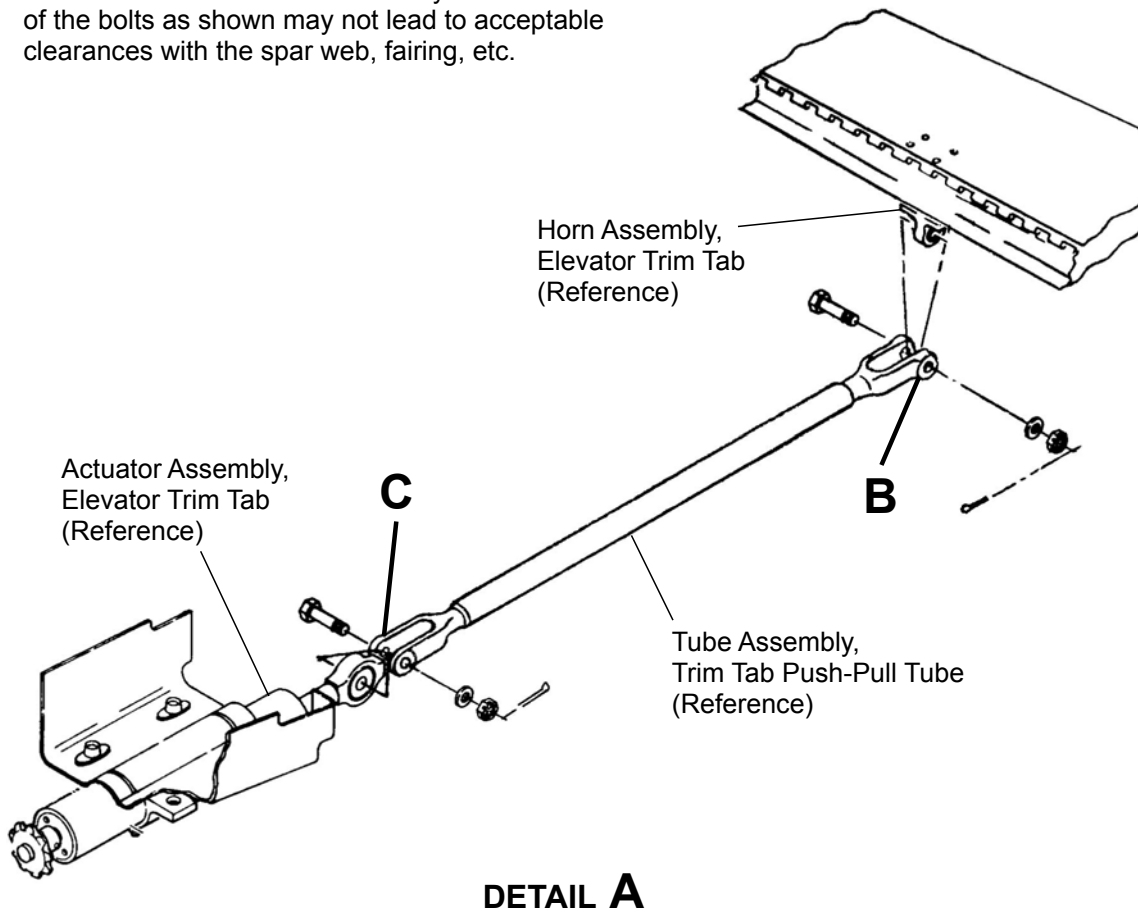
Figure 1. Elevator Trim-Tab Push-Pull Tube Hardware (Sheet 1)

NOTE: Model 310R shown, location for trim tab push-pull tube similar on other models.

NOTE: This illustration is for reference only. The orientation of the bolts as shown may not lead to acceptable clearances with the spar web, fairing, etc.

4. (Refer to Figure 1, Sheet 1 and Sheet 2.) Install the NAS464P3-8 Bolt, NAS1149F0332P Washer, MS17826-3 Nut and MS24665-132 Cotter Pin in the elevator trim tab actuator rod end to push-pull tube connection as follows:

- NOTE:** It is permissible to substitute the NAS464P3-X bolt with a NAS6203-X bolt.
 - A. (Refer to Figure 1, Sheet 1 and Sheet 2.) Install the NAS464P3-8 Bolt in the elevator trim tab actuator rod end to push-pull tube connection in the orientation (i.e., bolt head inboard or outboard) which yields the greatest clearance with the spar web cut-out and any other structures.

- D. Make sure a minimum of one full bolt thread is protruding from the castellated nut.
 - E. Install the MS24665-132 Cotter Pin.
5. (Refer to Figure 1, Sheet 1 and Sheet 2.) Remove the nut, washer and bolt from the elevator trim actuator push-pull tube to elevator trim tab horn.

6. (Refer to Figure 1, Sheet 1 and Sheet 2.) Install the NAS464P3-8 Bolt, NAS1149F0332P Washer, MS17826-3 Nut and MS24665-132 Cotter Pin in the elevator trim tab actuator push-pull tube to elevator trim tab horn connection as follows:

- NOTE:** It is permissible to substitute the NAS464P3-X bolt with a NAS6203-X bolt.
 - A. (Refer to Figure 1, Sheet 1 and Sheet 2.) Install the NAS464P3-8 Bolt in the push-pull tube to elevator trim tab horn.

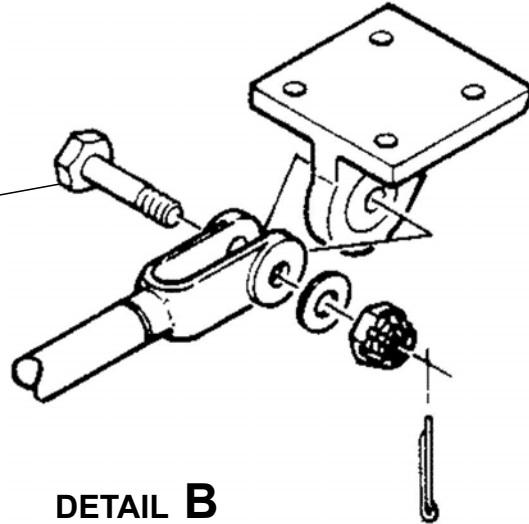
DETAIL B

NAS464P3-8 or
 NAS464P3-9
 Bolt
 (1 Required)
 NAS1149F0332P
 and/or
 NAS1149F0316P
 Washer
 (1 or More as Required)
 MS17826-3
 Nut
 MS24665-132
 Cotter Pin
 (1 Each Required)

NOTE: This illustration is for reference only.
 The orientation of the bolts as shown may
 not lead to acceptable clearances with
 the spar web, fairing, etc.

- NOTE:** The bolt grip length may be adjusted to the next longer grip length (NAS464P3-9) to permit proper installation of the castellated nut and cotter pin. This may require extra washers (NAS1149F0316P and/or NAS1149F0332P) for proper alignment of the castellated nut cotter pin slot and the cotter pin hole in the bolt.

- C. Torque the MS17826-3 Nut 12 Inch-Pounds, if a castellation of the nut does not align with the cotter pin hole in the bolt, continue tightening to the next alignment position up to 20 Inch-Pounds.

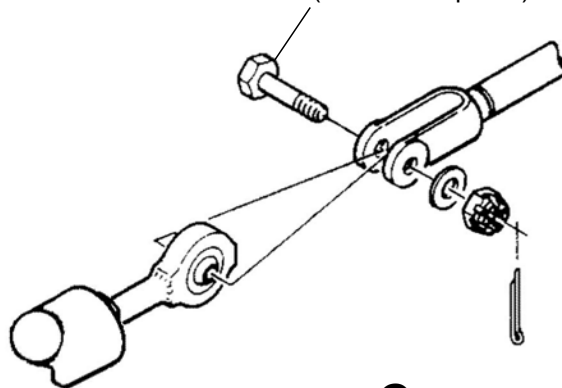
DETAIL C

NAS464P3-8 or
 NAS464P3-9
 Bolt
 (1 Required)
 NAS1149F0332P
 and/or
 NAS1149F0316P
 Washer
 (1 or More as Required)
 MS17826-3
 Nut
 MS24665-132
 Cotter Pin
 (1 Each Required)

- NOTE:** The bolt grip length may be adjusted to the next longer grip length (NAS464P3-9) to permit proper installation of the castellated nut and cotter pin. This may require extra washers (NAS1149F0316P and/or NAS1149F0332P) for proper alignment of the castellated nut cotter pin slot and the cotter pin hole in the bolt.

- C. Torque the MS17826-3 Nut 12 Inch-Pounds, if a castellation of the nut does not align with the cotter pin hole in the bolt, continue tightening to the next alignment position up to 20 Inch-Pounds.
