NATIONAL TRANSPORTATION SAFETY BOARD

Cockpit Display

Specialist's Factual Report
by Bill Tuccio, Ph.D.

Location: Friendly, Maryland
Date: February 6, 2017
Aircraft: Piper PA-32R-301
Registration: N21HD
Operator: Private
NTSB Number: ERA17LA100

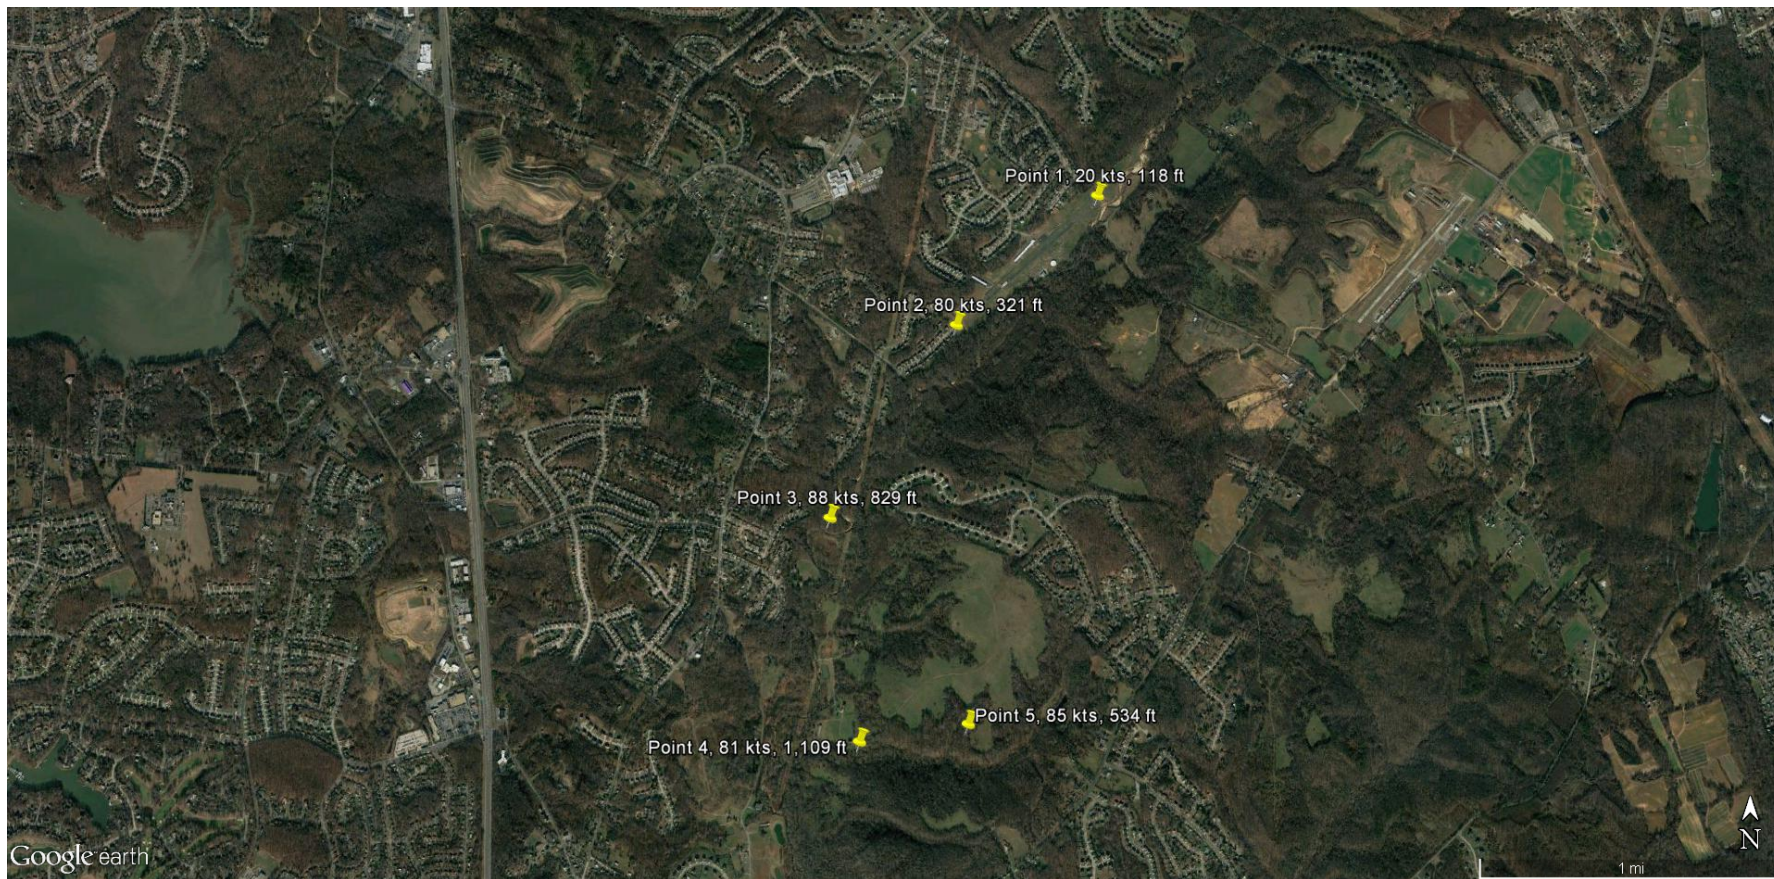
Figure 1. Accident flight.

Figure 1 shows a Google Earth overlay of the five points. The first recorded point was at the northeast side of runway 24 at VKX. After departure, the aircraft tracked left (southerly) and climbed. The maximum recorded altitude was 1,109 ft (the fourth recorded point). The fifth and final point was northeast of the prior point, at an altitude of 534 ft.

Weather and lighting conditions shown in figure 1 are not necessarily representative of the weather and lighting conditions at the time of the accident.
