# NATIONAL TRANSPORTATION SAFETY BOARD

## Cockpit Display

**Specialist's Factual Report**  
**By Bill Tuccio, Ph.D.**

Location: Methuen, Massachusetts  
Date: February 28, 2017  
Aircraft: Sonex  
Registration: N315AL  
Operator: Private  
NTSB Number: ERA17FA117

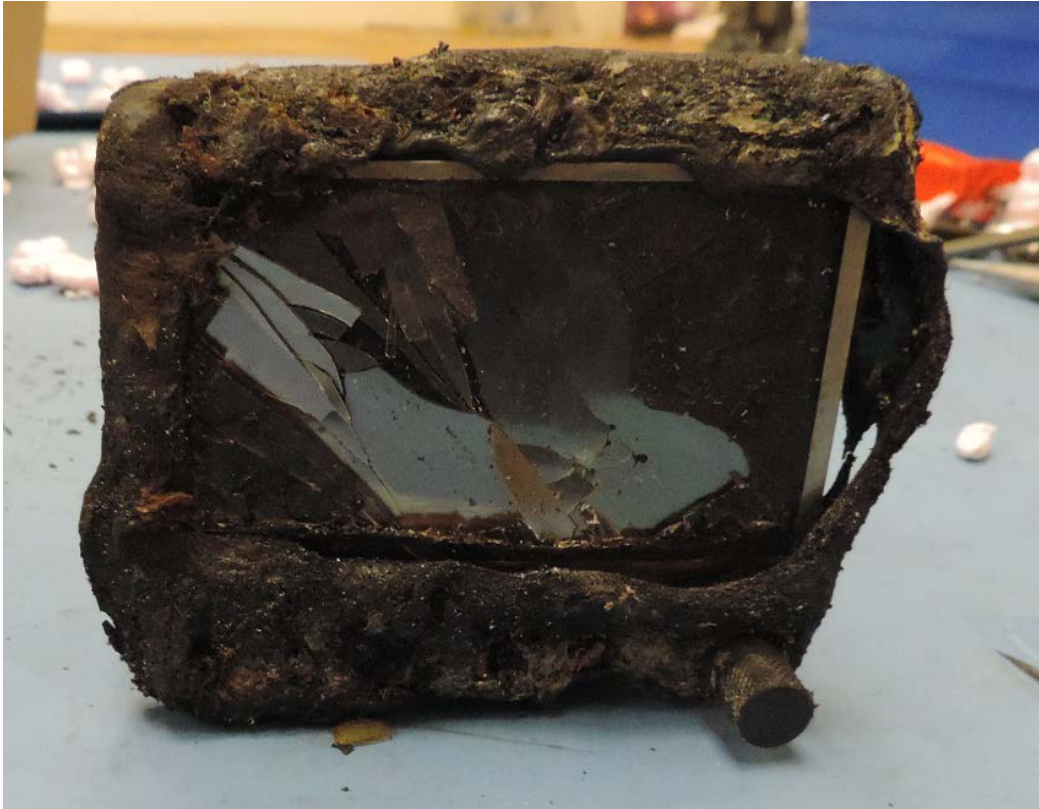
The instrument panel was damaged by impact and heat damage. The Xtreme-EFIS was removed from the instrument panel, as shown in figure 1. The front-loaded SD card was not accessible due to heat damage, so the unit was disassembled, as shown in figure 2. The SD card was recovered, though the non-terminal side was fused to part of the Xtreme-EFIS assembly, as shown in figure 3.

**Figure 1. Xtreme-EFIS, after removal from instrument panel.**

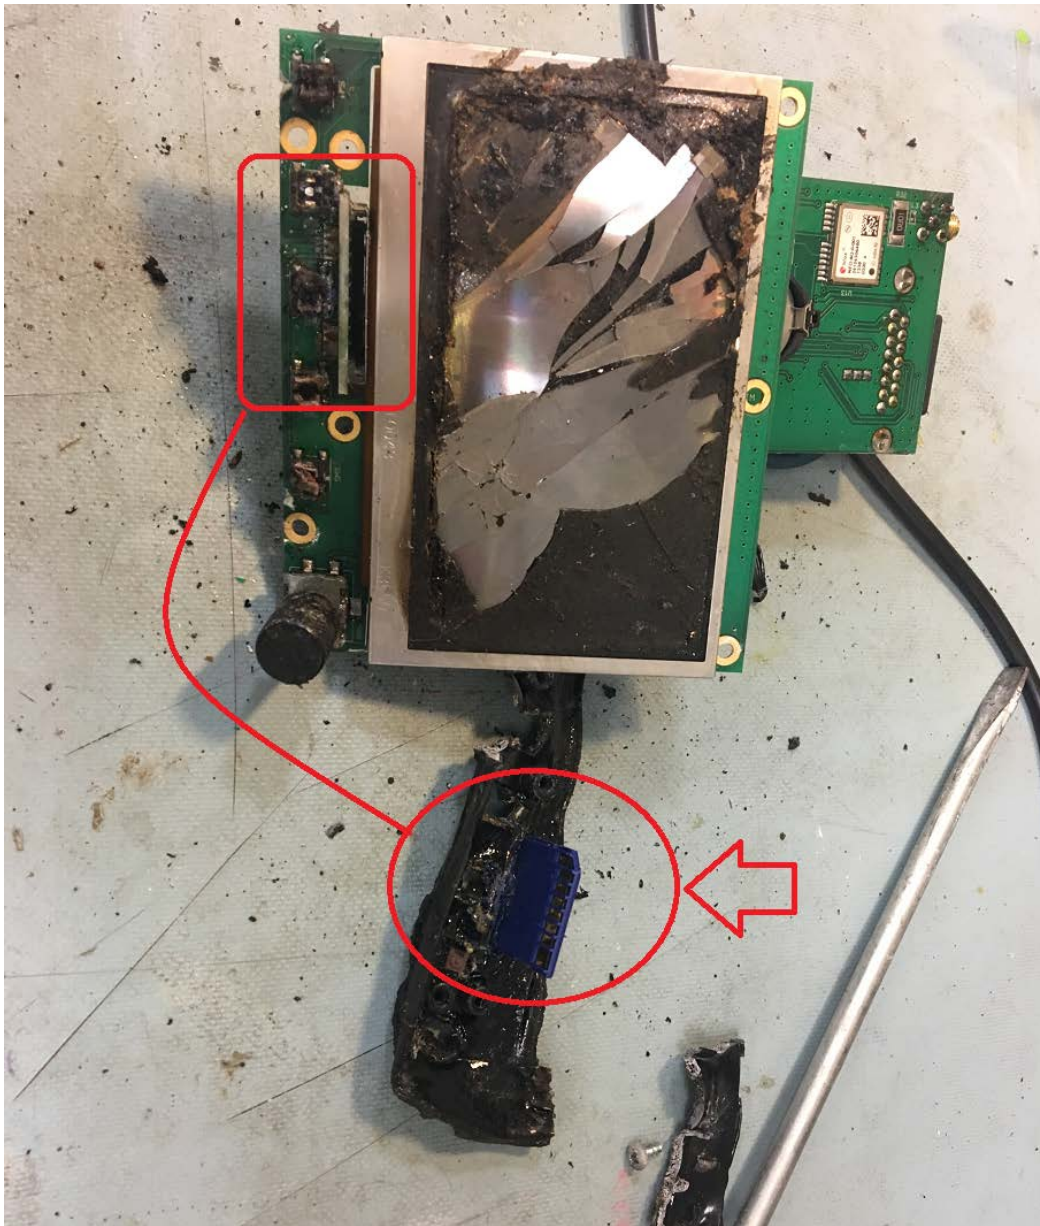
Figure 2. Disassembly to remove SD card.

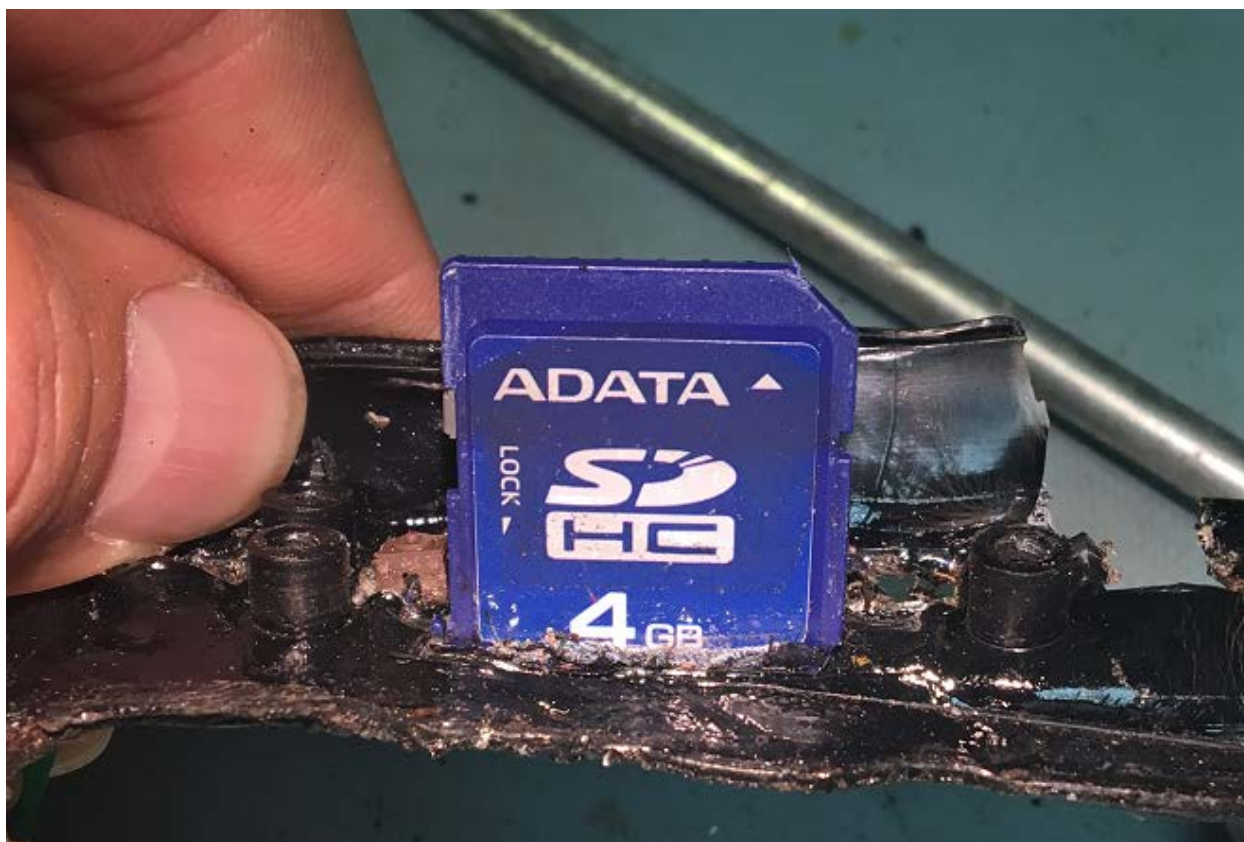
Figure 3. SD Card removed from unit.

The SD card was successfully read and the enigma.rec file was converted using the manufacturer's software. Only one file from February 5, 2016, was recovered and this file was consistent with a ground-only operation. No data pertinent to the investigation was recovered.
