NATIONAL TRANSPORTATION SAFETY BOARD

Cockpit Displays – Recorded Flight Data

Specialist's Factual Report
by Kyle Garner

Location: Seward, Alaska
Date: June 21, 2019
Aircraft: Helio H-250
Registration: N6314V
Operator: Private
NTSB Number: ANC19FA026

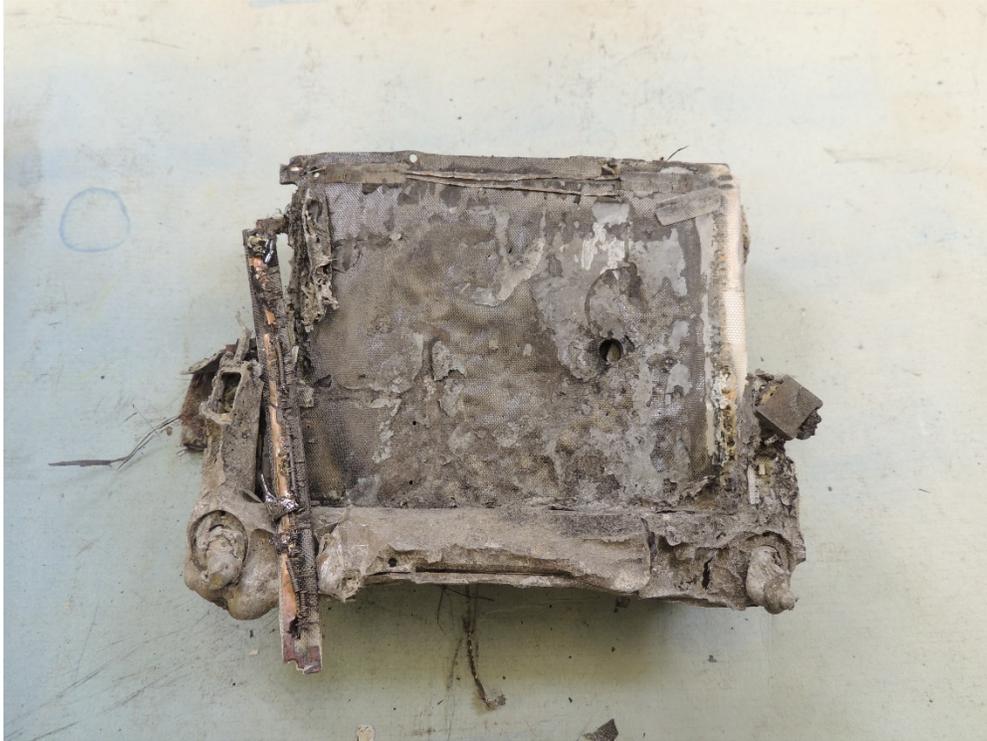
Upon arrival at the Vehicle Recorder Laboratory, an initial examination revealed that both units had sustained severe fire damage. The extent of the damage is shown in Figure 1 and 2.

Figure 1. Photo of damaged unit #1

This device is capable of storing data in the non-volatile memory (NVM)¹. The extent of the fire damage precluded normal recovery procedures and additional attempts were unsuccessful in yielding usable data. Therefore, no data pertinent to the event were recovered.

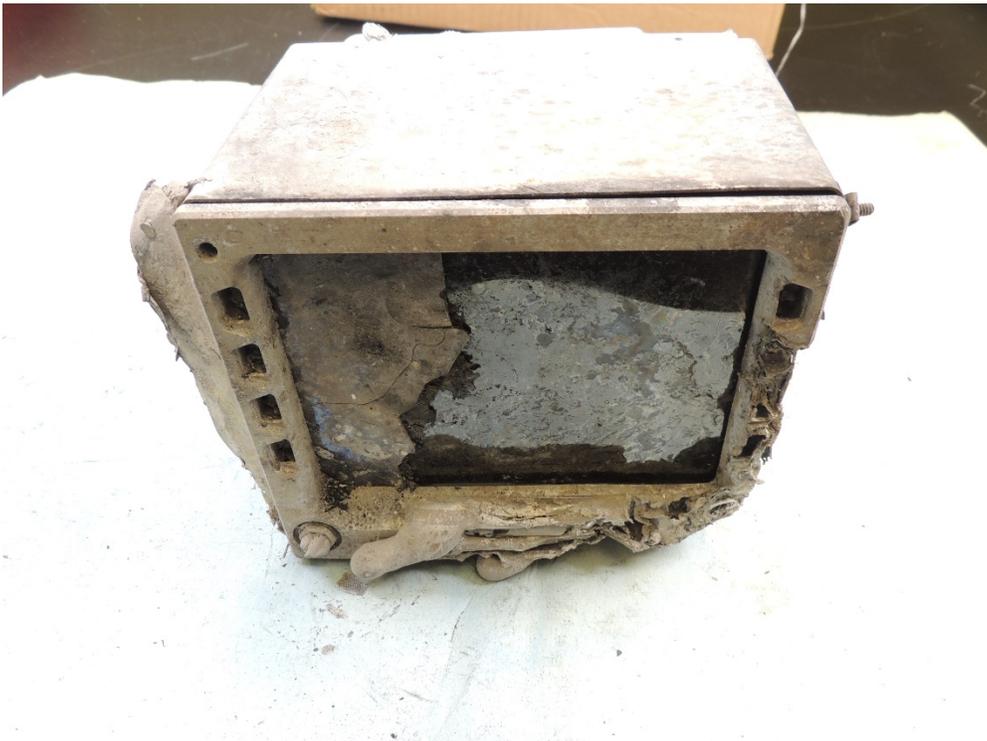
Figure 2. Photo of damaged unit #2

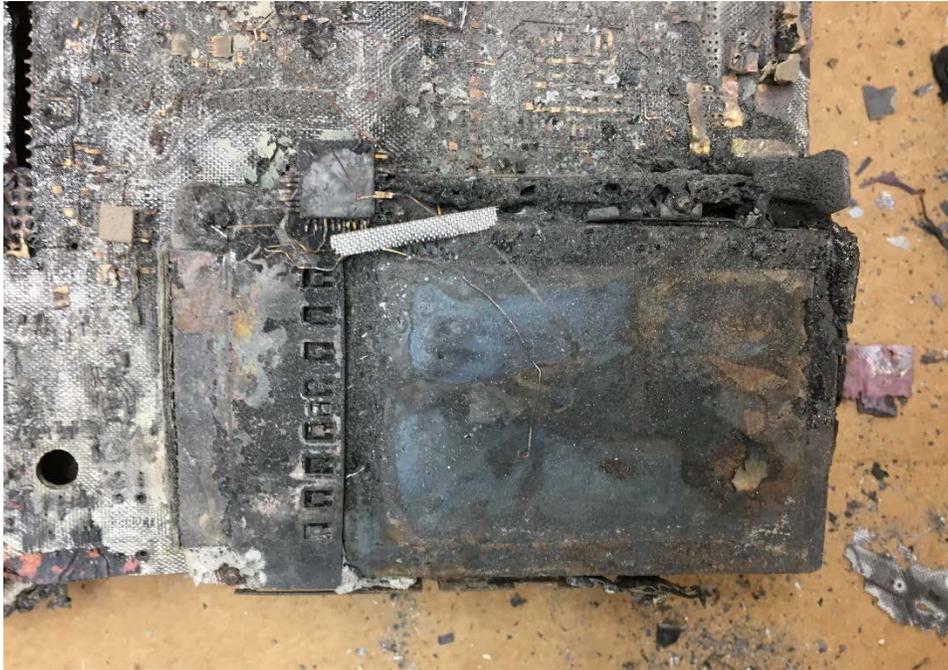
The PCMCIA flash memory cards were located on each device and were found to also have severe fire damage. The extent of the damage to the flash memory cards is shown in Figure 3 and 4.

Figure 3. Photo of damaged PCMCIA flash memory card on unit #1

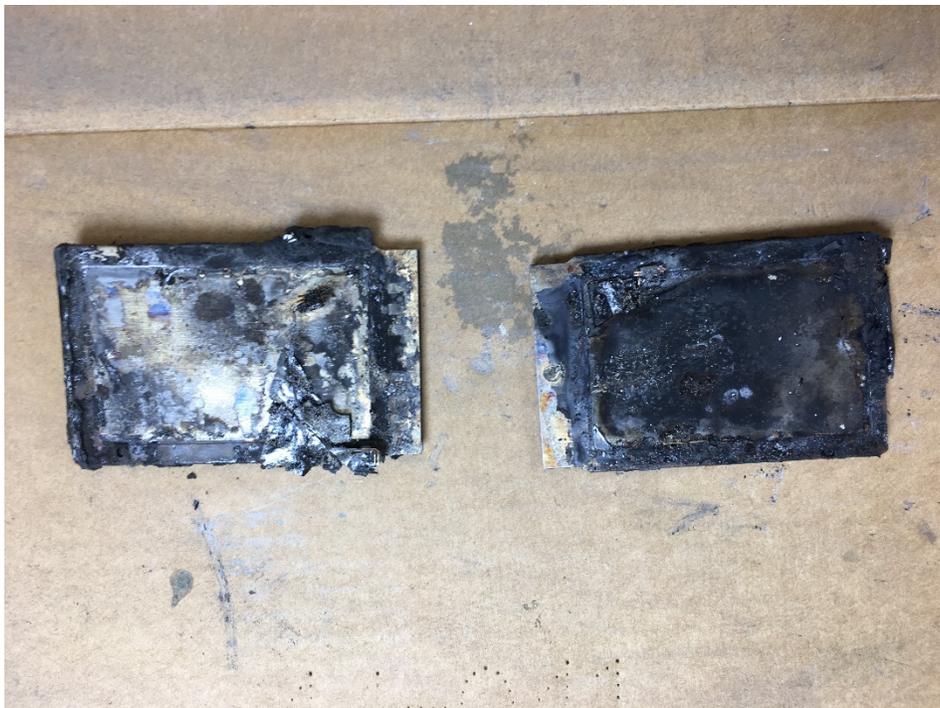
Figure 4. Photo of damaged PCMCIA flash memory card on unit #2
