NATIONAL TRANSPORTATION SAFETY BOARD

Vehicle Recorder Division

Cockpit Displays – Recorded Flight Data

Specialist's Factual Report

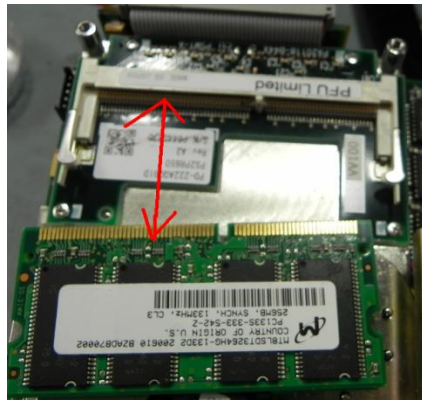
Figure 2. Dislodged internal component (from Sierra Flight Systems IDU Serial Number 201).

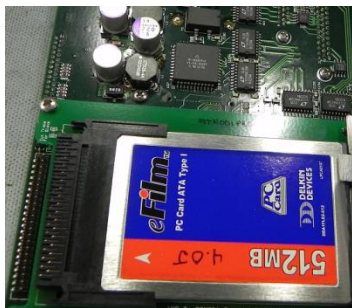
Figure 3. Internal PCMCIA card from Sierra Flight Systems IDU Serial Number 201.

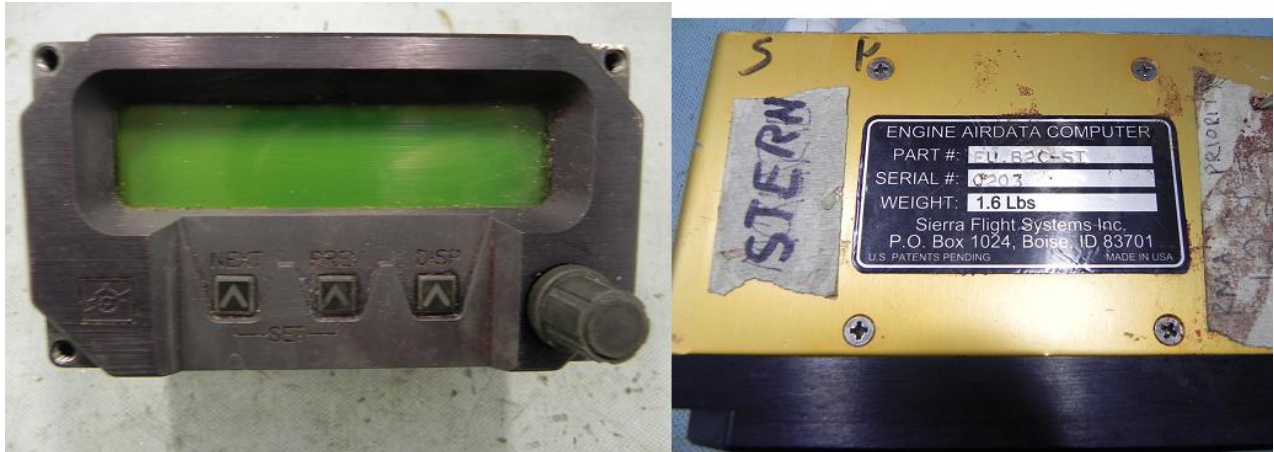
The Sierra Flight Systems Engine AirData Computer (figure 4) and the three SmartMedia memory cards (figure 5) were not analyzed for this report. The Sierra Flight Systems Engine AirData Computer did not record any data; instead it supplied its data to the Sierra Flight Systems IDUs.

Figure 4. Sierra Flight Systems Engine AirData Computer.

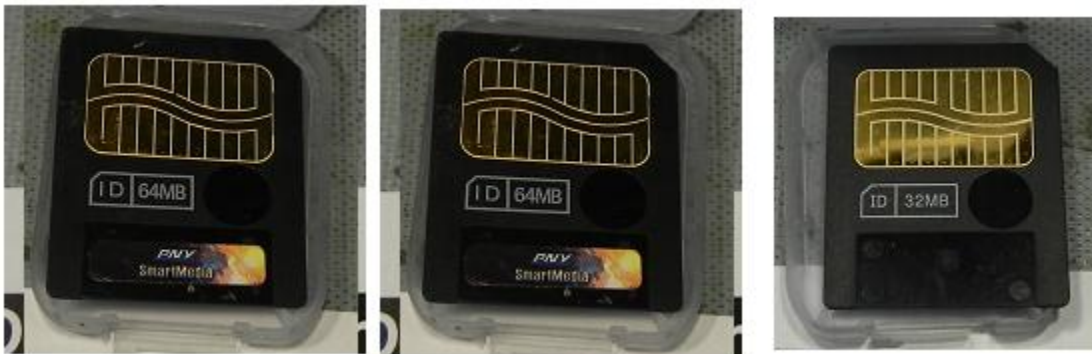
The SmartMedia cards are normally used to transfer database information to or from the various Sierra Flight Systems units. Rather than using the SmartMedia cards for data download, the internal PCMCIA cards from the Sierra Flight Systems IDUs were directly downloaded to retrieve the recorded information as described in section 3.1.1.1.

Figure 5. Smartmedia memory cards.
