GROUP CHAIRMAN'S FACTUAL REPORT OF INVESTIGATION

ERA17FA066

Cockpit Voice Recorder

Location: Camilla, Georgia
Date: December 05, 2016
Aircraft: Fairchild SA227-AC, Registration N765FA
Operator: Key Lime Air Corp, Flight 308
NTSB Number: ERA17FA066

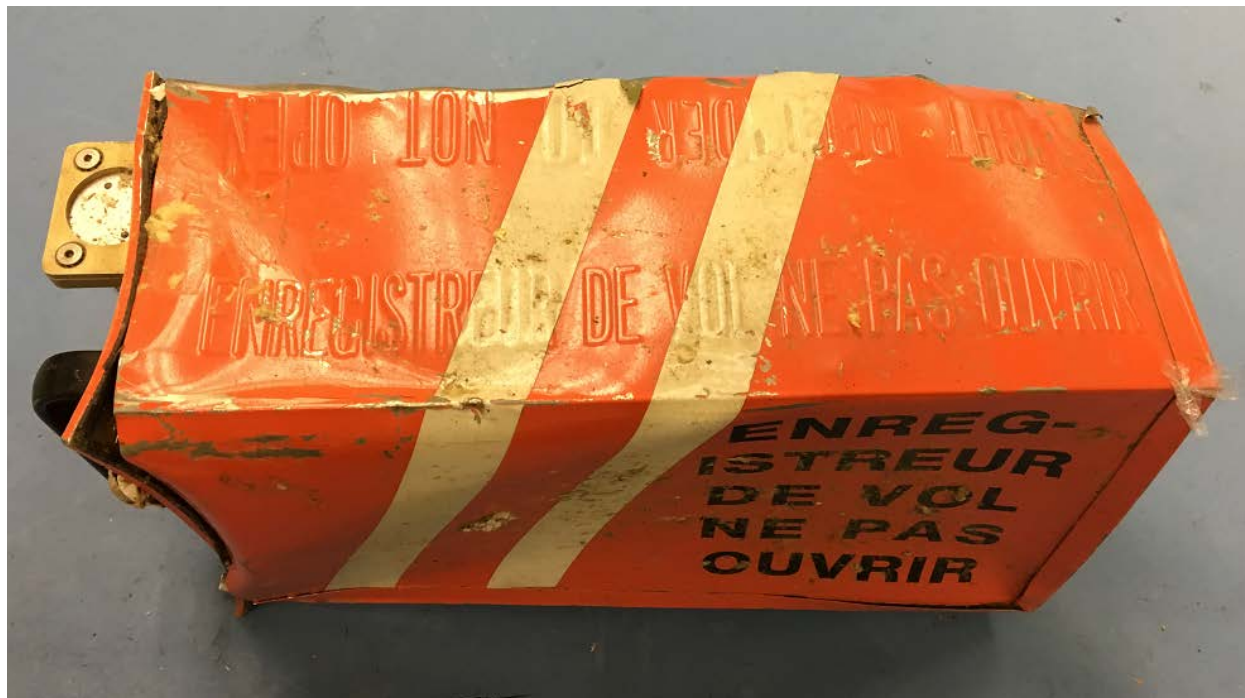
Figure 1. CVR as received.

Upon arrival at the laboratory, it was evident that the exterior of the CVR had sustained structural damage, as shown in figure 1. The outer case was removed and the interior crash-protected case did not appear to have any significant structural damage, as shown in figure 2. The crash-protected case was opened and revealed damage to part of the tape, as shown in figures 3 and 4. The magnetic tape was retrieved from within the crash-protected case and was successfully read out, with minor distortion audible in limited portions of the 30-minute recording.

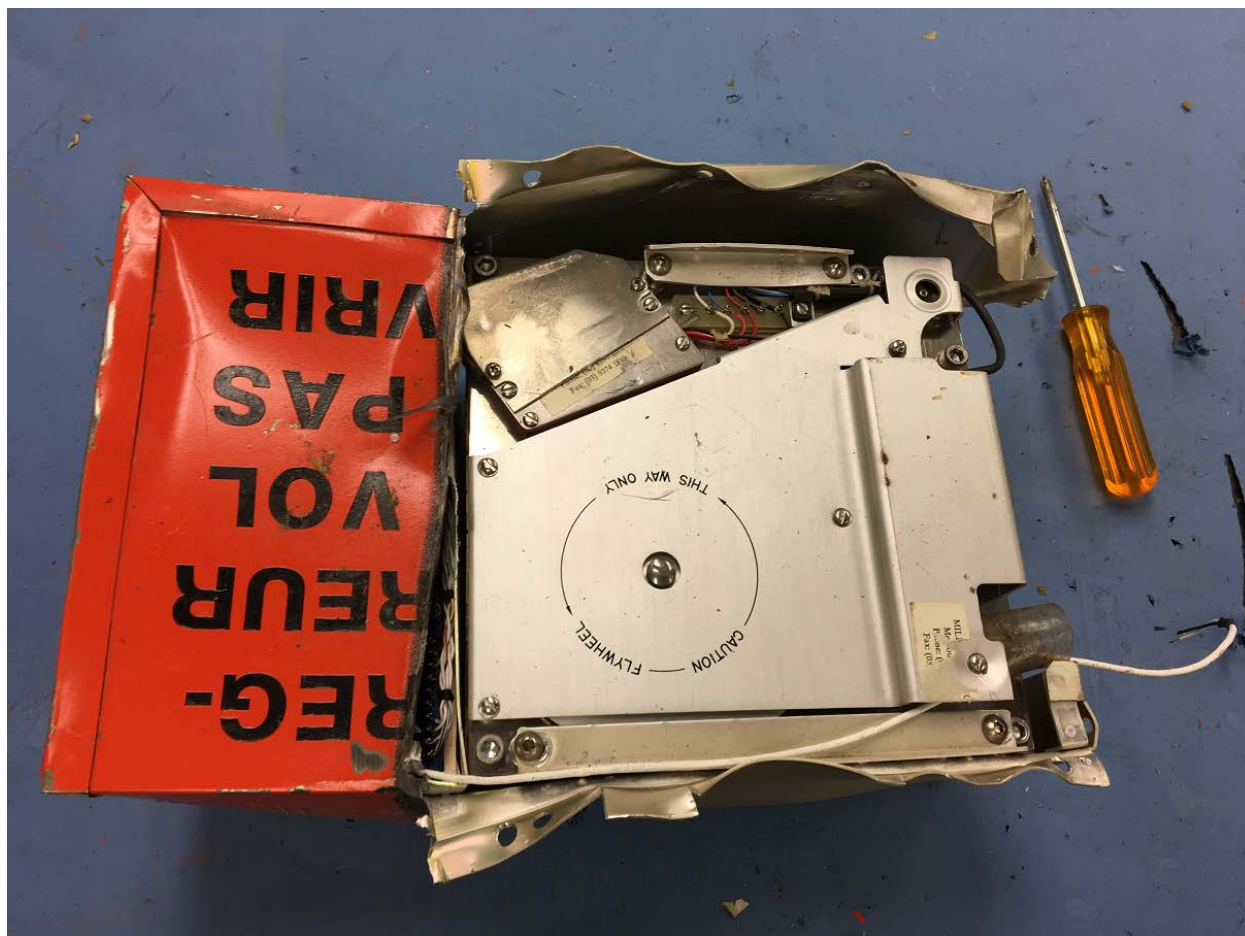
Figure 2. Crash-protected case.

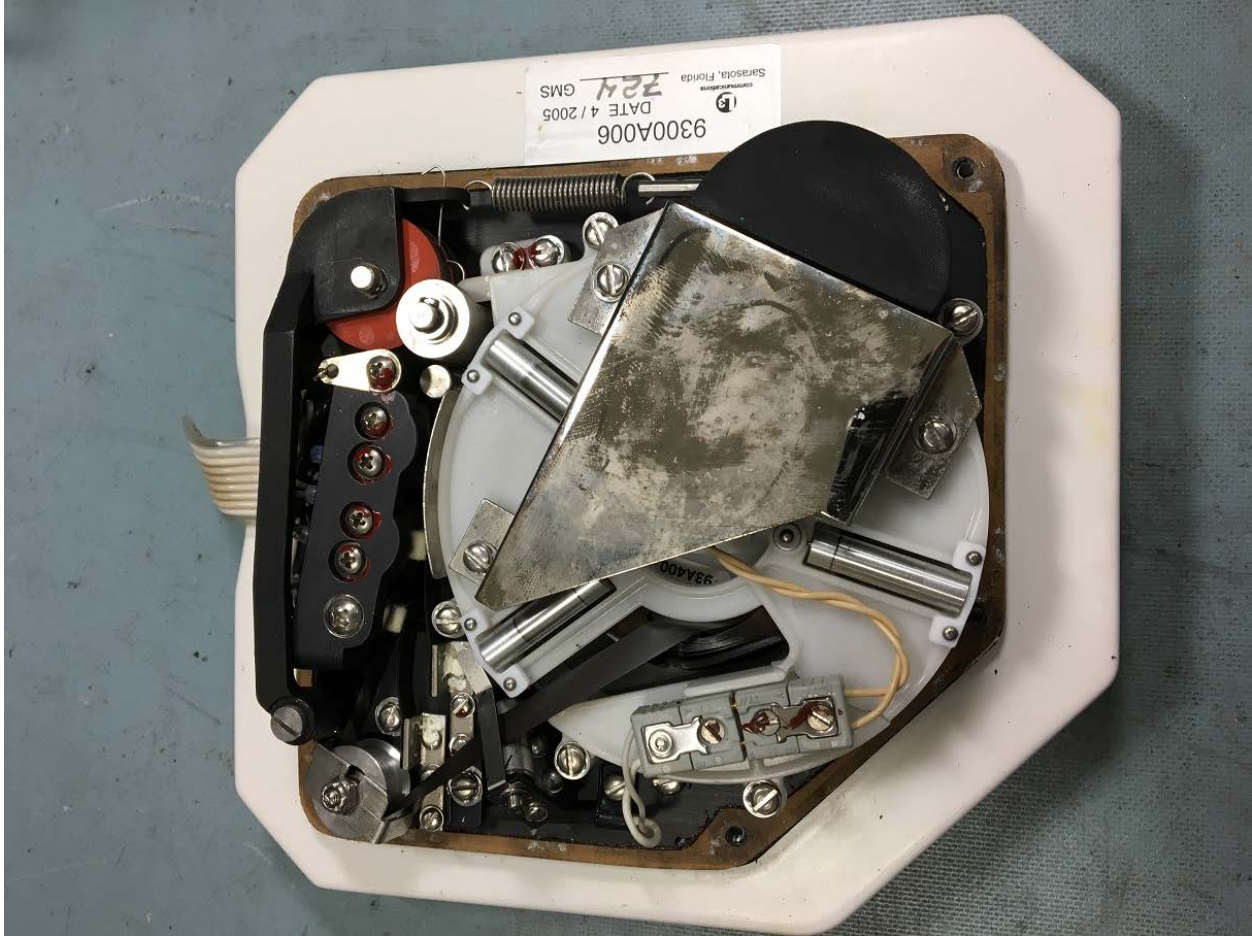
Figure 3. Tape housing inside crash-protected case.

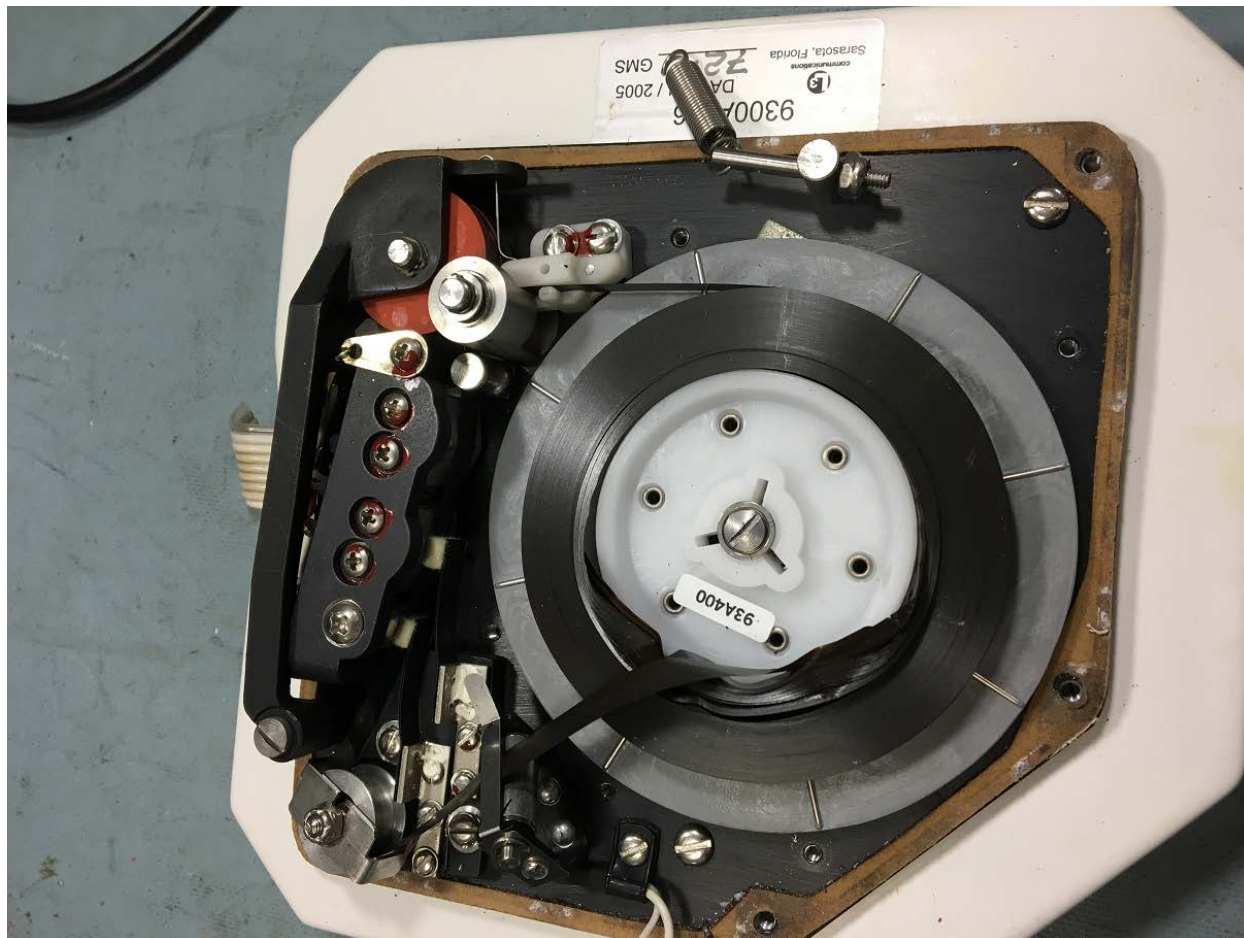
Figure 4. Damaged tape on spool.
