# **Continental Motors**

## **ENGINE OPERATIONAL TEST**

<b>DATE</b>	July 24, 2014
<b>REGISTRATION #</b>	N7311U
<b>ENGINE MODEL</b>	TSIO-520-GcM
<b>ENGINE SERIAL</b>	216054-R
<b>INSPECTOR</b>	Phillip Grice
<b>SEARCH CODE</b>	15-12-68

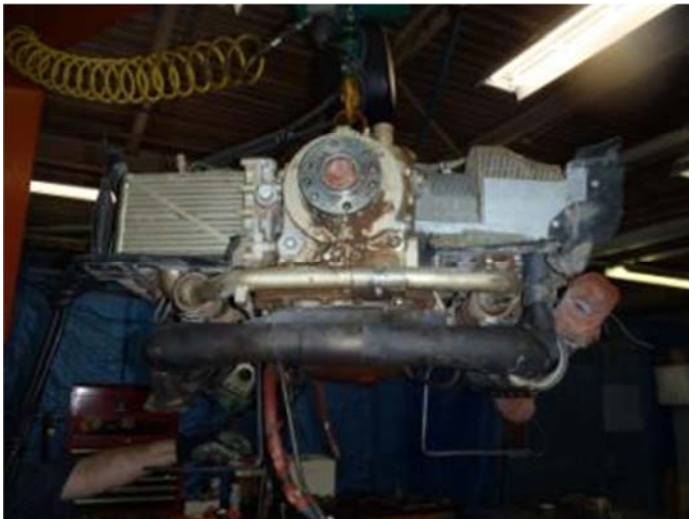
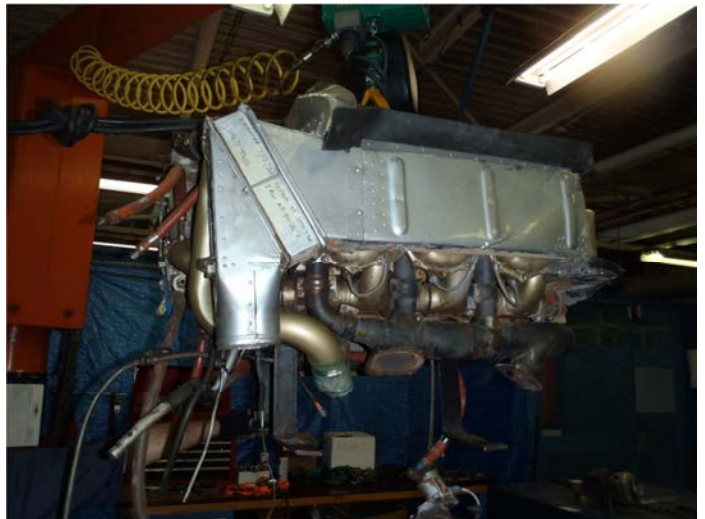
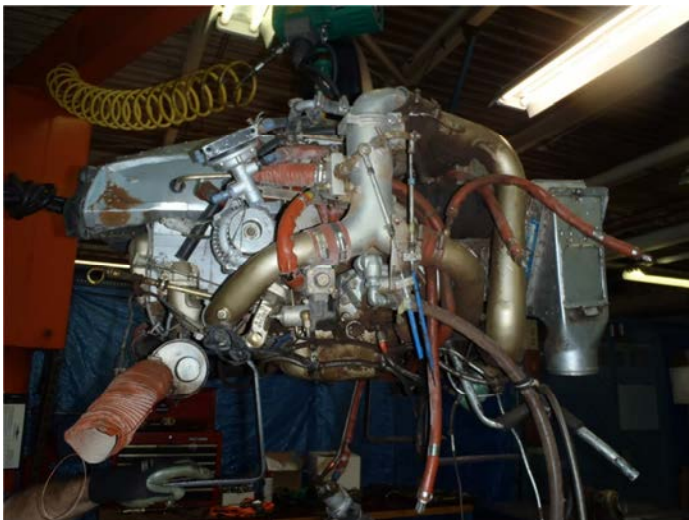
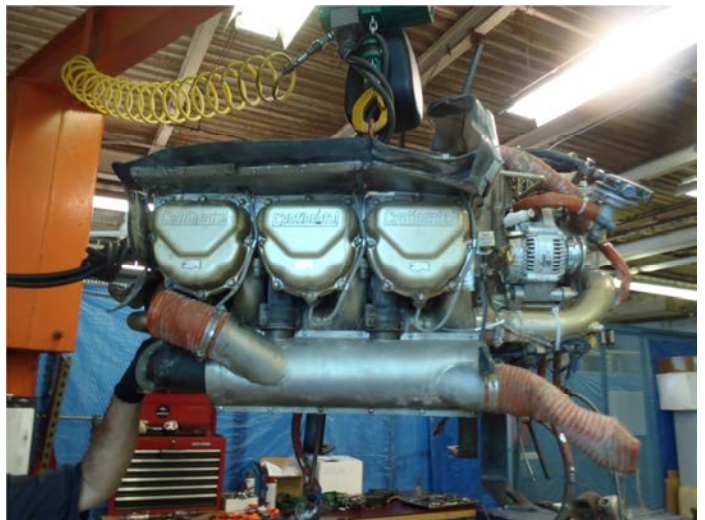
The engine exhibited impact damage concentrated at the bottom of the engine. The oil sump sustained impact damage and was crushed. The intake elbow going into the throttle body displayed impact damage and was cracked. The exhaust tailpipe displayed impact damage and was bent. It was noted that two of the intake coupling clamps were only partially secured to the coupling.

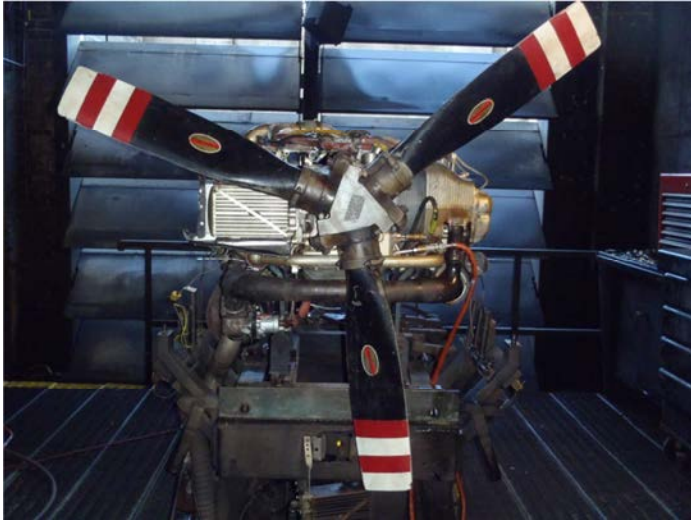
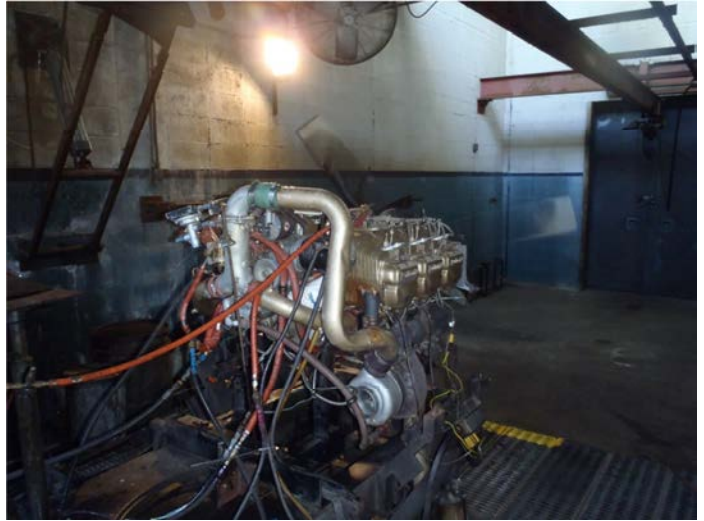
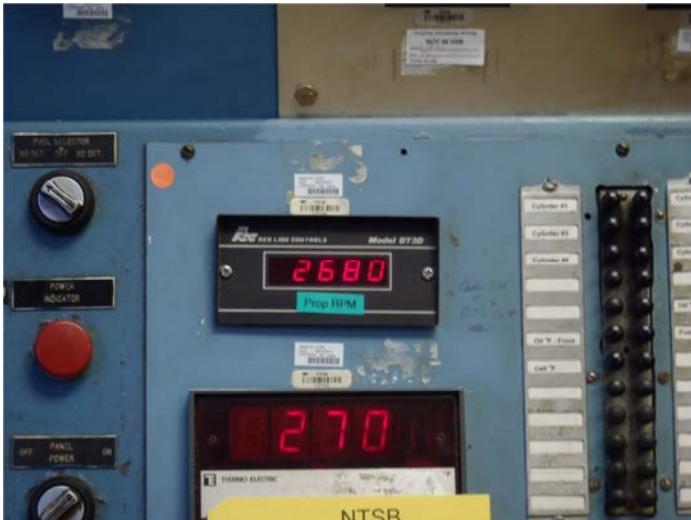
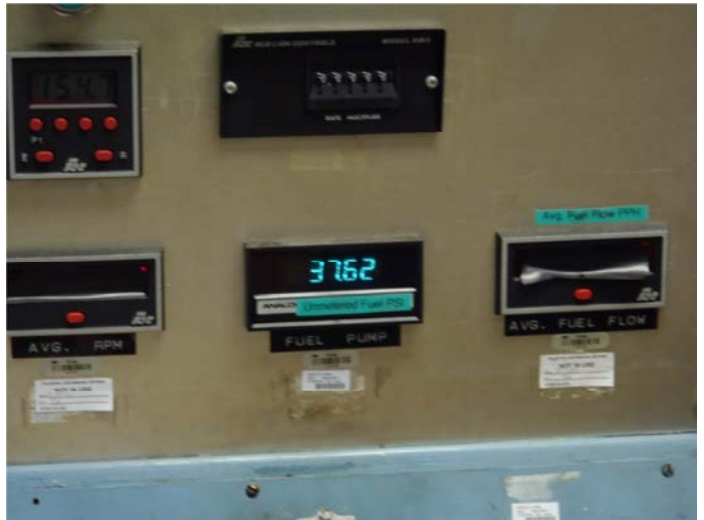
The operation of this engine was normal and did not reveal any abnormalities that would have prevented normal operation and production of rated horsepower. An inspection of the spark plug electrodes after the engine run displayed normal operation signatures.
