Continental Motors, Inc.

ENGINE EXAMINATION REPORT

ENGINE MODEL: IO520L

AIRCRAFT MODEL: Cessna 210L

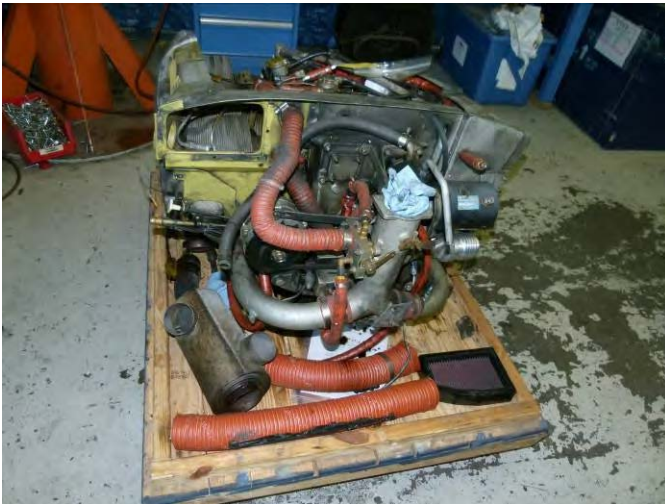
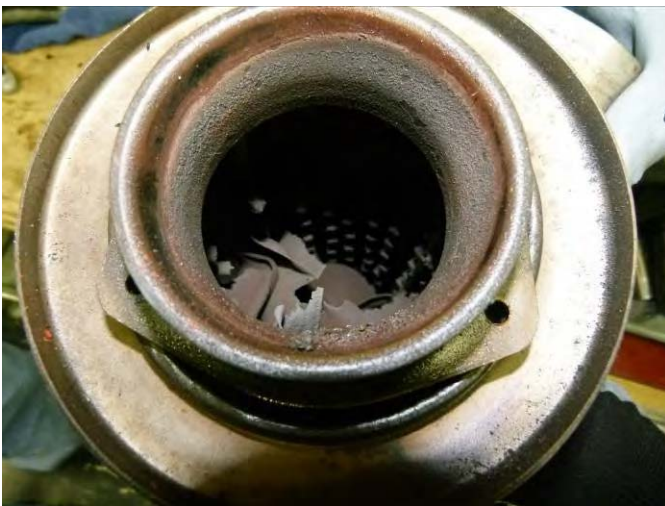
Exhaust System

Condition: The exhaust system components were returned with the engine. The flame cones were missing in both mufflers.

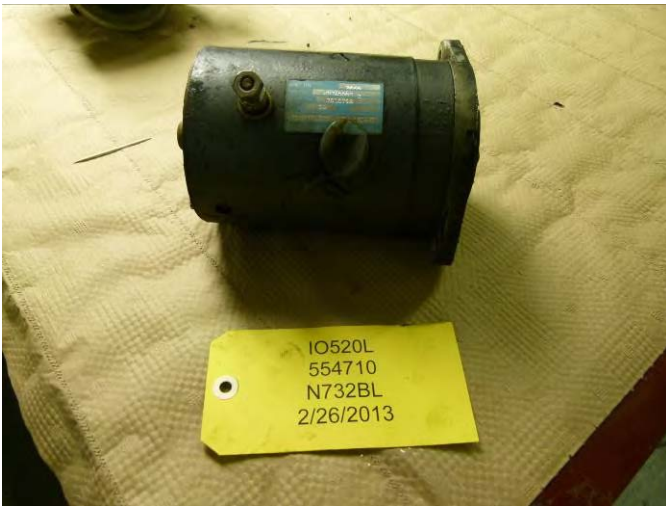
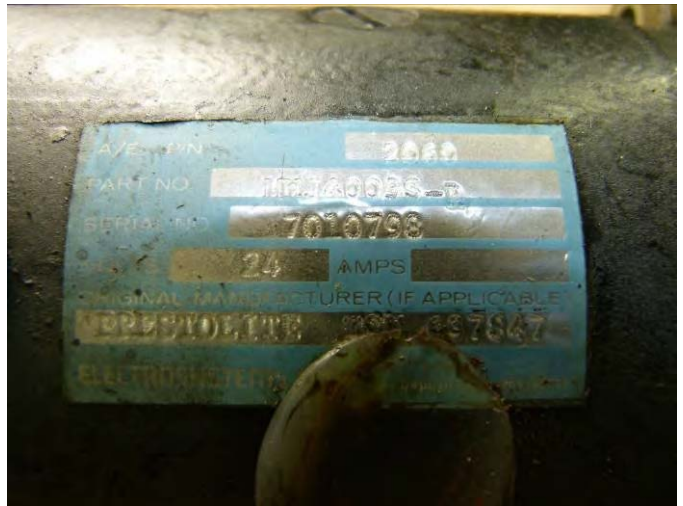
Starter

Condition: The starter rotated by hand and was intact and undamaged.

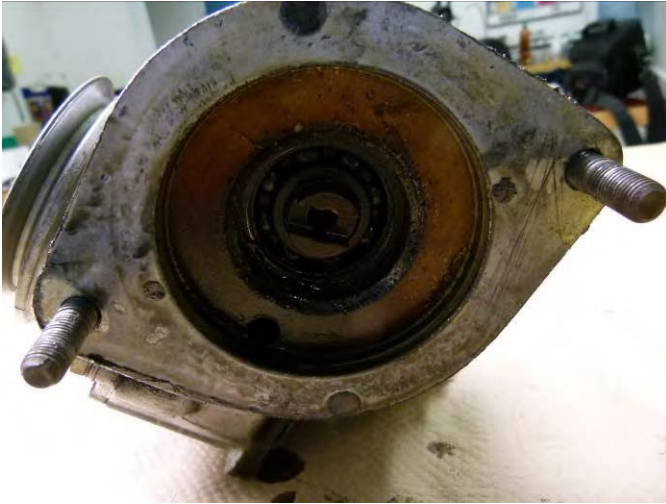
Condition: The starter rotated by hand and was intact and undamaged.

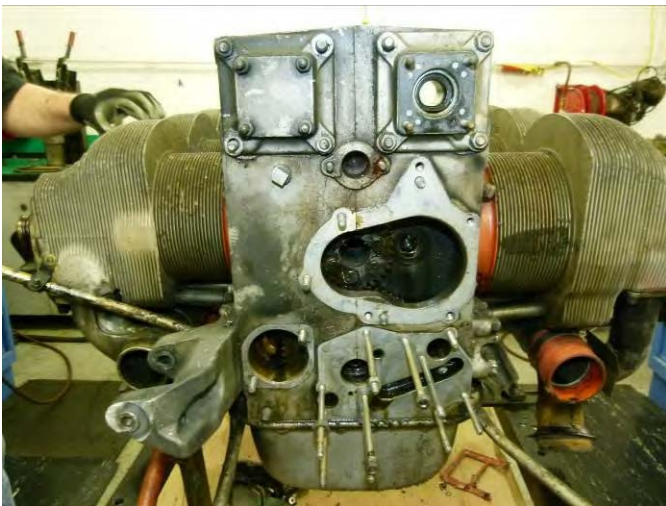
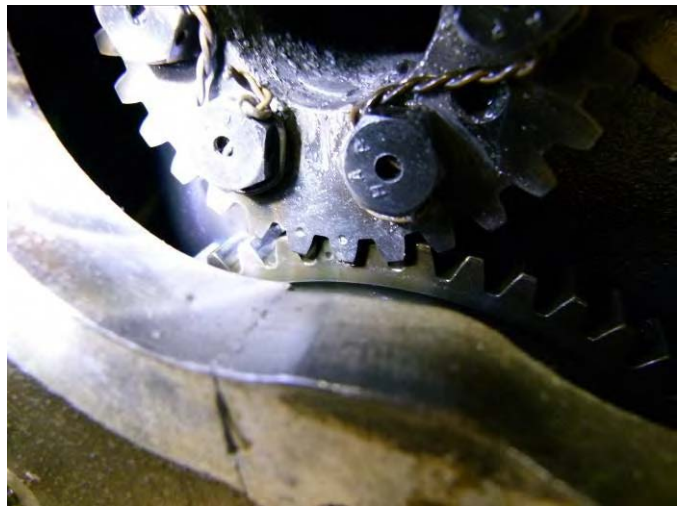
Crankshaft to Camshaft Timing

The crankshaft to camshaft timing was verified by the alignment of the gear's timing marks.

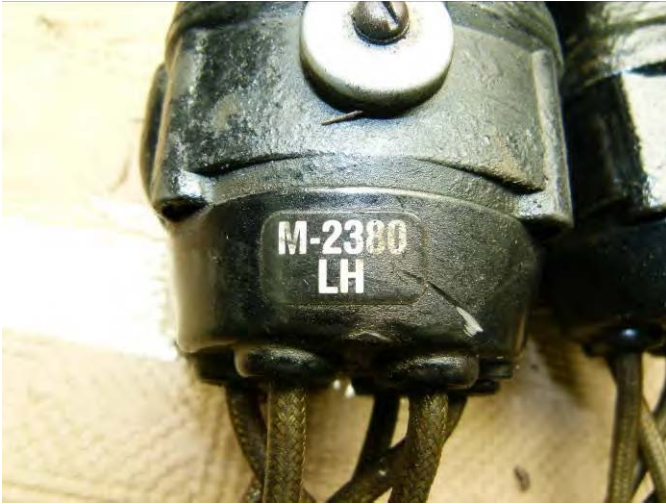
Ignition Harness Manufacturer: Slick Model/Part Number: M-2380 LH M-2379 RH Serial #: N/A

Condition: All leads were free of frayed or damaged shielding and exhibited normal operating signatures.

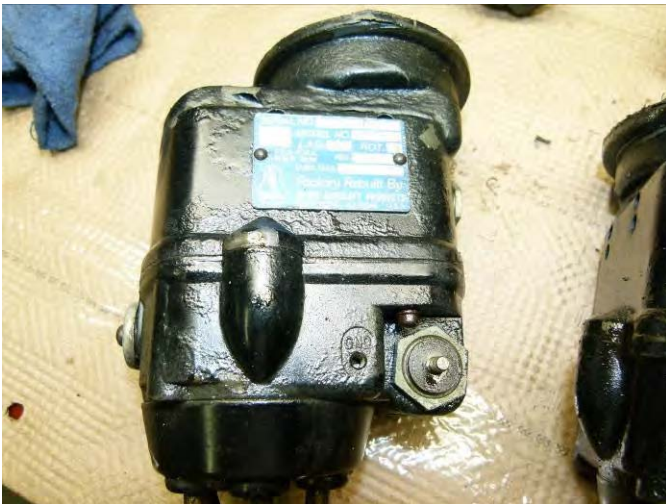
L/H Magneto Manufacturer: Slick Model: 6210R Serial #: 6100301

Condition: The left-hand magneto turned freely with impulse coupling engagement. The magneto was installed and tested on the test bench and produced a blue spark across a 7 mm gap through the full range of test bench RPM.

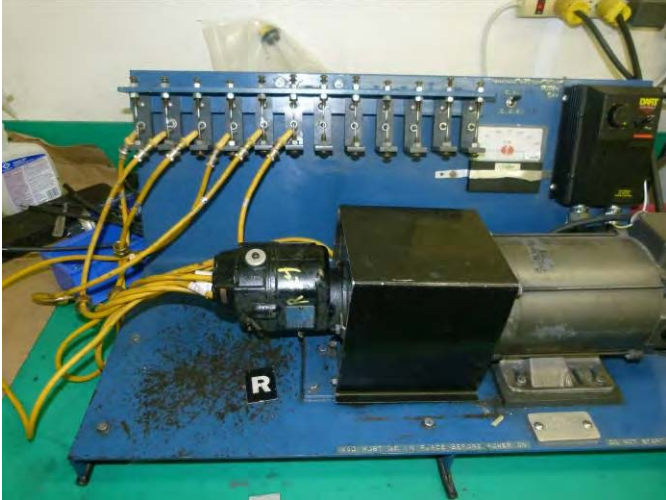
R/H Magneto

Condition: The right-hand magneto turned freely with impulse coupling engagement. The magneto was installed and tested on the test bench and produced a blue spark across a 7 mm gap through the full range of test bench RPM.

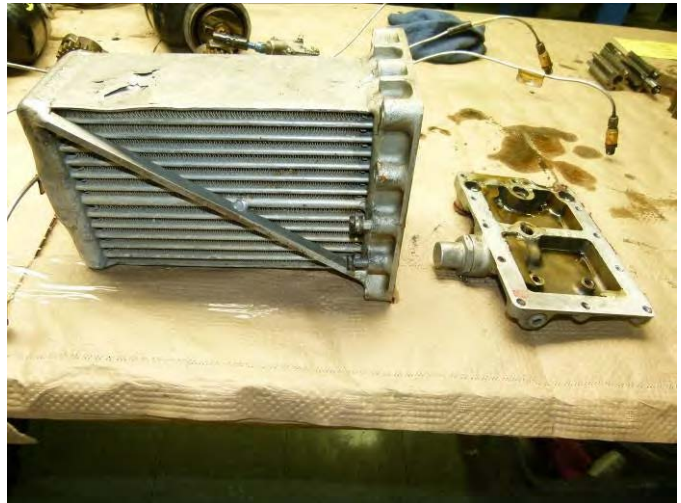
Oil Cooler

Condition: The oil cooler was undamaged and exhibited normal operating signatures.

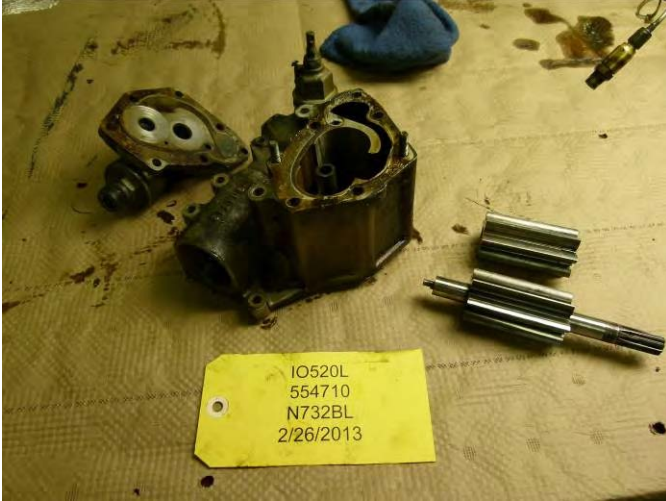
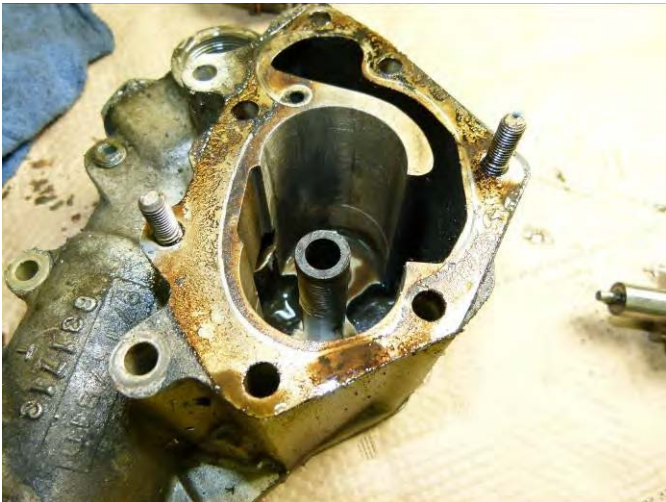
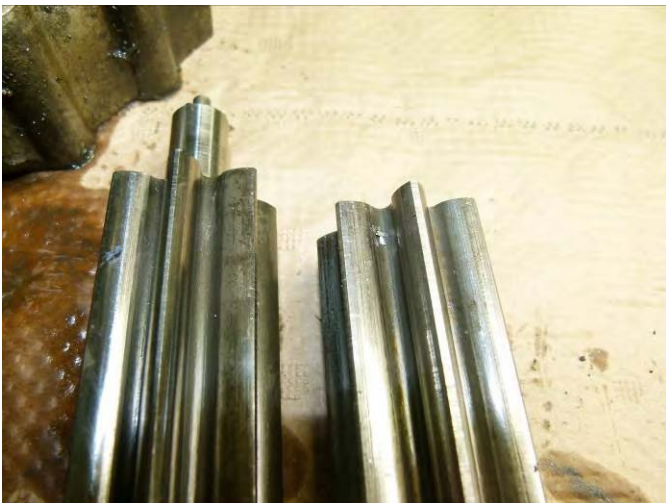
Oil Pump

Condition: The oil pump drive was intact. The oil pump cavity contained heavy scratches and exhibited signatures. The oil pump gear teeth exhibited normal operating signatures. The oil pressure relief valve and seat contained no obstructions and exhibited signatures of proper seating.

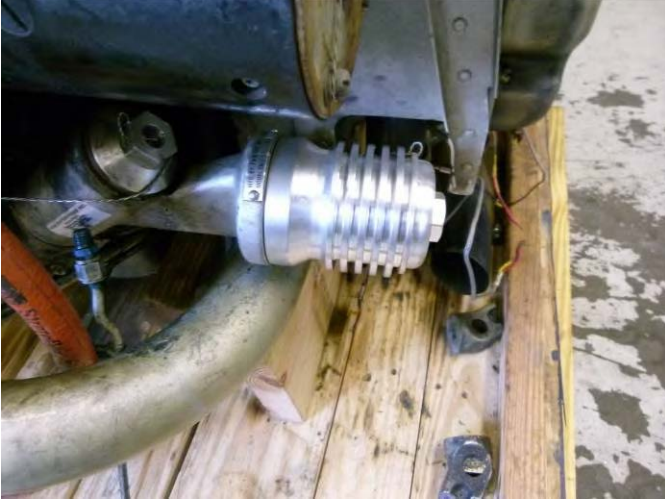
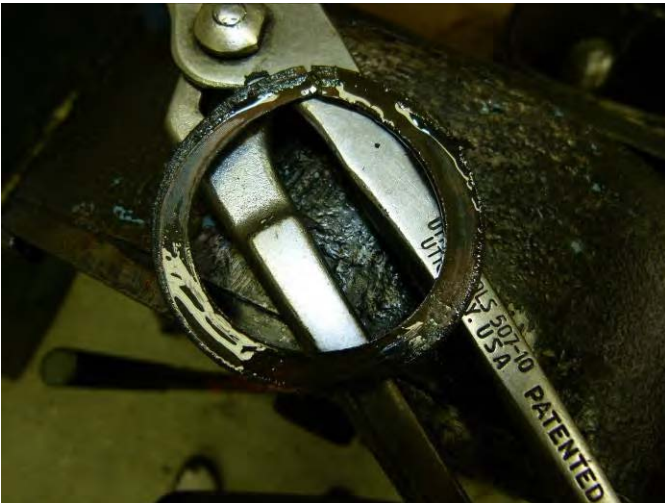
Oil Filter adapter

Condition: The oil filter was opened to allow examination. The oil filter element was examined and contained an abundance of flakes and slivers from the damaged internal engine components. The oil filter adapter fiber seal washer was torn where the adaptor attaches to the oil pump housing. The seal had signatures of miss-alignment with the oil filter adaptor. The condition is a possible oil leak source.

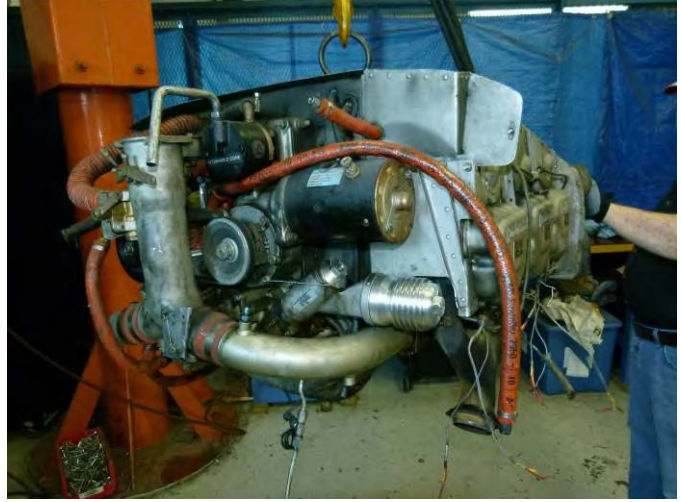
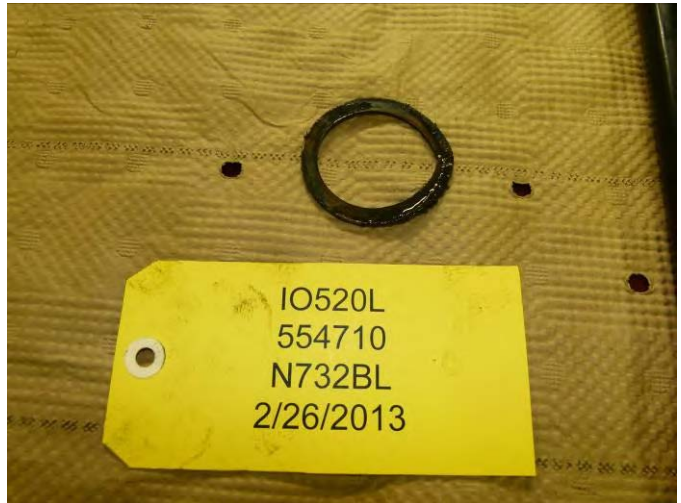
The engine was return with a hole above the number four cylinder in the top of the crank case. Disassembly of the engine revealed the engine suffered an oil starvation event. The number four connecting rod released from the crankshaft the remaining rods exhibited oil starvation signatures. The engine was equipped with an F&M oil filter adapter this adapter was returned in a condition which allow rotation on the engine the lower fiber washer seal was torn upon inspection. This is a possible leak source for the oil starvation to occur.

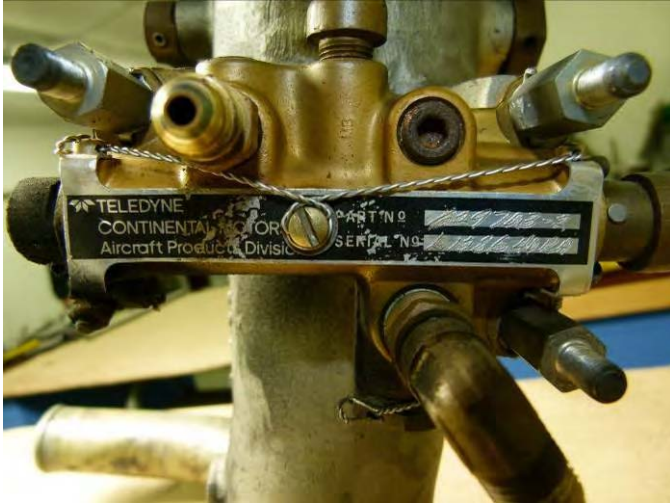
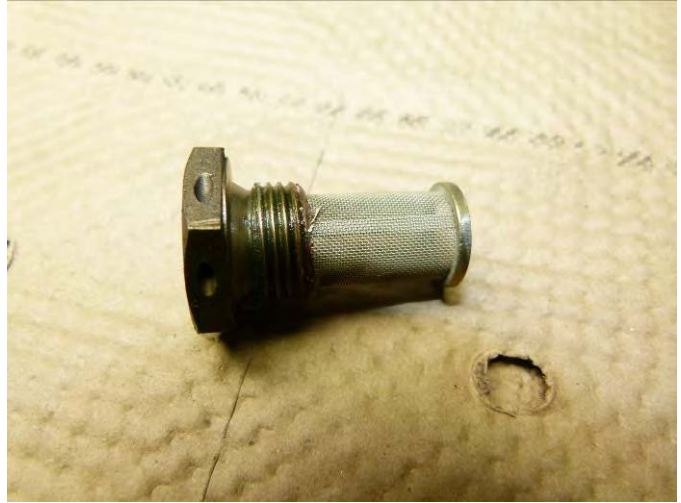
Throttle and Fuel Control / Metering Assembly

Condition: The throttle control had normal operating signatures. Finger screen removed and no material was present.

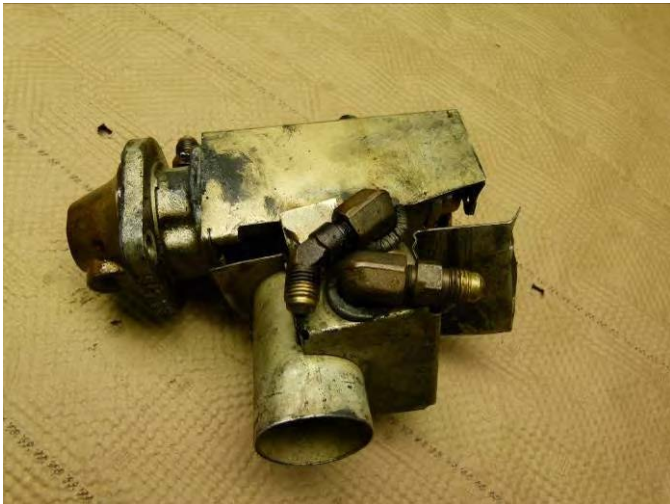
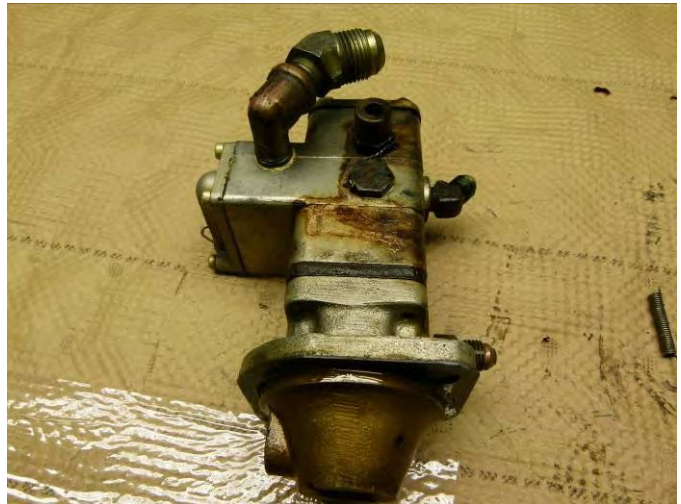
Fuel Pump

Condition: The fuel pump turned freely and there were no abnormalities present. The fuel pump drive was intact and undamaged.

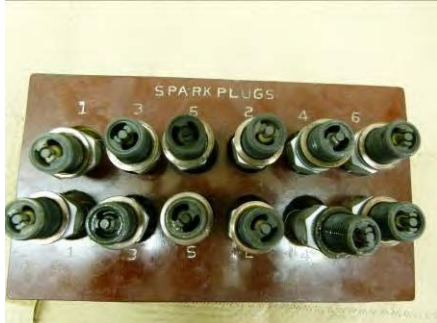
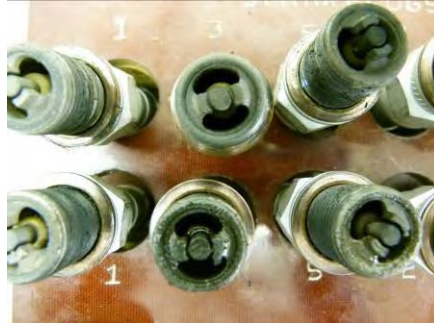
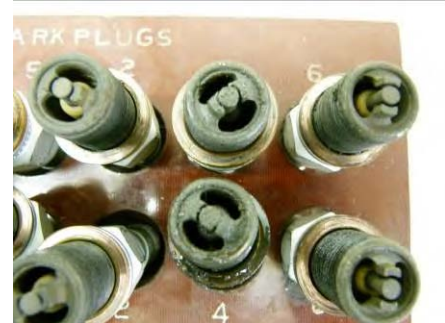
Spark Plugs Manufacturer: Champion Part number: RHB32E

Condition: The top and bottom sparkplugs had normal wear signatures in accordance with the Champion aviation check-a-plug comparison chart.

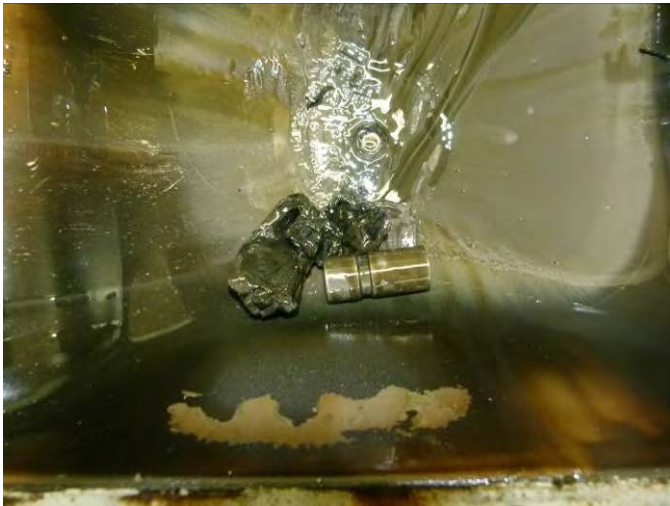
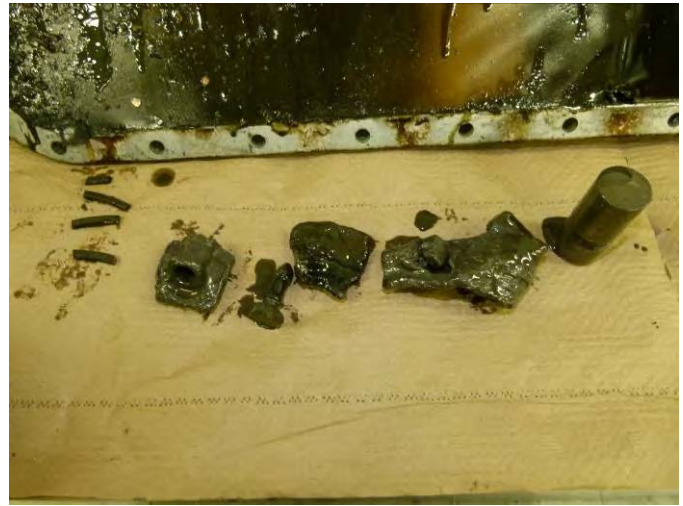
Oil Sump

Condition: The oil sump drain plug was not safetied. The oil sump was undamaged and exhibited normal operating signatures. . The oil was dark in color and contained the number three intake lifter, the number four rod cap (fractured), piston ring fragments, bearing fragments, and crankcase fragments.

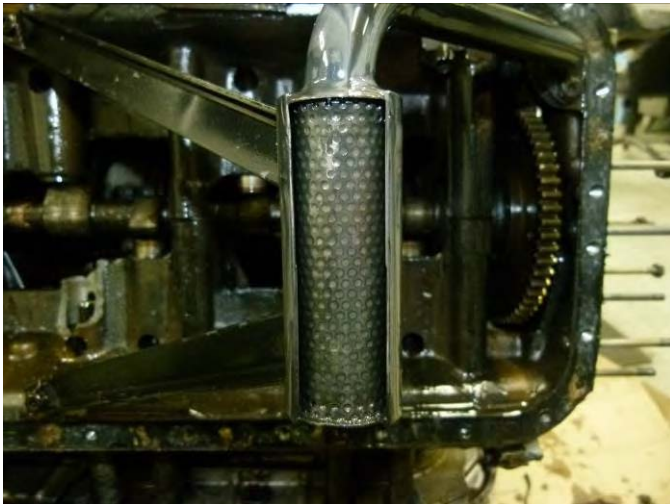
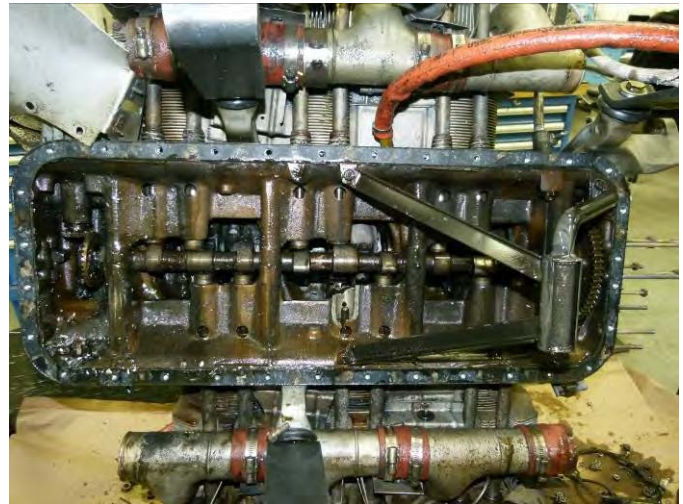
Oil Pick-up Tube & Screen

Condition: The oil pick-up tube was undamaged. The oil suction screen was unrestricted.

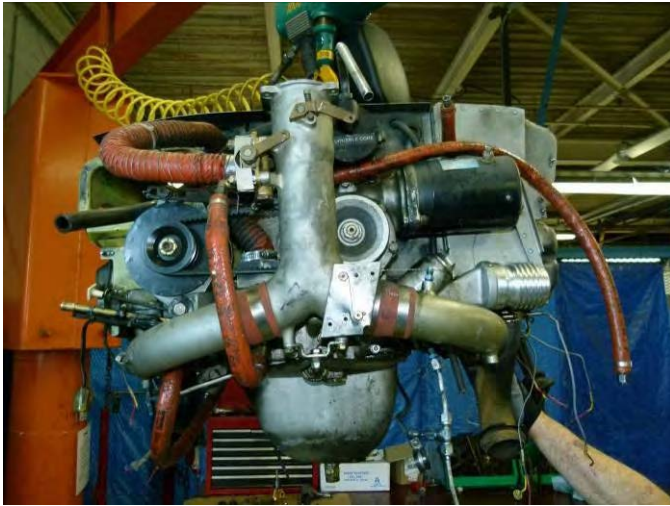
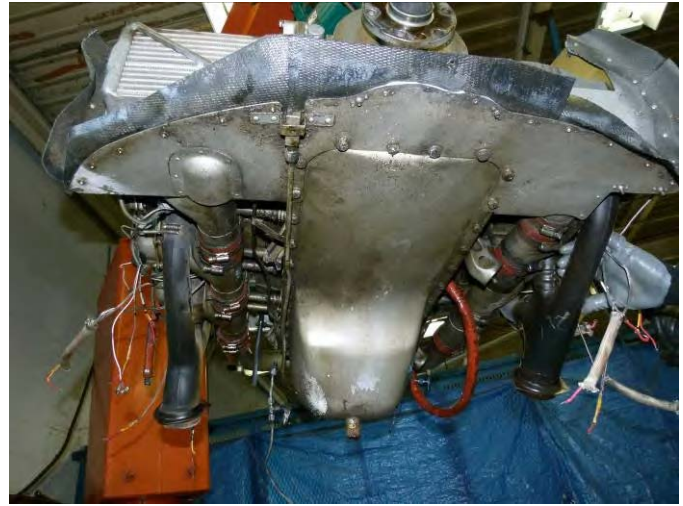
Induction System

Condition: The induction risers and balance tube were undamaged and exhibited normal operating signatures.

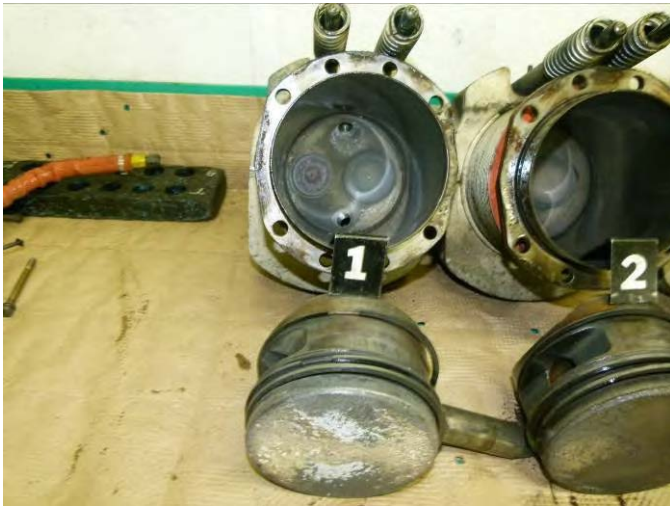
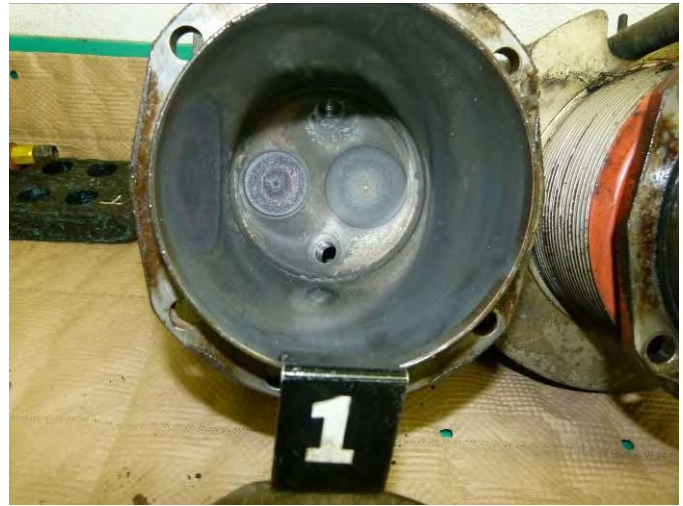
Cylinder #1

Condition: The spot putty was not evident on the cylinder hold-down nuts. The cylinder combustion chamber had a normal amount of combustion deposits and the bore condition was free of scoring and undamaged. The cylinder skirt was intact and undamaged and there were no hone marks visible in the cylinder bore ring travel area. The intake and exhaust valve heads exhibited normal deposits and operating signatures. The rocker box area had an oil residue indicating lubrication to the overhead. The cylinder overhead components (valves, rocker arms, guides, springs, retainers and shafts) were lubricated and undamaged.

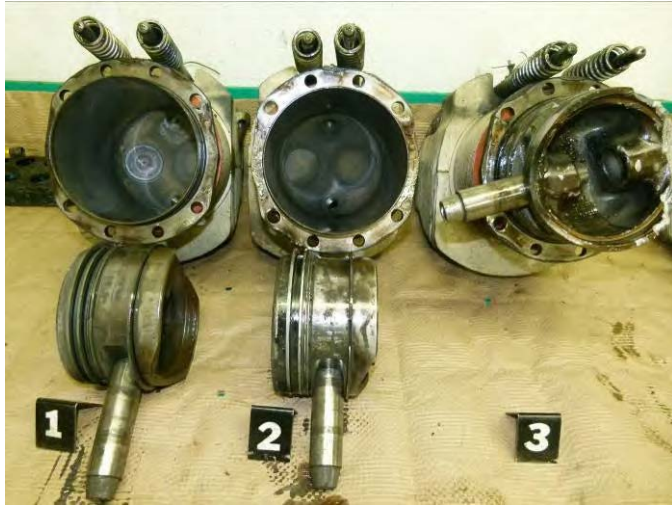
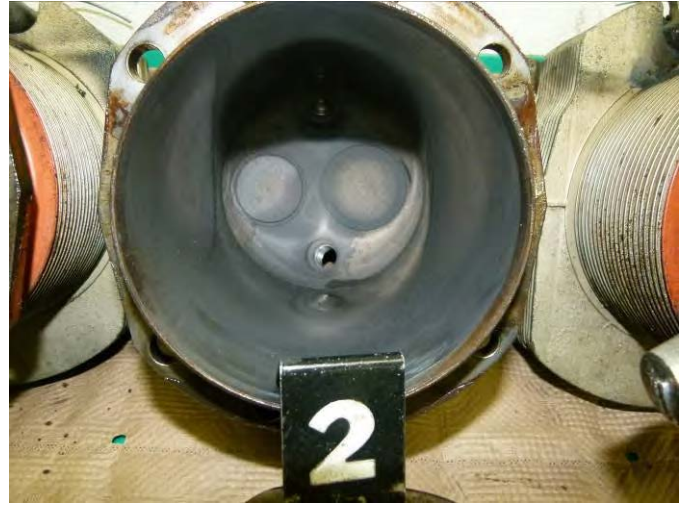
Cylinder #2 Part Number: : 639272CP Head Date: N/A Barrel Surface: Chrome
 Serial #: 156859 Work Order Numbers: None

Condition: The spot putty was not evident on the cylinder hold-down nuts. The cylinder combustion chamber had a normal amount of combustion deposits and the bore condition was free of scoring and undamaged. The cylinder skirt was intact and undamaged and there were no hone marks visible in the cylinder bore ring travel area. The intake and exhaust valve heads exhibited normal deposits and operating signatures. The rocker box area had an oil residue indicating lubrication to the overhead. The cylinder overhead components (valves, rocker arms, guides, springs, retainers and shafts) were lubricated and undamaged.

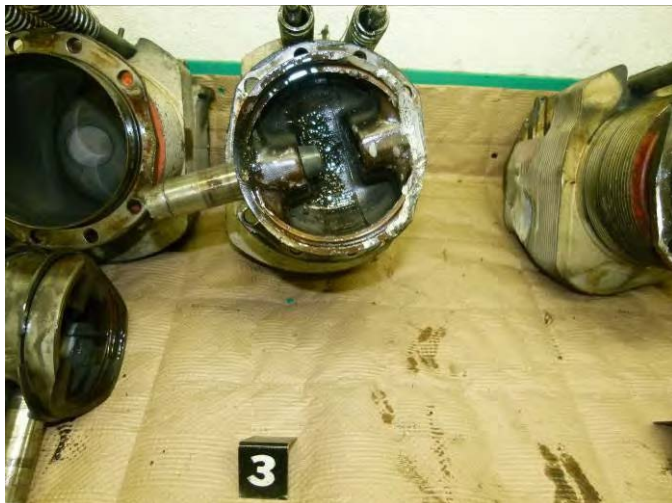
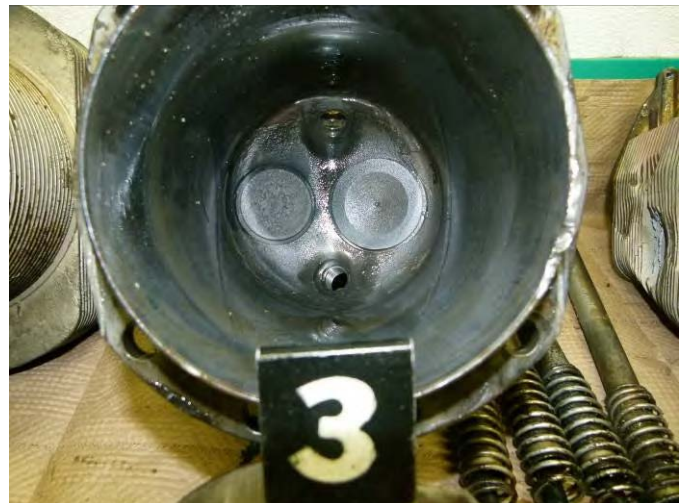
Cylinder #3 Part Number: : 639272CP Head Date: N/A Barrel Surface: Steel Chrome
 Serial #: 156678 Work Order Numbers: None

Condition: The spot putty was not evident on the cylinder hold-down nuts. The cylinder combustion chamber had a normal amount of combustion deposits and the bore condition was free of scoring and undamaged. The cylinder skirt was damaged and there were no hone marks visible in the cylinder bore ring travel area. The intake and exhaust valve heads exhibited normal deposits and operating signatures. The rocker box area had an oil residue indicating lubrication to the overhead. The cylinder overhead components (valves, rocker arms, guides, springs, retainers and shafts) were lubricated and undamaged.

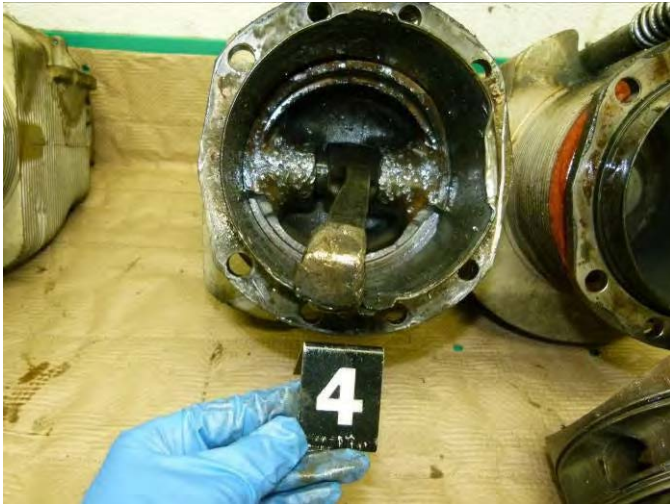
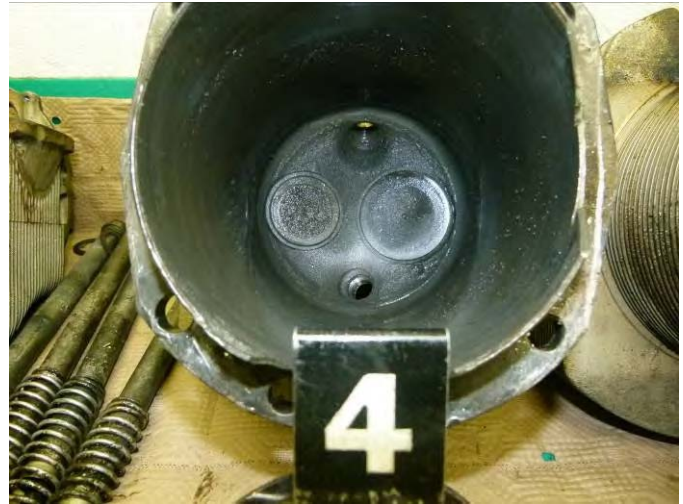
Cylinder #4 Part Number : 639272CP Head Date: N/A Barrel Surface: Steel Chrome
 Serial #: 156783 Work Order Numbers: None

Condition: The spot putty was not evident on the cylinder hold-down nuts. The cylinder combustion chamber had a normal amount of combustion deposits and the bore condition was free of scoring and undamaged. The cylinder skirt was damaged and there were no hone marks visible in the cylinder bore ring travel area. The intake and exhaust valve heads exhibited normal deposits and operating signatures. The rocker box area had an oil residue indicating lubrication to the overhead. The cylinder overhead components (valves, rocker arms, guides, springs, retainers and shafts) were lubricated and undamaged.

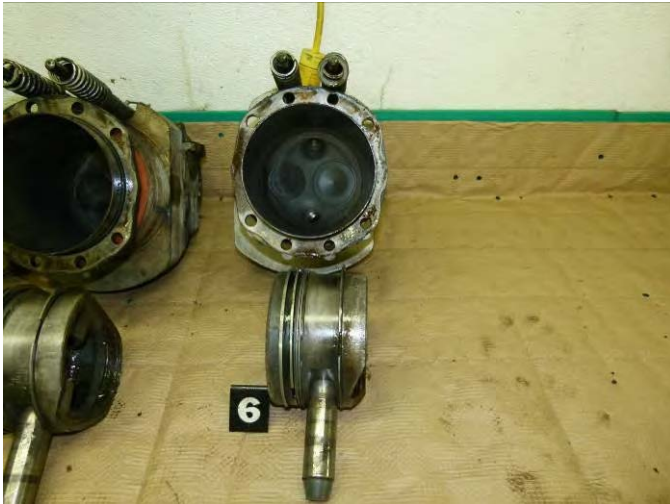
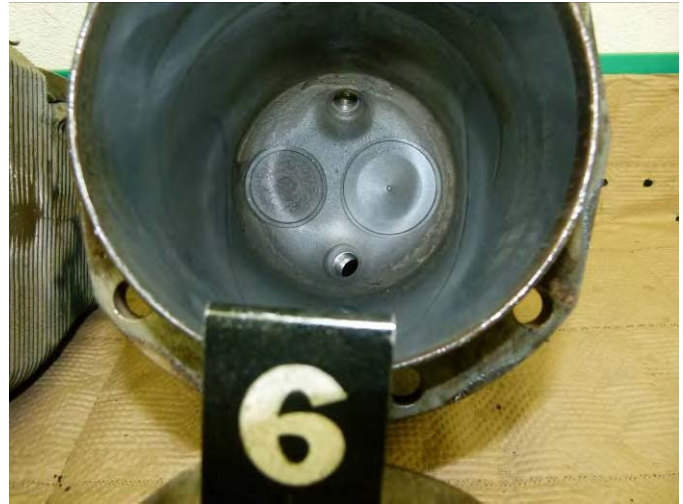
Cylinder #6 Part Number : 639272CP Head Date: N/A Barrel Surface: Chrome
 Serial #: 156638 Work Order Numbers: None

Condition: The spot putty was not evident on the cylinder hold-down nuts. The cylinder combustion chamber had a normal amount of combustion deposits and the bore condition was free of scoring and undamaged. The cylinder skirt was intact and undamaged and there were no hone marks visible in the cylinder bore ring travel area. The intake and exhaust valve heads exhibited normal deposits and operating signatures. The rocker box area had an oil residue indicating lubrication to the overhead. The cylinder overhead components (valves, rocker arms, guides, springs, retainers and shafts) were lubricated and undamaged.

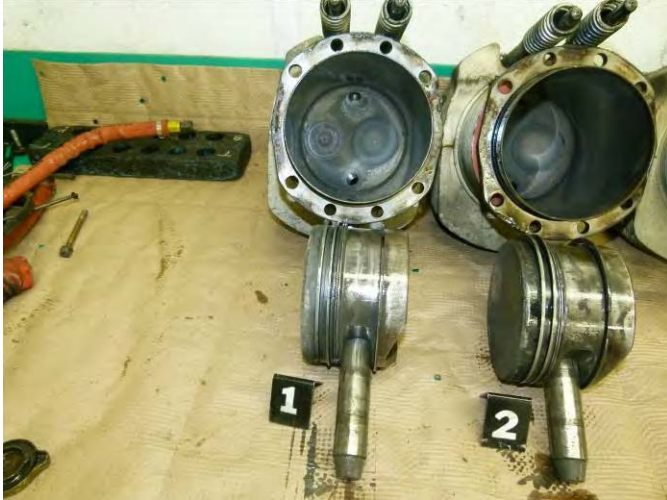
#1 Piston, Rings and Pin Piston Part Number: 648045

Condition: The piston head exhibited a normal amount of combustion deposits and the piston skirt was free of scoring and damage. The piston rings were intact, free in their grooves, exhibited normal wear and operating signatures. The piston pin and plug assembly was intact and undamaged.

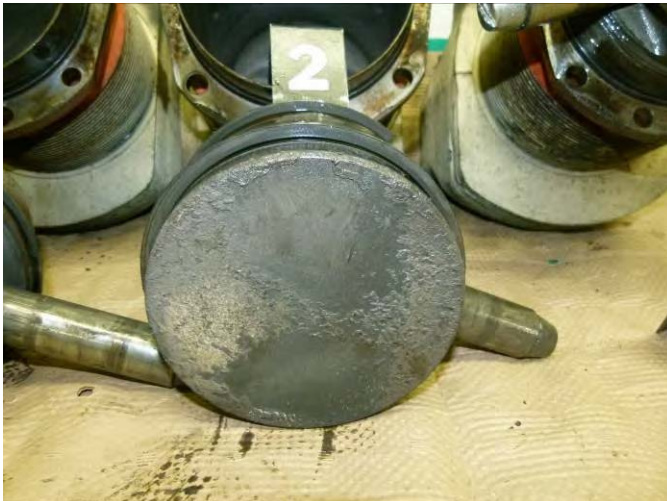
#2 Piston, Rings and Pin Piston Part Number: 648045

Condition: The piston head exhibited a normal amount of combustion deposits and the piston skirt was free of scoring and damage. The piston rings were intact, free in their grooves, exhibited normal wear and operating signatures. The piston pin and plug assembly was intact and undamaged.

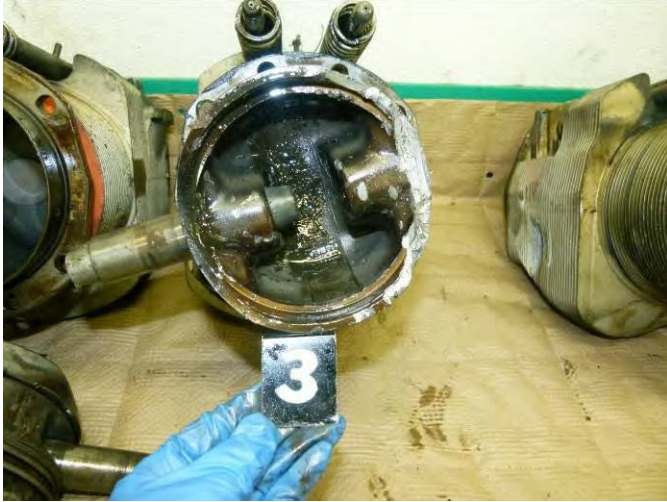
#3 Piston, Rings and Pin Piston Part Number: 648045

Condition: The piston head exhibited a normal amount of combustion deposits and the piston skirt exhibited mechanical damage. The piston rings were intact, free in their grooves, exhibited normal wear and operating signatures. The piston pin and plug assembly was intact and undamaged.

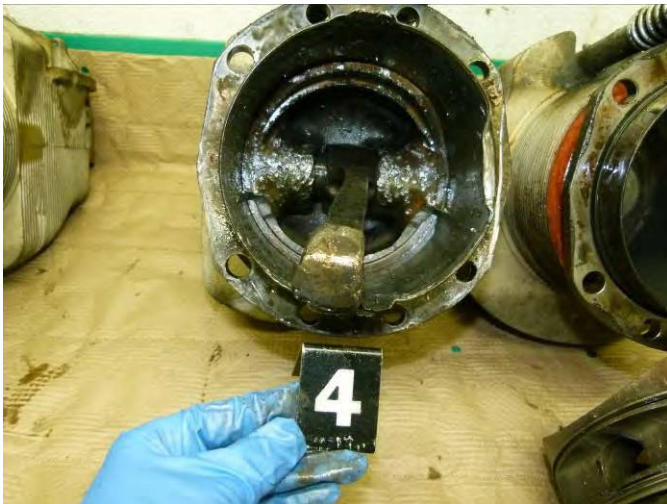
#4 Piston, Rings and Pin Piston Part Number: 648045

Condition: The piston head exhibited a normal amount of combustion deposits and the piston skirt exhibited mechanical damage. The piston head exhibited mechanical damage and it was required to be driven from the cylinder bore. The piston rings were intact, free in their grooves, exhibited normal wear and operating signatures. The piston pin and plug assembly was intact and undamaged.

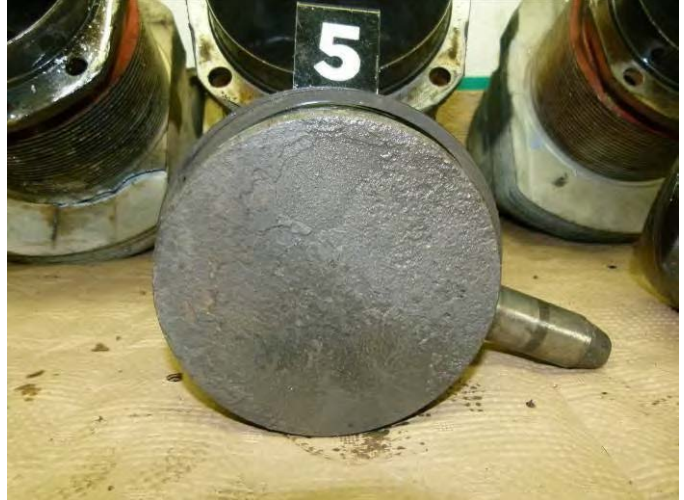
#5 Piston, Rings and Pin Piston Part Number: 648045

Condition: The piston head exhibited a normal amount of combustion deposits and the piston skirt was free of scoring and damage. The piston rings were intact, free in their grooves, exhibited normal wear and operating signatures. The piston pin and plug assembly was intact and undamaged.

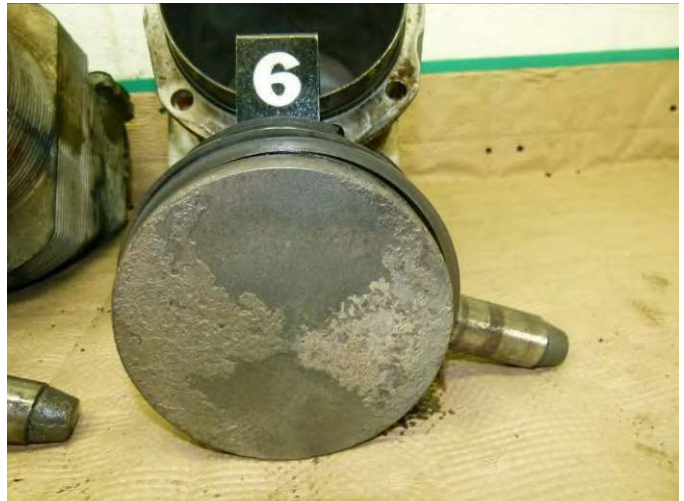
#6 Piston, Rings and Pin Piston Part Number: 648045

Condition: The piston head exhibited a normal amount of combustion deposits and the piston skirt was free of scoring and damage. The piston rings were intact, free in their grooves, exhibited normal wear and operating signatures. The piston pin and plug assembly was intact and undamaged.

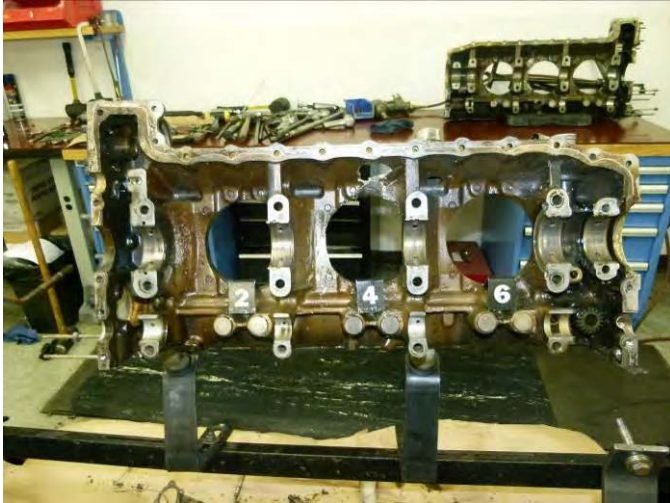
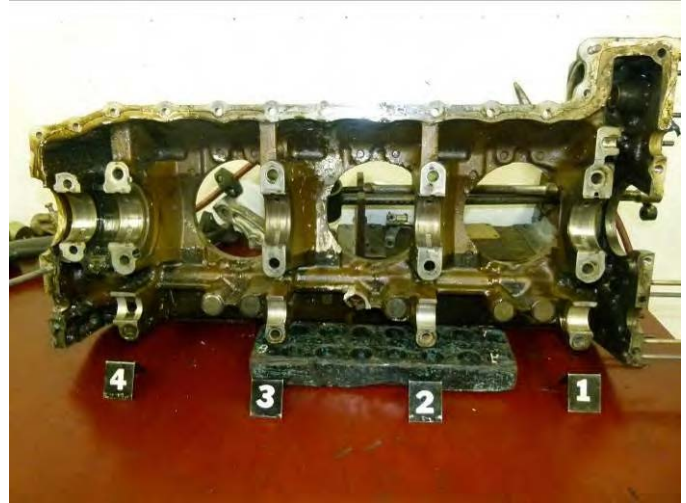
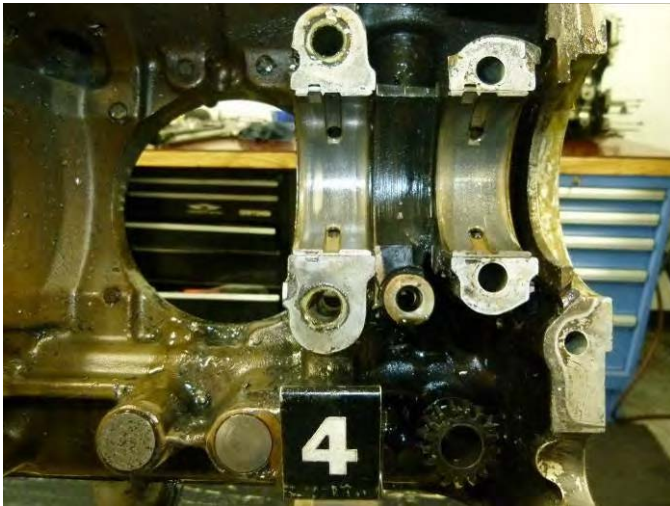
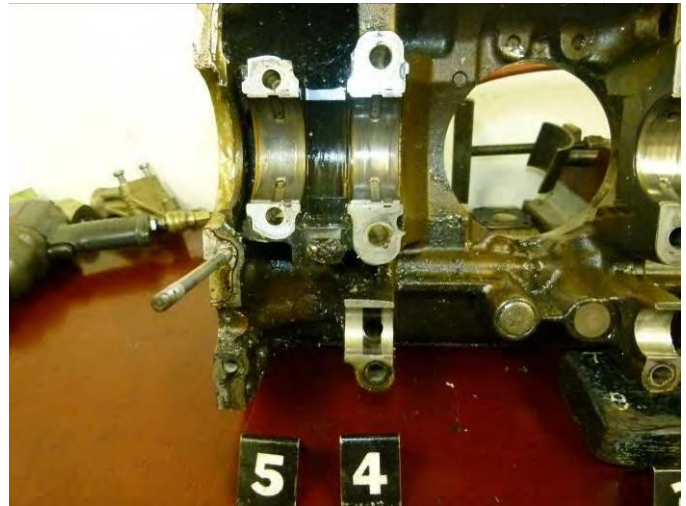
Condition: Except for the number five and six cylinder intake lifters, the lifter faces were undamaged and exhibited normal operating signatures. The lifter bodies were undamaged and exhibited normal operating signatures. The number five and six intake lifters exhibited heavy spalling. The number three cylinder intake lifter was found in the sump due to mechanical damage to the crank case

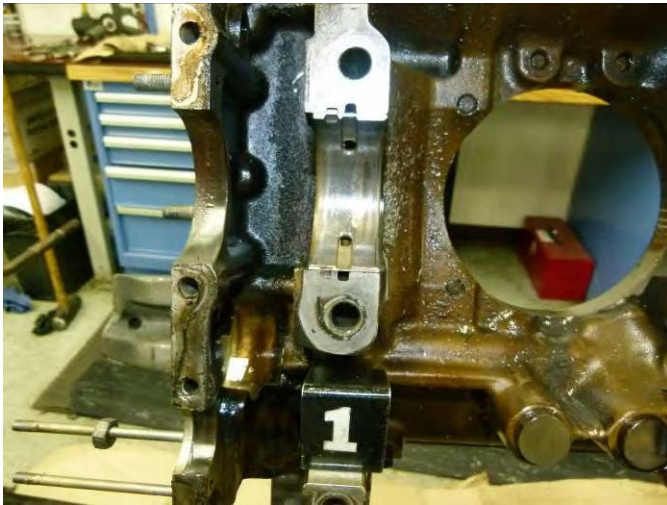
#1 Main Bearings Part #: 642720

Condition The #1 (rear) The bearings exhibited contamination imbedded in the surface layer. The bearings exhibited lubrication distress and thermal smearing of the surface babbit.

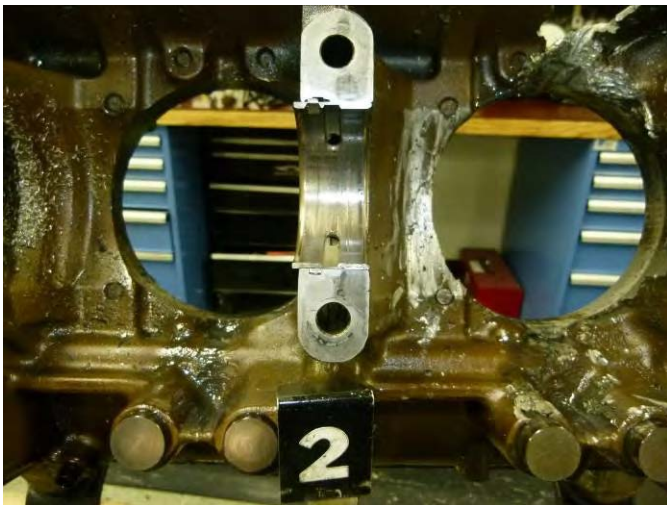
Condition The #2 (intermediate) The bearings exhibited contamination imbedded in the surface layer. The bearings exhibited lubrication distress and thermal smearing of the surface babbit.

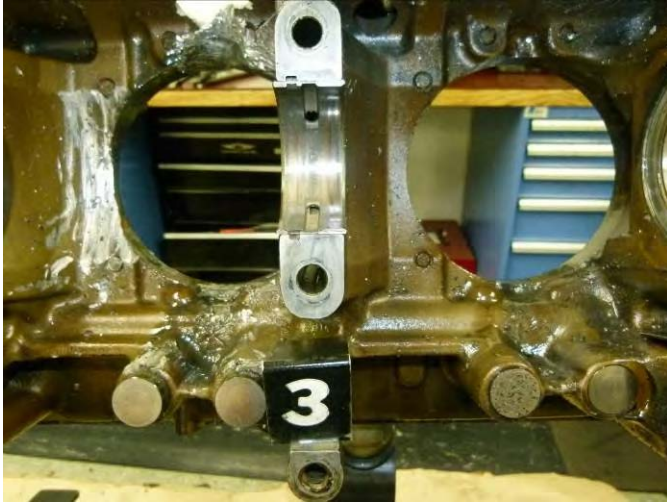
#3 Main Bearings Part #: 642720

Condition The #3 (intermediate) The bearings exhibited contamination imbedded in the surface layer. The bearings exhibited lubrication distress and thermal smearing of the surface babbit.

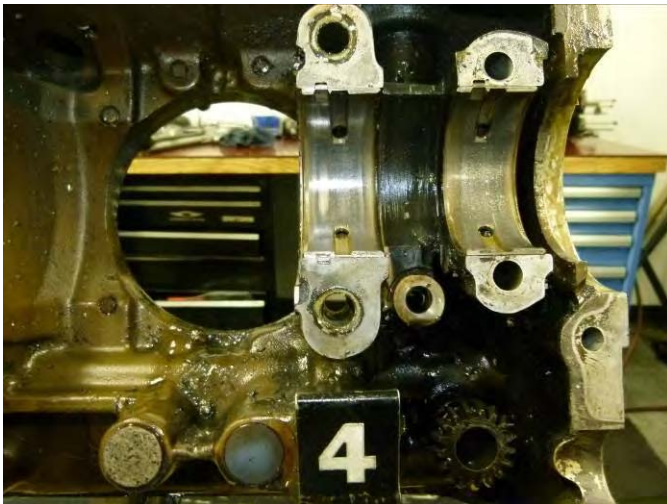
#4 Main Bearings Part #: 642720

Condition The #4 (intermediate or front) The bearings exhibited contamination imbedded in the surface layer. The bearings exhibited lubrication distress and thermal smearing of the surface babbit.

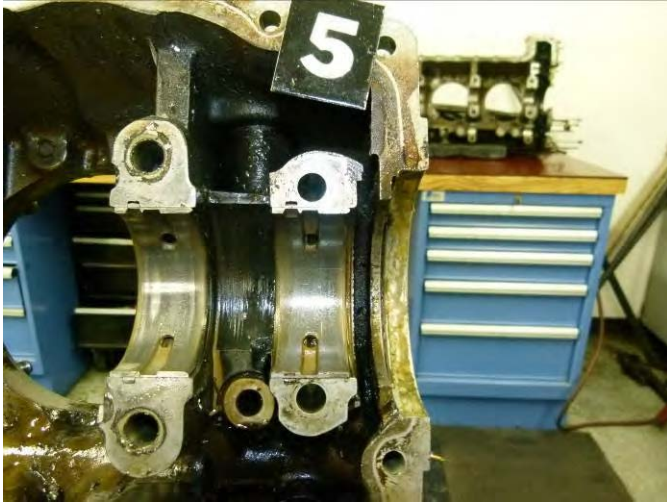
#5 Main Bearings Part #: 642720

Condition The #5 (front) The bearings exhibited contamination imbedded in the surface layer. The bearings exhibited lubrication distress and thermal smearing of the surface babbit.

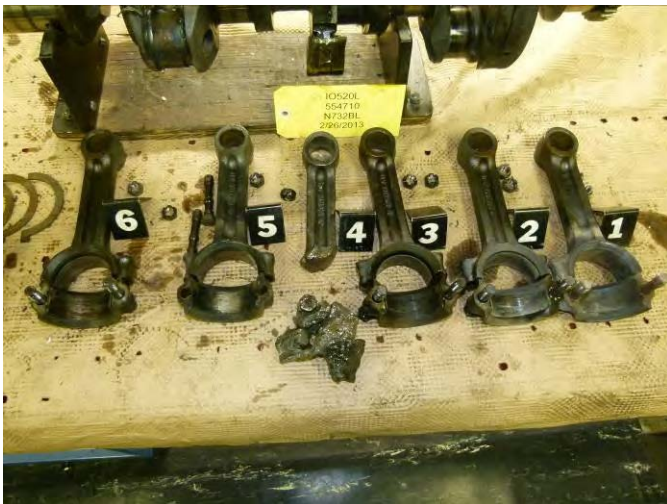
Condition: The connecting rod assembly was intact and exhibited thermal discoloration. The Number four connecting rod was released from the crankshaft and exhibited extreme mechanical damage from the lack of lubrication.

Condition: The connecting rod bearing exhibited lubrication distress and thermal smearing of the surface babbit, exposing the copper layer. A number of the bearing shells were extruded from the connecting rods.

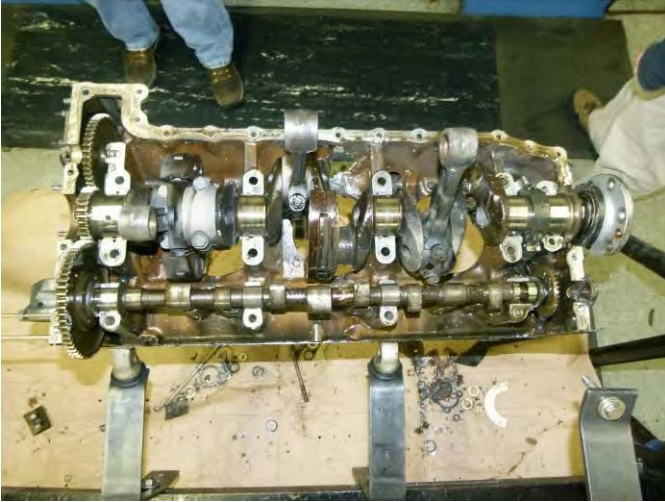
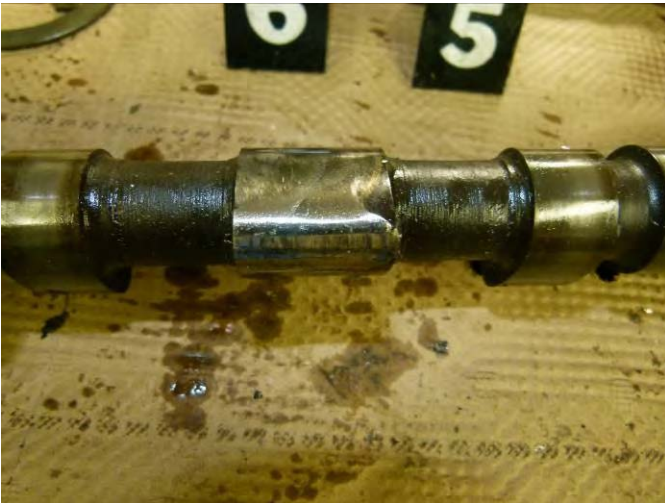
Camshaft Part number: 535661

Condition: The camshaft cluster gear was intact and exhibited normal operating signatures. The gear bolts were tight and safety wired and the gear teeth were undamaged. The number five and six intake lobe exhibited mechanical damage.

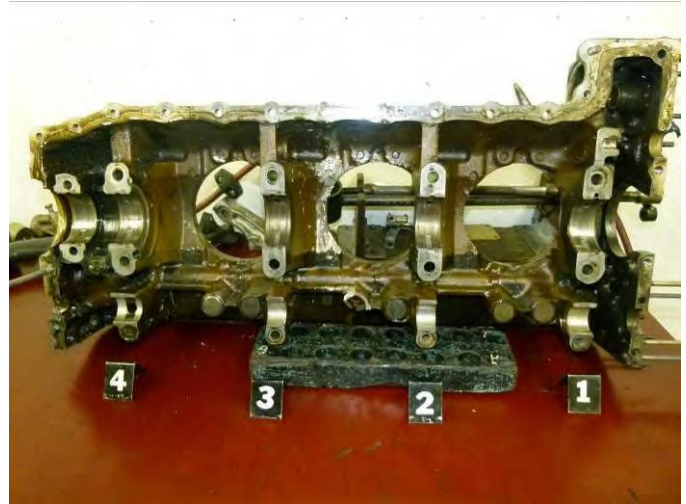
Crankcase Casting Number 1-3-5 Side: 649043 2-4-6 Side: 649042 Serial number: 862059S

Condition: The crankcase exhibited exterior damage concentrated above the number four cylinder. The main bearing support mating surfaces were intact and exhibited signs of fretting or bearing tang lock-slot elongation. The main bearing support diameters were intact and exhibited signs of bearing movement. The oil galleys and passages in the left and right crankcase halves were intact, clear and unrestricted.
