Continental Motors, Inc.

ENGINE EXAMINATION REPORT

ENGINE MODEL: IO520L

AIRCRAFT MODEL: Cessna 210L

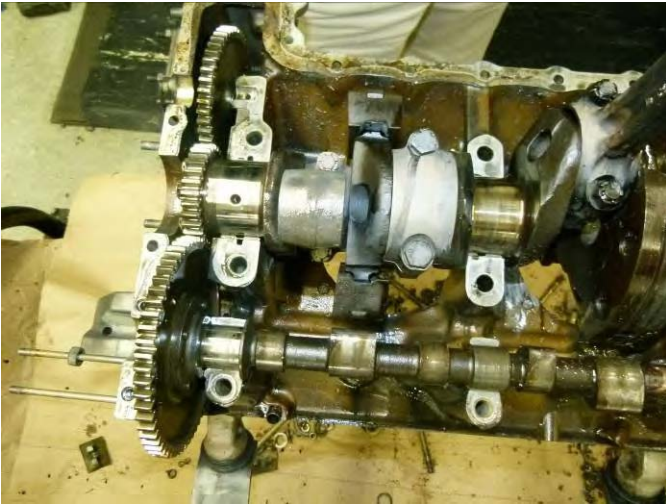
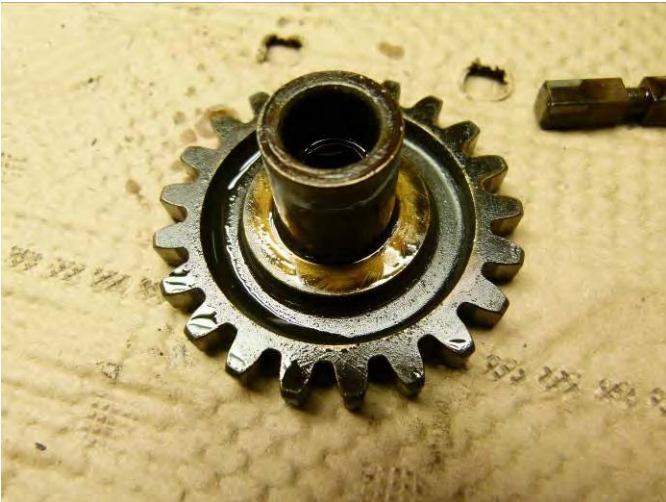
Accessory Gears

Condition: The accessory gears had continuity. The teeth were undamaged and exhibited normal operating signatures.

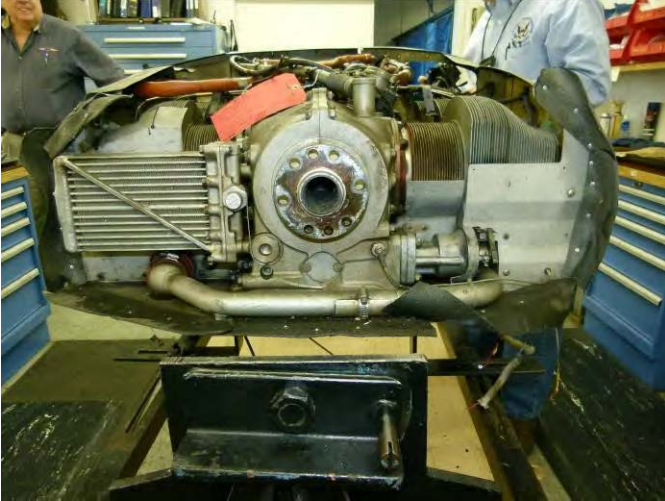
Propeller Governor Model number: McCauley 290D4A/T4 Serial Number: 760877

Condition: The propeller governor could be rotated by hand, was intact and undamaged.

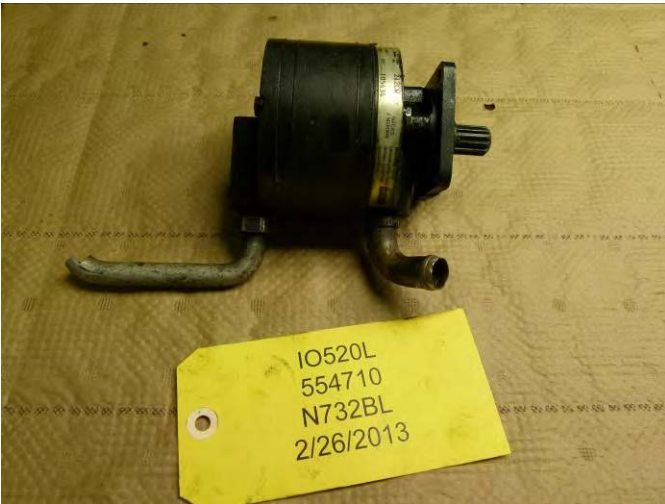
Vacuum Pump Rapco Part Number:212CW Serial Number: 105434

Condition: The vacuum pump could be rotated by hand, was intact and undamaged.
