# NATIONAL TRANSPORTATION SAFETY BOARD

### Specialist's Factual Report By Michael Bauer

Location: Reno, Nevada  
Date: Sep 16, 2011  
Aircraft: P-51D  
Registration: N79111  
Operator: Aero-Trans Corp.  
NTSB Number: WPR11MA454

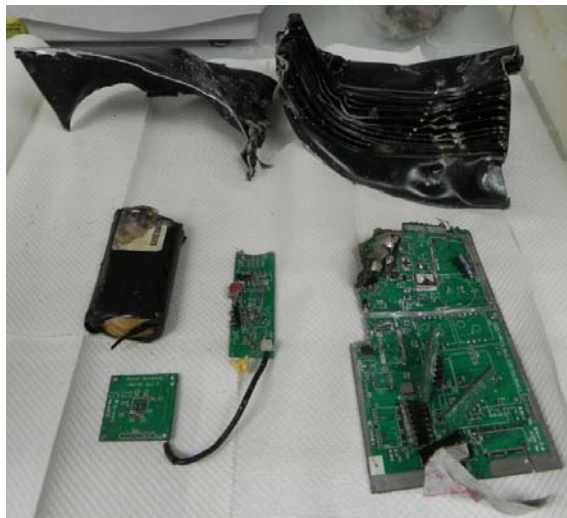
Figure 1 - Dynon EFIS-10A recovered components

The recorder was substantially damaged in the event, see Figure 1 and Figure 2. Multiple components were identified as pieces of the EFIS-D10A. The components were inspected to locate the non-volatile memory component. On the EFIS-D10A, one surface mounted flash TSOP<sup>2</sup> memory chip contains the flight data log information. The memory chip is mounted on a circuit board behind the display. Due to the damage the device sustained in the accident, the memory chip was not attached to the circuit board and was not located. Without the memory chip, no data could be recovered from the EFIS-D10A.

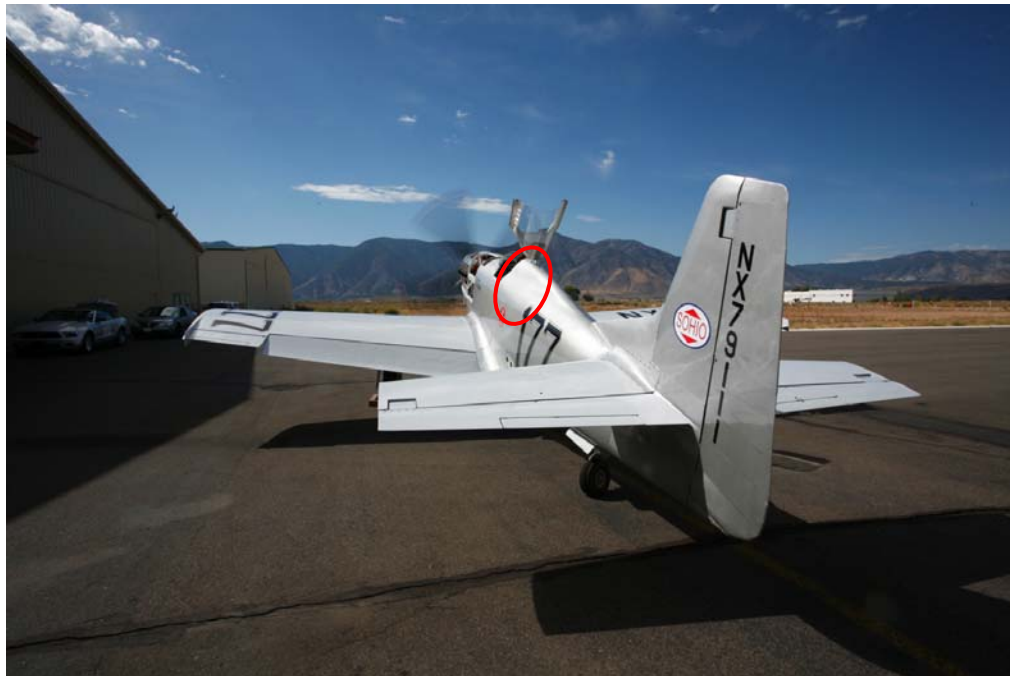
Figure 3 – Accident aircraft (N79111) with approx. location (red oval) of the RCATS telemetry system

The aircraft was equipped with a custom RCATS P-51 Telemetry System. The system consisted of three main components, a Data Collection Unit, a RF data link, and Virtual Instrument Panel software. The system was installed aft of the cockpit, see Figure 3 and Figure 4<sup>3</sup>.

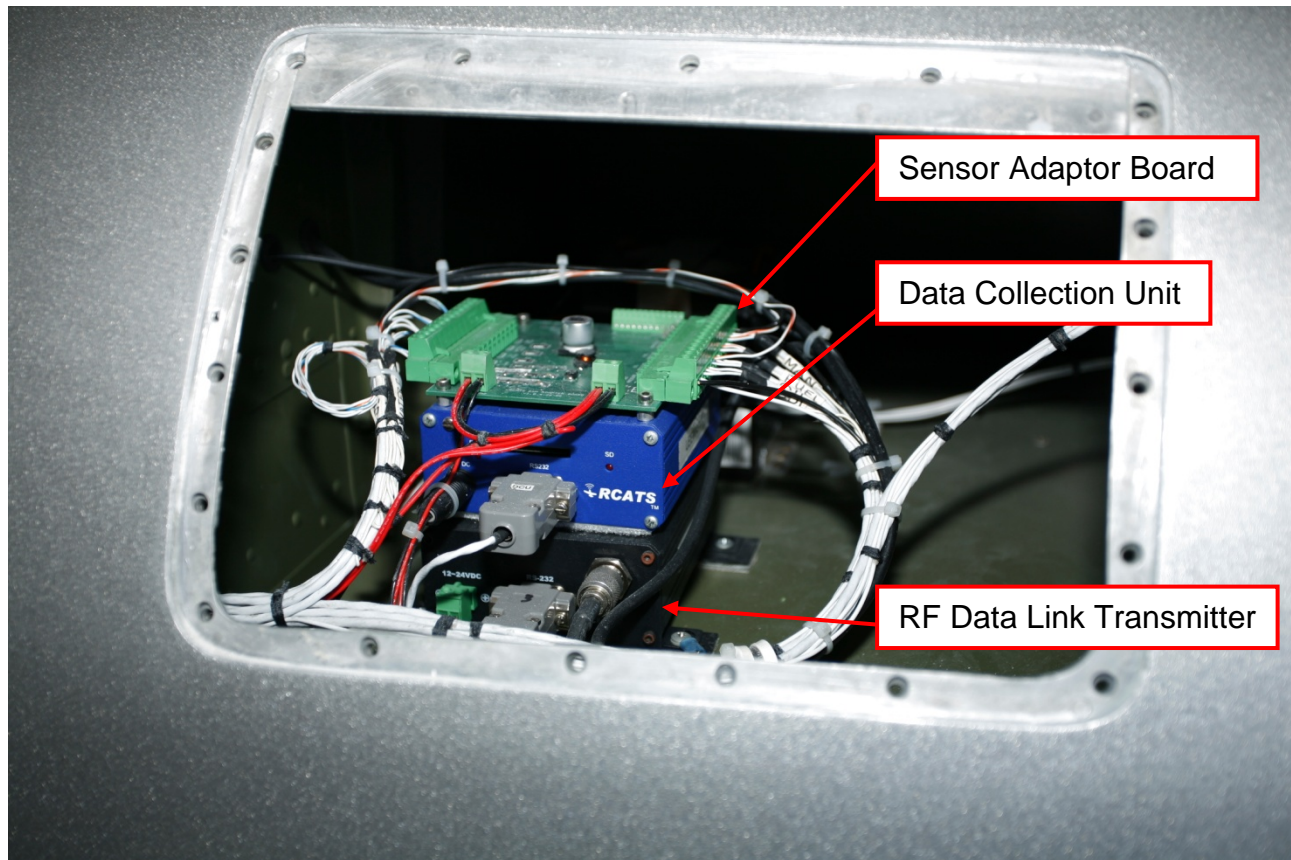
**Figure 4 - Accident aircraft (N79111) RCATS telemetry system installation**

The Data Collection Unit (DCU), collects the data from various onboard sensors, an internal GPS receiver and an internal accelerometer. The DCU also contains three pressure inputs and two thermocouples. A sensor adaptor board is mounted on top of the DCU which allows for additional inputs. The sensor board inputs are transmitted to the DCU. The DCU has a SD (secure digital) card slot in order to record data from the installed sensors. The sensor data is stored at an approximate rate of 2-3 Hz and GPS system parameters are stored at a 1 Hz rate.

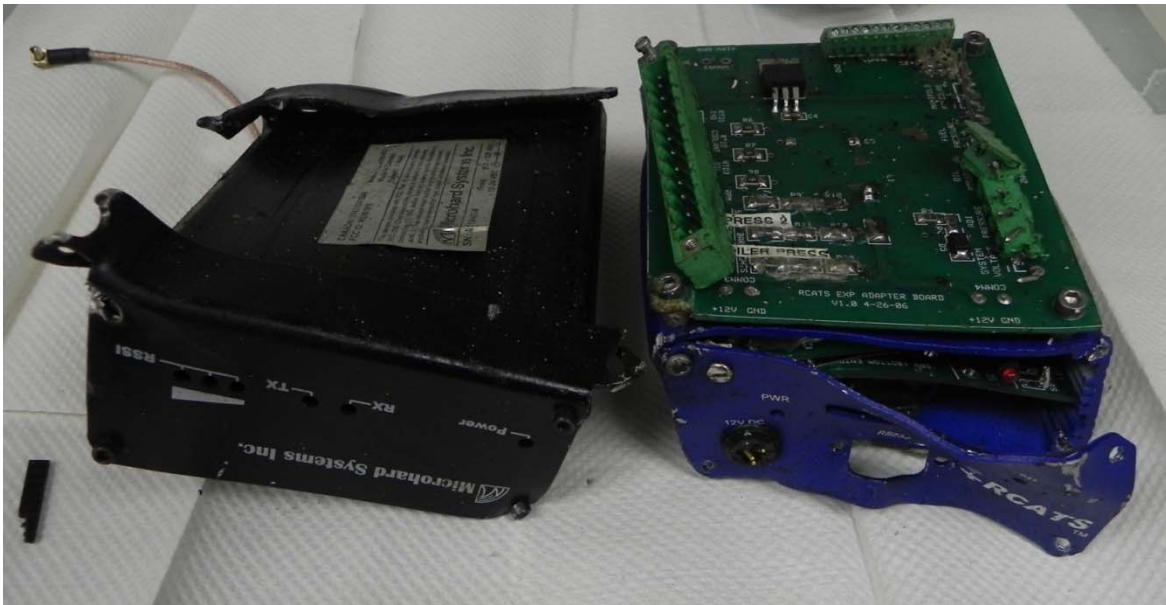
Figure 6 - DCU, sensor adaptor and RF transmitter

The DCU, sensor adapter board and the RF transmitter were substantially damaged in the accident, see Figure 6. The DCU was disassembled to gain access to the SD card installed in the unit. One 2 GB SD card was removed from the DCU, see Figure 7. An external inspection of the SD card showed no signs of the external packaging being compromised but did show some surface scratches. The external packaging was removed and the SD card circuit board was visually inspected. No obvious signs of damage were noted. The unit was cleaned and an attempt was made to access the device using an SD card reader. The SD card would mount on the PC, however the drive size was substantially lower (30 Megabytes) than the card capacity.

Due to the damage to the DCU and the SD card, data recorded onboard the aircraft was not recovered. Data from the ground station TM system was retained and provided to the Safety Board.

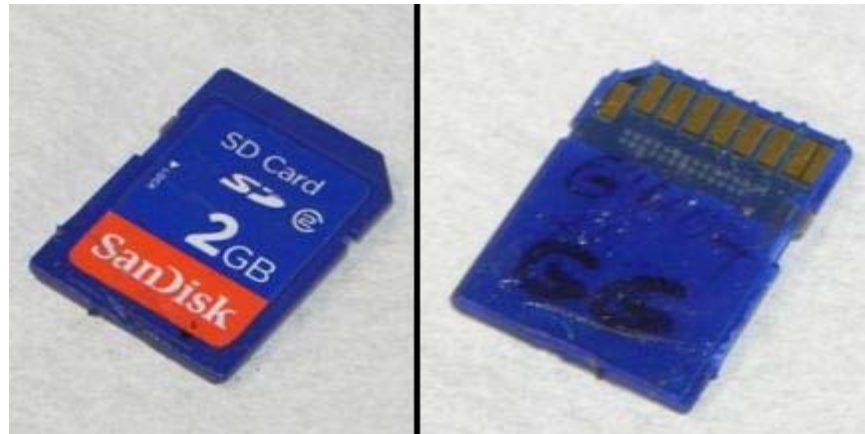
Figure 7 - Top and bottom view of recovered SD card

The SD card was sent to the Federal Bureau of Investigations' Cryptologic and Electronic Analysis Unit in Quantico, VA, to attempt recovery of the data on the SD card. Attempts to recover the data were unsuccessful. During polishing of the device packaging in order to expose the internal die surface, severe cracks in the backside of the memory device were found. The cracks in the memory device make recovery of data from the device unfeasible. The FBI report is included as attachment 1 to this report.

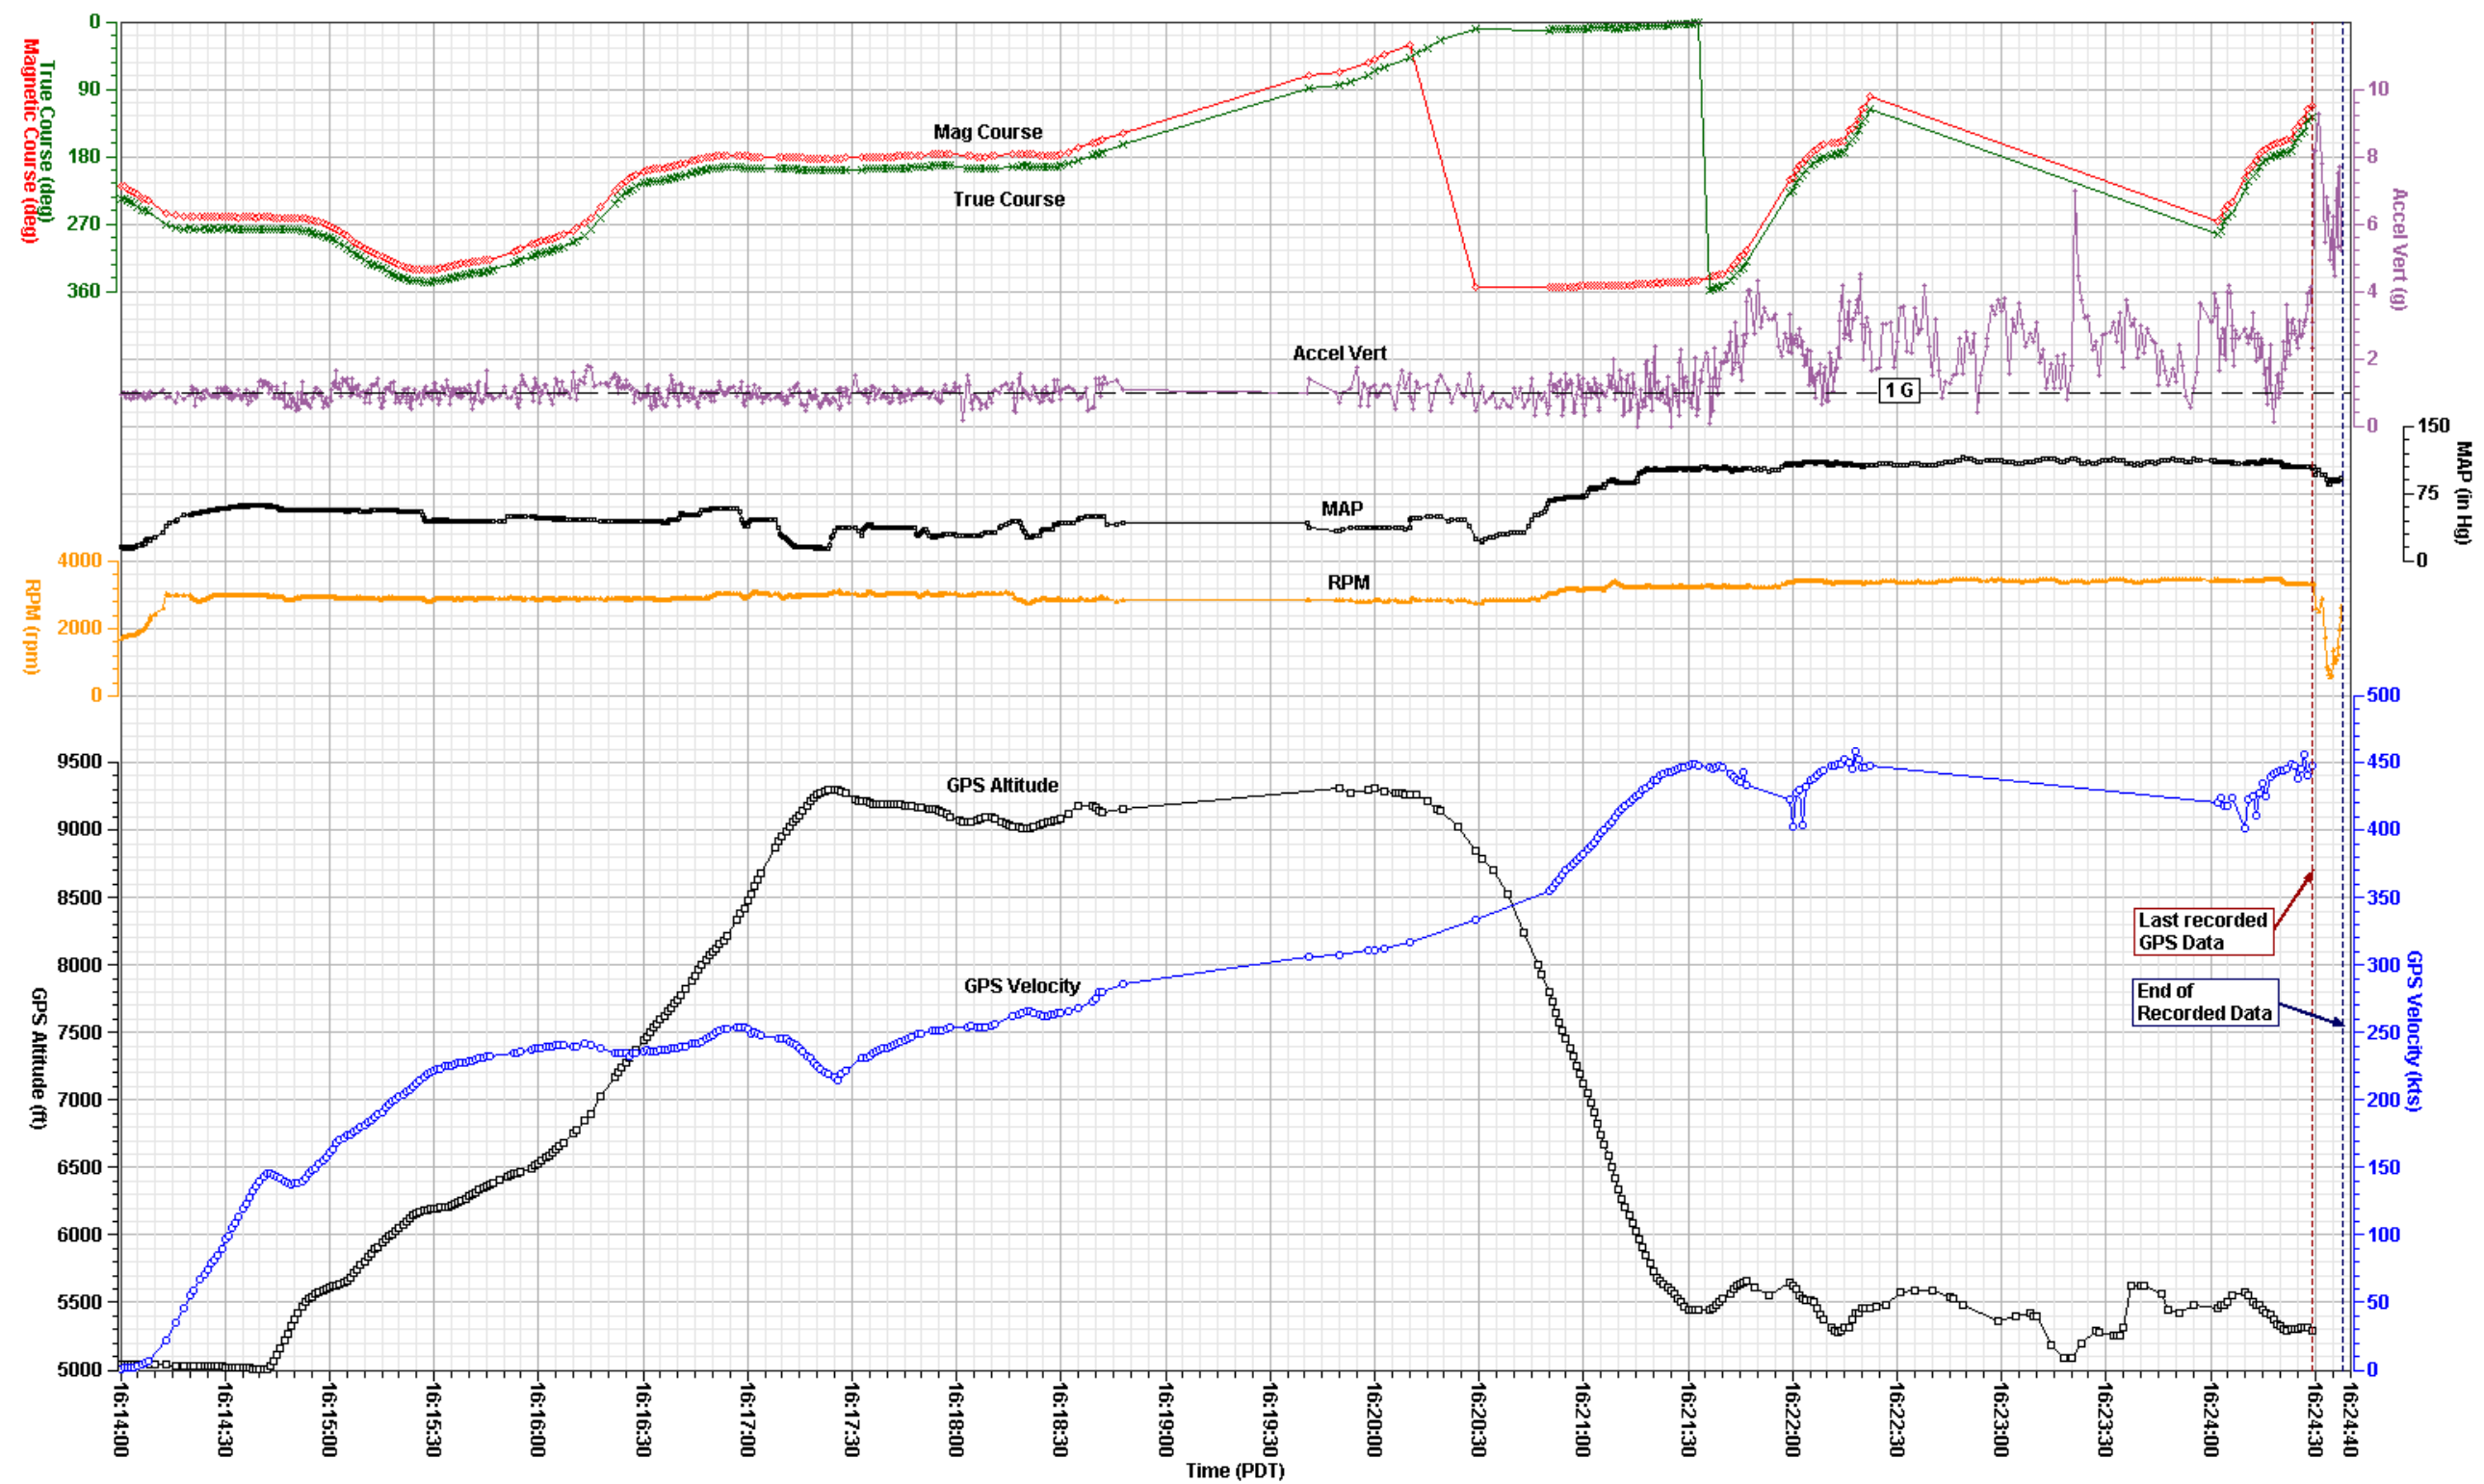
Figure 8 - Basic parameters for accident aircraft from TM system on accident flight

Data used in figures 8 through 13 have had invalid data removed from the dataset and timing has been adjusted based on the UTC timestamp and the frame counter parameters. The data was recorded using the telemetry ground station.

Figure 8 and Figure 9 contain plots of basic and engine parameters from the accident aircraft during the accident flight. The time period covered is from 16:14:00 to 16:24:40 PDT.

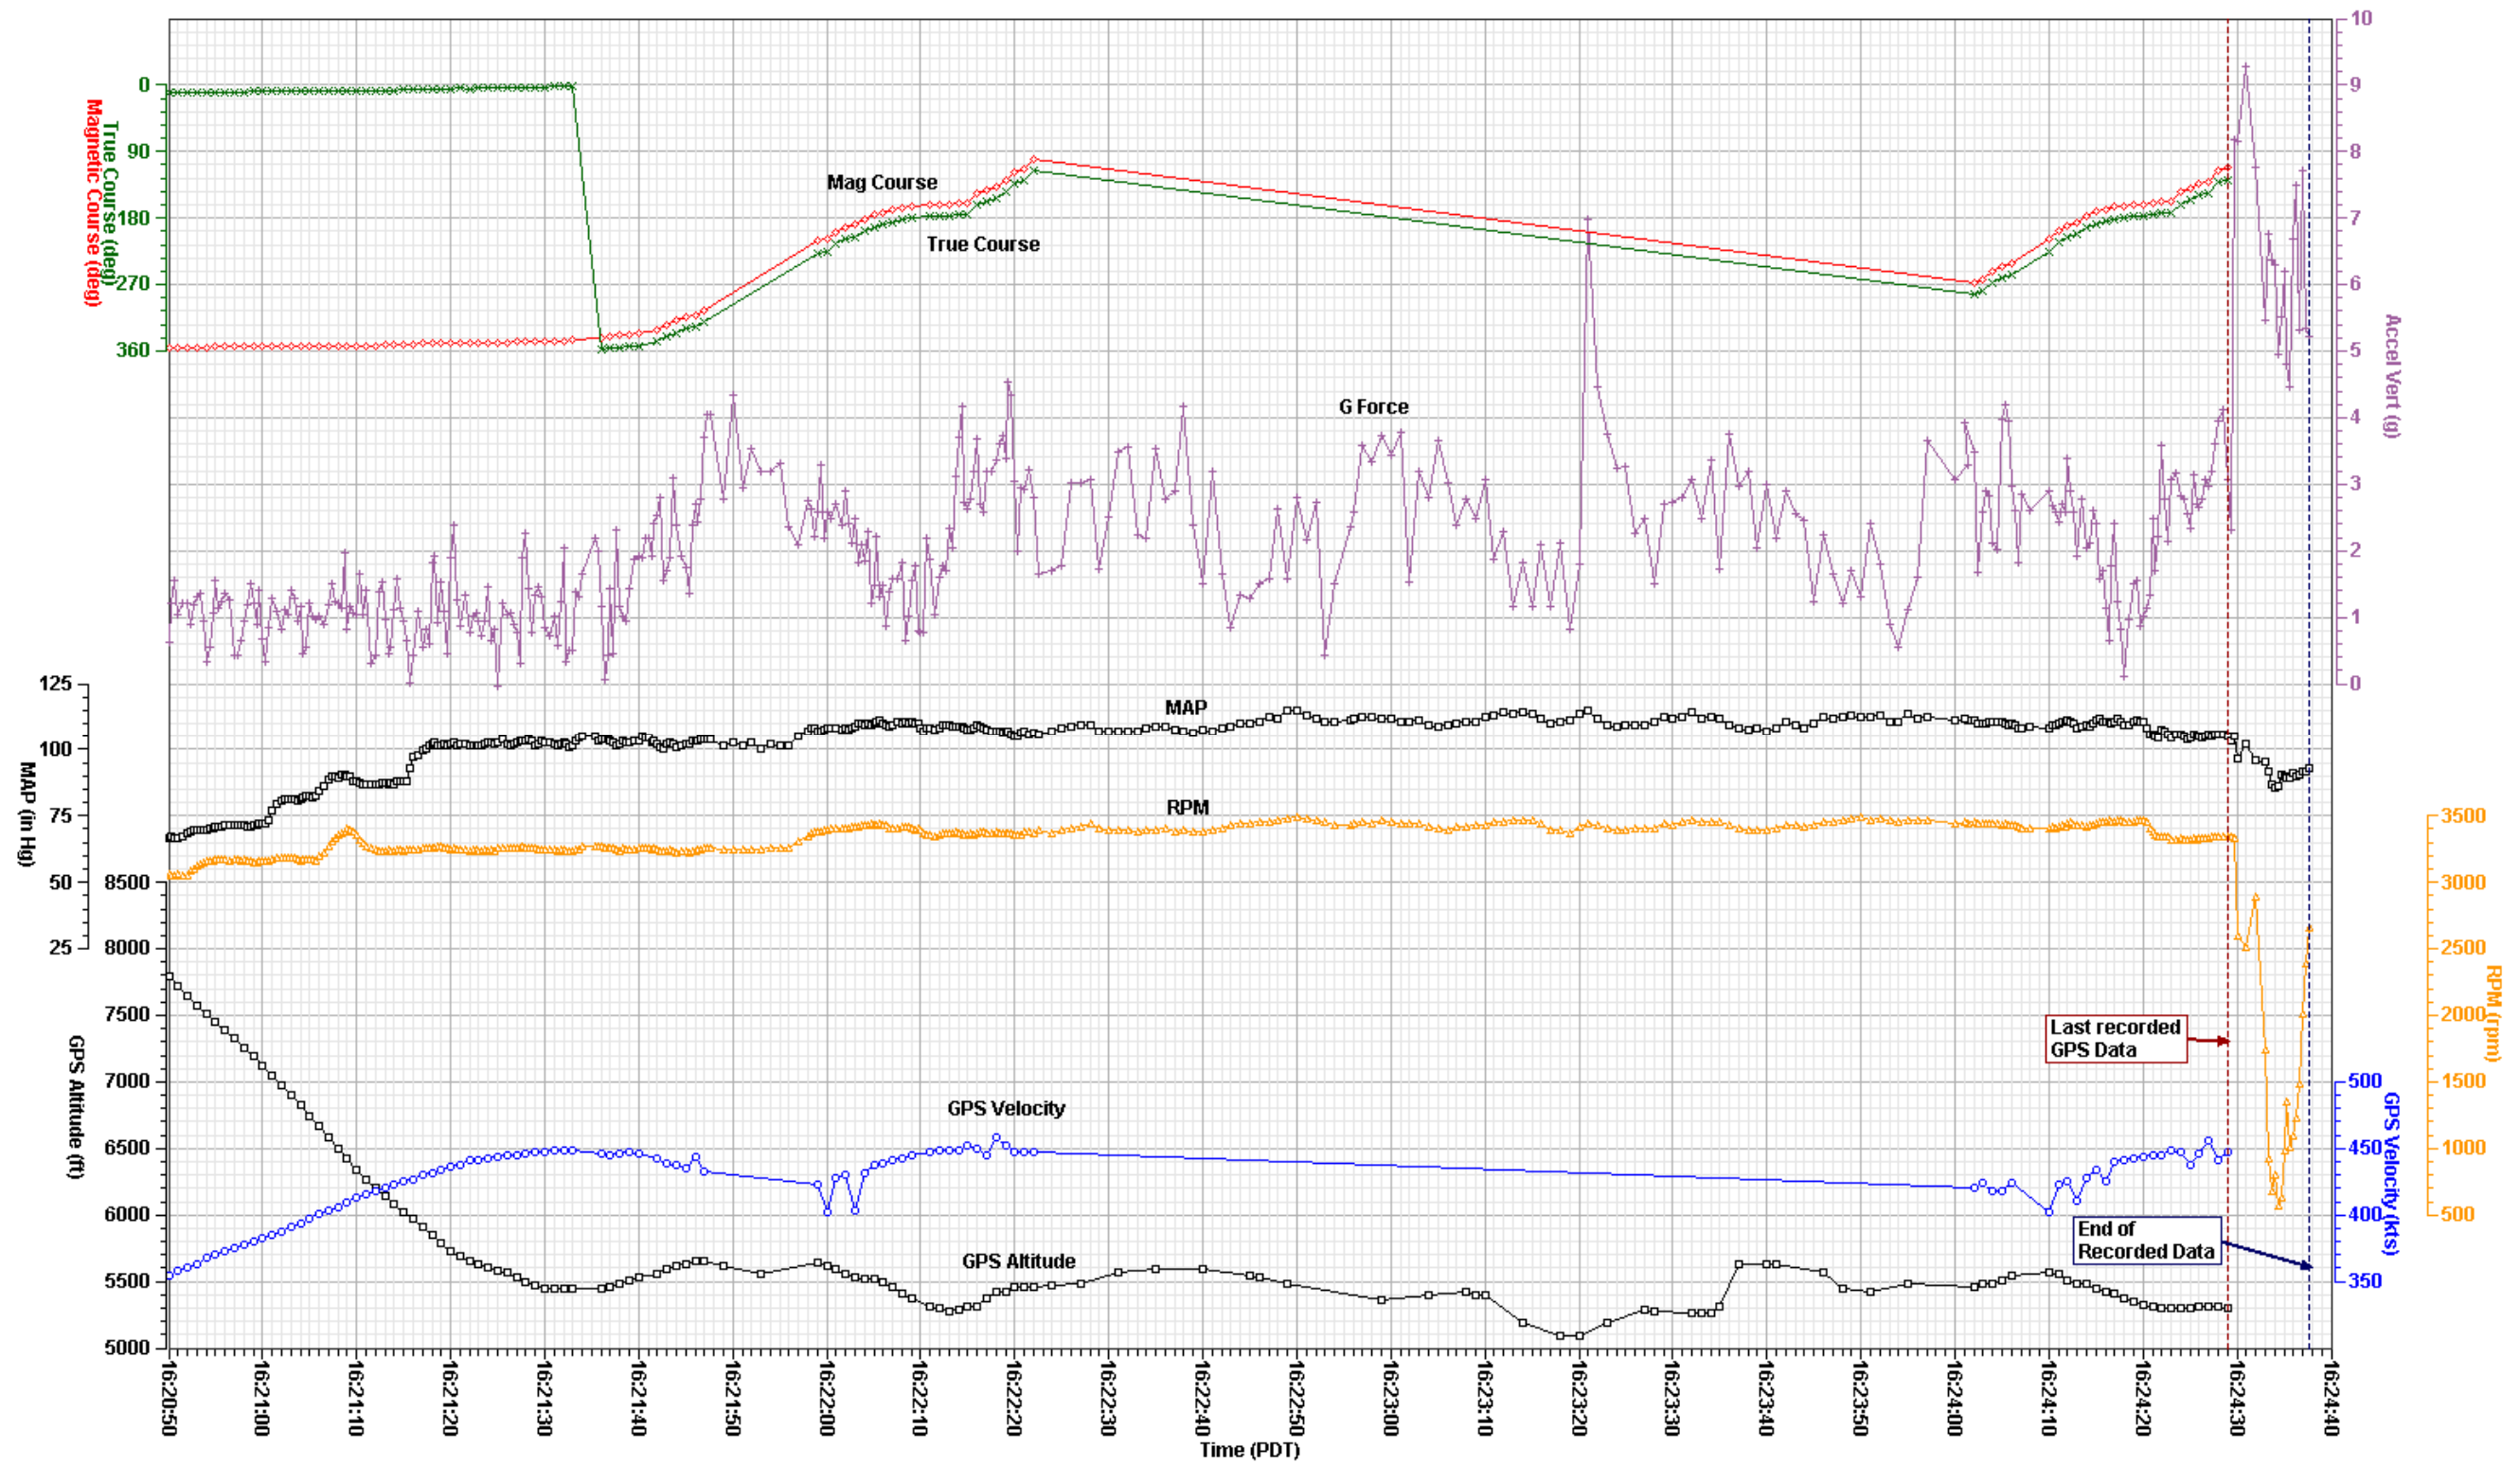
Figure 10 - Basic parameters for accident aircraft from TM system on accident flight, approximately last four minutes

Figure 10 and Figure 11 contain plots of basic and engine data parameters from the accident aircraft during the race portion of the accident flight. The time period covered is from 16:20:50 to 16:24:40 PDT.

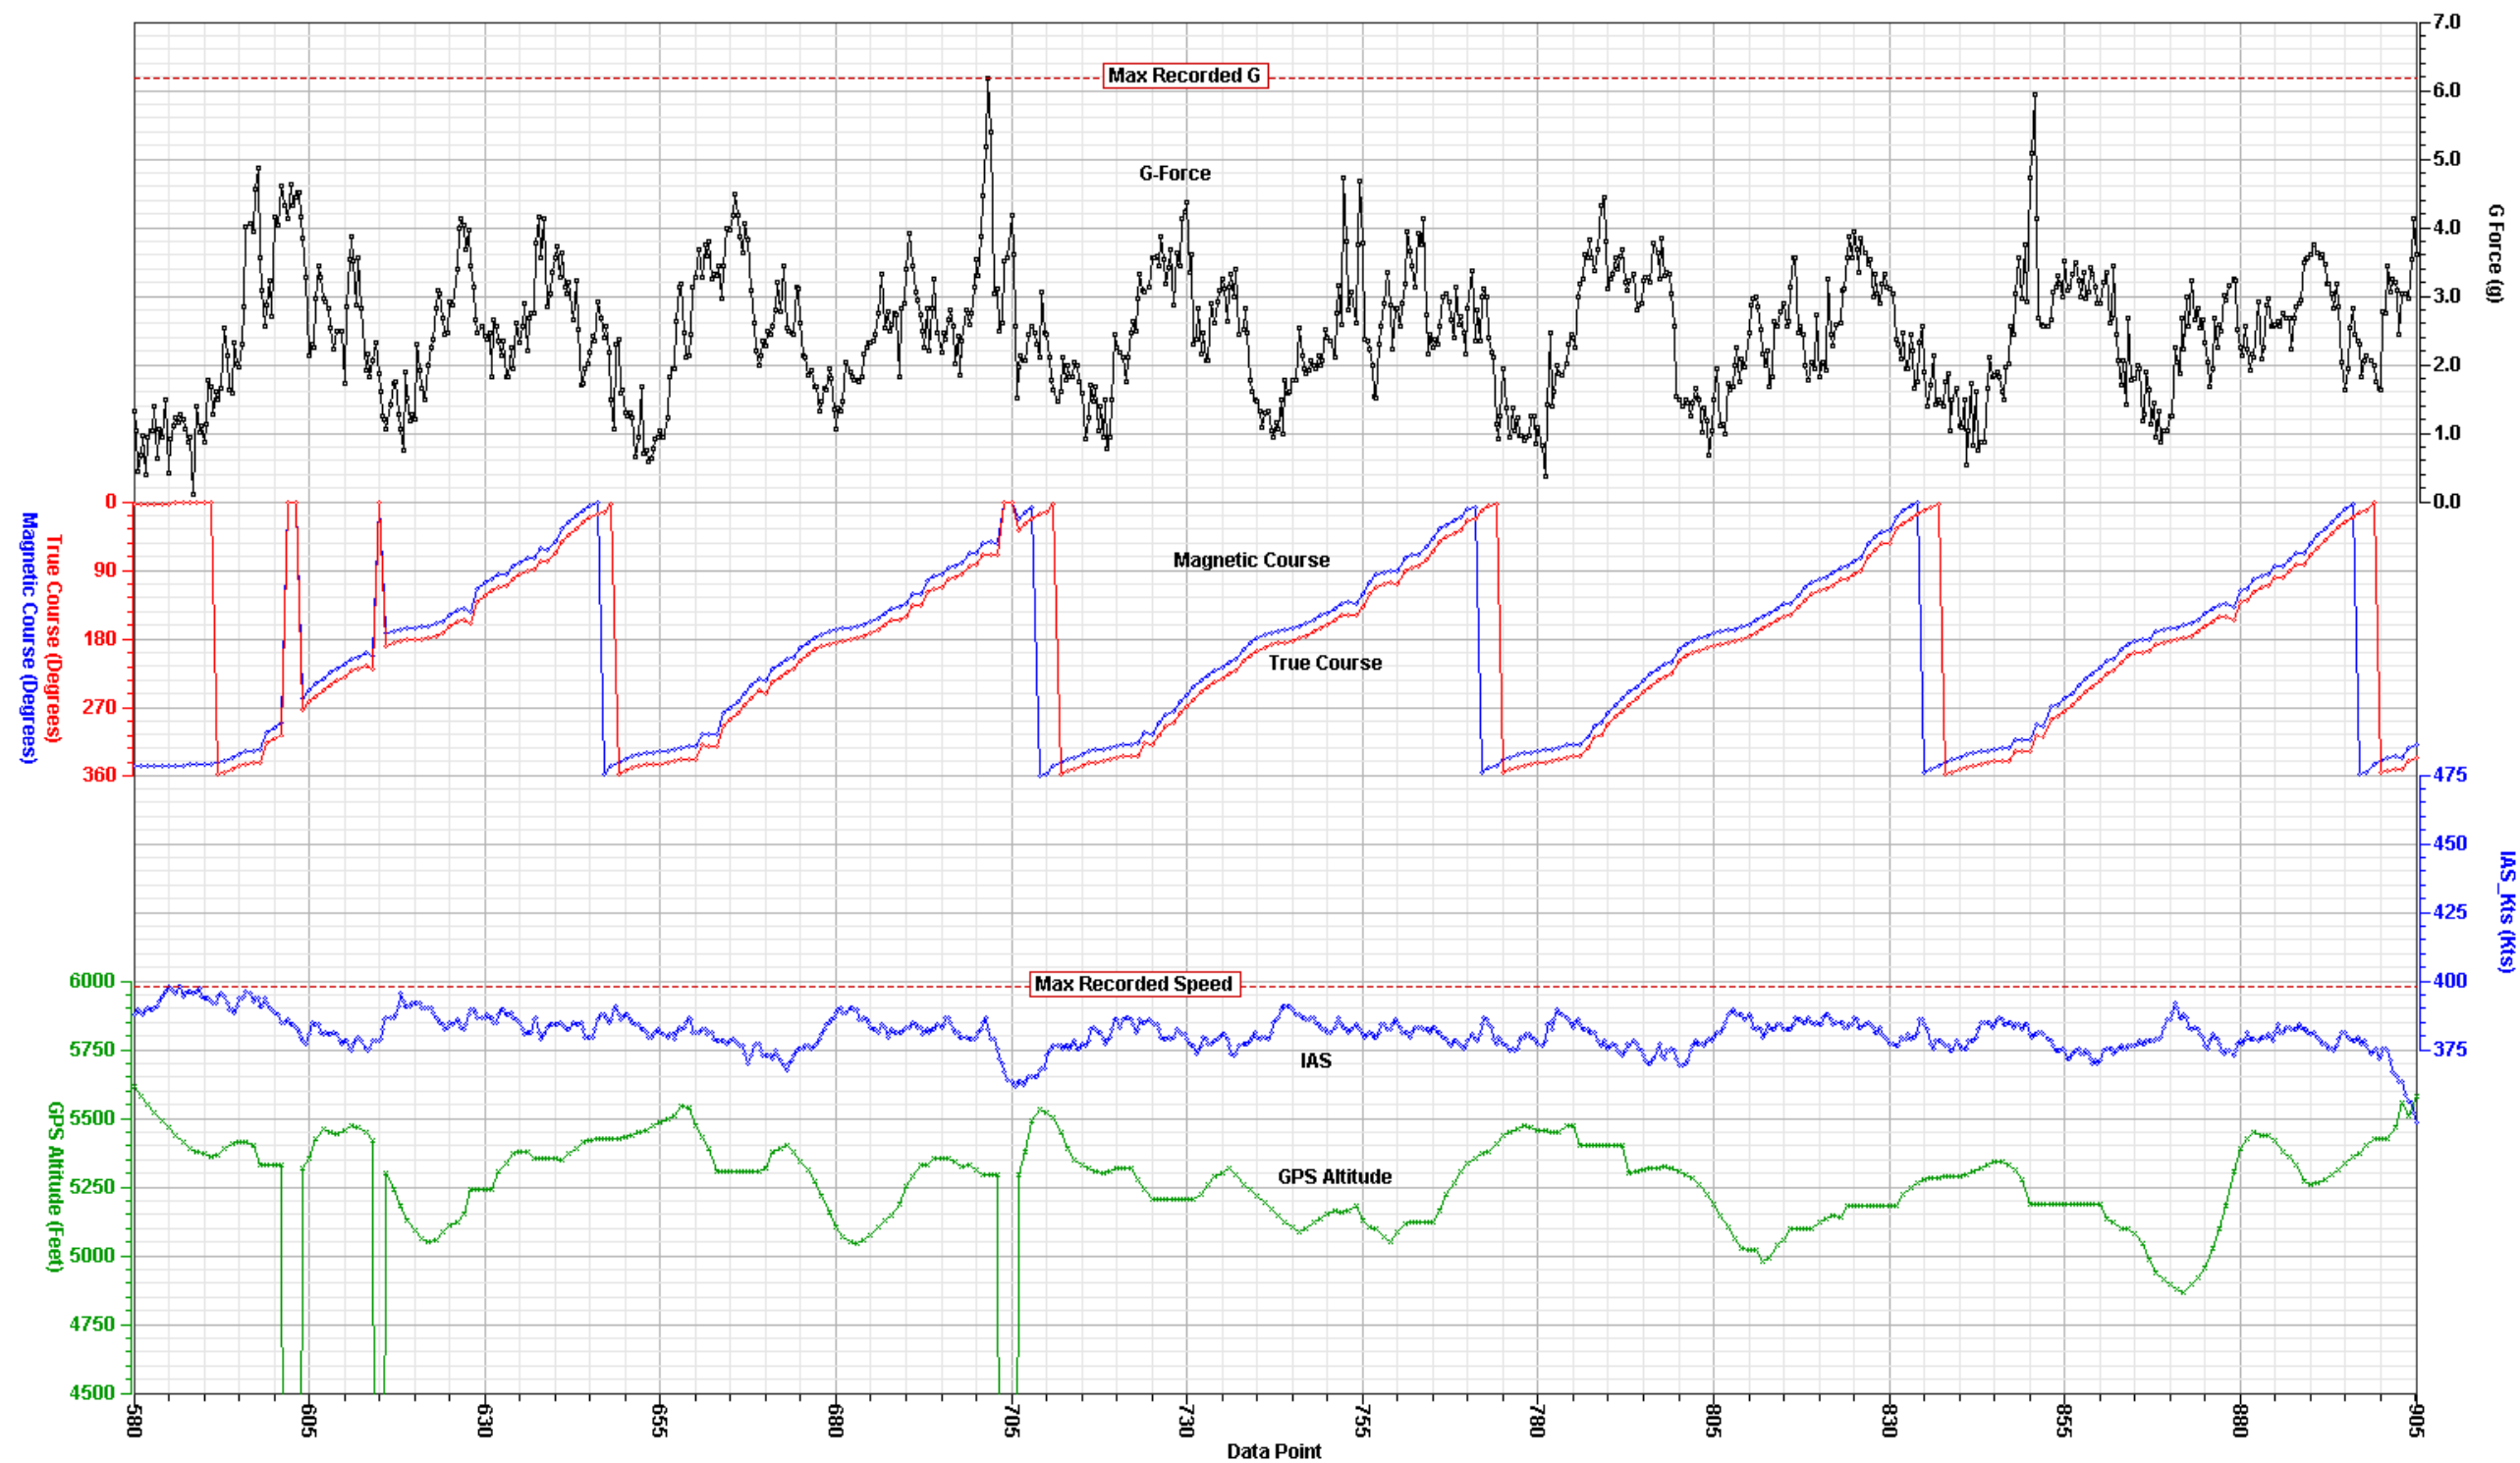
Figure 14 - Basic information for additional aircraft 1 (Voodoo) recorded during a gold class race in 2009

Figure 14 contains a plot of basic information from a gold class race in 2006. The portion of the data plotted was recorded during maneuvering on the NCAR course. The maximum recorded velocity was 398 kts and the maximum recorded vertical acceleration was 6.2 g. The flight originated and terminated at RTS.

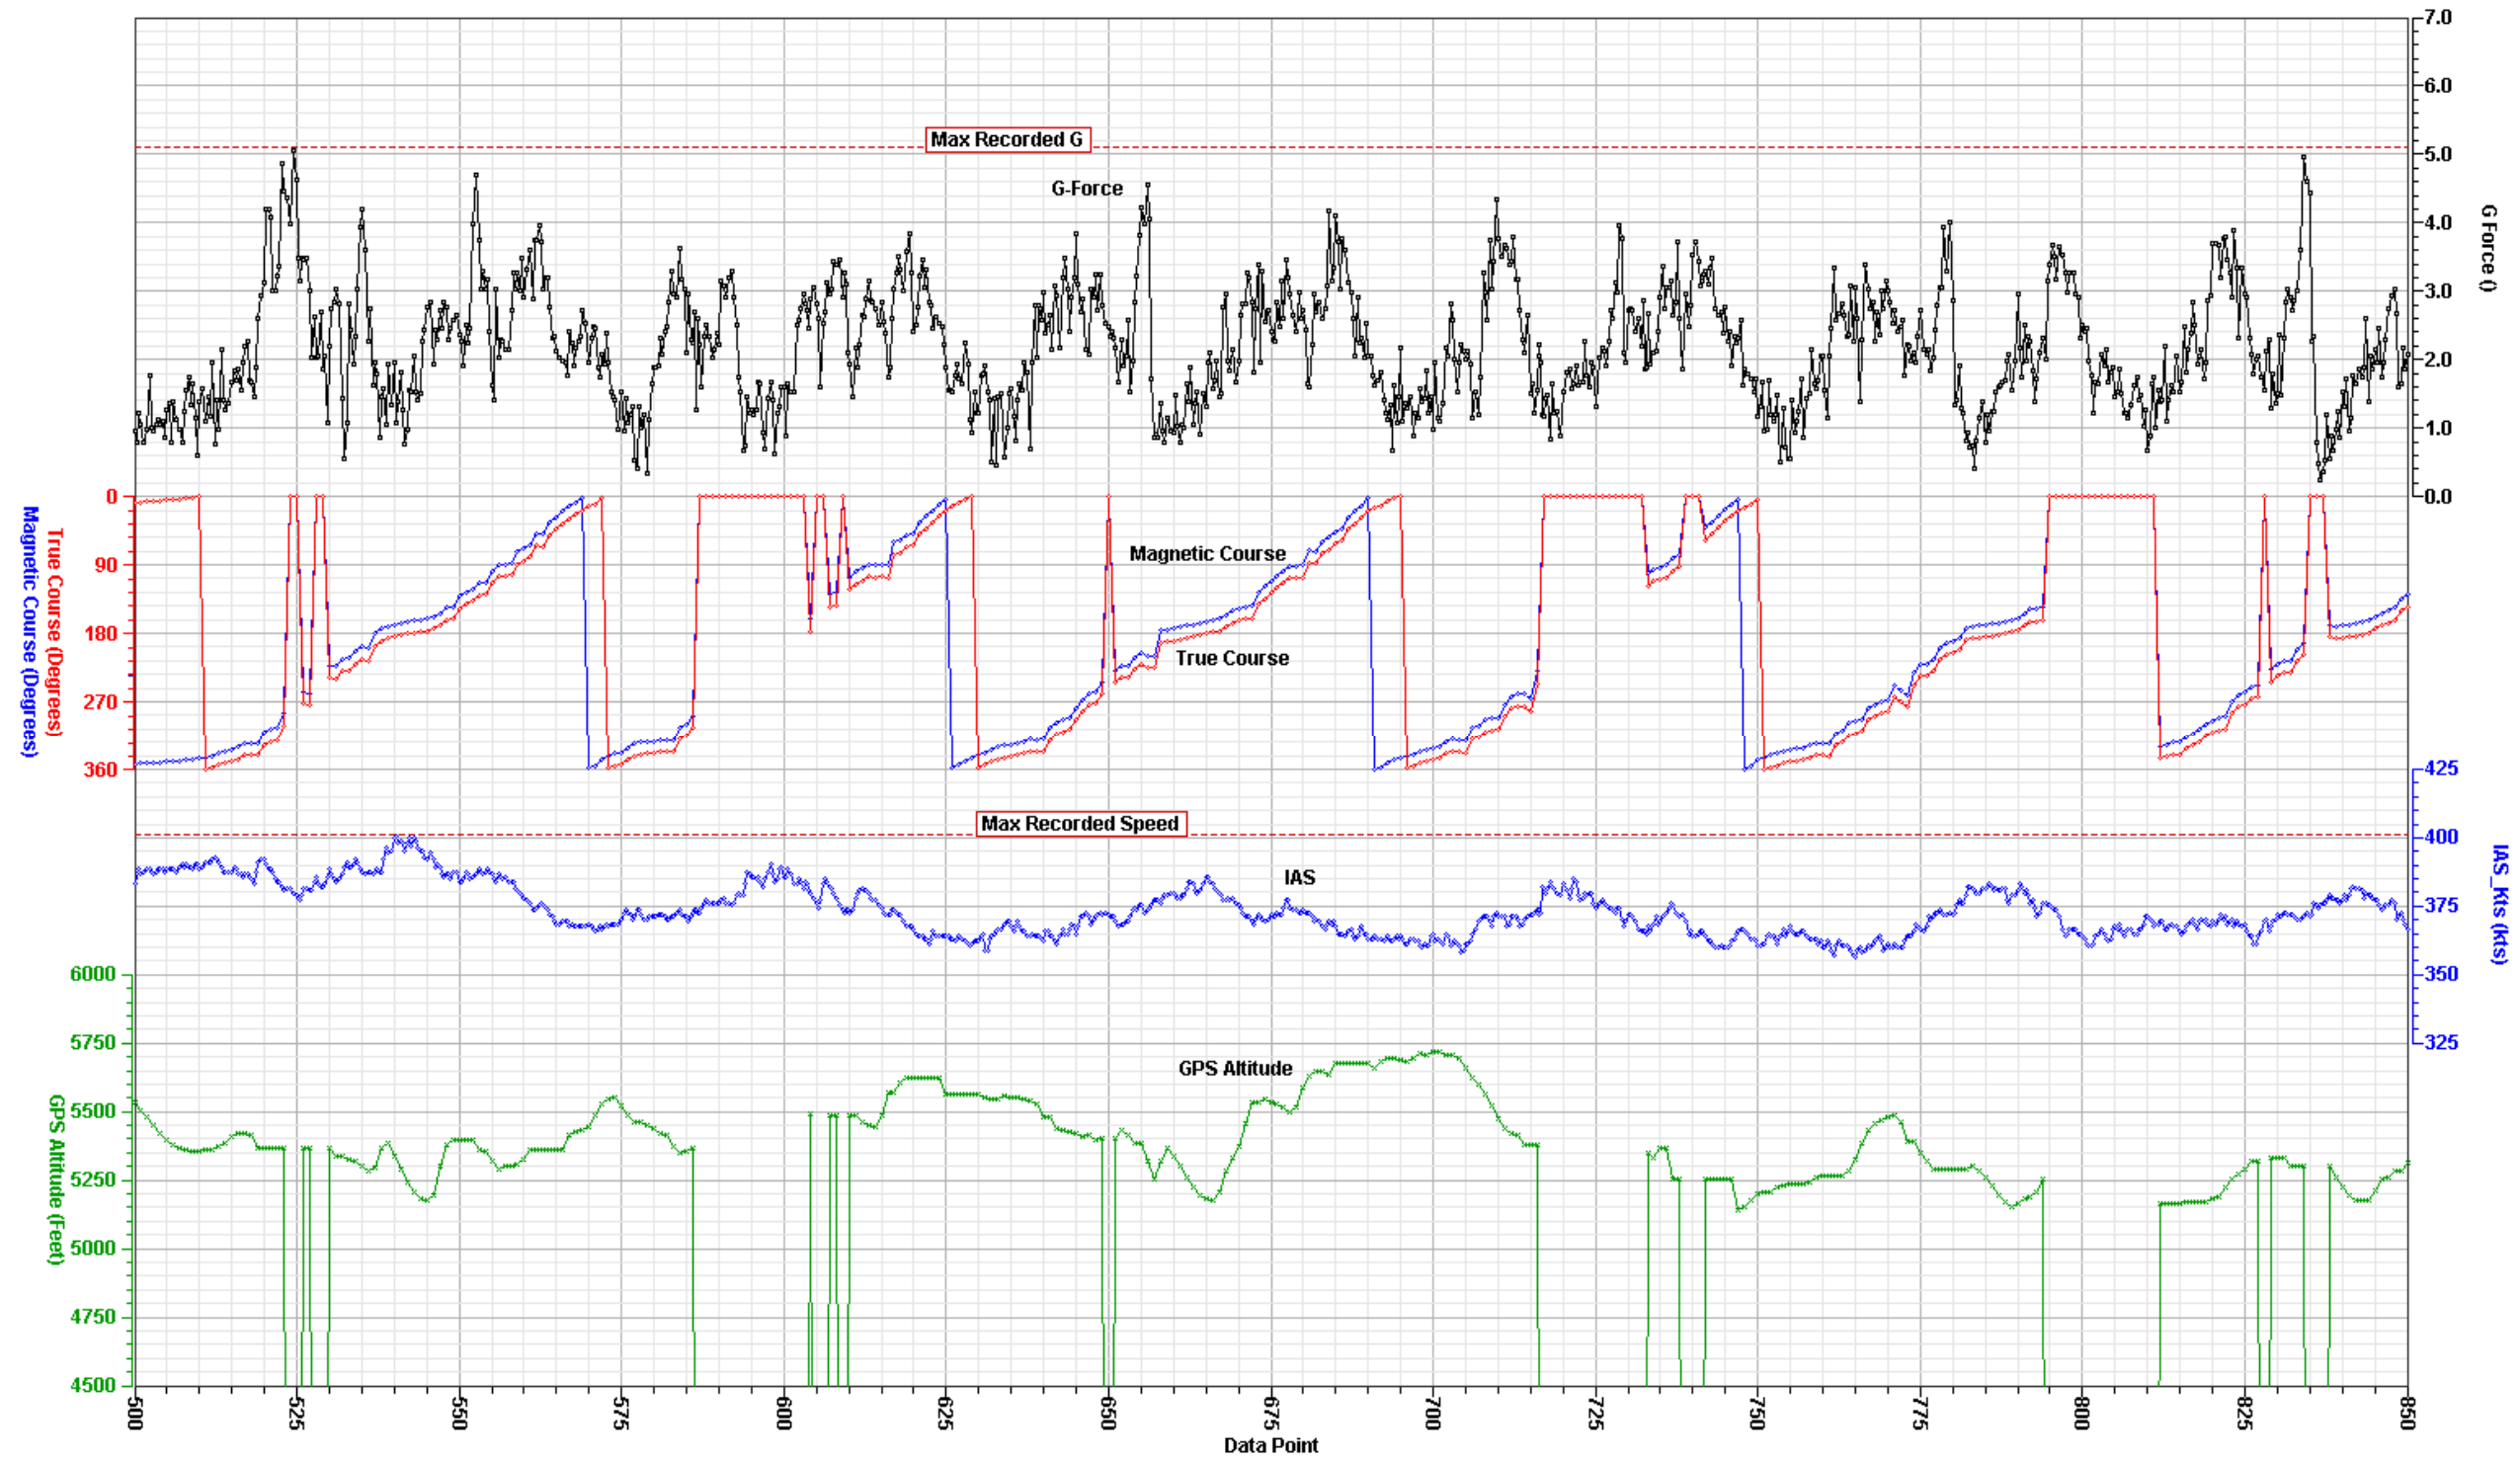
Figure 15 - Basic information for additional aircraft 1 (Voodoo) recorded during a gold class race in 2010

Figure 15 contains a plot of basic information from a gold class race in 2010. The portion of the data plotted was recorded during maneuvering on the NCAR course. The maximum recorded velocity was 401 kts and the maximum recorded vertical acceleration was 5.1 g. The flight originated and terminated at RTS.
