# NATIONAL TRANSPORTATION SAFETY BOARD

### Specialist's Factual Report By Michael Bauer

Location: Reno, Nevada  
Date: Sep 16, 2011  
Aircraft: P-51D  
Registration: N79111  
Operator: Aero-Trans Corp.  
NTSB Number: WPR11MA454

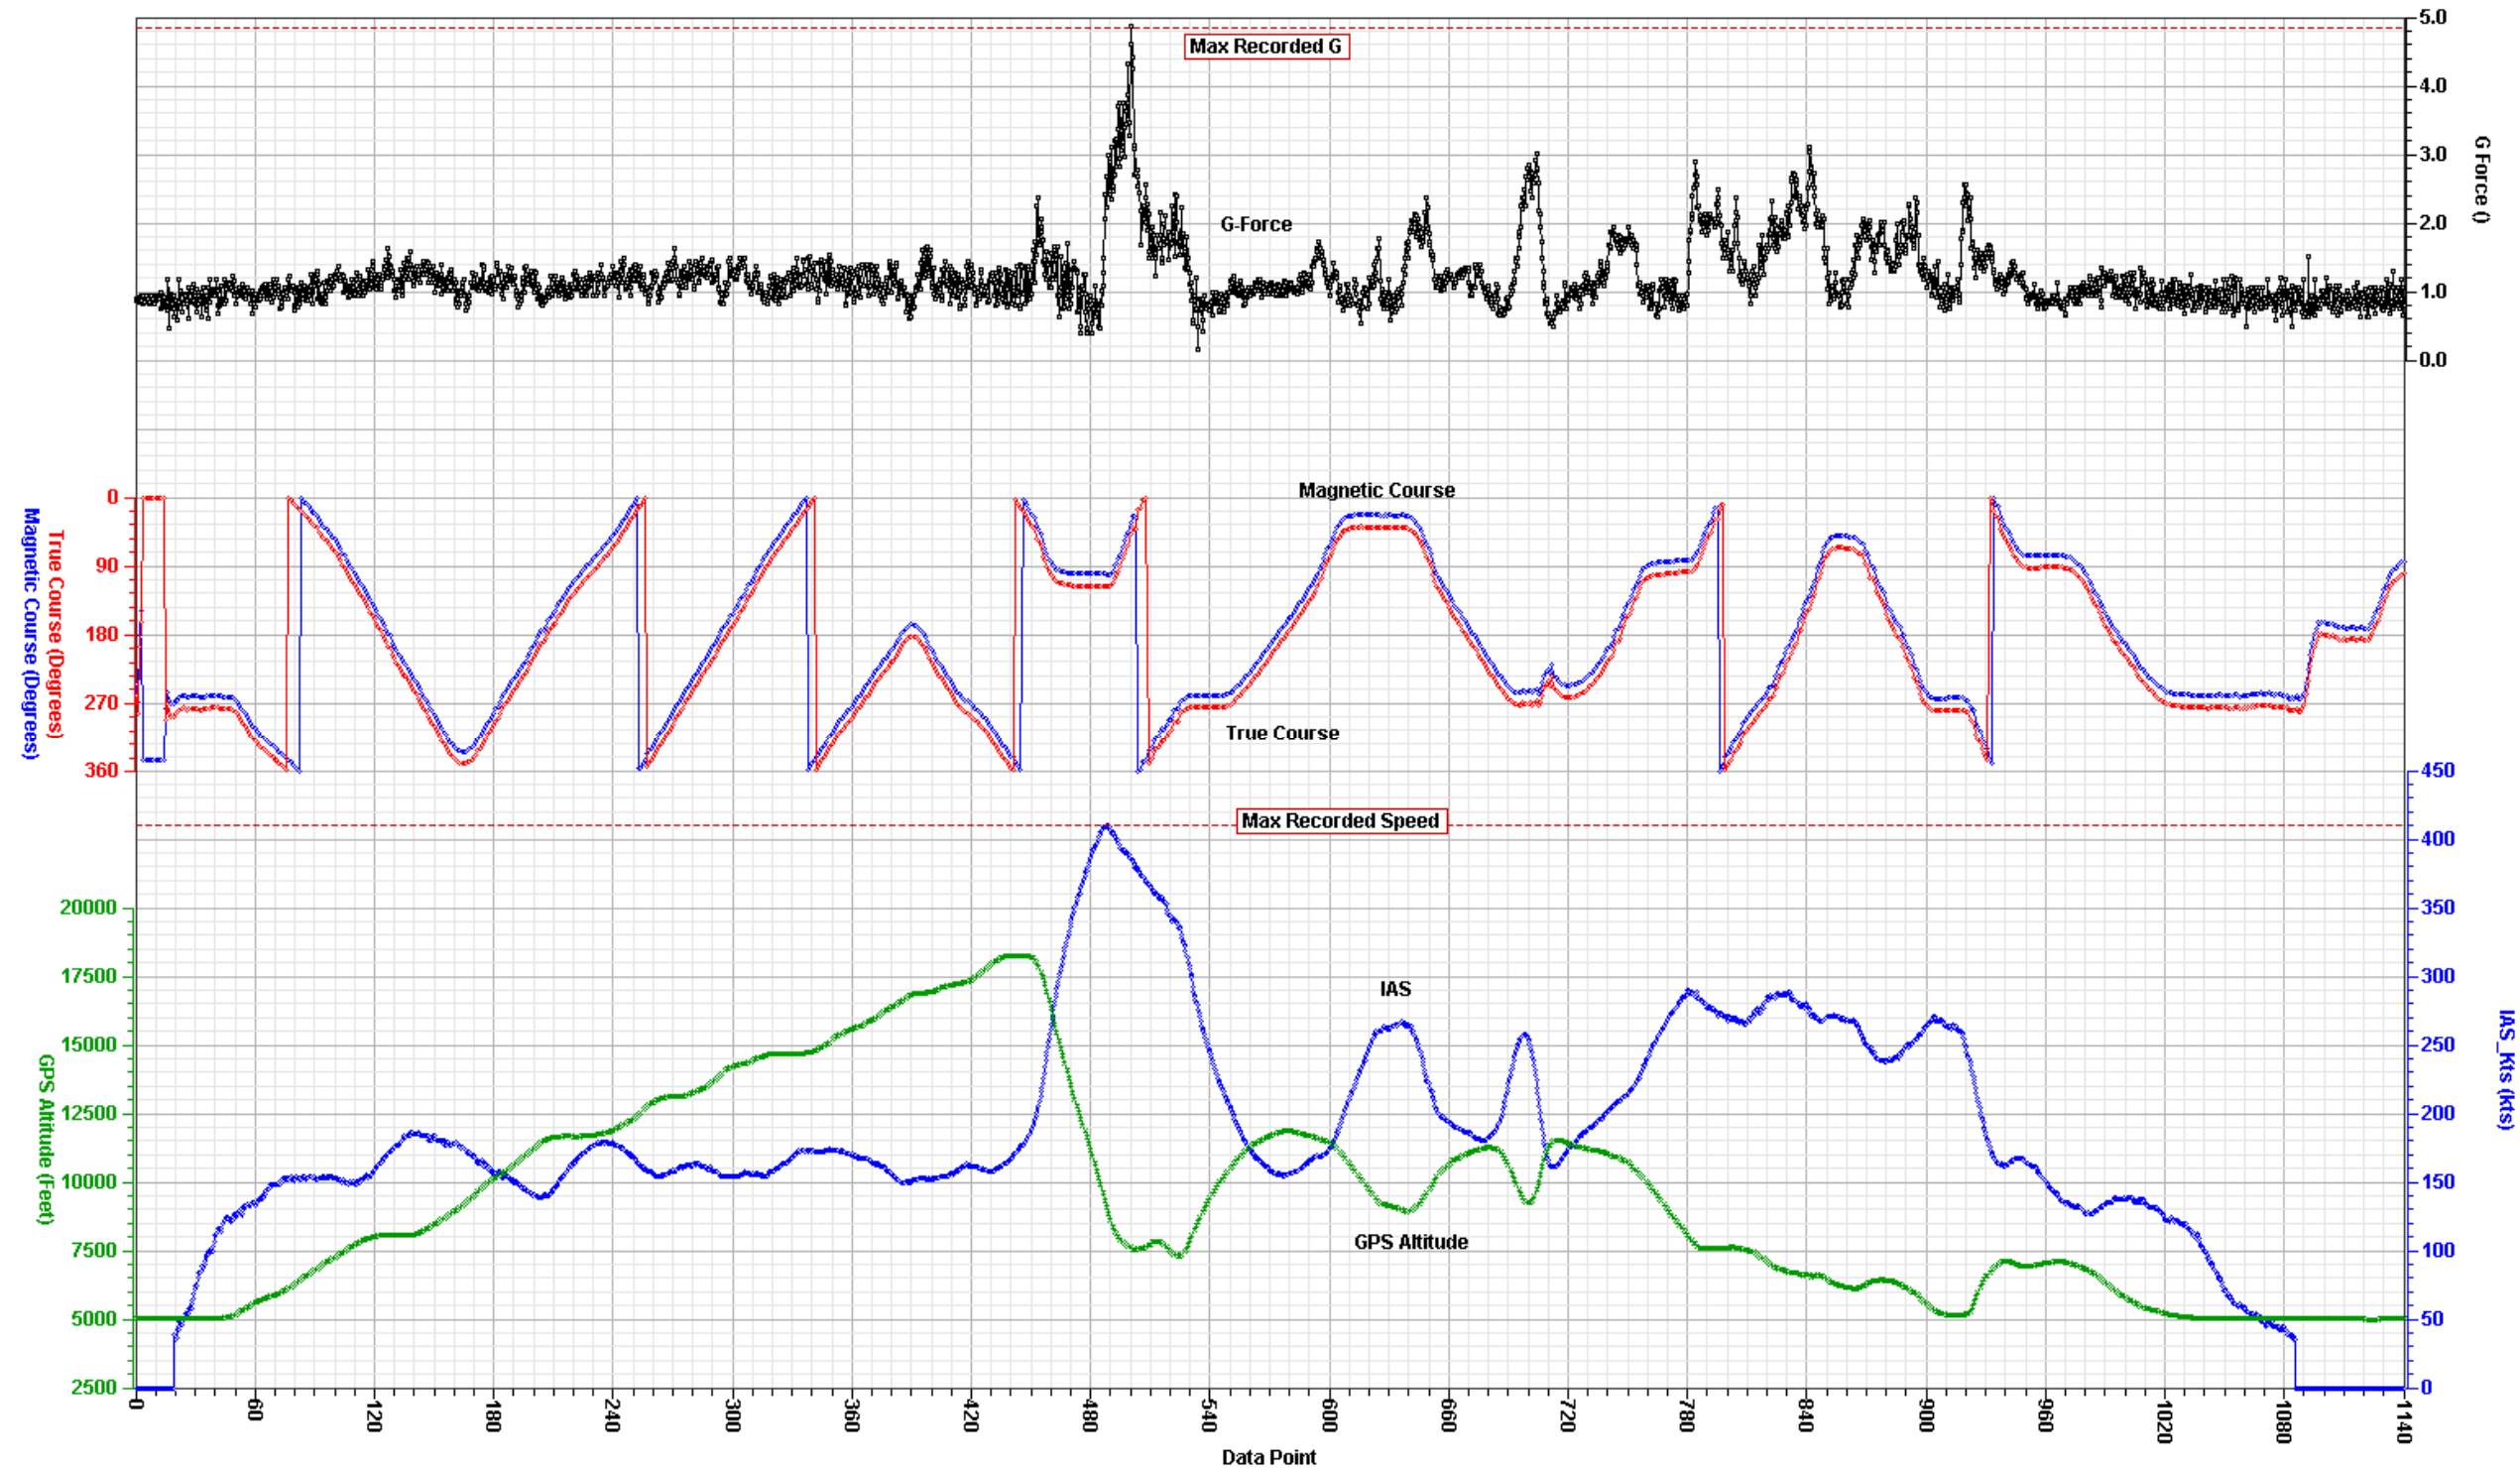
Figure 16 - Basic information for additional aircraft 1 (Voodoo) recorded during a test flight in 2011

Figure 16 contains a plot of basic information from a test flight in 2011. The portion of the data plotted was recorded during a dive, followed by a pull-up. During the dive the maximum recorded velocity was 409 kts and the maximum recorded vertical acceleration was 4.9 g. The flight originated and terminated at RTS.

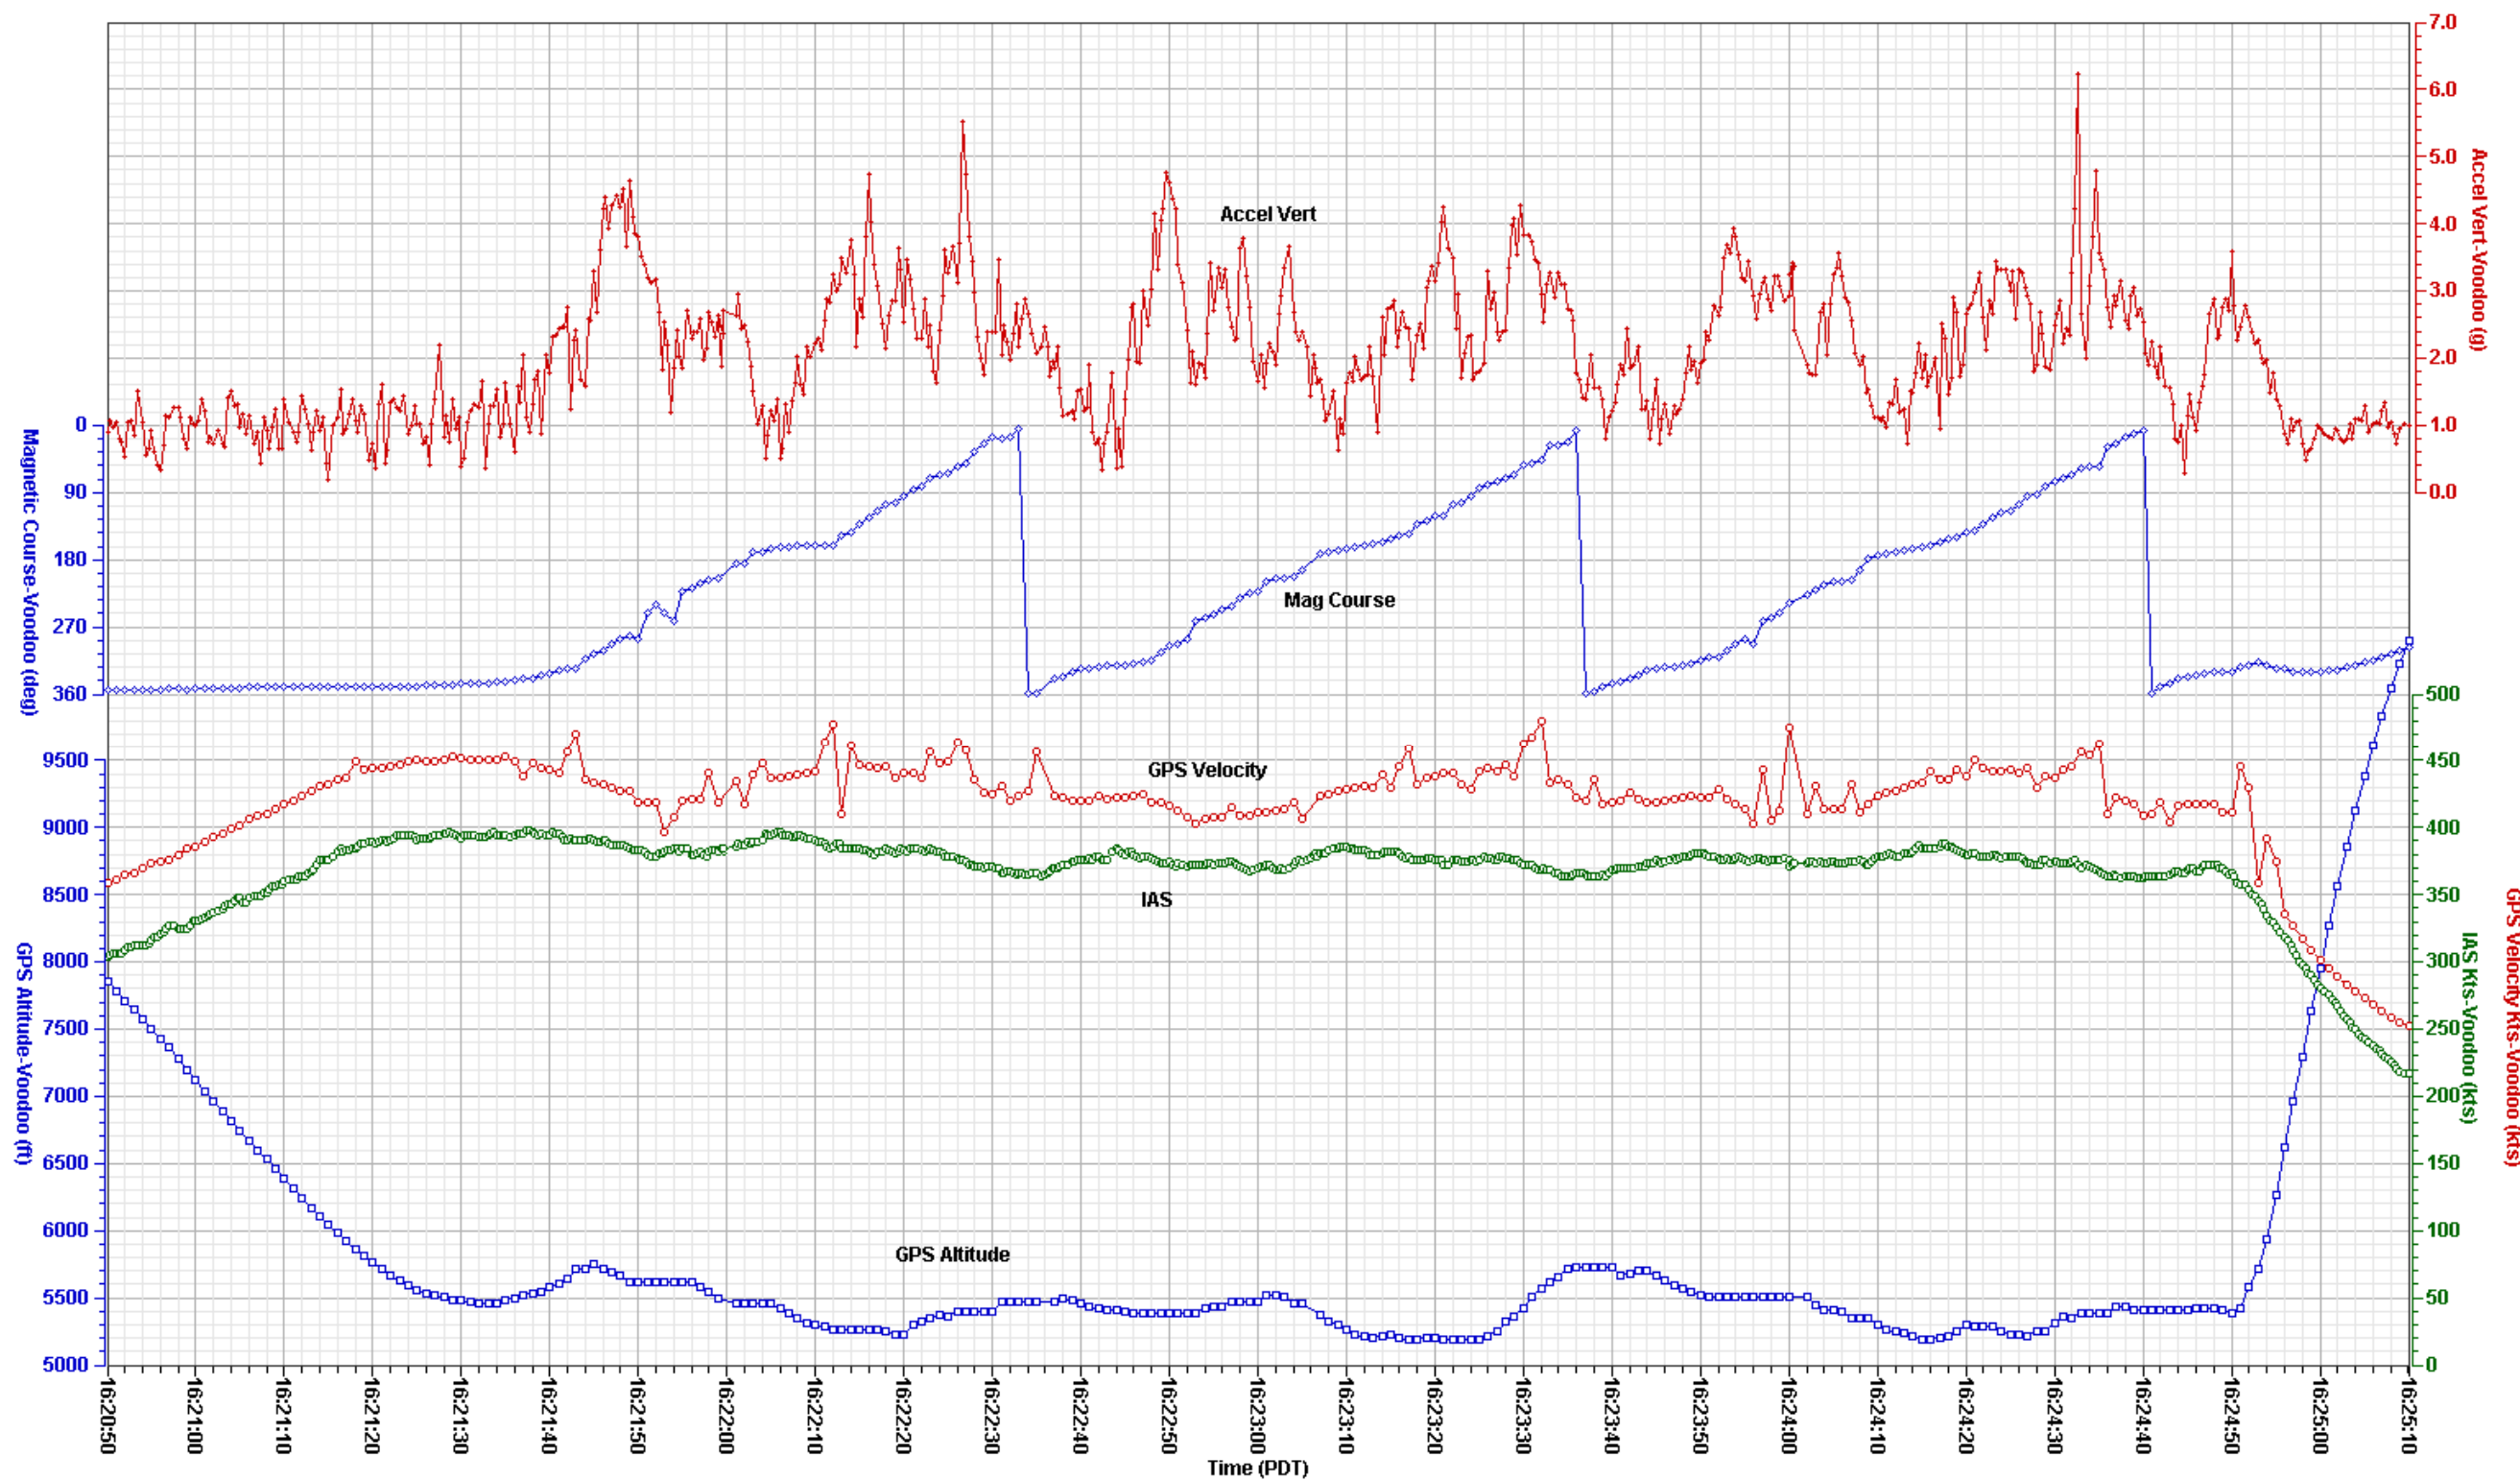
Figure 17 - Basic information for additional aircraft 1 (Voodoo) recorded in 2011 (same race as accident flight)

Figure 17 contains a plot of basic information from the same race in which the accident occurred on September 16, 2011. The portion of the data plotted was recorded during maneuvering on the NCAR course. The flight originated and terminated at RTS.

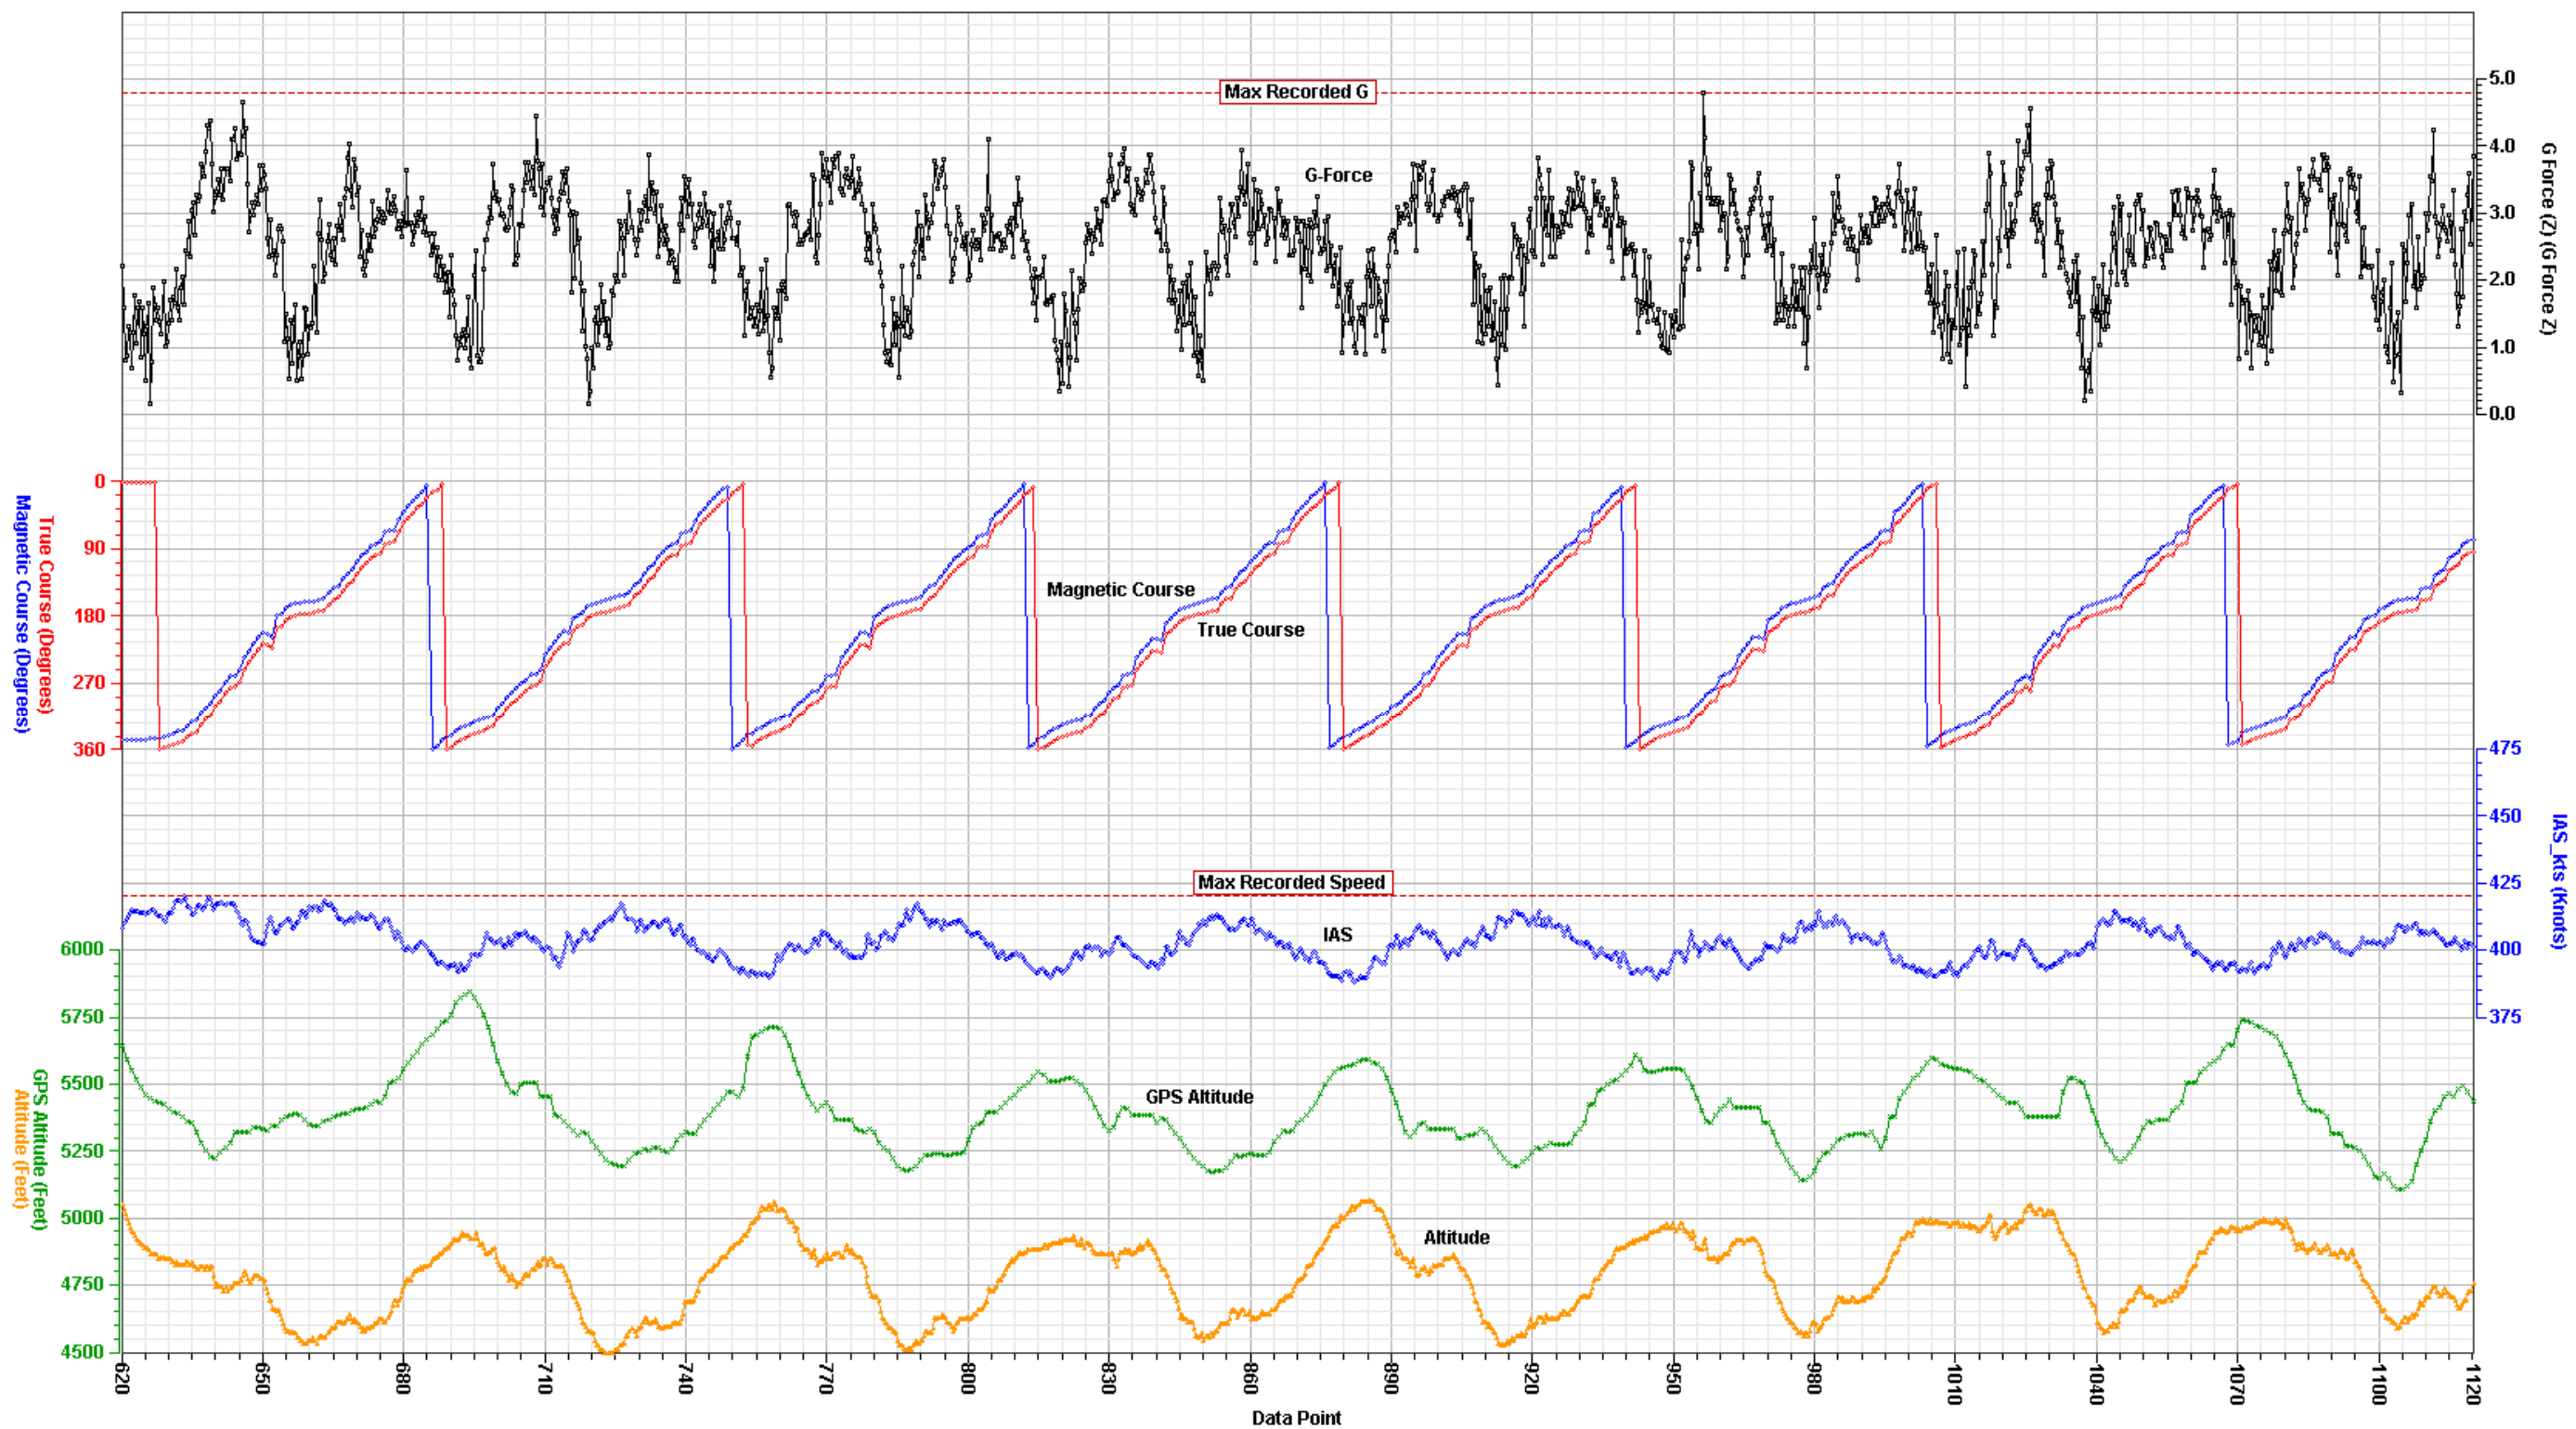
Figure 18 - Basic information for additional aircraft 2 (September Fury) recorded during a gold class race in 2006 (original wings)

Figure 18 contains a plot of basic information from a gold class race in 2006. The aircraft wing was in its original manufactured configuration. The portion of the data plotted was recorded during maneuvering on the NCAR course. The maximum recorded velocity was 420 kts and the maximum recorded vertical acceleration was 4.8 g. The flight originated and terminated at RTS.

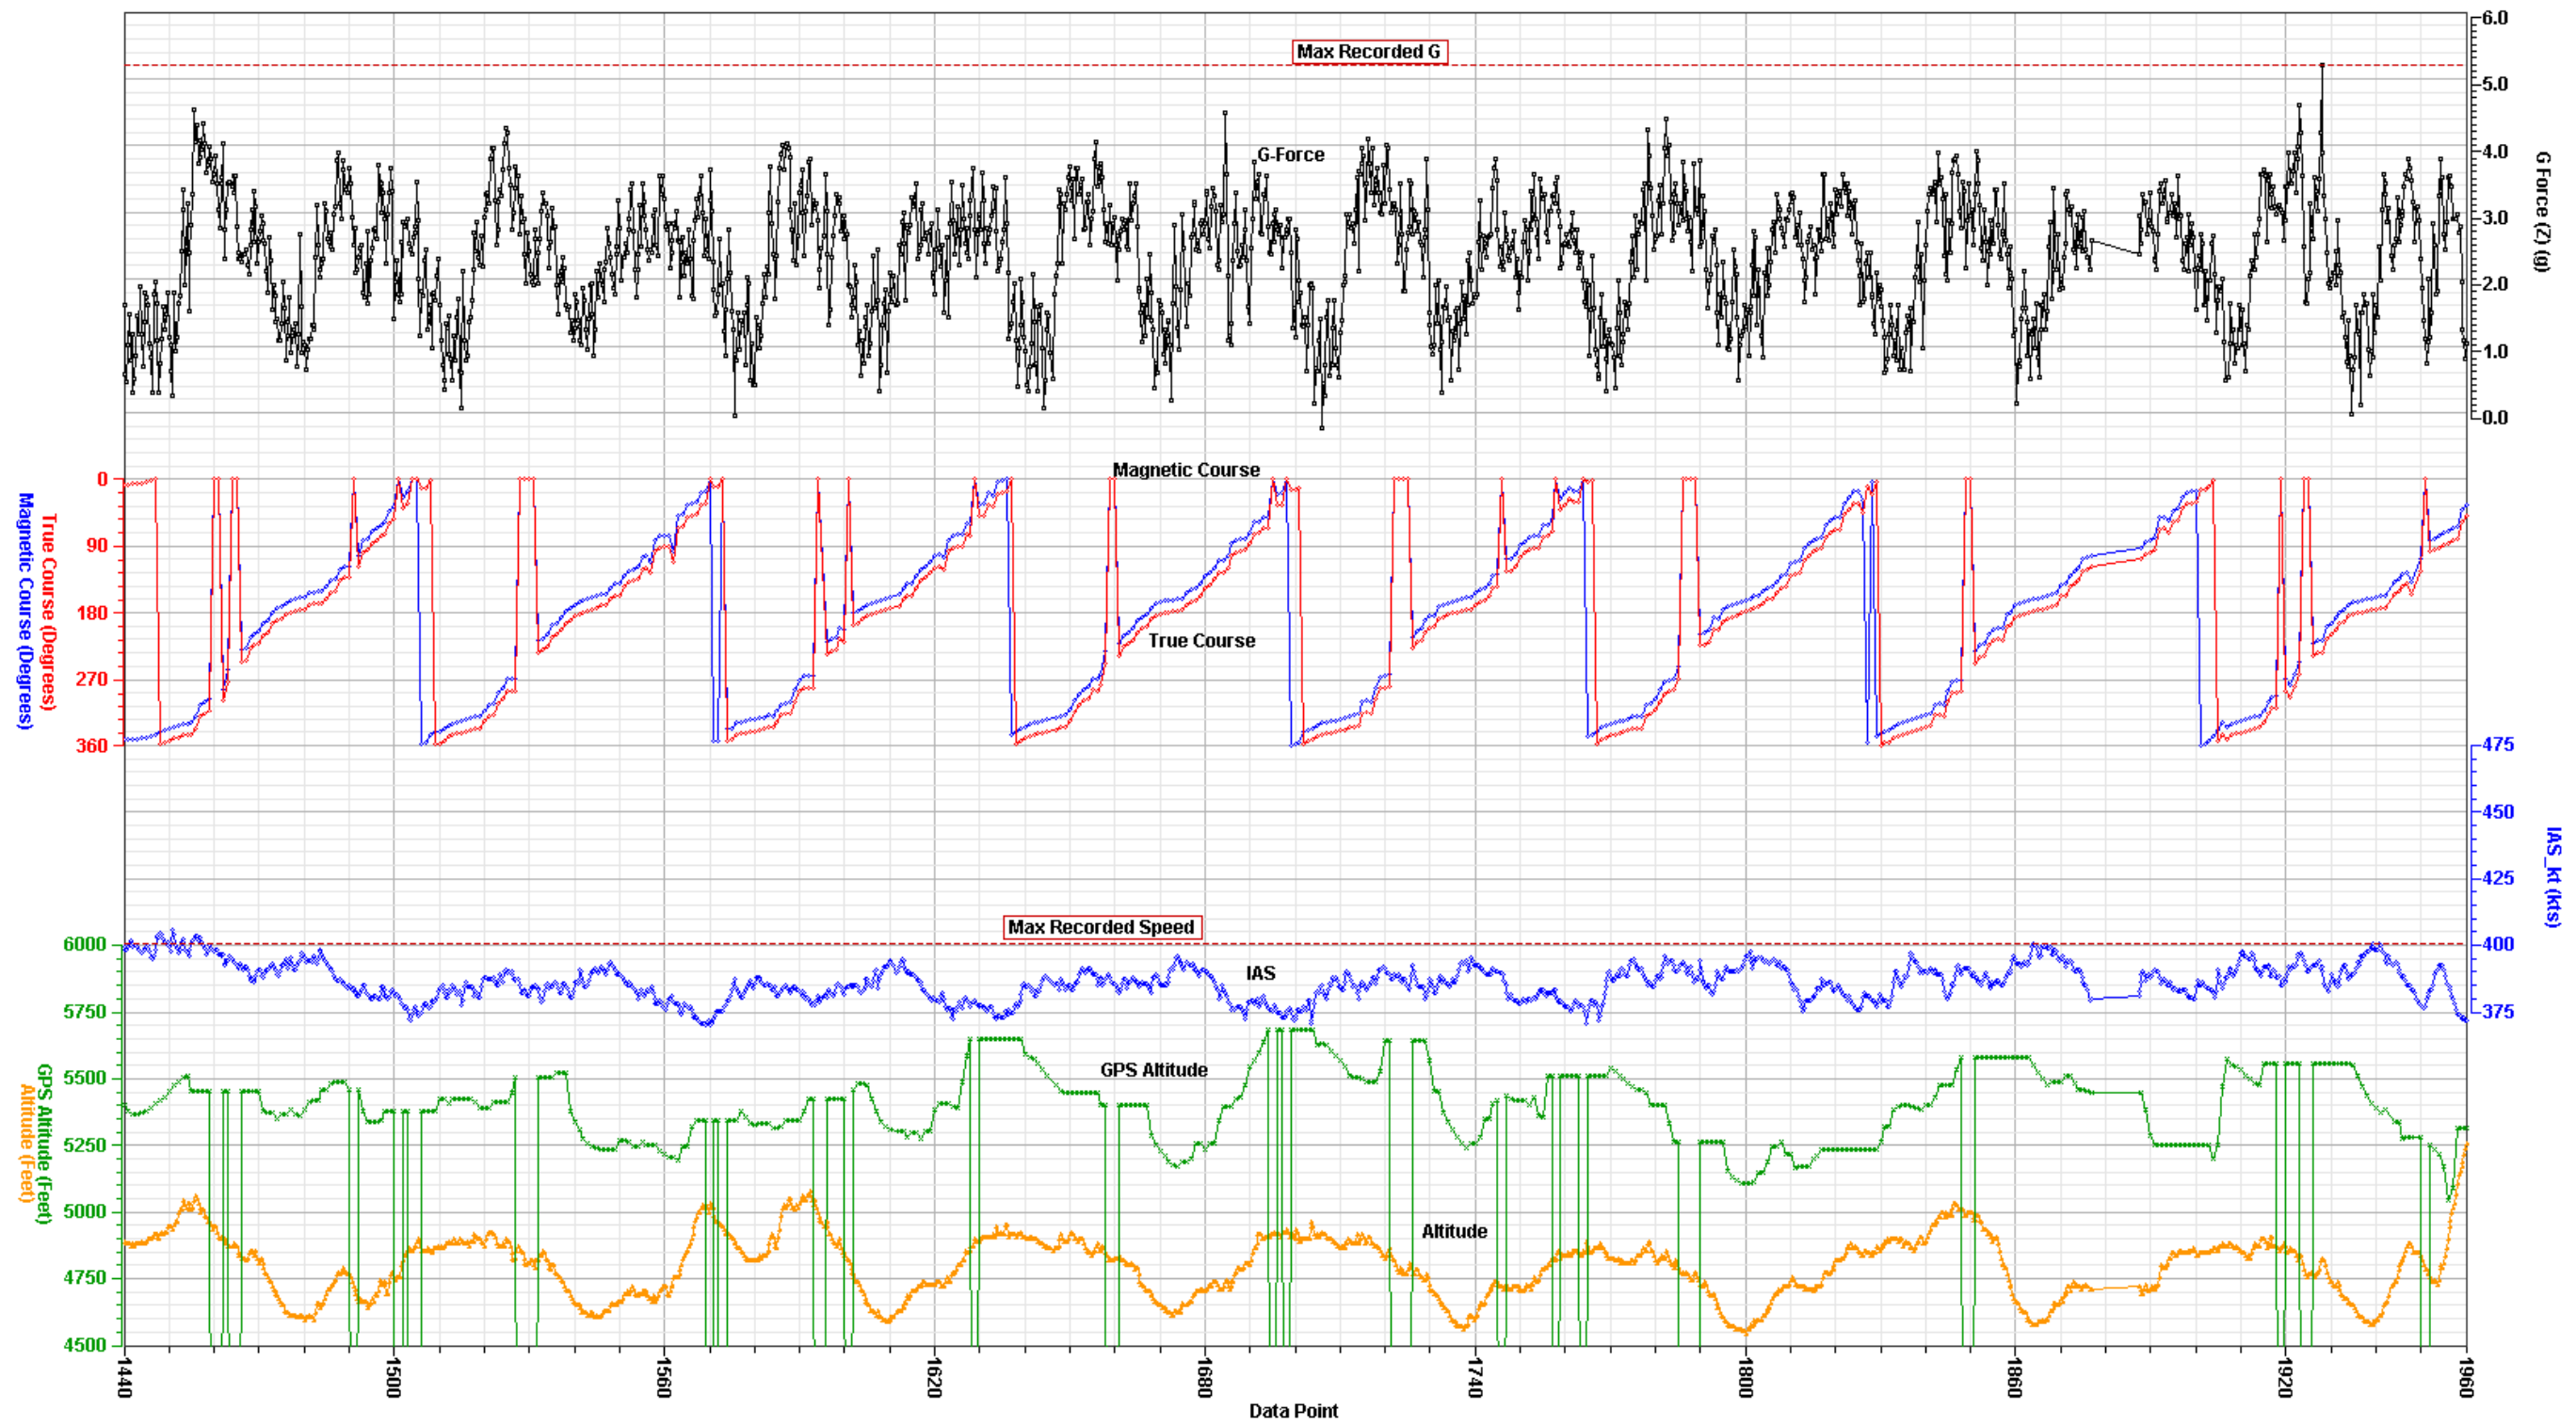
Figure 19 - Basic information for additional aircraft 2 (September Fury) recorded during a gold class race in 2008 (clipped wings)

Figure 19 contains a plot of basic information from a gold class race in 2008. The aircraft wing was modified from its original manufactured configuration by reducing the overall wingspan. The portion of the data plotted was recorded during maneuvering on the NCAR course. The maximum recorded velocity was 401 kts and the maximum recorded vertical acceleration was 5.3 g. The flight originated and terminated at RTS.
