# NATIONAL TRANSPORTATION SAFETY BOARD

# **Digital Camera**

Specialist's Factual Report By Bill Tuccio, Ph.D.

Location:	Ancho, New Mexico
Date:	September 16, 2017
Aircraft:	Bell 206L-3
Registration:	N213TV
Operator:	WQRE TV-13
NTSB Number:	CEN17FA355

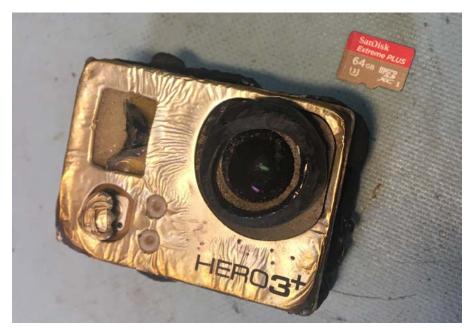
Figure 1. GoPro, as received.

Upon arrival at the Vehicle Recorder Laboratory, an examination revealed the unit had sustained significant heat damage, as shown in figure 1. The 64 gigabyte (gb) microSD card was removed with some difficulty, and appeared intact, as shown in figure 2.
