# NATIONAL TRANSPORTATION SAFETY BOARD

## 17 – Electronic Device Factual Report

Specialist's Factual Report  
by Bill Tuccio

Location: Parkton, North Carolina  
Date: December 16, 2012  
Aircraft: Piper PA-28-160  
Registration: N5714W  
Operator: Private  
NTSB Number: ERA13FA088

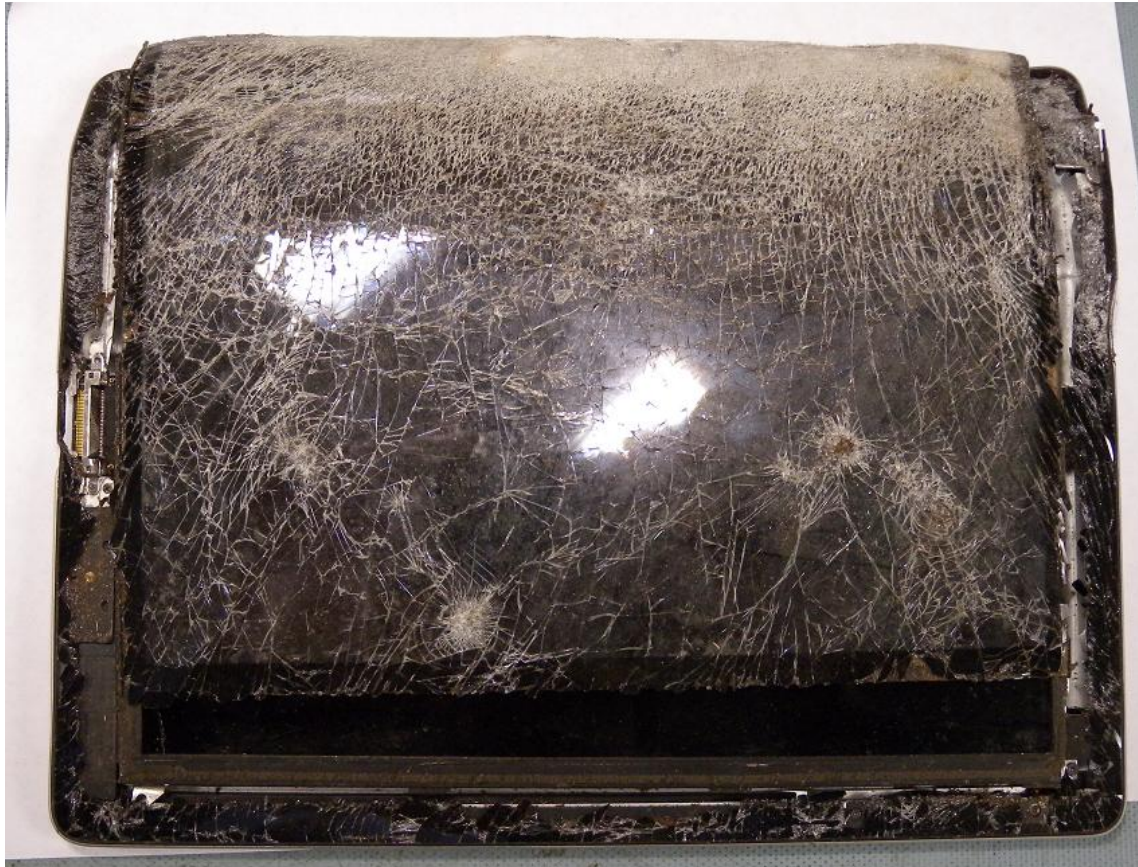
Upon arrival at the Vehicle Recorder Laboratory, an exterior examination revealed that the unit had sustained significant impact damage, as shown in figure 1. The unit was disassembled, as shown in figure 2. The main memory board was bent and at least two internal chips were cracked, as shown in figure 3. No further recovery efforts to obtain data were attempted.

**Figure 1. Apple iPad 3 - front.**

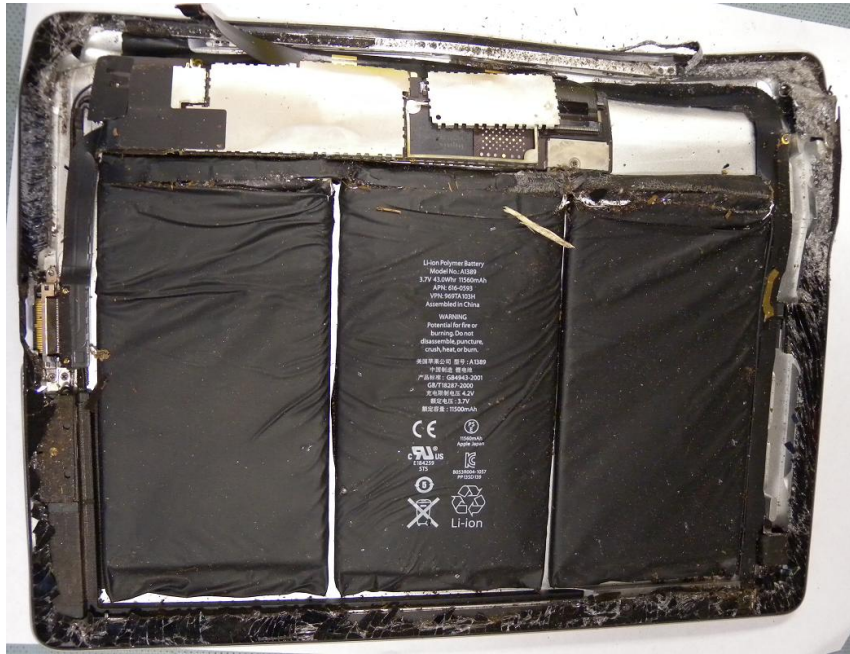
Figure 2. Apple iPad 3 - internal.

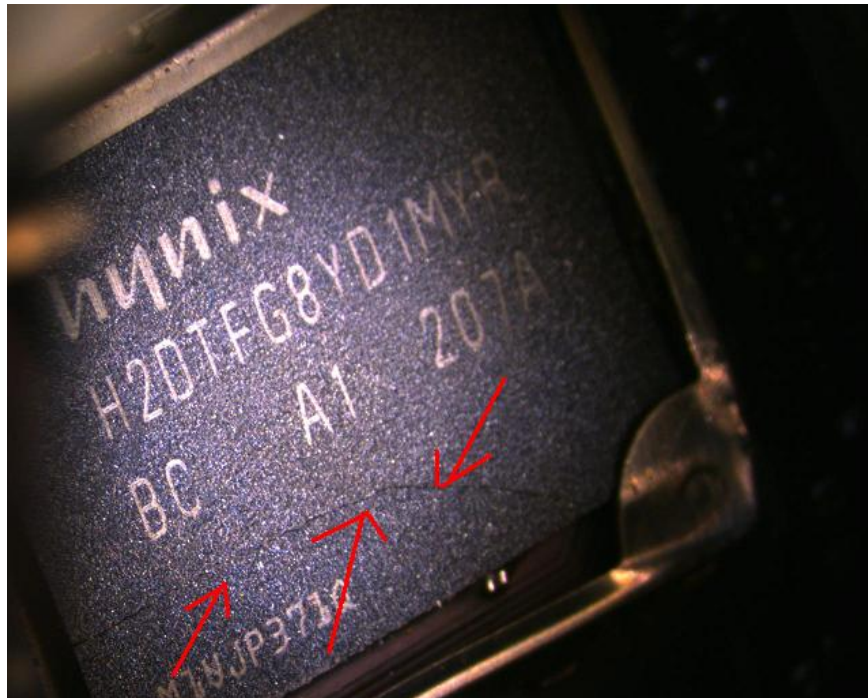
Figure 3. Cracked chip.
