NATIONAL TRANSPORTATION SAFETY BOARD

17 – Electronic Device Factual Report

Location:Moscow, TennesseeDate:July 11, 2012Aircraft:Cirrus SR20Registration:N764RVOperator:PrivateNTSB Number:ERA12FA438

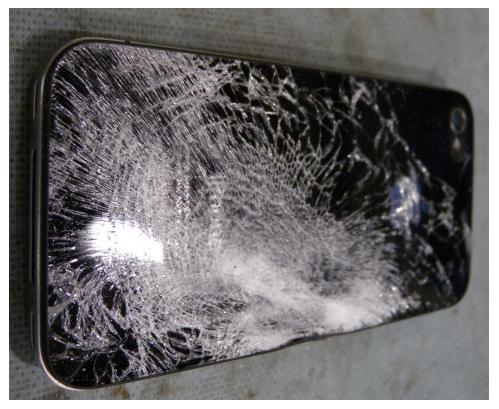
Figure 2. Damaged iPhone - rear.

Upon arrival at the Vehicle Recorder Laboratory, an exterior examination revealed the iPhone had sustained substantial damage (see figures 1 and 2); however information was extracted using forensic software.
