**NATIONAL TRANSPORTATION SAFETY BOARD**

**Electronic Device Factual Report**

**Specialist's Factual Report  
by Bill Tuccio**

Location: Jennings, Louisiana  
Date: February 15, 2013  
Aircraft: WSK PZL Mielec M-18A  
Registration: N4305D  
Operator: Riceland Aviation, Inc.  
NTSB Number: CEN13LA163

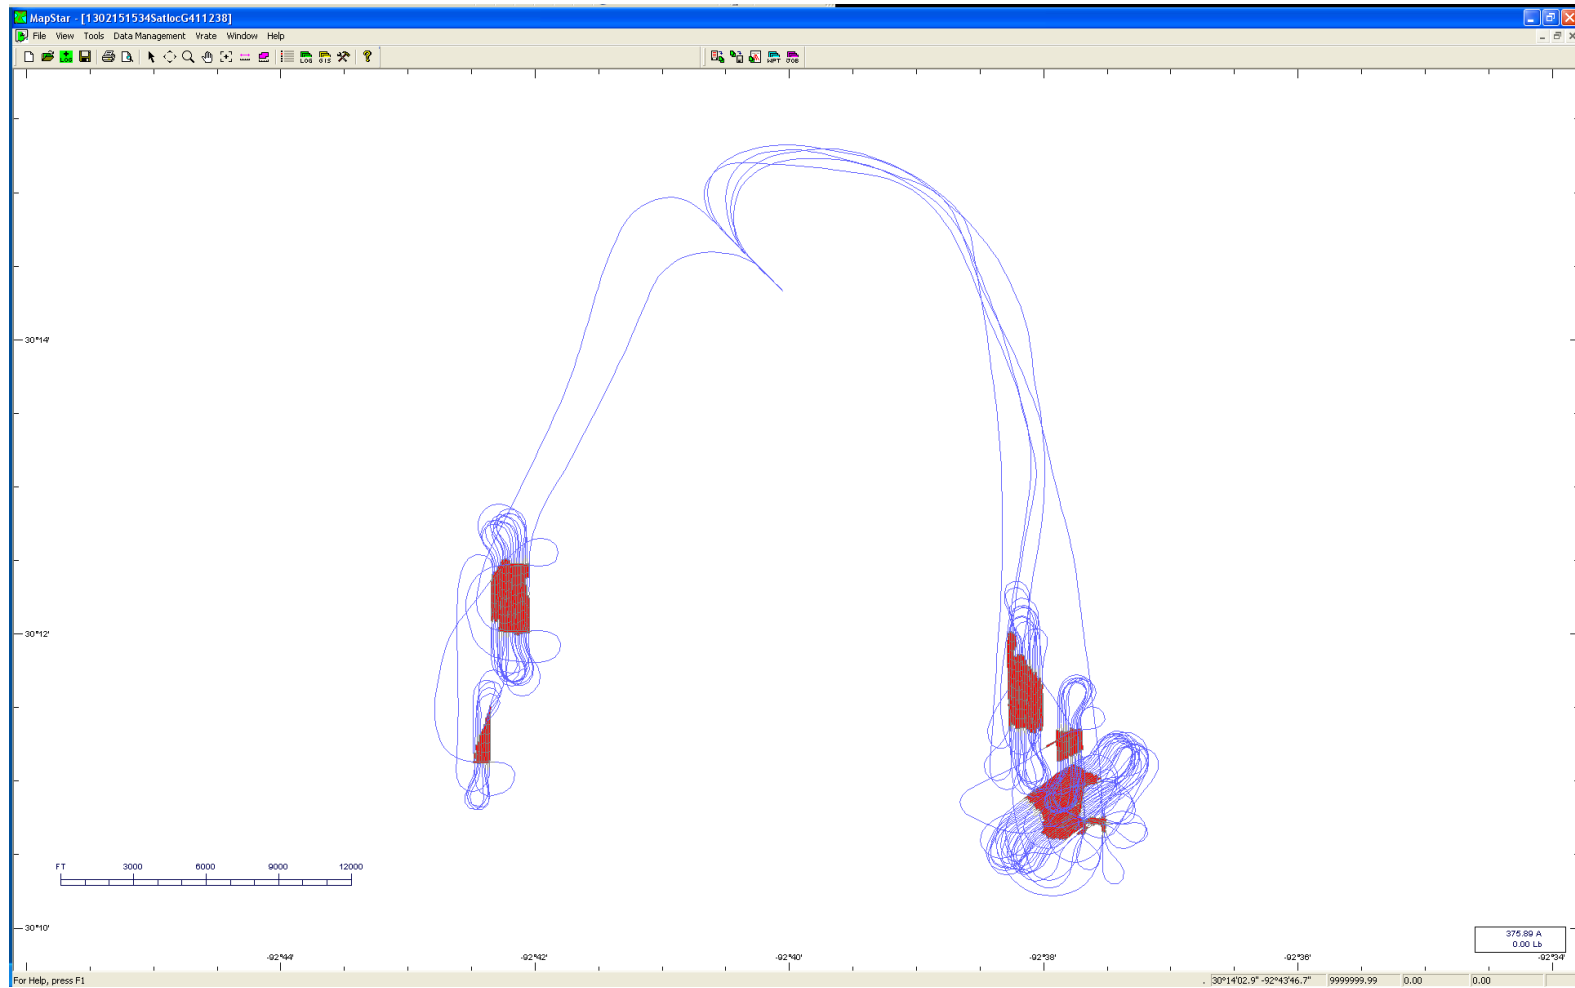
Figure 3. MapStar output of track and spray pattern.

Figure 3 shows a MapStar output from the file containing the accident flight. The output covers the period from 1551:20.39 to 1756:38.29 Satloc recorded time on February 15, 2013. The red areas in Figure 3 are those areas where the Spray discrete recorded value was non-zero. Figure 4 shows the same time period as figure 3, overlaid using Google Earth, with select points annotated. The last recorded point at 1756:38.29 Satloc recorded time is shown in the eastern portion of the recorded track.

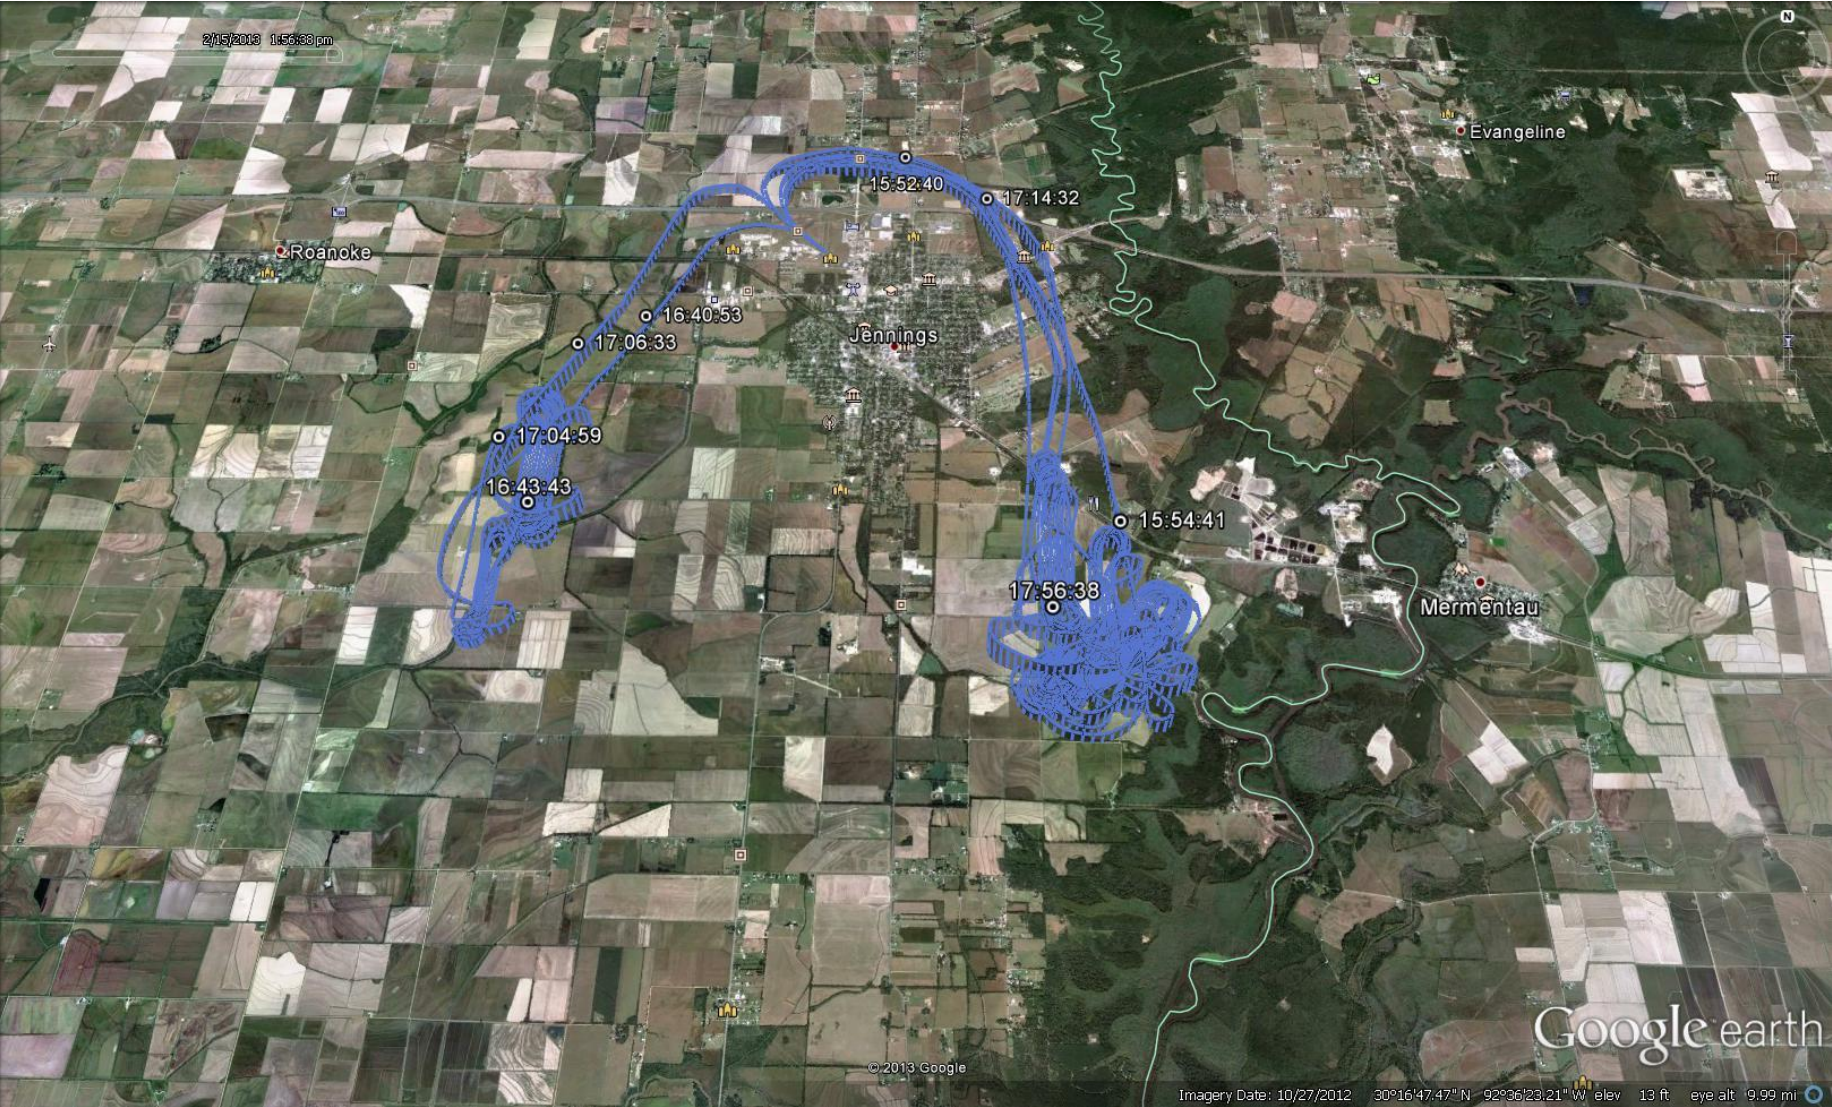
Figure 4. Google Earth overlay of ground track for entire recording.
