NATIONAL TRANSPORTATION SAFETY BOARD

Electronic Device Report

Specialist's Factual Report

Location: Veneta, Oregon
Date: June 23, 2012
Aircraft: Cessna 172, N5781A
Operator: Private
NTSB Number: WPR12FA274

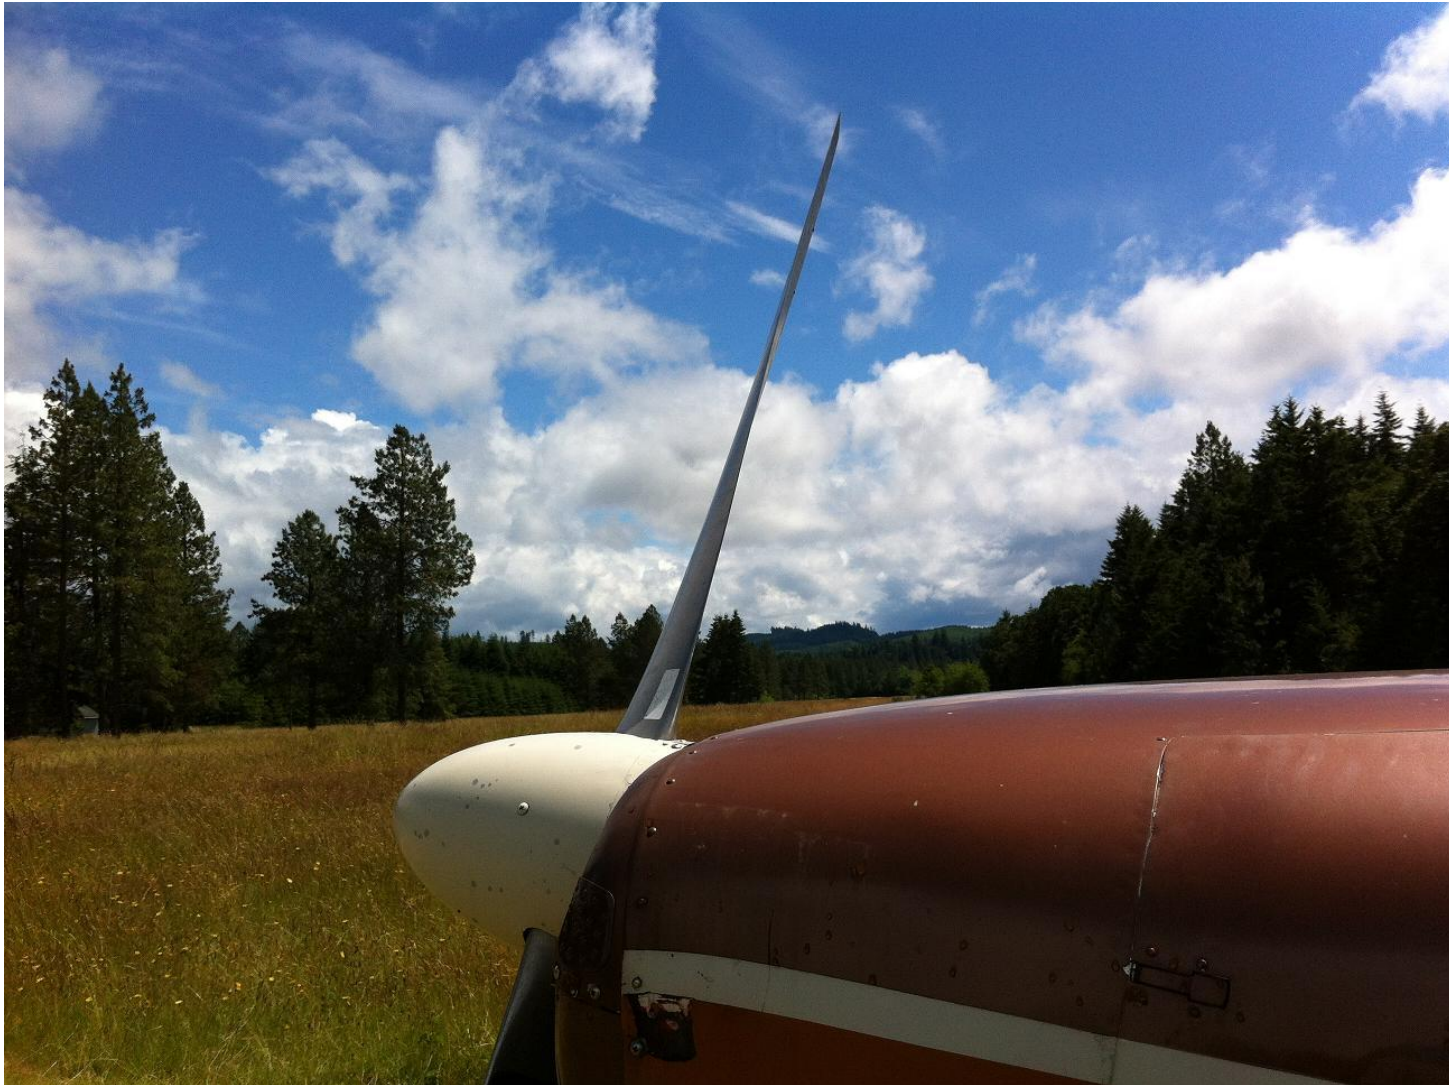
Figure 1 is a photo of the accident aircraft taken at 14:44:51 PDT. The photo shows the front left engine cowl and aircraft propeller. The background shows partly cloudy sky conditions about a half hour before the accident and part of the airport environment.

Figure 1: Front left engine cowling and propeller, 14:44:51 PDT
