NATIONAL TRANSPORTATION SAFETY BOARD

Electronic Devices

Specialist's Factual Report
by Bill Tuccio, Ph.D.

Location: Togiak, Alaska
Date: October 2, 2016
Aircraft: Cessna 208B
Registration: N208SD
Operator: Hageland Aviation Services, Inc.
NTSB Number: ANC17MA001

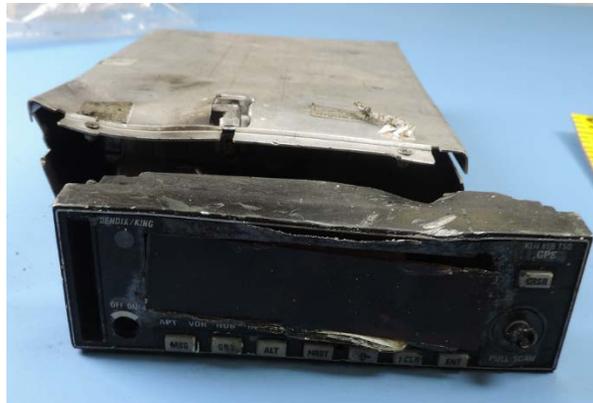
Figure 1 shows the King KLN-89B as received. Notably, the database card was absent from the leftmost slot. Figure 2 shows an internal inspection, revealing heat damage to memory chips in the forward part of the compartment. Given this damage, no data recovery was attempted.

Figure 1. Device 1: King KLN-89B, as received.

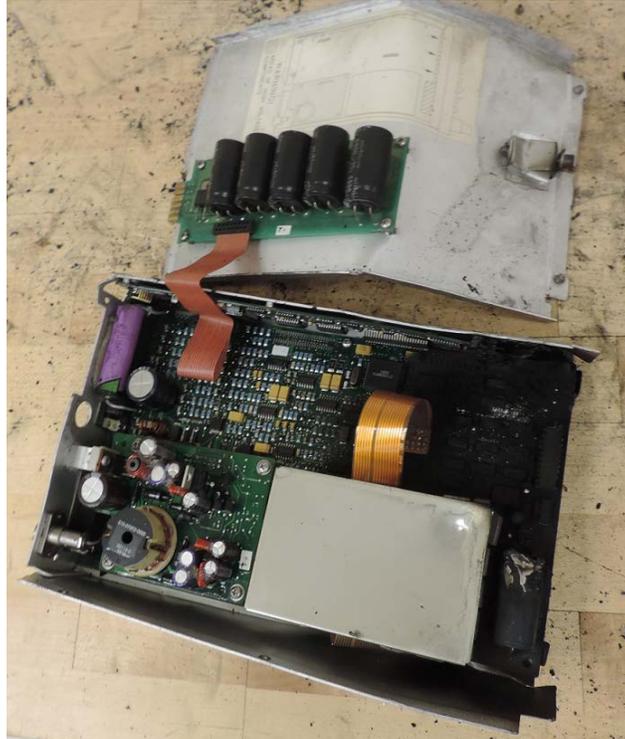
Figure 2. Device 1: King KLN-89B, internal.

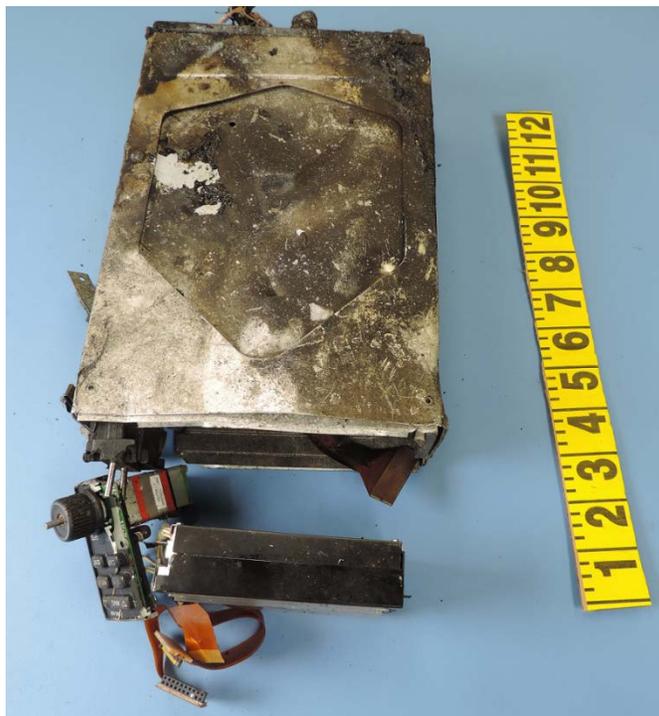
Figure 3 shows the Garmin 430W as received, and figure 4 shows the internal components of the device. The database cards were missing from the device. The Garmin 430W does not record track history and retains few state parameters (for example, last frequencies). Given the damage, no recovery was attempted.

Figure 3. Device 2: Garmin 430W, as received.

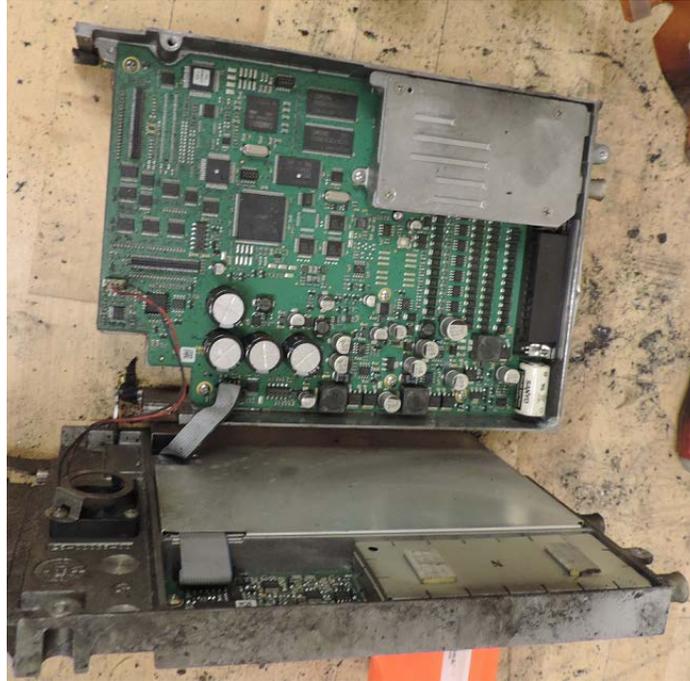
Figure 4. Device 2: Garmin 430W, internals.

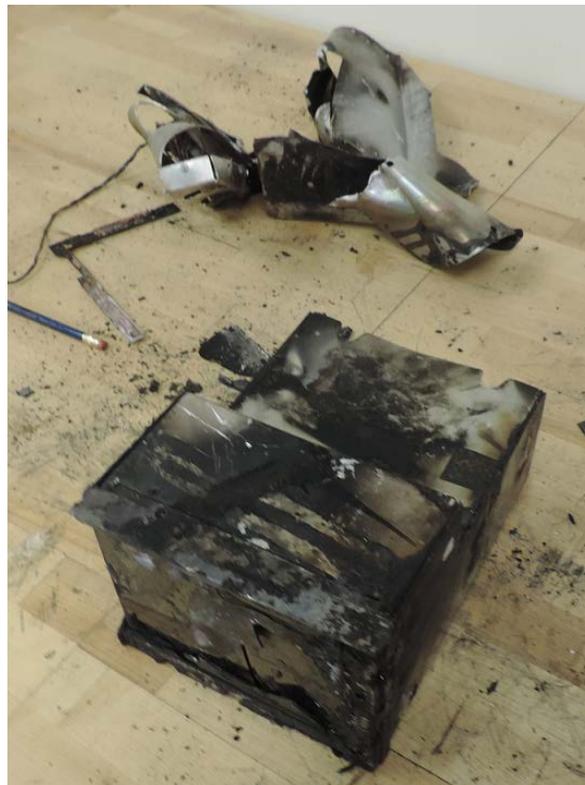
Figure 5 shows the Garmin GMX200, with its exterior mounting rack removed. Figure 6 shows the internal inspection, with most electronic components destroyed by heat damage. No recovery was possible due to the heat damage.

Figure 5. Device 3: Garmin GMX200, exterior.

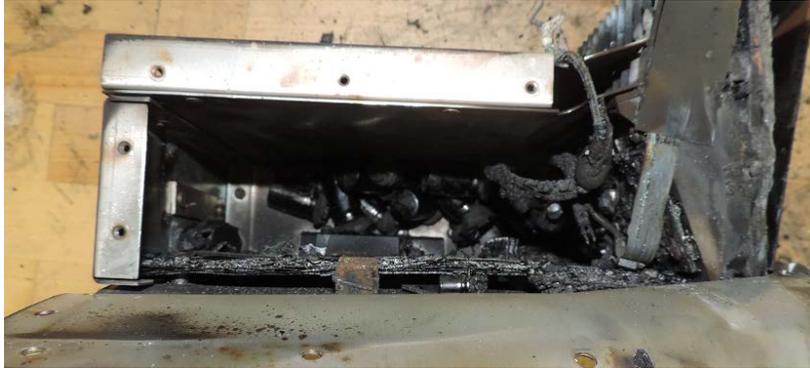
Figure 6. Device 3: Garmin GMX200, interior.

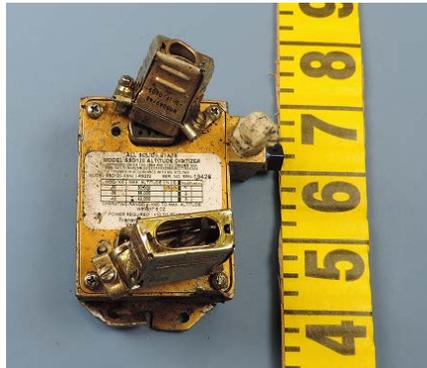
Figure 7 shows the Trans Cal Altitude Digitizer. According to the manufacturer, the device did not record any historical data; thus, no data recovery was attempted.

Figure 7. Device 4: Trans Cal SSD 120 Altitude Digitizer, as received.

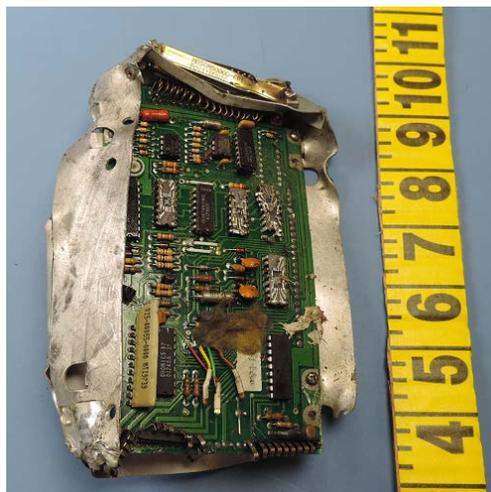
Figure 8 shows the Bendix/King DME. Due to significant damage to electronic chips on the printed circuit board, no recovery was attempted.

Figure 8. Device 5: Bendix/King KDI 572 DME, as received.

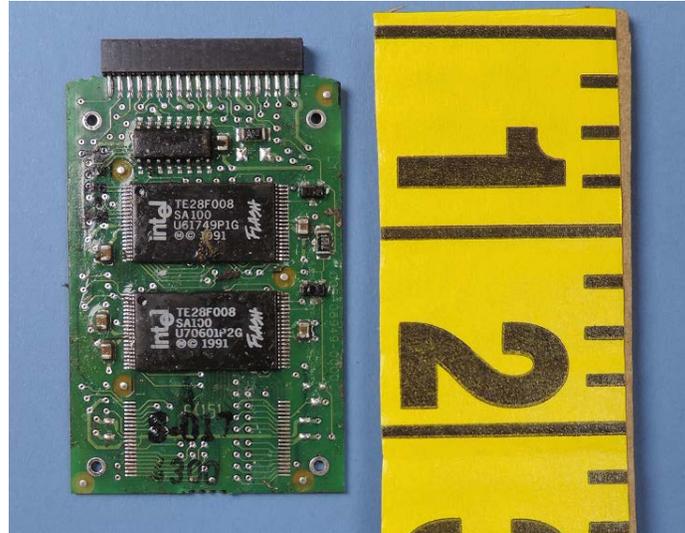
Figure 9 shows a printed circuit board (PCB), as received. Exterior inspection was insufficient to determine the origin of the PCB. The non-volatile memory chips were

removed from the board and read out, creating a binary image of the memory chips. The binary images revealed the PCB was a database card for a Bendix/King KLN89 generation device. The binary image was sent to the manufacturer to determine the database cycle contained on the card.

Figure 9. Device 6: Bendix/King KLN89 Database Card, as received.

According to the manufacturer, the card contained database cycle 1610, which was effective between September 15, 2016, and October 12, 2016.
