NATIONAL TRANSPORTATION SAFETY BOARD

Electronic Devices Factual Report

Location: Conway, South Carolina
Date: August 3, 2013
Aircraft: Beech D55
Registration: N7641N
Operator: Private
NTSB Number: ERA13FA348

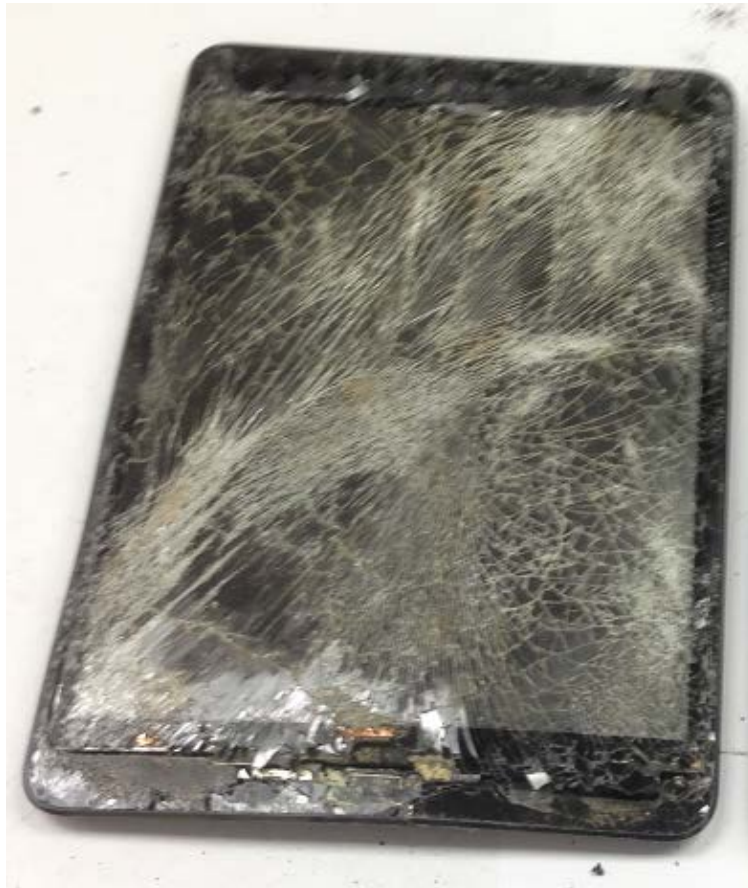
Figure 1. Apple iPad Mini.

Upon arrival at the Vehicle Recorder Laboratory, an exterior examination revealed the Apple iPad Mini (figure 1), an unidentified device (figure 2), a Garmin Aera 560 (figure 3), a BF Goodrich Stormscope (figure 4), and a Garmin GTN 750 (figure 5) had sustained extensive structural and/or heat damage. Recovery was attempted, but due to the damage, data was not recovered.

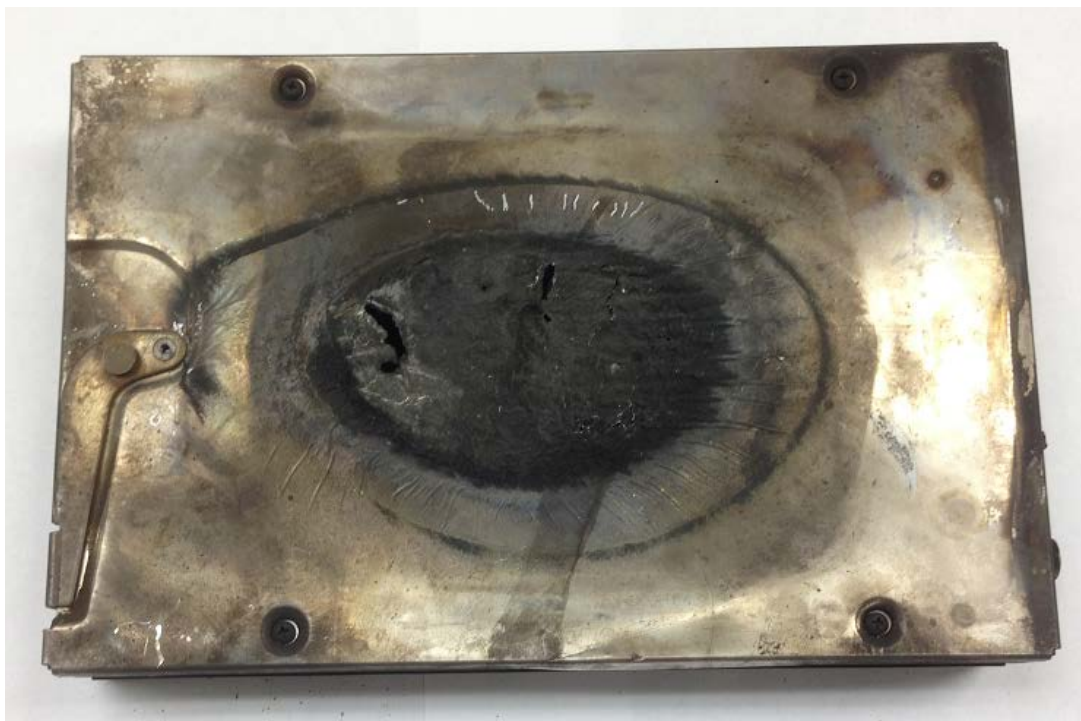
Figure 2. Unidentified device.

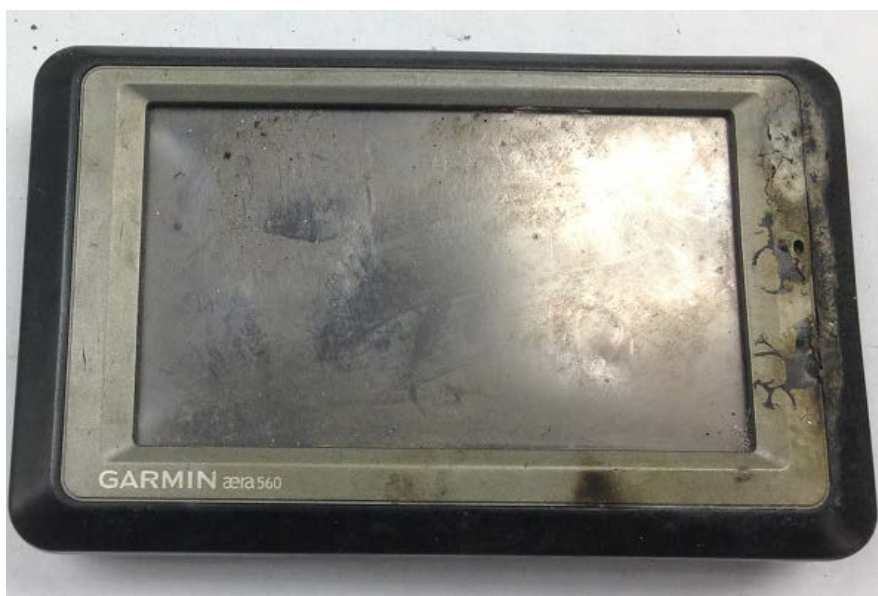
Figure 3. Garmin aera 560.

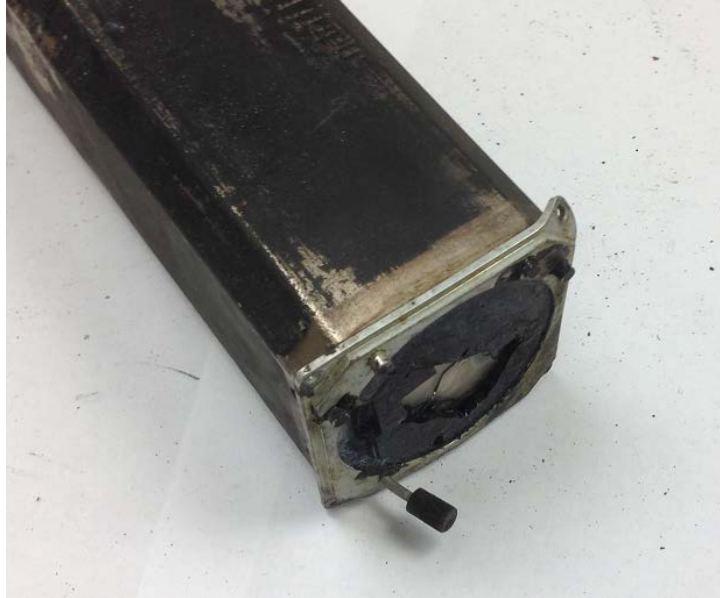
Figure 4. BF Goodrich Stormscope.

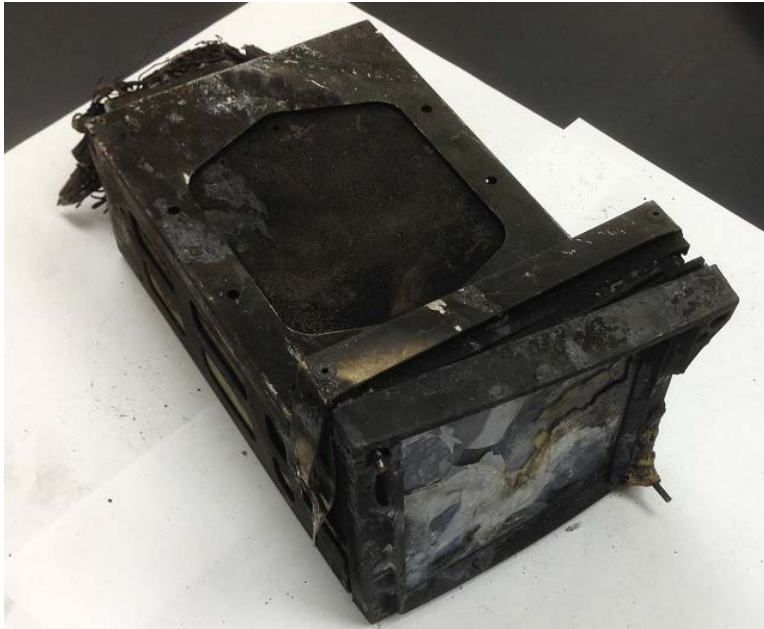
Figure 5. Garmin GTN 750.

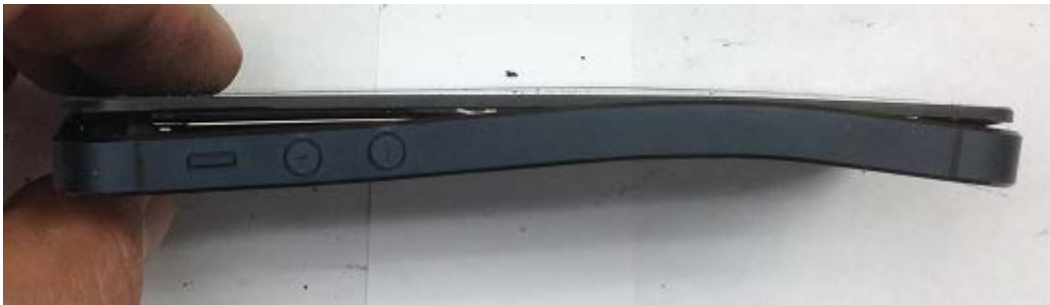
Upon arrival at the Vehicle Recorder Laboratory, an exterior examination revealed the unit had sustained significant impact damage, as shown in figure 6. The device was disassembled, as shown in figure 7. The main internal board was installed in a surrogate unit, and the surrogate unit started normally, as shown in figure 8. Data was then extracted through an examination of user interface screens and electronic downloads.

Figure 6. Apple iPhone 5 impact damage.

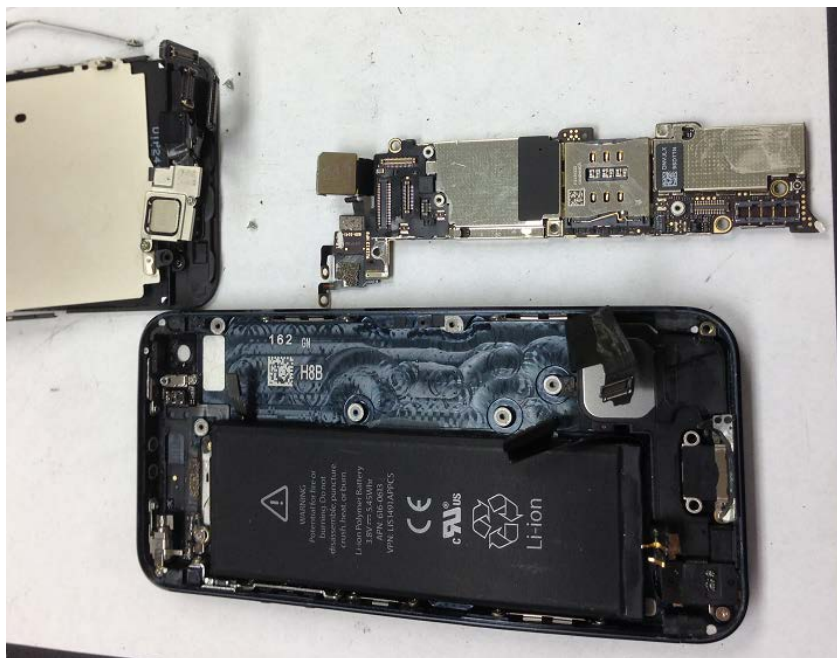
Figure 7. Apple iPhone 5 disassembled.

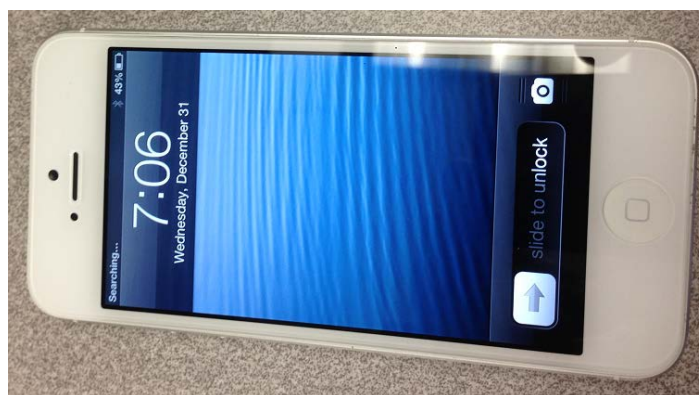
Figure 8. Apple iPhone 5 started in surrogate unit.
