# NATIONAL TRANSPORTATION SAFETY BOARD

## Electronic Devices

Specialist's Factual Report  
by Bill Tuccio, Ph.D.

Location: Russell, Iowa  
Date: August 9, 2014  
Aircraft: Barger Van's Aircraft RV-7  
Registration: N92BF  
Operator: Private  
NTSB Number: CEN14LA424

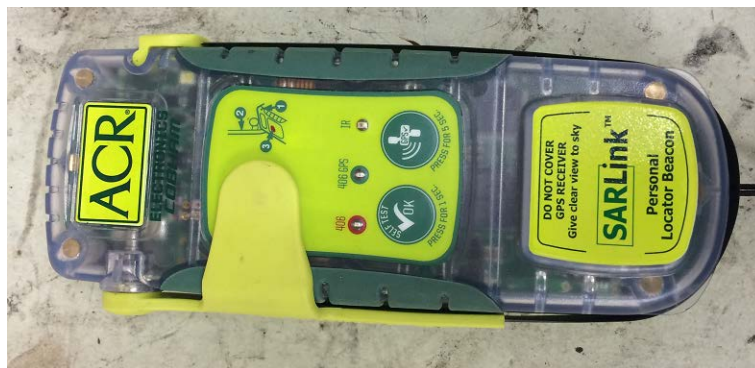
The Artex SARLink, shown in figure 1, is a satellite-based emergency locator beacon; in agreement with the Investigator-in-Charge (IIC), it was determined the device did not contain any pertinent information.

Figure 1. Artex SARLink device.

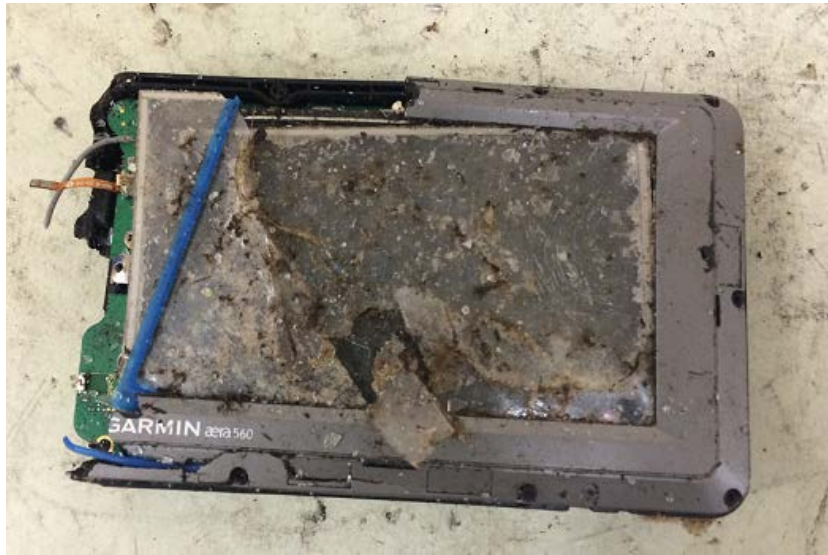
The Garmin Aera 560, shown in figure 2, is a GPS device capable of recording track history. Due to the extensive damage of the Garmin Aera 560 and the recoverability of pertinent information from the Garmin GPSMAP 196, it was determined the Garmin Aera 560 would not provide any additional information for the investigation.

**Figure 2. Garmin Aera 560.**

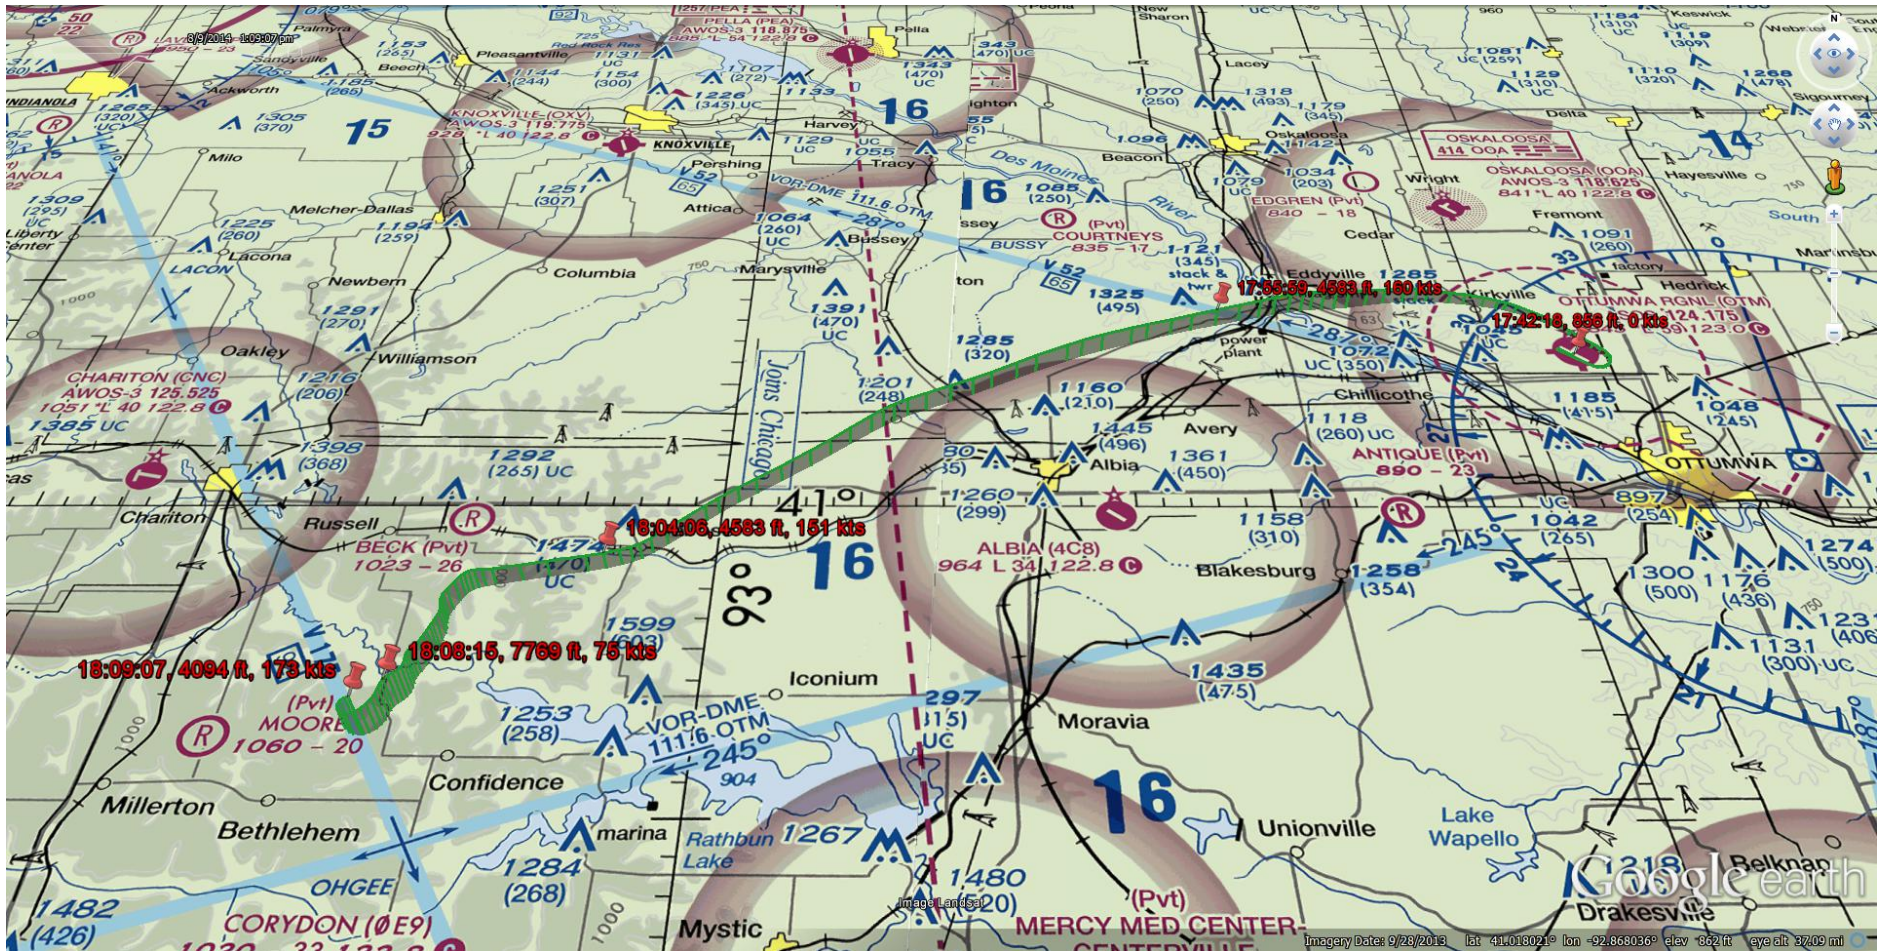
Figures 8 and 9 provide an overview of the flight overlaid on satellite imagery and an aviation sectional chart, respectively. The recorded data began at 17:42:18 UTC at OTM. The aircraft departed and proceeded west/southwest at an initial altitude of about 4,500 feet. At about 18:04:51 UTC, the track of the aircraft became more westerly as the aircraft began to climb to a maximum recorded altitude of 7,769 feet. The aircraft then descended and increased speed until the end of the recording at 18:09:07 UTC.

Figure 9. Accident flight as recorded by Garmin 196 (sectional chart overlay).

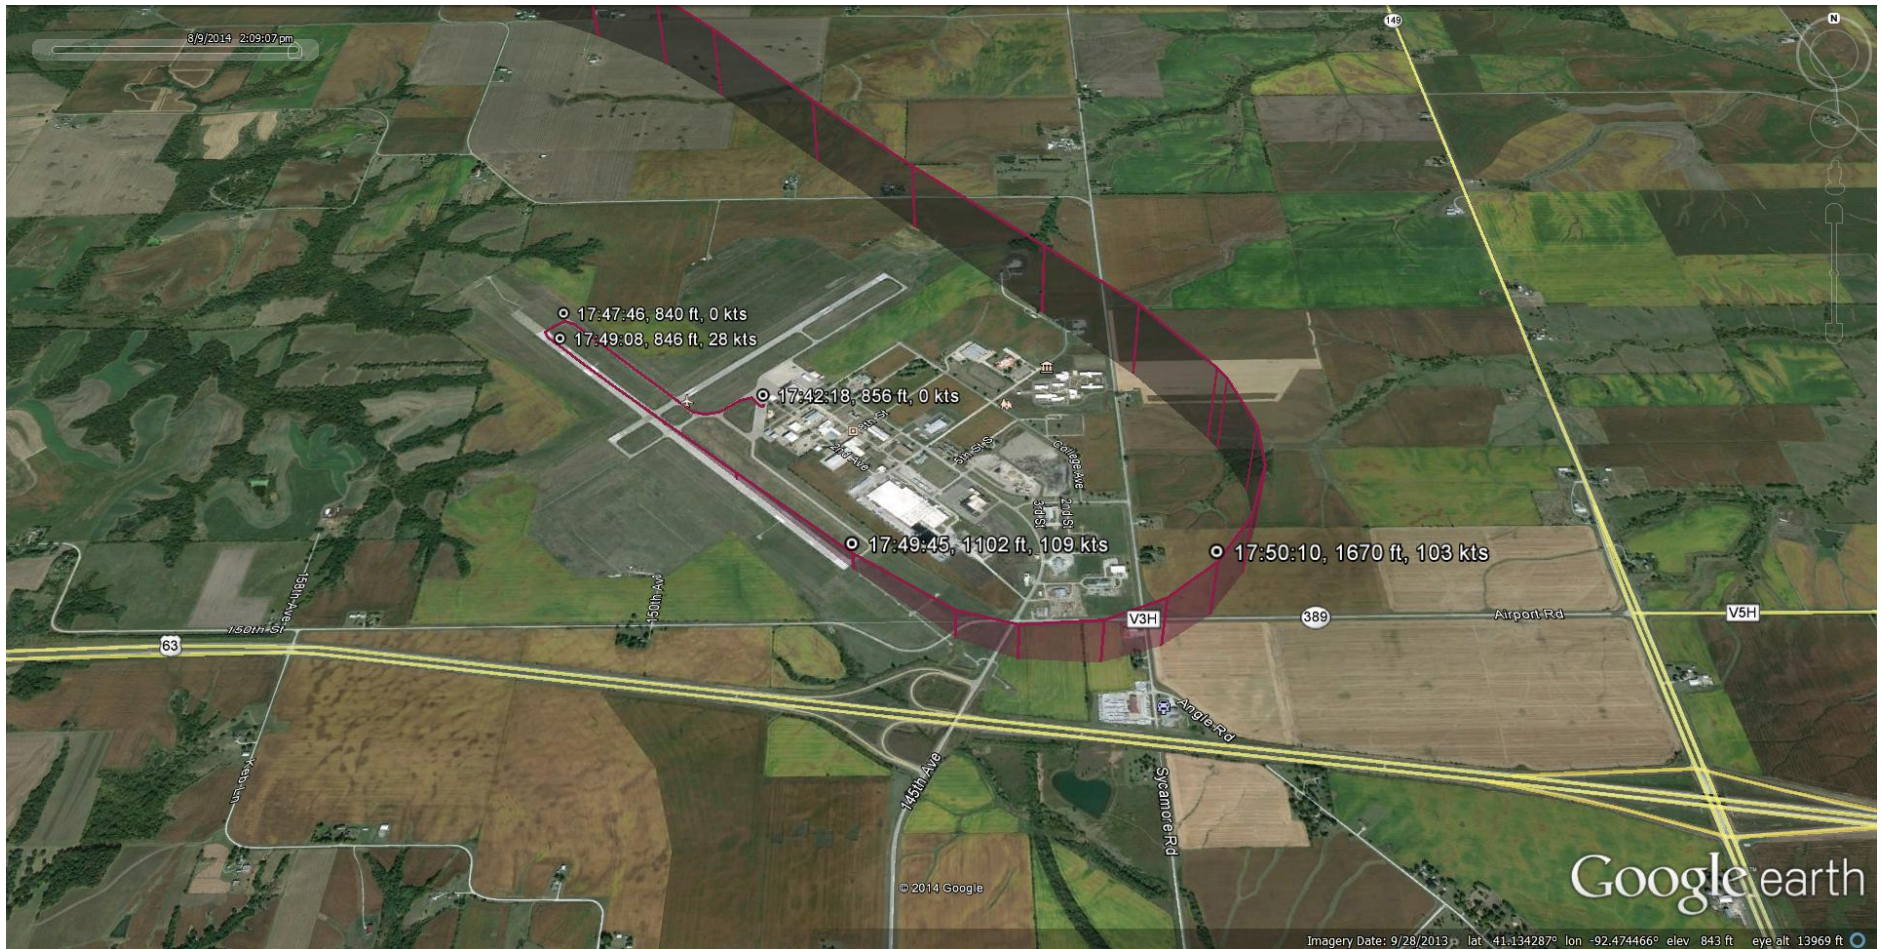
Figure 10 shows the start of the recording at OTM. The recording began at 17:42:18 UTC on a ramp area. The aircraft taxied to runway 13 and took off about 17:49 UTC. After takeoff, the aircraft made a left turn and climbed to the northwest before proceeding southwest. After reaching an initial recorded altitude of 5,052 feet at 17:54:46 UTC, the aircraft descended to an average enroute altitude of 4,500 feet by 17:56 UTC. The average enroute groundspeed was about 150 knots.

Figure 10. Accident flight – start of recording and departure from OTM.

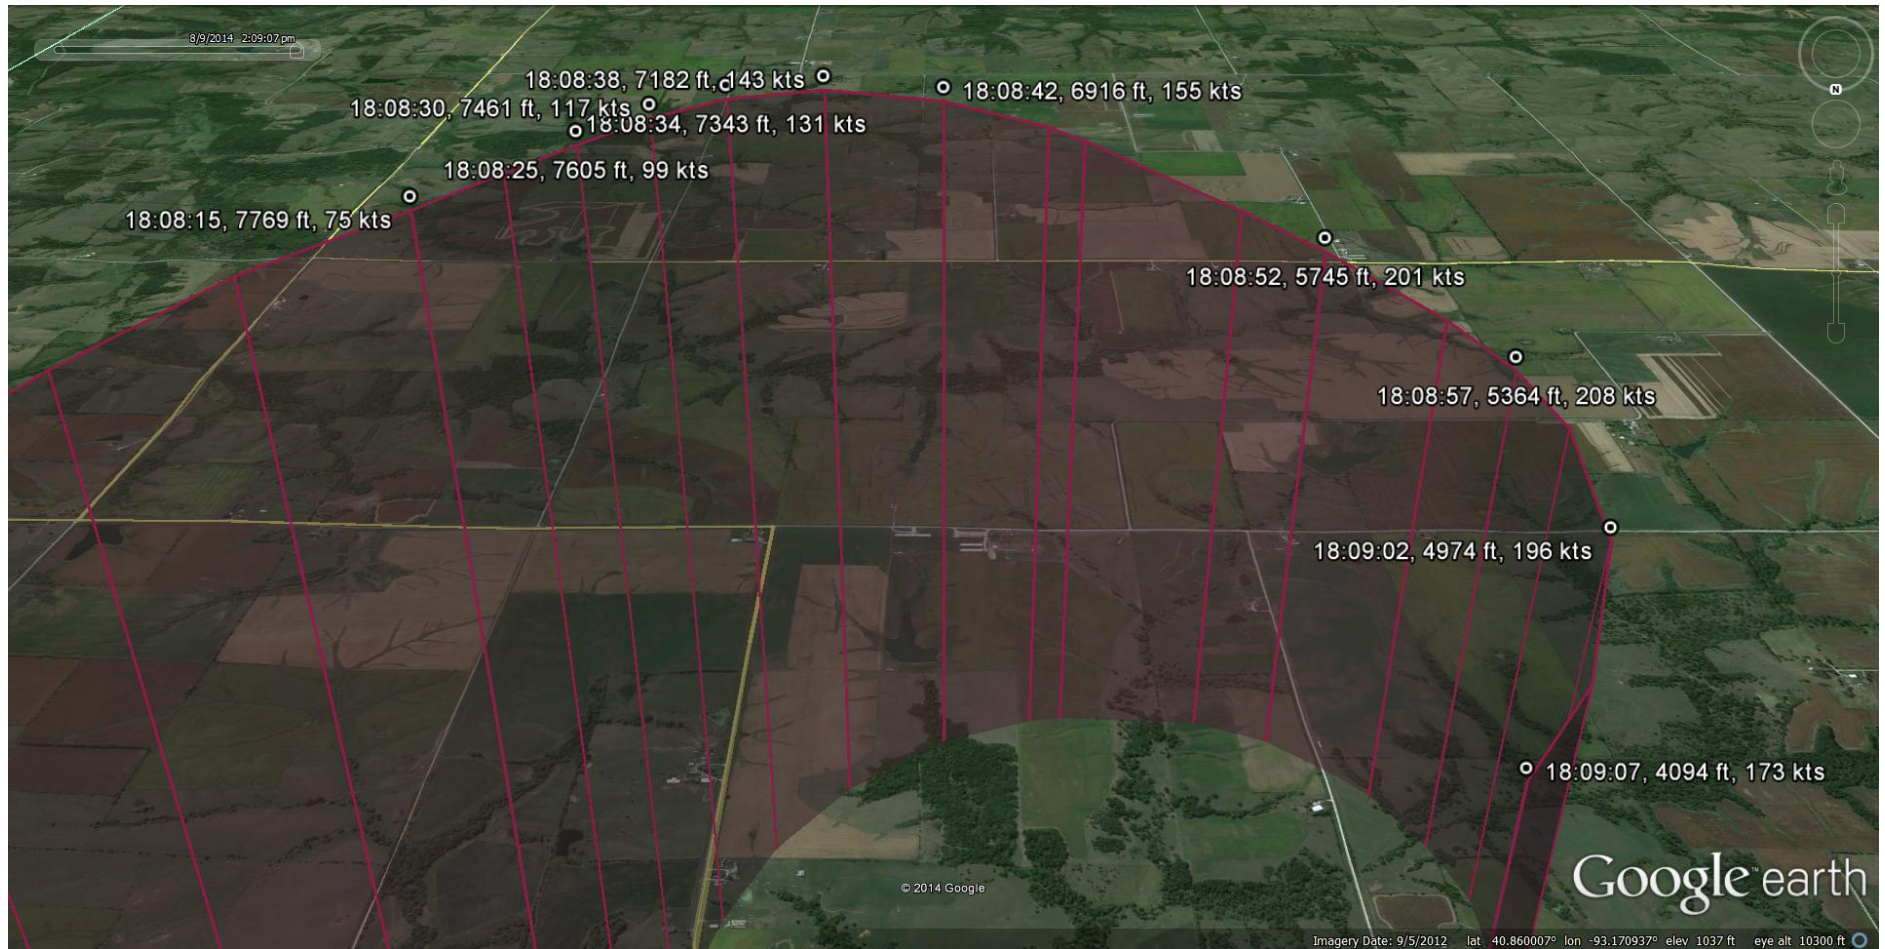
Figure 12 shows the descent from 7,769 feet, starting at 18:08:15 UTC until the end of the recording. After 18:08:15 UTC, the recorded track described a descending right turn of increasing groundspeed; reaching a maximum computed groundspeed of 208 knots by 18:08:57 UTC, as the aircraft was descending through 5,364 feet in excess of 3,000 feet per minute. The last recorded point was at 18:09:07 UTC when the aircraft was descending through 4,094 feet.

Figure 12. Accident flight – end of recording.
