**NATIONAL TRANSPORTATION SAFETY BOARD**

**Electronic Devices**

**Specialist's Factual Report  
by Bill Tuccio, Ph.D.**

Location: Parsons, Tennessee  
Date: August 20, 2014  
Aircraft: Air Tractor AT-802A  
Registration: N802BB  
Operator: Ag Air, LLC  
NTSB Number: ERA14FA399

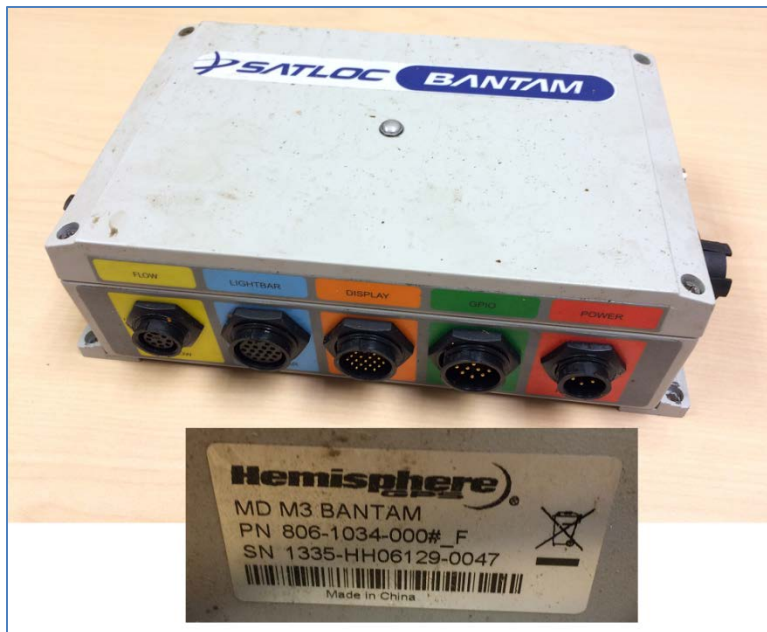
Figure 1. Photo of Satloc M3 and dataplate.

Upon arrival at the Vehicle Recorder Laboratory, an exterior examination revealed the device had not sustained any damage, as shown in figure 1. The unit was opened and the internal CF card removed, as shown in figure 2. The CF card was formatted as a Microsoft Windows file system, and binary log files were copied from the CF card. The log file on August 20, 2014, containing the accident flight was decoded using AgJunction's MapStar software.

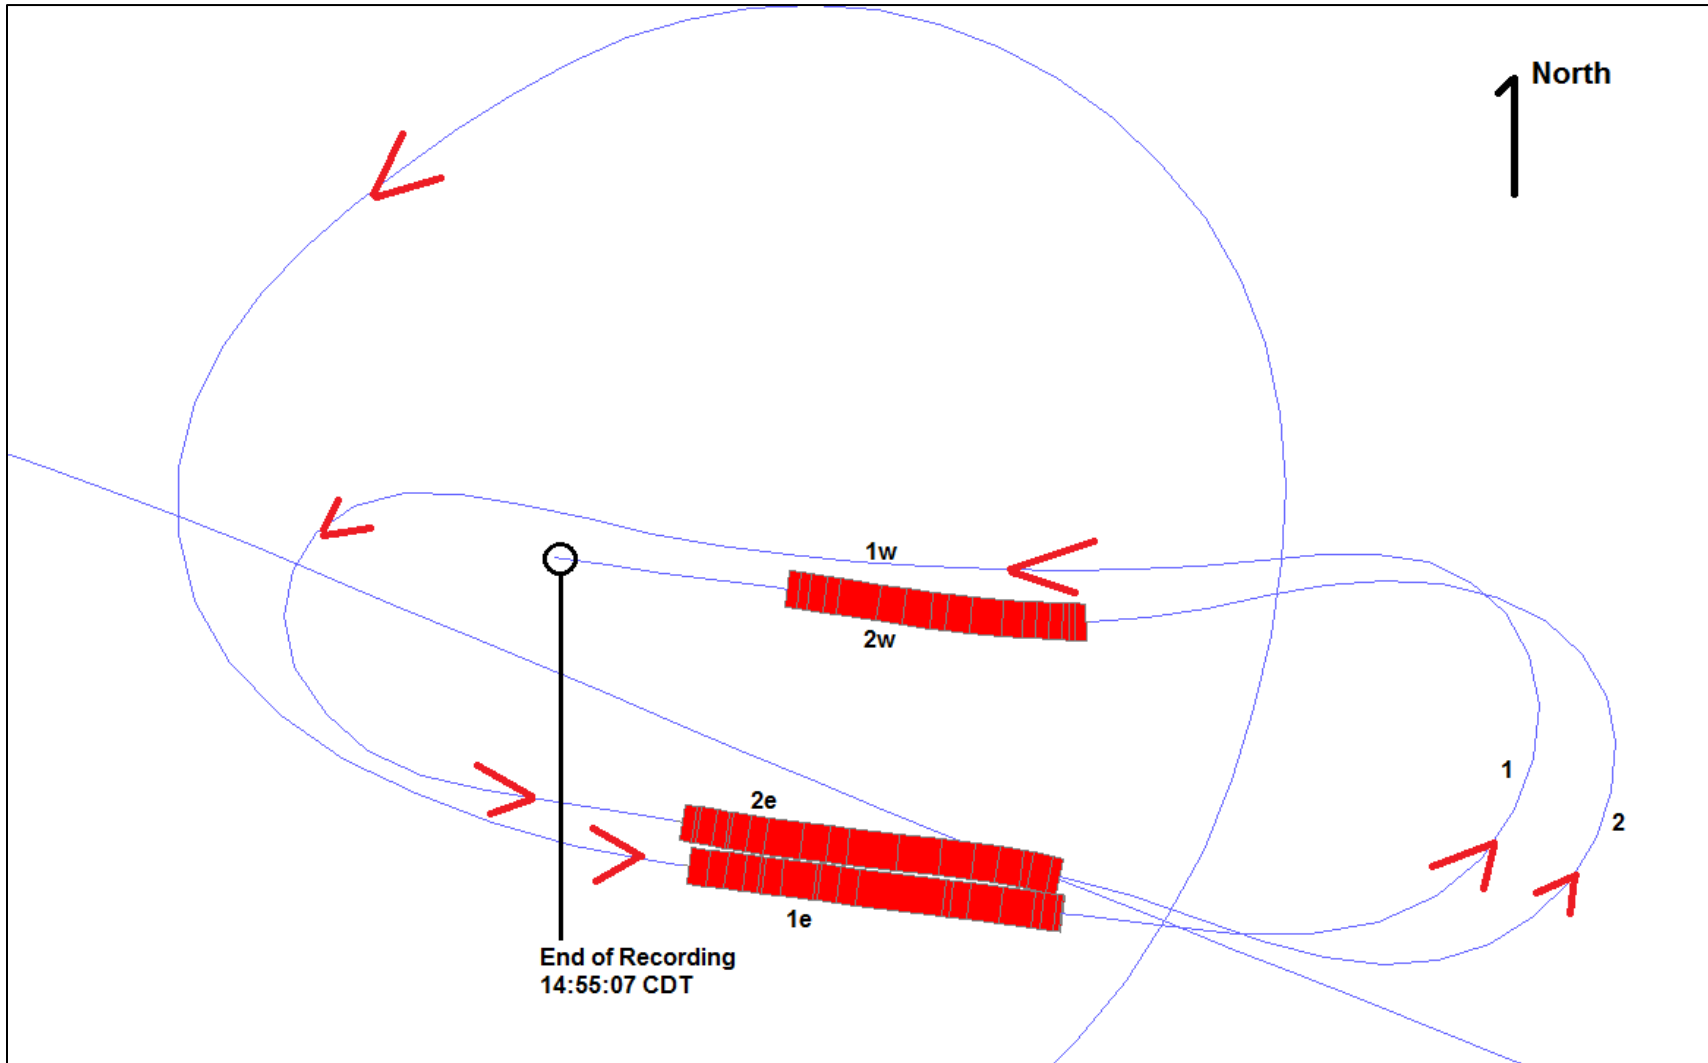
Figure 6 is an output from MapStar showing information similar to figure 5 with spray information included. Passes 1e, 2e, and 2w recorded spray applications; pass 1w did not record a spray application.

Figure 6. MapStar depiction of accident site activity.

According to the IIC, the aircraft wreckage path was on an easterly track north of pass 2e. The actual path of the aircraft after the last recorded point at 14:55:07 CDT is unknown, likely due to the delay in writing data to the CF card during an abrupt power interruption.
